# California Tree and Landscape Consulting, Inc.

## PRELIMINARY ARBORIST REPORT

RE: 7705 Hickory Ave, APN #224-0240-013-0000, Orangevale CA, jurisdiction of Sacramento County, California

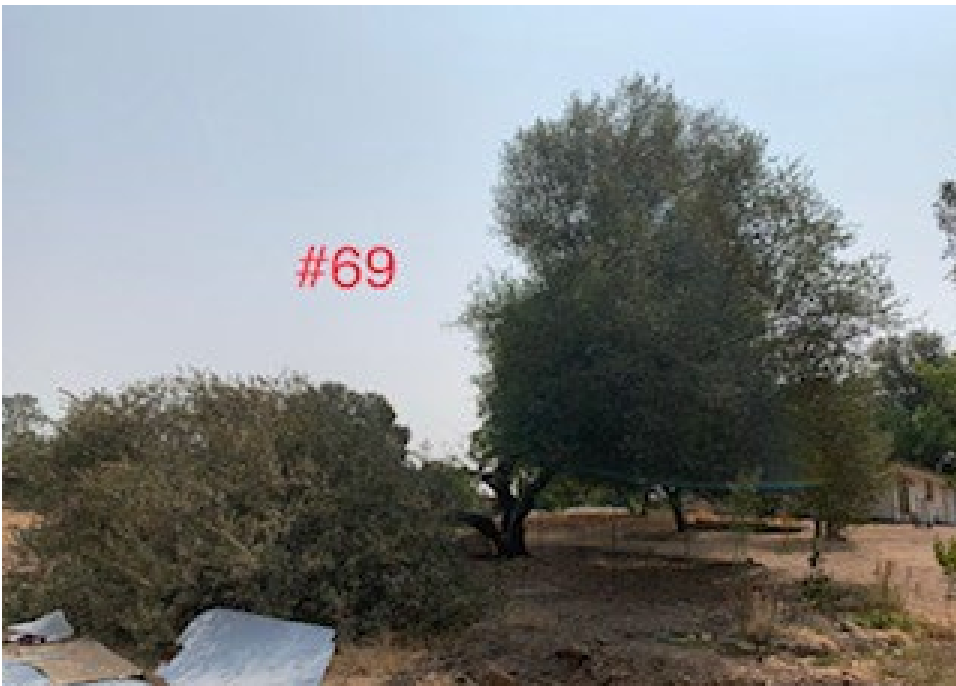
Field Tag #	Protected By Code	Off-site	Species Botanical Name	Species Common Name	DBH (in.)	Multi-Stems	Measured at (in.)	Canopy Radius (ft.)	Arborist Rating	Dvlpmt Status	Field Notes	Date of Evaluations
69	Yes		<i>Quercus wislizeni</i>	Interior live oak	23	20,12.5	54	20	1 Extreme Structure or Health Problems		Codominant at 24 inches. Severe inclusion. Two northern stems failed laying on ground. Remaining two stems one sided leaning canopy south. Recommend remoValley oak	9/16/2020
70	Yes		<i>Quercus wislizeni</i>	Interior live oak	45		36	35	3 Fair - Minor Problems		Trunk at Fenceline east side. Codominant at 5 feet. Trunk located in between two garage structures. Canopy is growing on top of roofs.	9/16/2020
71	Yes		<i>Quercus wislizeni</i>	Interior live oak	26		36	40	1 Extreme Structure or Health Problems		26 inch stem. separation from parent tree. Severe lean north making contact with garage building.	9/16/2020

Photo 6. Tree #69. Failure of northern stem

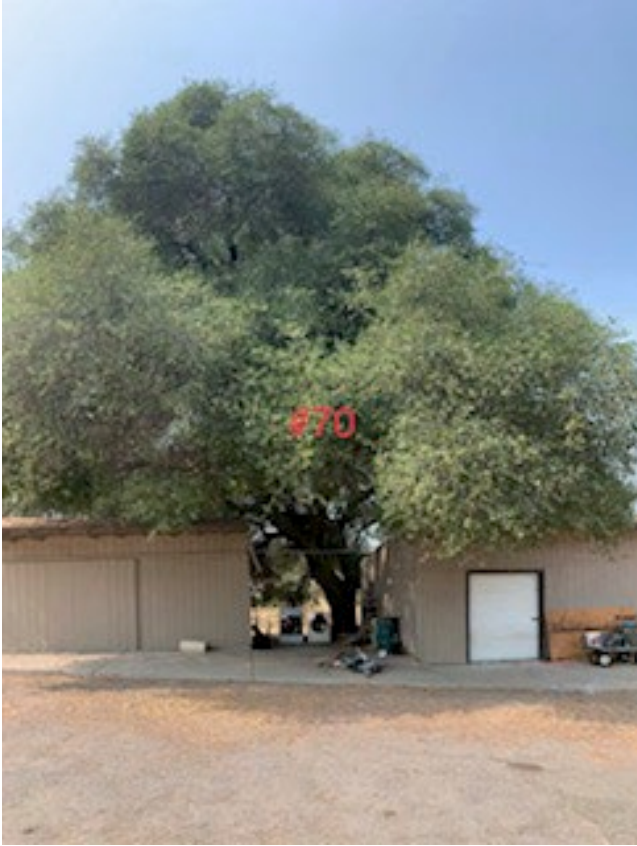
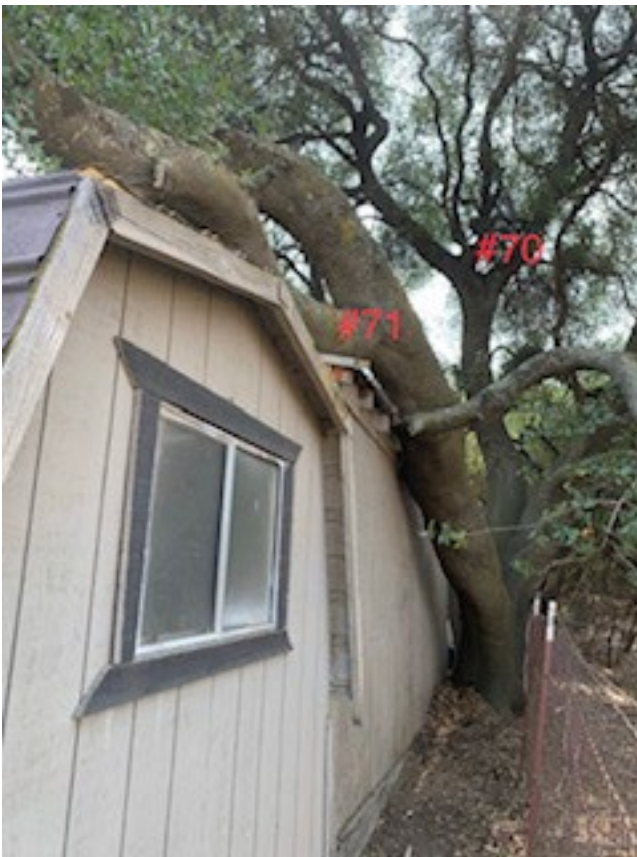
Photo 7 and 8. Trees #70 and 71. Showing proximity to existing structures

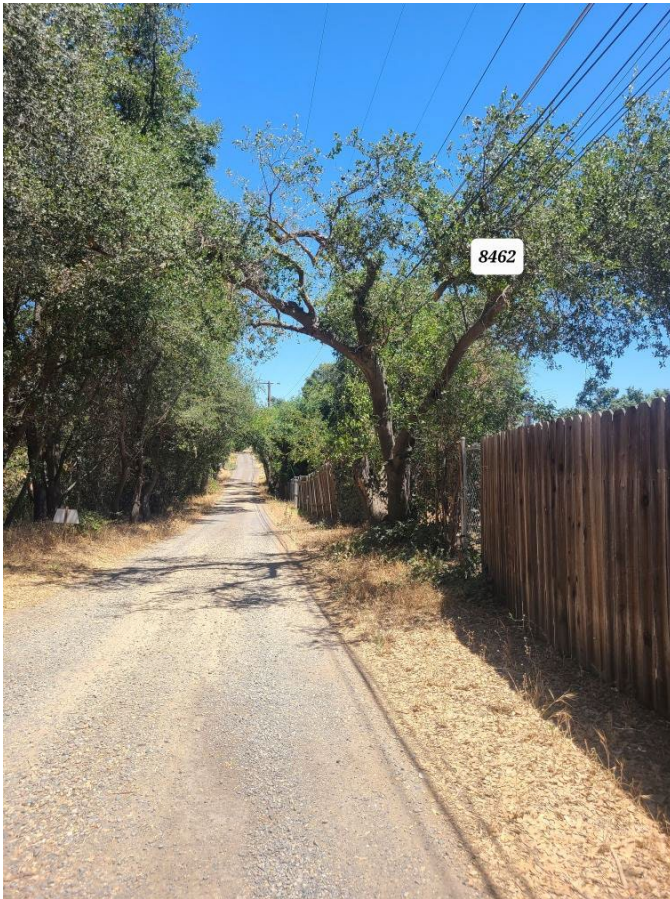
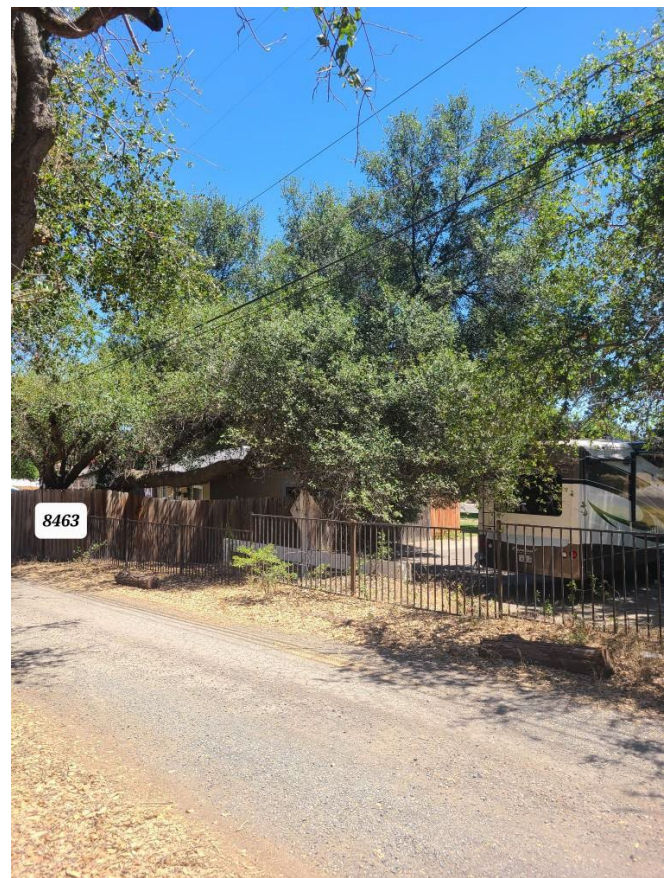
Above: Overhanging off-site trees on driveway easement.  
Right: Stumps along driveway easement.
