ASBESTOS-CONTAINING MATERIALS AND LEAD-CONTAINING MATERIALS SURVEY REPORT

COMMERCIAL PROPERTY
777 WEST ORANGETHORPE AVENUE
PLACENTIA, CALIFORNIA 90065

PROJECT No. 092878-AS, XRF

SURVEY DATE: JUNE 3 & JUNE 10, 2021

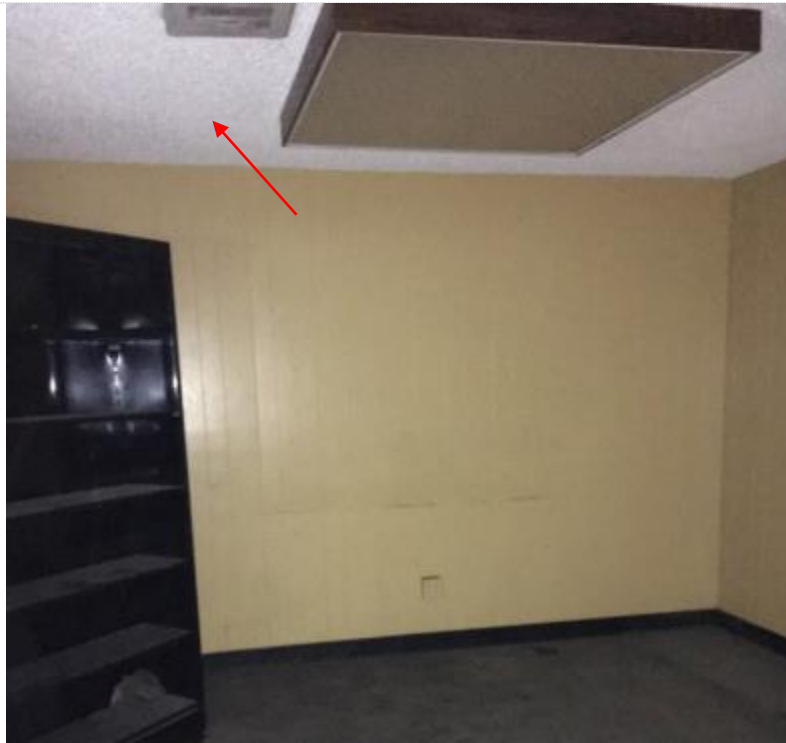
Photo #3: Photo of positive sample group 0603-02 – White Acoustic

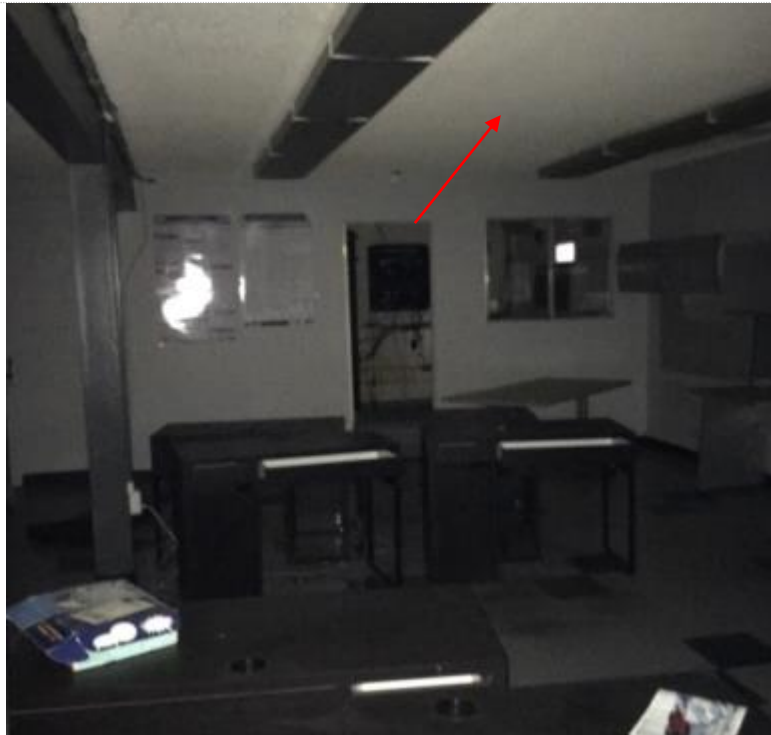
Photo #4: Photo of positive sample group 0603-02 – White Acoustic

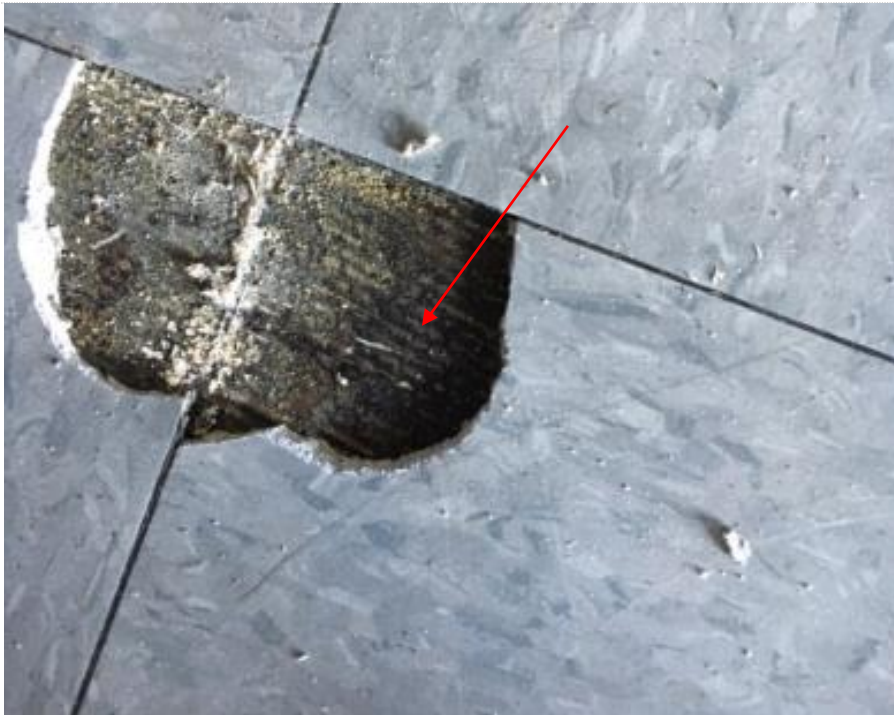
Photo #5: Photo of sample group 0603-08 (12x12 gray floor tile) and positive sample group 0603-09 (black mastic),

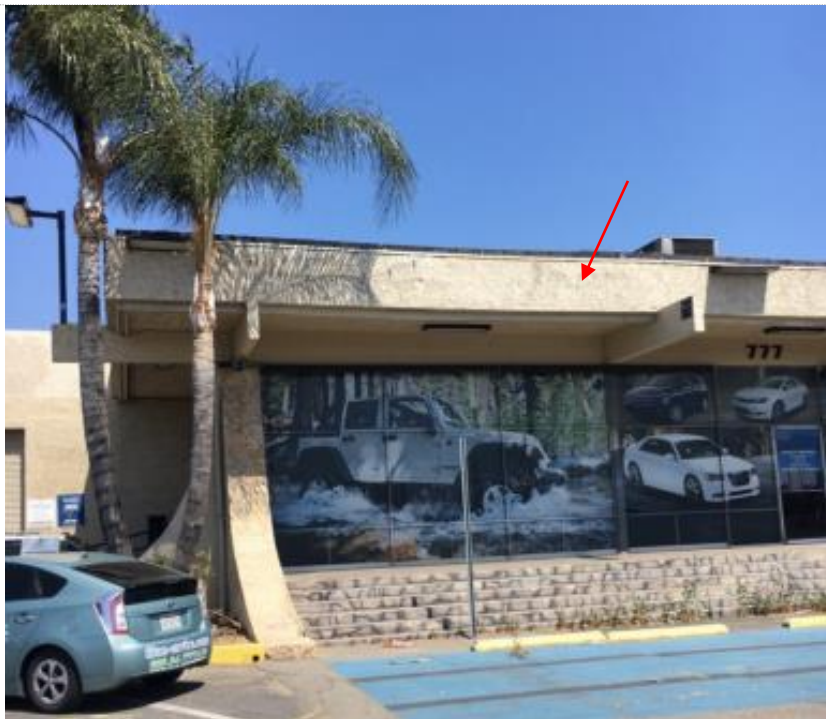
Photo #6: Photo of positive sample group 0603-18 (gray stucco)

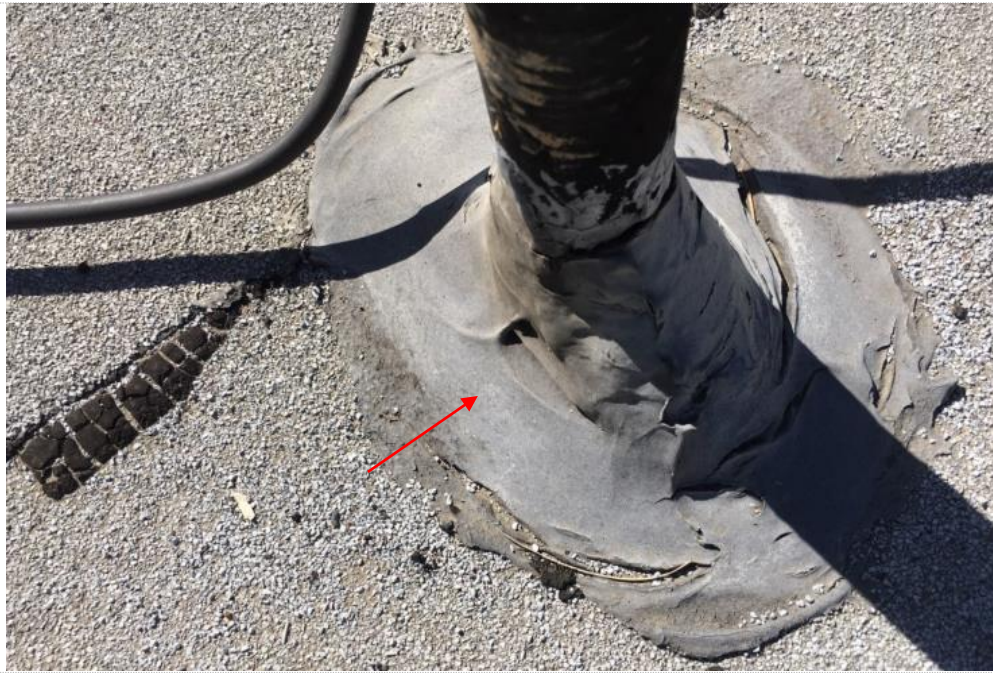
Photo #7: Photo of positive sample group 0610-04 – Gray Roof Penetration Mastic

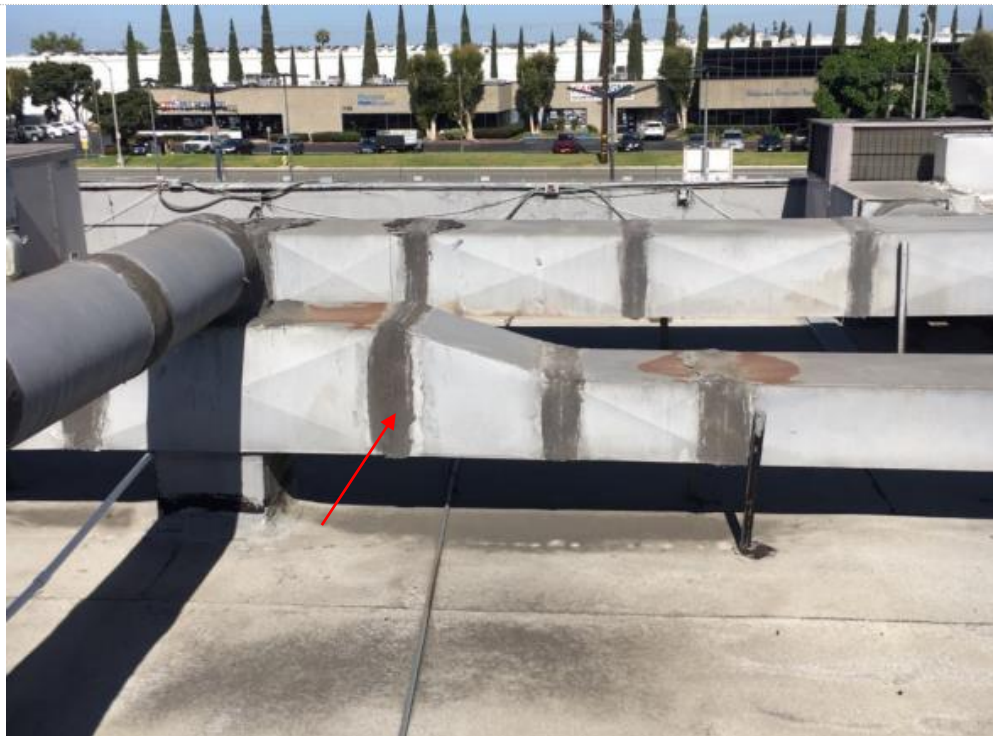
Photo #8: Photo of positive sample group 0610-05 – Gray HVAC Duct Mastic
