Appendix C
Arborist Report

MEMORANDUM

Date: December 19, 2023

SUBJECT: Arborist Report for the Marina High School Multi-Sports Field Project

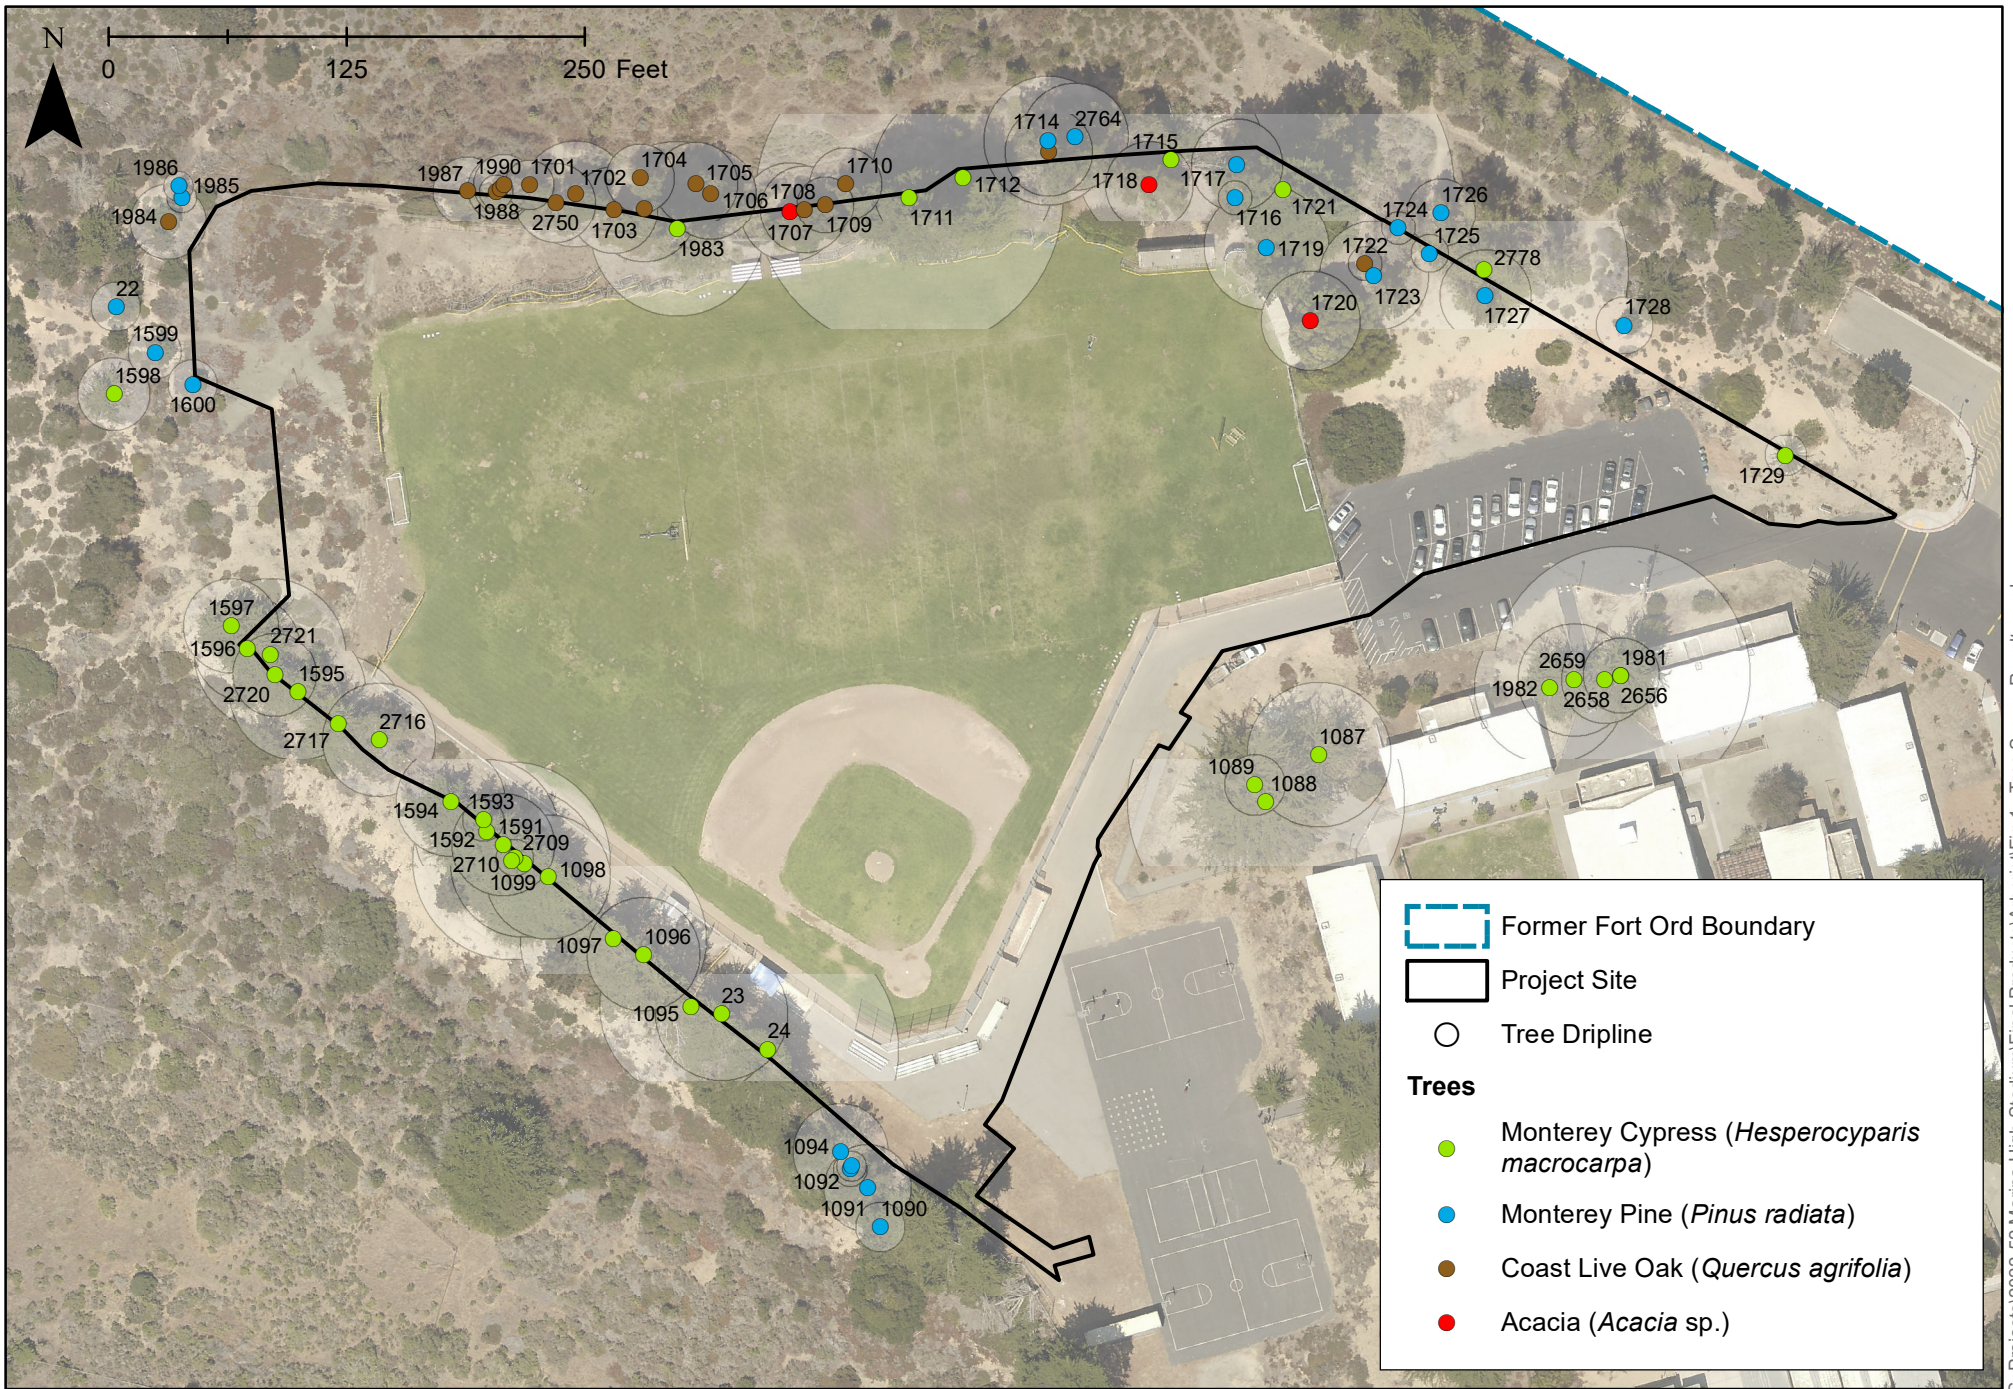
Figure
1

DD&A inventoried 78 trees within and directly adjacent to the project site (see **Figure 1** and **Appendix A**). Tree species identified include 36 Monterey cypresses (*Hesperocyparis macrocarpa*), 21 Monterey pines (*Pinus radiata*), 18 coast live oaks (*Quercus agrifolia*), and three (3) acacias (*Acacia* sp.). Most trees are in fair condition (see **Appendix A**); they are in average vigor for the area and are showing small signs of decay, disease, or and/or insect infestations, including seiridium canker fungus, pine beetle and *Phytophthora* root and crown rot. However, 10 trees are in poor condition; they are showing signs of significant decline, including seiridium canker fungus, pine beetle and *Phytophthora* root and crown rot. No indicators or symptoms of sudden oak death were observed.

The following 31 trees lie within the currently proposed project site:

- 16 Monterey cypresses in fair condition and one (1) Monterey cypress in poor condition,
- Two (2) Monterey pines in fair condition and four (4) Monterey pines in poor condition,
- Four (4) coast live oaks in fair condition and one (1) coast live oak in poor condition, and
- Three (3) acacias in fair condition.

Although they are located outside the project site, the following 18 trees have a significant portion (more than 25 percent) of their driplines within the site:

- Nine (9) Monterey cypresses in good or fair condition,
- One (1) Monterey pine in fair condition, and one (1) Monterey pine in poor condition, and
- Seven (7) coast live oaks in fair condition.

The remaining 29 trees are located outside the currently proposed project site.

As described above, 31 trees lie within the proposed project site. Nine (9) of those trees are recommended for removal because they are in poor condition or are non-native (see **Appendix A**). It is recommended that the remaining 22 trees located within the project site are protected in place to the extent feasible in accordance with Best Management Practices (BMPs) described in **Appendix B**; however, these trees may need to be removed to facilitate construction of the project and, therefore, should be included in the tree removal permit as “potential removals.” See **Figure 2** for the tree removal plan and **Appendix C** for a photo log of trees which are recommended for removal, or which may need to be removed to facilitate construction of the project.
