August 12, 2022 (revised 3-9-23)

Re: Revised Arborist Report for 865 Embedded Way – Parcel B

Project:
865 Embedded Way
 San Jose, CA 95138

Sheet Title:
TREE INVENTORY & PROTECTION PLAN

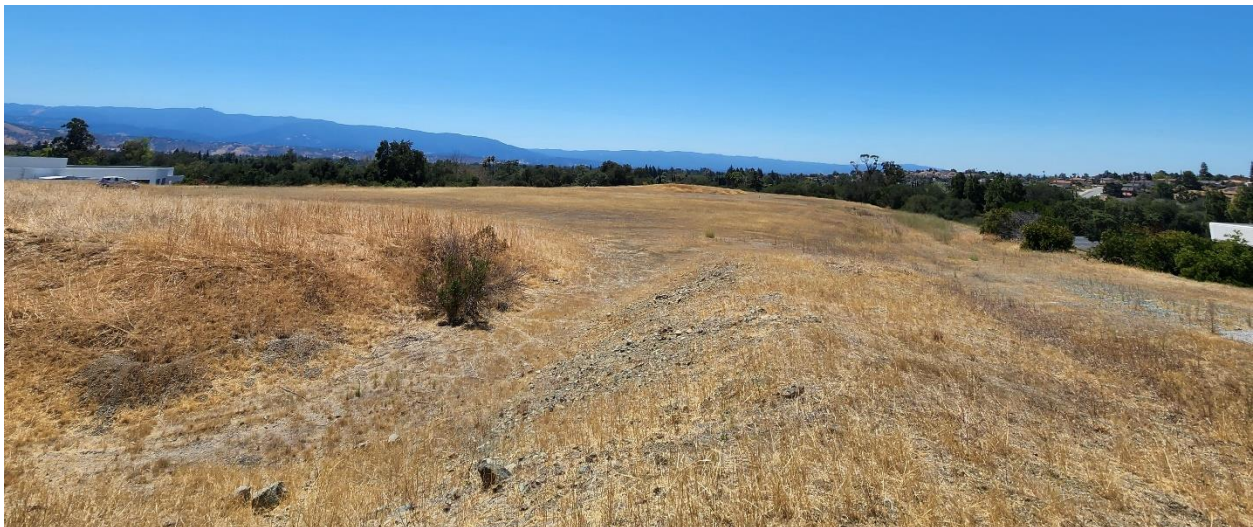
Parcel B is a 10.17 acre site located in an office park on the southeastern edge of San Jose, east of Highway 101. The western property line butts up to walking trails along Coyote Creek with single-family homes west of the creek. The site is at a similar elevation to Parcel A, but sits above the other adjacent properties, with steep slopes to the north, south, and west. Though undeveloped, the plateau portion of the site appears to have been graded and consists of mainly grassy vegetation and some shrubs (figure 1).

Figure 1. Plateau portion of Parcel B appears to have been graded and consists of mostly grass and some shrubs. Photo taken from the northeastern corner looking west.

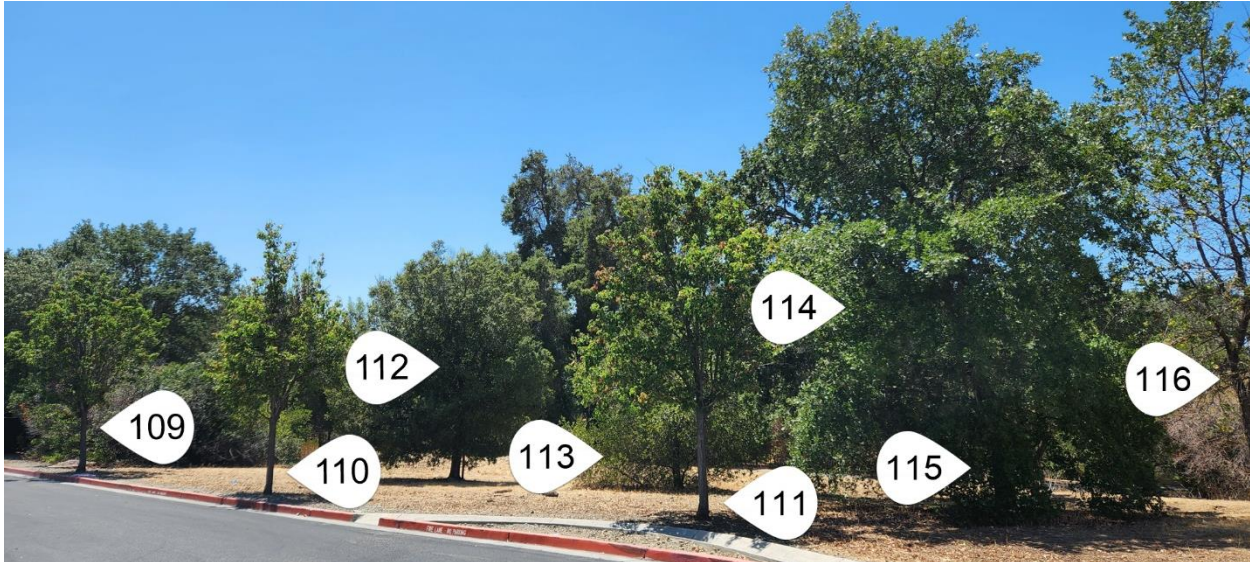
Figure 2. Trees #109-113 & 115-116 will need to be removed to accommodate the proposed bioretention basin. Three additional trees (#117-119 not pictured) will also need to be removed. Recent design changes reduce root encroachment on tree #114, so this tree will be retained.

The proposed bioretention basin on the southern sliver of Parcel B will require the removal of 10 trees, two of which are ordinance-sized (figure 2). Per my communication with Roger Bernstein, Oppidan's Vice President of Construction, constructing the bioretention basin will require approximately 4' of over-excavation and extensive grading surrounding the basin to create the necessary slope for drainage. Original design plans would have resulted in extensive root loss for trees just outside the basin (#112 & 114), necessitating their removal. You asked me to provide recommendations to preserve tree #114, which is reflected in the latest plan for Parcel B. To avoid impacting large structural roots, the bioretention basin was shifted to provide an additional 4' from the trunk.

Lastly, tree #114 has a buried root crown (area of transition from trunk to root). Buried root crowns hold moisture next to the trunk, which creates an environment preferable to decay pathogens. Over time, this can negatively impact tree health and even stability. To reduce stress and increase the longevity of tree #114, I recommend uncovering the root crown with hand tools or an air spade under the project arborist's supervision.

Though plans have been modified to reduce encroachment, trees can be negatively impacted during the construction process when excavators pull roots and compact soil. To minimize damage to roots during excavation, the project arborist shall be called on-site to monitor excavation within the dripline of tree #114. Moreover, to keep construction-related activity outside the tree's root zone, contractors shall install temporary 6' chain-link protection fencing, as indicated on the tree protection plan.

- Remove trees #109-113 & 115-120.
- Mulch from tree removals may be spread out under the driplines of trees that will be retained, keeping at least 12" away from the trunks, to improve soil and general tree health.
- Prior to construction or grading, contractor shall install fencing to construct a temporary Tree Protection Zone (TPZ) around each tree or grove of trees as indicated on the tree protection plan.
 - Fencing shall be attached to metal stakes spaced 10' apart and driven firmly into the ground. They can be supported by stands if over pavement & wired together to avoid easily moving them.
 - Heavy gauge poly-vinyl fencing shall be spaced on 6' centers.
- TPZ fencing shall remain in an upright sturdy manner from the start of grading until the completion of construction. Fencing shall not be adjusted or removed without consulting the project arborist.

- PA shall be called on-site to monitor excavation within the dripline of tree #114.
 - Excavation may need to be performed by hand or with an air spade.

- Uncover buried root crown of tree #114 by hand or with an air spade under PA supervision.
- If roots ≥ 2 " in diameter are encountered during demolition or excavation by trees #128-129, consult the PA for recommendations. If appropriate, roots shall be cleanly pruned with a handsaw or sawzall, immediately covered, and kept moist till backfilled.

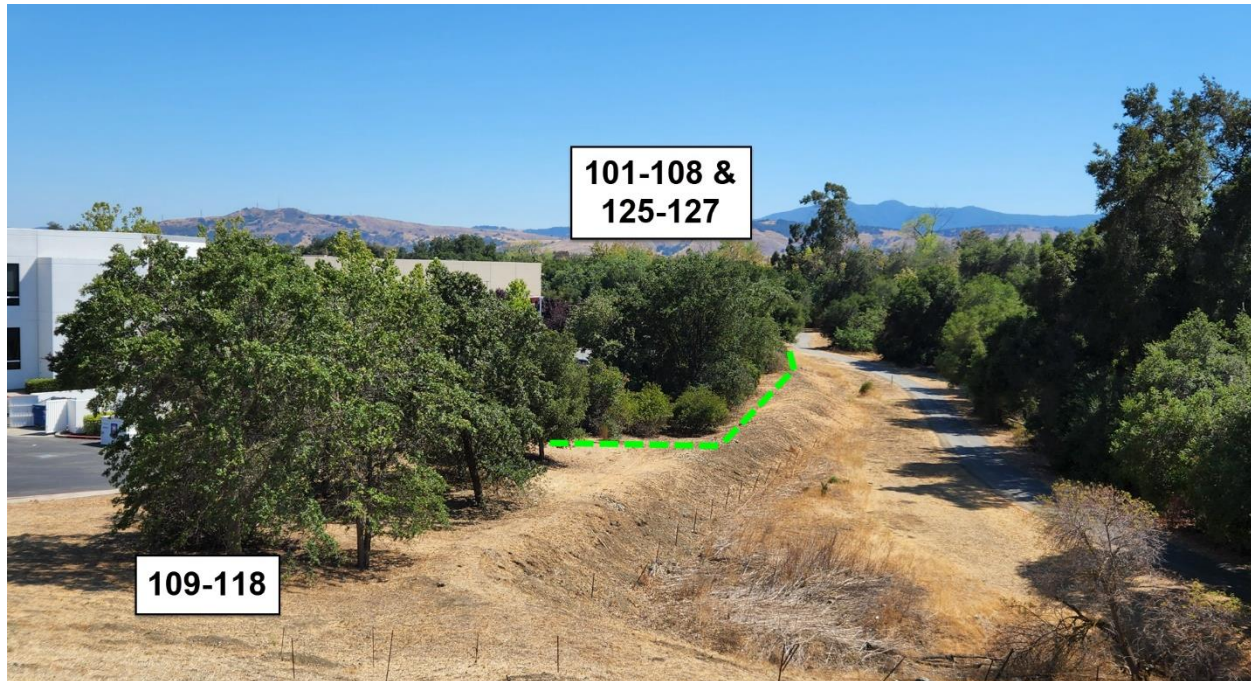
South of the plateau, a narrow sliver of Parcel B is nestled between an existing paved driveway and Coyote Creek (figure 3). This is where most of the trees reviewed in my report are located (76%). Many of them appear to be planted, though 59% are native oak species. One additional on-site tree is on the northeastern corner of the project site and six off-site trees are on Parcels 1 and A. The northwest corner of Parcel B and southwest corner of Parcel 1 have several native oaks that are clear of construction and were not inventoried.

Figure 3. South sliver of Parcel B. Trees #101-108 & 125-127 can be preserved by rerouting the proposed storm drain and water lines to the west of the grove (green line approximate suggested path). Trees #109-113 & 115-118 conflict with the proposed bioretention basin and will need to be removed.

The proposed storm drain and water lines run directly south from the proposed bioretention basin towards Embedded Way. This would require the removal of several trees, many of which are ordinance-sized. Per my suggestion, the VP of Construction said it was feasible to reroute the lines to the west (figure 3), which would avoid these removals (see suggested alternate route on tree protection plan). Assuming the storm drain and water lines will be rerouted, contractors shall install temporary protection fencing around trees #101-108 & 125-127, to protect roots and soil.

- Reroute proposed storm drain & water lines to the west of trees #101-108 & 125-127, keeping outside of the Tree Protection Zone (TPZ).
 - See suggested alternate path (in green) on tree protection plan.

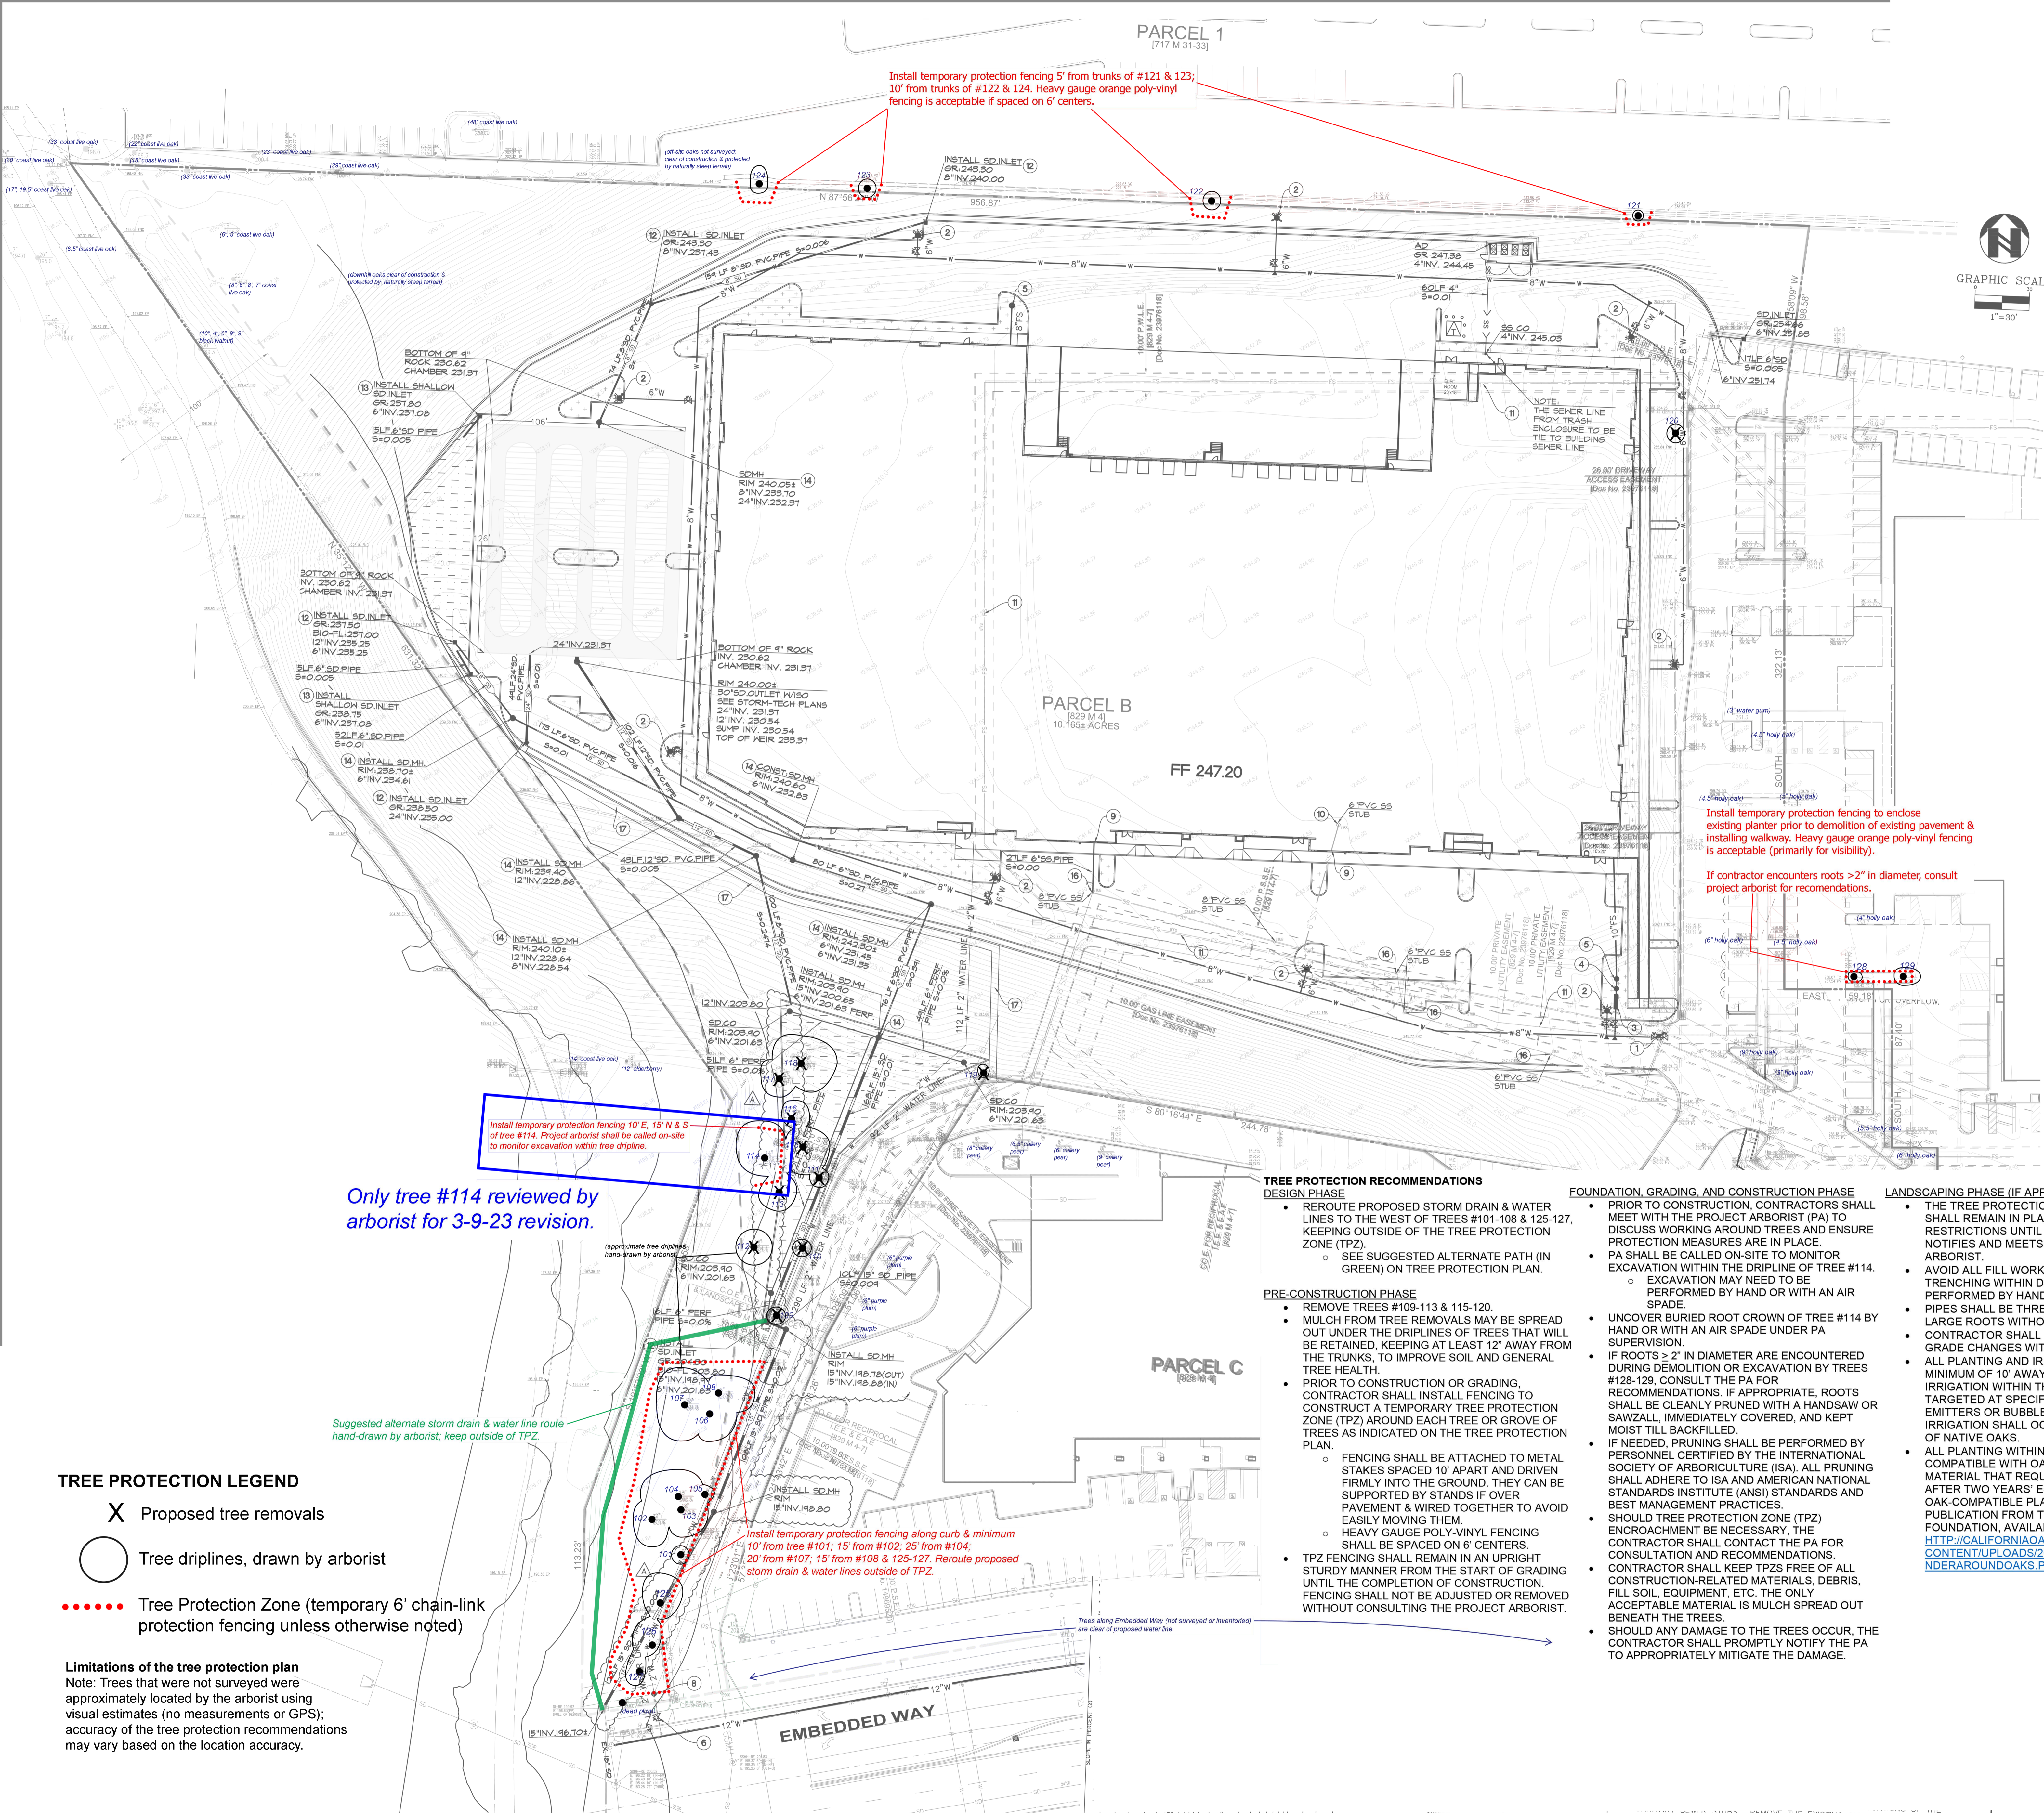
No.	Change(s)	Date
1	Bioretention basin redesign to preserve #114.	3-9-23

- TREE PROTECTION RECOMMENDATIONS**
- DESIGN PHASE**
- REROUTE PROPOSED STORM DRAIN & WATER LINES TO THE WEST OF TREES #101-108 & 125-127, KEEPING OUTSIDE OF THE TREE PROTECTION ZONE (TPZ).

- SEE SUGGESTED ALTERNATE PATH (IN GREEN) ON TREE PROTECTION PLAN.
- PRE-CONSTRUCTION PHASE**
- REMOVE TREES #109-113 & 115-120.
 - MULCH FROM TREE REMOVALS MAY BE SPREAD OUT UNDER THE DRIPLINES OF TREES THAT WILL BE RETAINED, KEEPING AT LEAST 12' AWAY FROM THE TRUNKS, TO IMPROVE SOIL AND GENERAL TREE HEALTH.

- PRIOR TO CONSTRUCTION OR GRADING, CONTRACTOR SHALL INSTALL FENCING TO CONSTRUCT A TEMPORARY TREE PROTECTION ZONE (TPZ) AROUND EACH TREE OR GROVE OF TREES AS INDICATED ON THE TREE PROTECTION PLAN.

- PA SHALL BE CALLED ON-SITE TO MONITOR EXCAVATION WITHIN THE DRIPLINE OF TREE #114.
 - EXCAVATION MAY NEED TO BE PERFORMED BY HAND OR WITH AN AIR SPADE.

- UNCOVER BURIED ROOT CROWN OF TREE #114 BY HAND OR WITH AN AIR SPADE UNDER PA SUPERVISION.
 - IF ROOTS > 2" IN DIAMETER ARE ENCOUNTERED DURING DEMOLITION OR EXCAVATION BY TREES #128-129, CONSULT THE PA FOR RECOMMENDATIONS. IF APPROPRIATE, ROOTS SHALL BE CLEANLY PRUNED WITH A HANDSAW OR SAWZALL, IMMEDIATELY COVERED, AND KEPT MOIST TILL BACKFILLED.
