ARBORIST REPORT for 10635 TWIN CITIES ROAD

September 9, 2021

This arborist report is required for the proposed subdivision of 10635 Twin Cities Road, APN 148-0730-015, owners Wade and Beverly Hammonds, into two parcels. It is for the requirements of the Sacramento County Tree Preservation Ordinance which shall be submitted to Planning and Environmental Review in order to evaluate project impacts and create appropriate mitigation pursuant to Sacramento County General Plan policies and CEQA.

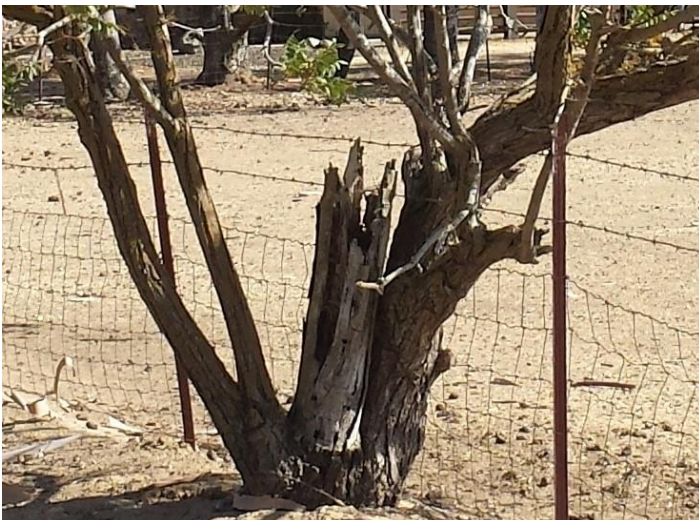
Picture above shows the dripline environment, as described above, the wire fence separating the two properties, and one of the larger multi-trunk trees with remnants of the English Walnut trunk. Left is a closeup of the remnants of the English Walnut trunk. The sprouts originated from below the graft. This is tree #32.

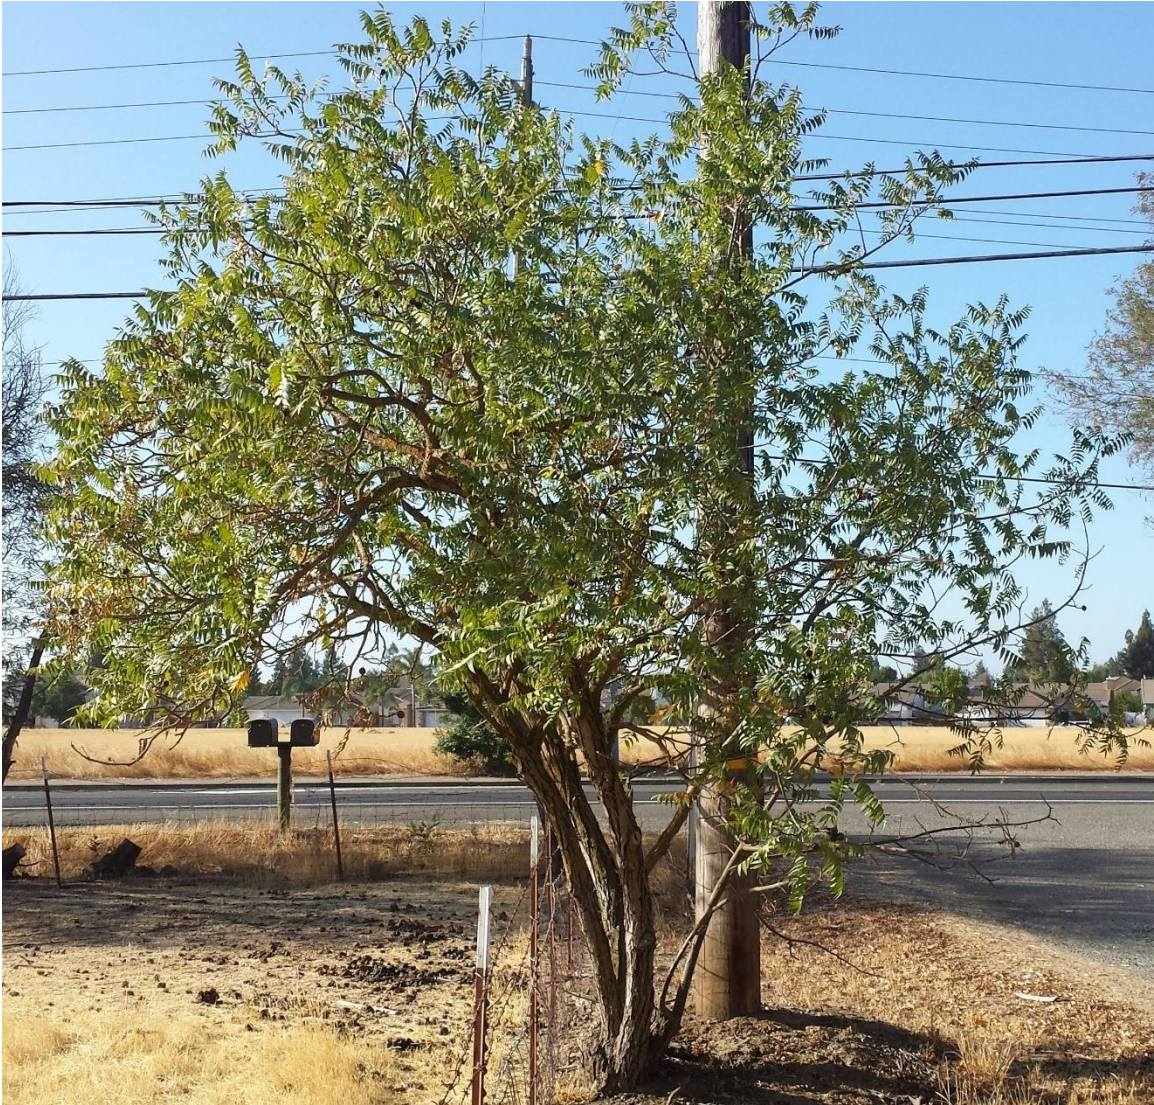
Tree #21. Northern California Black Walnut (*Juglans californica v. hindsii*)

Size: This is a multi-trunk tree with four trunks, 4.3", 3.9", 4.8' and 1.1", measured at DSH (diameter at shoulder height or 54 inches above grade). It is 14 feet high, 21 feet wide with an asymmetry to the southeast.

Tree Health: Fair condition, average foliage size, density, color and growth. 85% live wood in the canopy. Some minor wood rot decay at the base.

Tree Structure: Multi-trunk, round-headed tree that sprouted from the rootstock of a once healthy English Walnut.

Overall Tree Condition: (3) Fair

Recommendations: Preserve the tree. This is a viable tree that needs deadwood removal and minor reshaping, and irrigation once or twice a month in the dry season. Mulch to insulate and conserve soil moisture. This will improve the health of this native riparian tree.

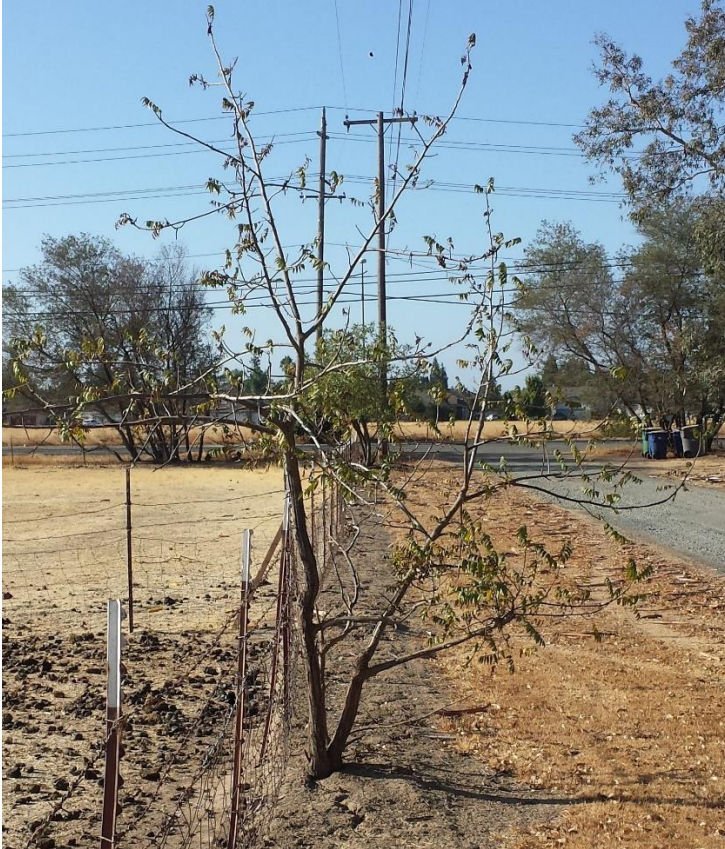
Tree #22. Northern California Black Walnut (*Juglans californica v. hindsii*)

Tree Health: Poor condition, lack of water has stunted the tree and caused early dormancy. Poor foliage size, density, color and growth. 50% live wood in the canopy. Some dieback in canopy. Extreme drought stress.

Tree Structure: Multi-trunk tree that sprouted from the rootstock of a once healthy English Walnut.

Overall Tree Condition: (1) Severe decline.

Recommendations: Preserve the tree. This is a barely viable tree that needs deadwood removal and irrigation once or twice a month in the dry season. Mulch to insulate and conserve soil moisture. This will improve the health and save this native riparian tree.

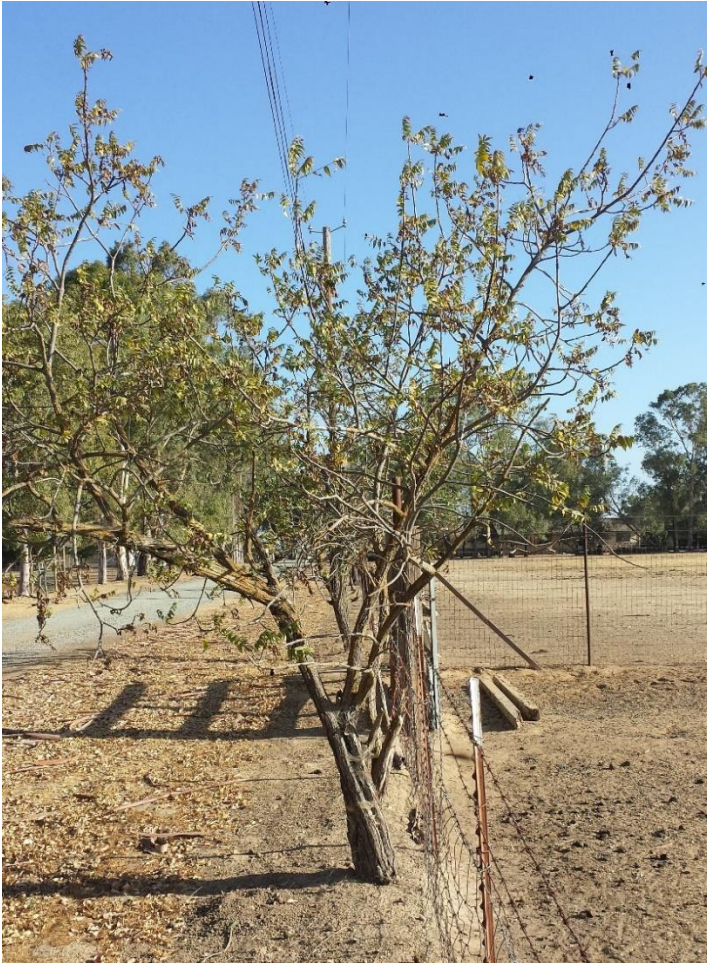
Tree #23. Northern California Black Walnut (*Juglans californica v. hindsii*)

Tree Health: Poor condition, lack of water has stunted the tree. Poor foliage size, density, color and growth. 60% live wood in the canopy. Some dieback in canopy. Extreme drought stress. Borers in the trunk. Decayed tissue in the 4.4" trunk and the two dead stubs that remain at the base.

Tree Structure: Multi-trunk, round-headed tree that sprouted from the rootstock of a once healthy English Walnut. Decay at base weakens attachment area for multi-trunks. Prone to failure and splitting as size increases.

Overall Tree Condition: (2) Declining

Recommendations: Preserve the tree. This is a barely viable tree that needs deadwood removal and irrigation once or twice a month in the dry season. Mulch to insulate and conserve soil moisture. This will improve the health and save this native riparian tree. May also treat for borers and wood rot decay.

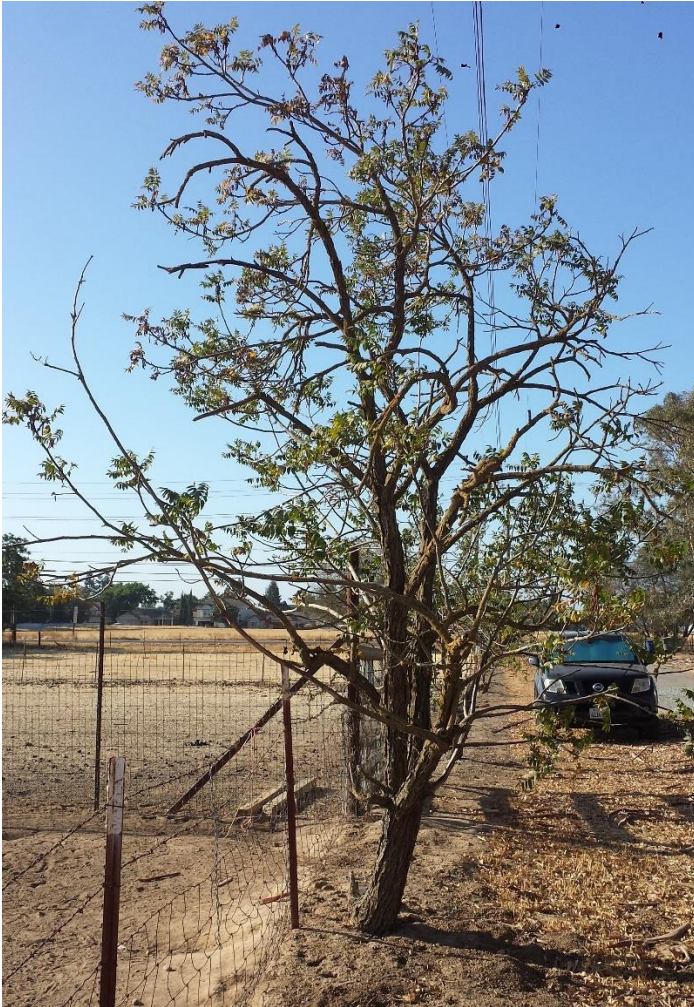
Tree #24. Northern California Black Walnut (*Juglans californica v. hindsii*)

Tree Health: Poor condition, lack of water has stunted the tree. Poor foliage size, density, color and growth. 60% live wood in the canopy. Some dieback in canopy. Extreme drought stress. Borers in dead wood and along the trunk.

Tree Structure: Twin or bifurcated trunk, round-headed tree that sprouted from the rootstock of a once healthy English Walnut. Bifurcated trunk prone to splitting as size increases. Minimize excessive end weight.

Overall Tree Condition: (2) Declining

Recommendations: Preserve the tree. This is a barely viable tree that needs deadwood removal and irrigation once or twice a month in the dry season. Mulch to insulate and conserve soil moisture. This will improve the health and save this native riparian tree. May also treat for borers and wood rot decay.

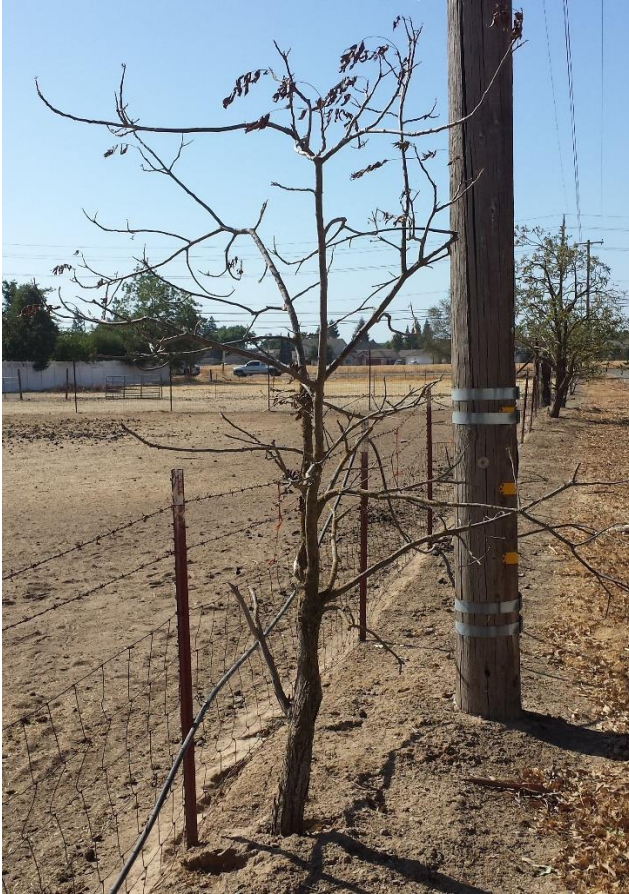
Tree #25. Northern California Black Walnut (*Juglans californica v. hindsii*)

Tree Health: Very poor condition, lack of water has stunted the tree. Poor foliage size, density, color and growth. 30-40% live wood in the canopy. Dieback and dead wood in canopy from extreme drought stress.

Tree Structure: Single trunk that branches into three scaffolds at 32 inches. Tree sprouted from the rootstock of a once healthy English Walnut.

Overall Tree Condition: (1) Severe decline.

Recommendations: Preserve tree. This is a barely viable tree that needs deadwood removal and irrigation once or twice a month in the dry season. Mulch to insulate and conserve soil moisture. This will improve the health and save this native riparian tree.

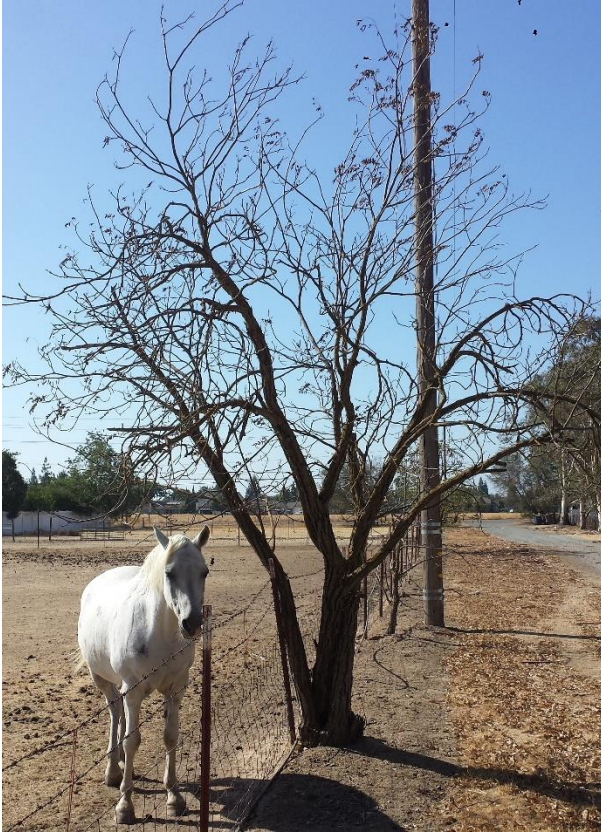
Tree #26. Northern California Black Walnut (*Juglans californica v. hindsii*)

Tree Health: Very poor condition, lack of water has stunted the tree. Poor foliage size, density, color and growth. 40% live wood in the canopy. Dieback and dead wood in canopy from extreme drought stress.

Tree Structure: Multi-trunk, round-headed oval canopy. Largest trunk crosses over another trunk. This is structurally unsound and prone to splitting. Decay at base from former sucker removal. Some borer activity. Tree sprouted from the rootstock of a once healthy English Walnut.

Overall Tree Condition: (1) Severe decline.

Recommendations: Preserve tree. This is a barely viable tree that needs deadwood removal and removal of cross over trunk. Irrigate once or twice a month in the dry season. Mulch to insulate and conserve soil moisture. This will improve the health and save this native riparian tree. May also treat for borers and wood rot decay.

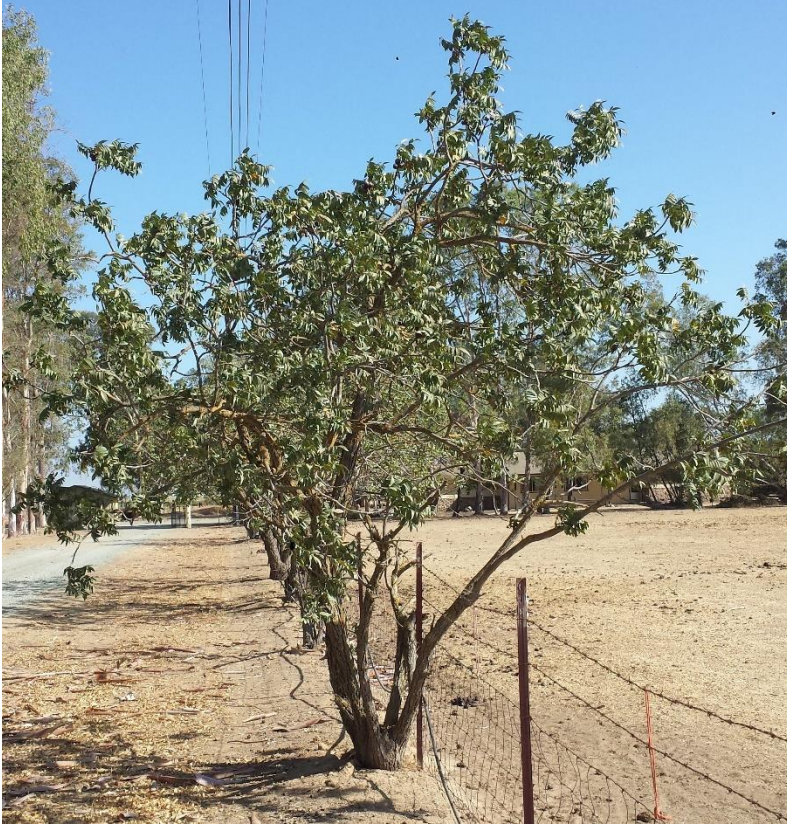
Tree #27. Northern California Black Walnut (*Juglans californica v. hindsii*)

Tree Health: Fair condition, average foliage size, density, color and growth. 70% live wood in the canopy. Three of the seven trunks have decay and borer activity.

Tree Structure: Multi-trunk, round-headed tree that sprouted from the rootstock of a once healthy English Walnut. The four live trunks have solid decay free attachments at the base.

Overall Tree Condition: (3) Fair

Recommendations: Preserve the tree. This is a viable tree that needs deadwood removal and minor reshaping, and irrigation once or twice a month in the dry season. Mulch to insulate and conserve soil moisture. This will improve the health of this native riparian tree. May also treat for borers and wood rot decay.

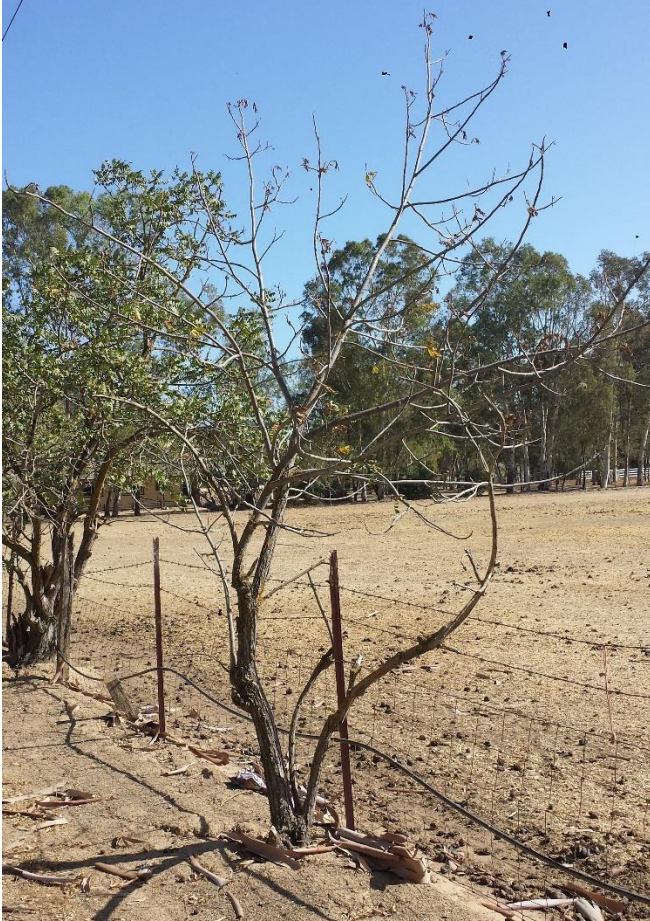
Tree #28. Northern California Black Walnut (*Juglans californica v. hindsii*)

Tree Health: Very poor condition, lack of water has stunted the tree. Poor foliage size, density, color and growth. 40% live wood in the canopy. Dieback and dead wood in canopy from extreme drought stress. Two of the three trunks are dead with wood rot decay and borers, and decay at base.

Tree Structure: Multi-trunk, somewhat round-headed tree. Tree sprouted from the rootstock of a once healthy English Walnut.

Overall Tree Condition: (1) Severe decline.

Recommendations: Preserve tree. This is a barely viable tree that needs deadwood removal and irrigation once or twice a month in the dry season. Mulch to insulate and conserve soil moisture. This will improve the health and save this native riparian tree. May also treat for borers and wood rot decay.

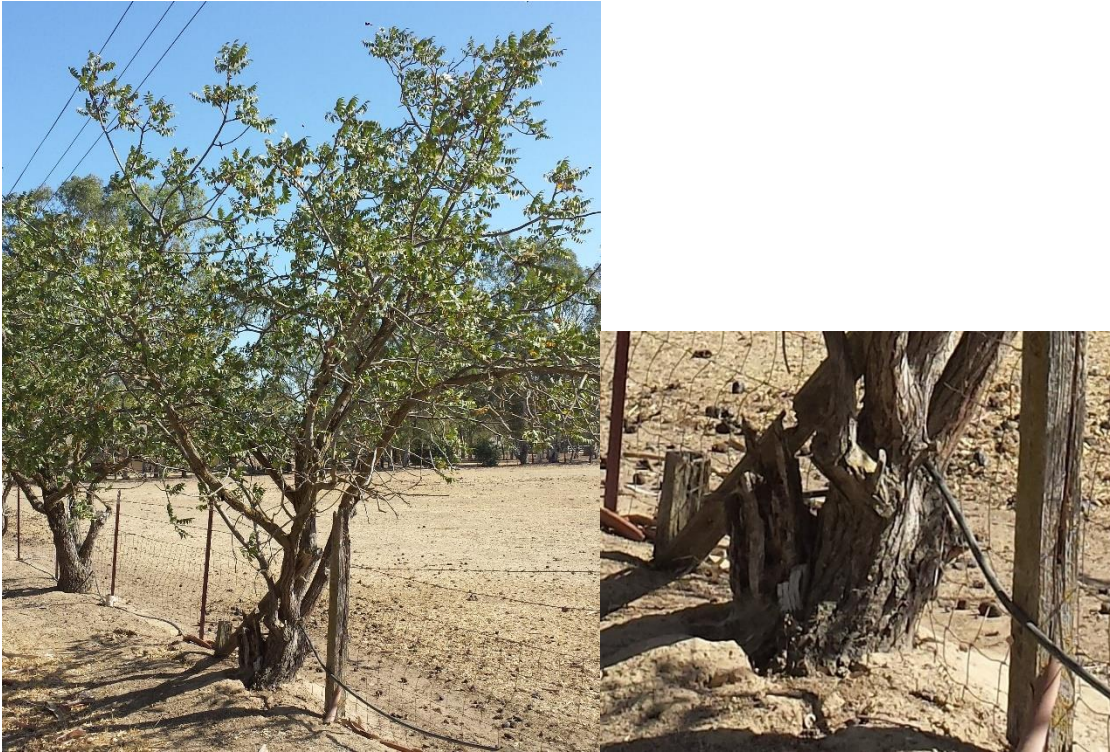
Tree #29. Northern California Black Walnut (*Juglans californica v. hindsii*)

Tree Health: Fair condition, average foliage size, density, color and growth. 80% live wood in the canopy. The base is solid except for one dead and decayed trunk (6.5") with borer activity. Also, some decay and borer activity in the canopy. Some of the wire fence has girdled the trunk.

Tree Structure: Multi-trunk, round-headed tree that sprouted from the rootstock of a once healthy English Walnut. The four live trunks have solid decay free attachments at the base.

Overall Tree Condition: (3) Fair

Recommendations: Preserve the tree. This is a viable tree that needs deadwood removal and minor reshaping, and irrigation once or twice a month in the dry season. Mulch to insulate and conserve soil moisture. This will improve the health of this native riparian tree. May also treat for borers and wood rot decay.

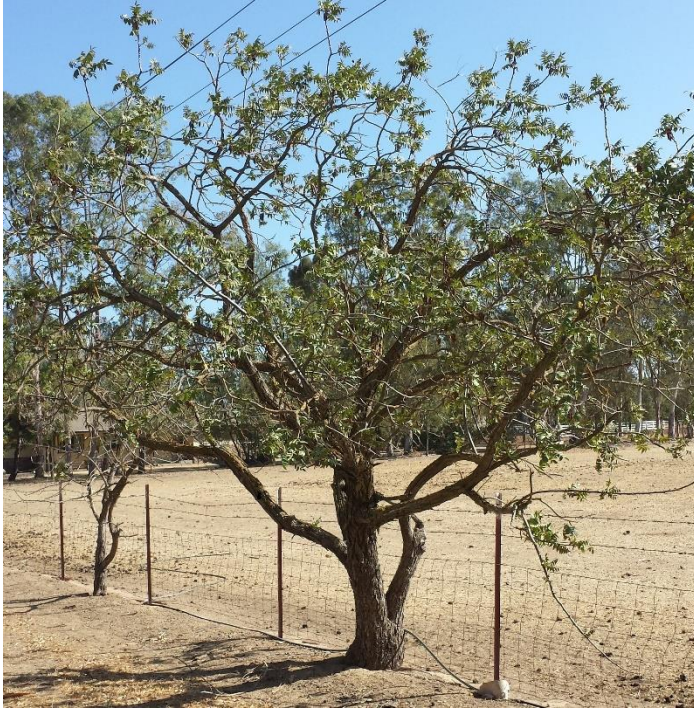
Tree #30. Northern California Black Walnut (*Juglans californica v. hindsii*)

Tree Health: Fair condition, average to poor foliage size, density, color and growth. 60-70% live wood in the canopy. Some decay and borer activity in the canopy. Decay between the trunks.

Tree Structure: Multi-trunk, round-headed tree that sprouted from the rootstock of a once healthy English Walnut. Included bark, cavity and decay at base. Potential to split at base. Multiple attachments in upper part of one trunk are also prone to splitting in the future.

Overall Tree Condition: (3) Fair

Recommendations: Preserve the tree. This is a viable tree that needs deadwood removal and minor reshaping, and irrigation once or twice a month in the dry season. Mulch to insulate and conserve soil moisture. This will improve the health of this native riparian tree. May also treat for borers and wood rot decay.

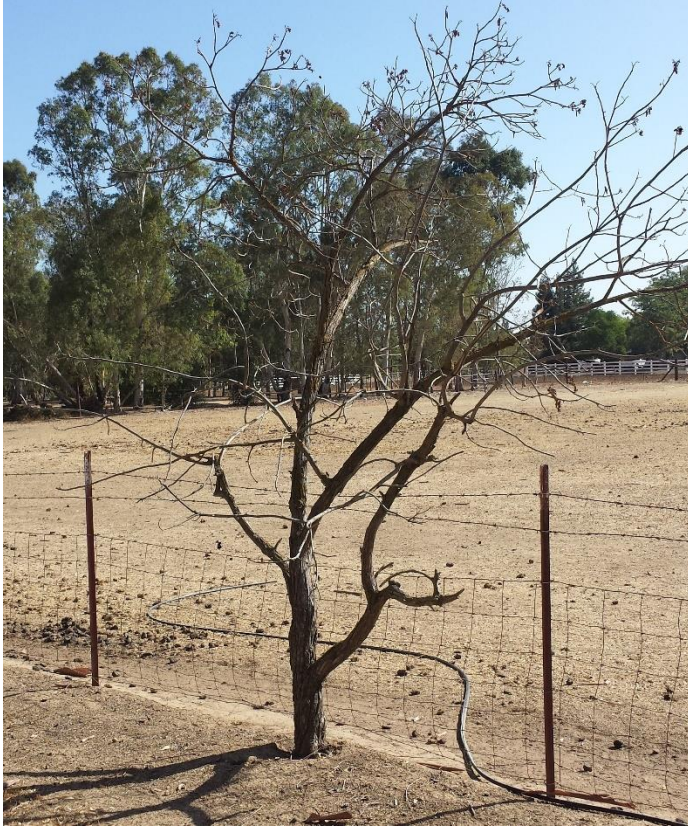
Tree #31. Northern California Black Walnut (*Juglans californica v. hindsii*)

Tree Health: Very poor condition, lack of water has stunted the tree. Poor foliage size, density, color and growth. 30-40% live wood in the canopy. Dieback and dead wood in canopy from extreme drought stress.

Tree Structure: Single trunk, round-headed tree with low branches. Tree sprouted from the rootstock of a once healthy English Walnut.

Overall Tree Condition: (1) Severe decline.

Recommendations: Preserve tree. This is a barely viable tree that needs deadwood removal and irrigation once or twice a month in the dry season. Mulch to insulate and conserve soil moisture. This will improve the health and save this native riparian tree.

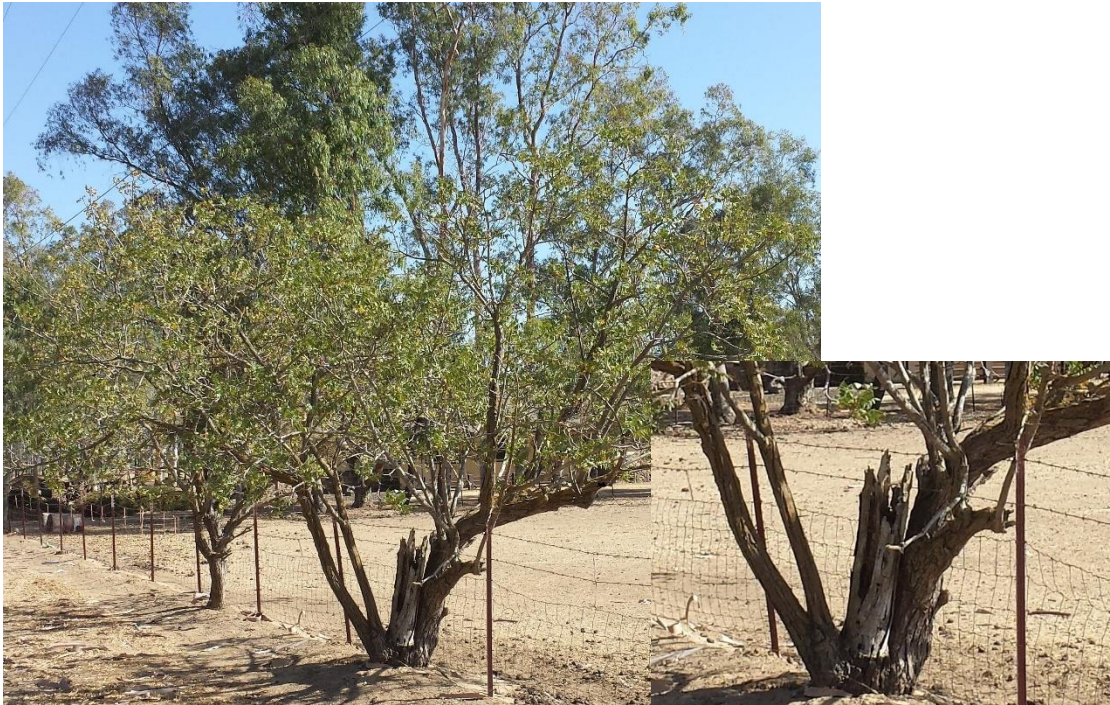
Tree #32. Northern California Black Walnut (*Juglans californica v. hindsii*)

Tree Health: Fair condition, average to poor foliage size, density, color and growth. 60-70% live wood in the canopy. Some decay and borer activity in the canopy. The dead, decaying and borer infested English Walnut trunk is the 9.6" trunk. Decay between the trunks.

Tree Structure: Multi-trunk, round-headed tree that sprouted from the rootstock of a once healthy English Walnut. Included bark at the base for the two smaller trunks, and decayed remnant of the English Walnut trunk is in the center of the multi-stem attachment. cavity and decay at base. Potential to split at base.

Overall Tree Condition: (3) Fair

Recommendations: Preserve the tree. This is a viable tree that needs deadwood removal and minor reshaping, and irrigation once or twice a month in the dry season. Mulch to insulate and conserve soil moisture. This will improve the health of this native riparian tree. May also treat for borers and wood rot decay.

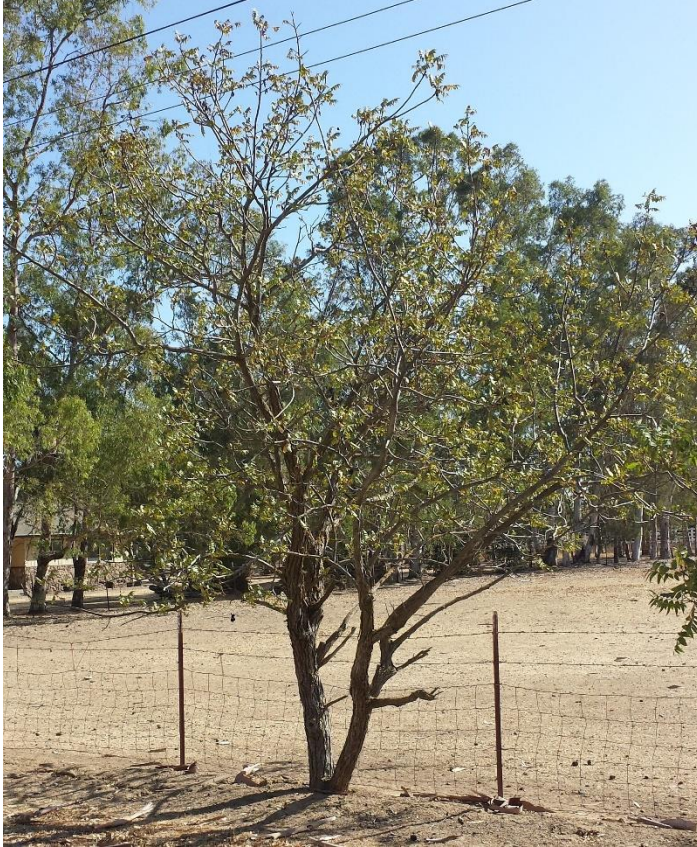
Tree #33. Northern California Black Walnut (*Juglans californica v. hindsii*)

Tree Health: Fair condition, average to poor foliage size, density, color and growth. 60-70% live wood in the canopy. Some decay and borer activity in the canopy. Small cavity and holes in one trunk.

Tree Structure: Multi-trunk, round-headed tree that sprouted from the rootstock of a once healthy English Walnut. Attachment starts at ground level and one trunk has some decay. Bifurcated or twin trunk is prone to splitting with excessive end weight.

Overall Tree Condition: (3) Fair

Recommendations: Preserve the tree. This is a viable tree that needs deadwood removal and minor reshaping, and irrigation once or twice a month in the dry season. Mulch to insulate and conserve soil moisture. This will improve the health of this native riparian tree. May also treat for borers and wood rot decay.

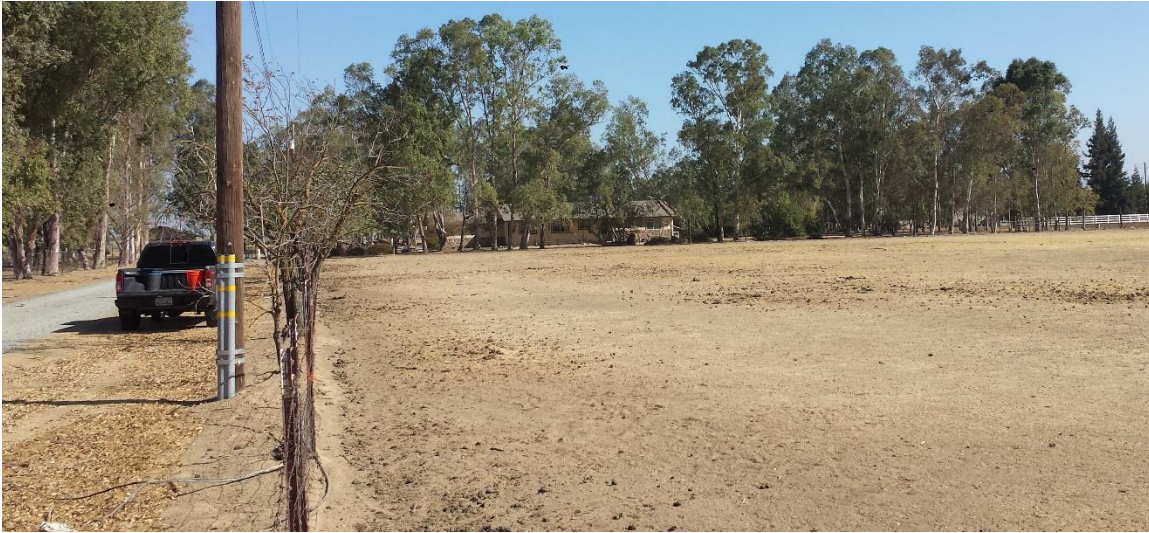
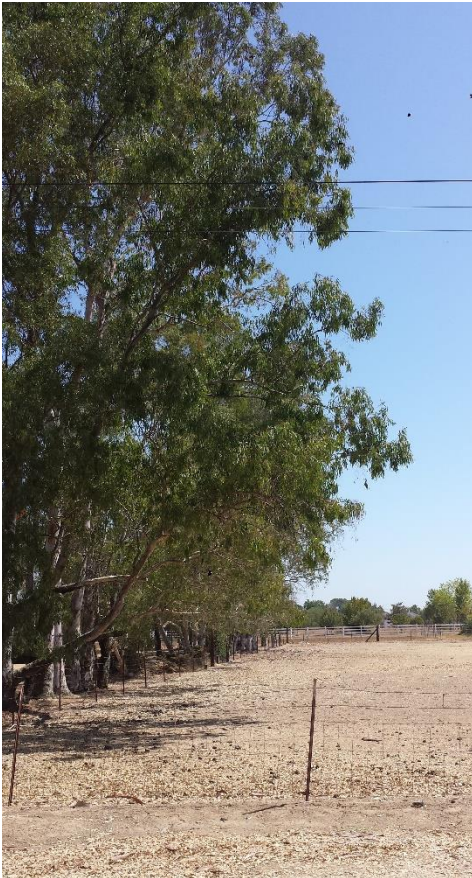
Thirty-four (34) non-native River Red Gum (*Eucalyptus camaldulensis*) off site

Along the 273-foot northern fence line are located off-site, thirty-four (34) non-native River Red Gum (*Eucalyptus camaldulensis*) whose canopies and root zones extend over the property line. These provide a large screen between the properties and they are located within 40 feet of the house at 10619 Twin Cities Road, APN 148-0730-013. They range in size from 4" to 22" DSH and from 18 to 75 feet in height.

Most of these trees are single trunk, straight, upright, and solid with a good structure. They have good to average foliage size, density, color and growth. 90% live wood in the canopy. Some have low branches that extend into the project area, as seen in the picture to the left. There are many younger smaller trees that were probably seedlings from the first ones planted. Four larger multi-trunk trees have fallen over, were cut back to the

trunks and allowed to resprout. These are lower in height and not well structured. Overall, there are 19 trees rated as (4) good, with a 5 trees rated as (5) excellent and a 10 trees rated as (3) fair.

The Root Protection Zone or RPZ should extend to the outermost extent of the canopies into the project area. No significant trenching or structures should be installed in this zone. These trees are established, drought tolerant and healthy. Any loss of roots underneath their canopies may trigger stress reactions, such as dead tissue, and/or insect and disease infestations. Trenching and equipment may also introduce unwanted pathogens into the root zone.

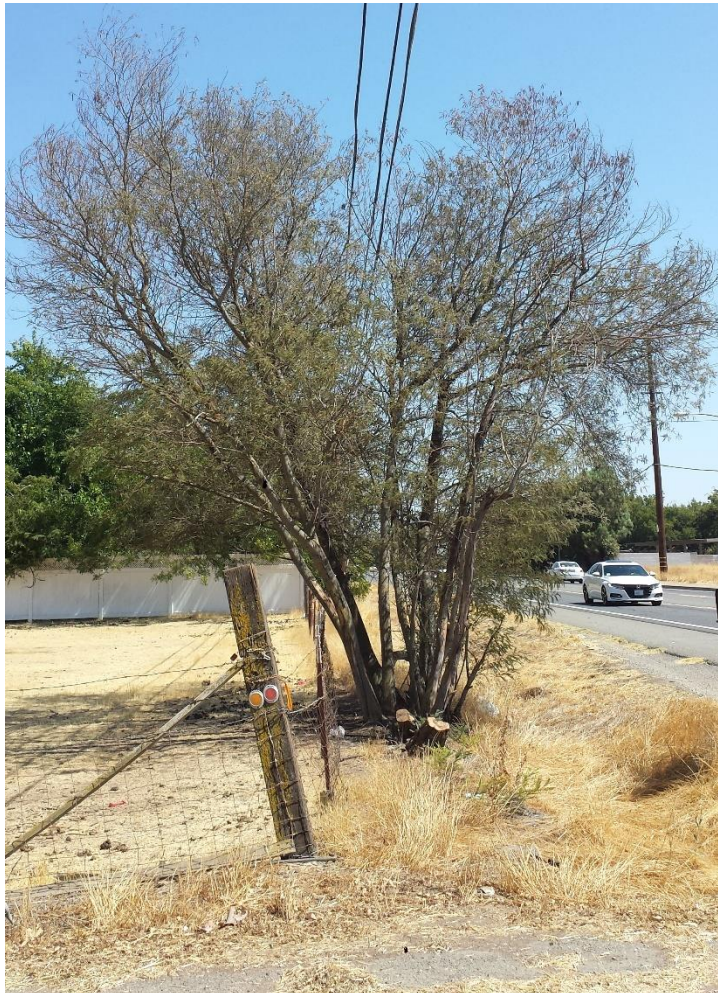
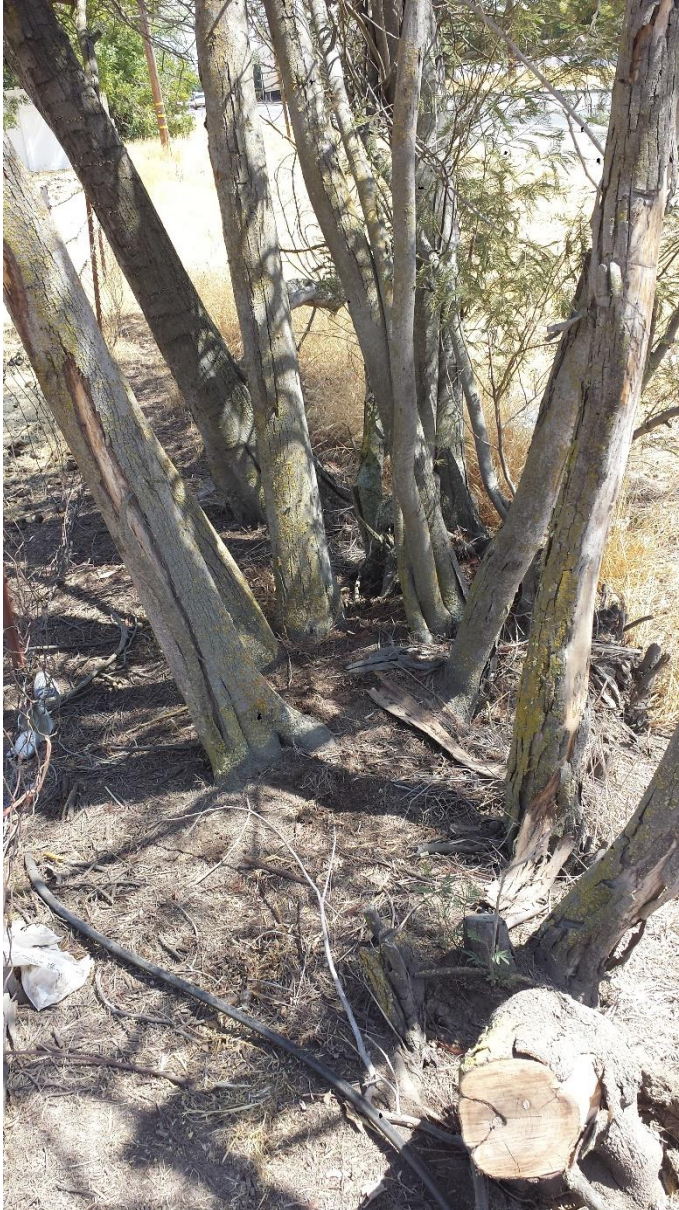
Picture below of ten (10) Green Wattle (*Acacia decurrens*) at the proposed driveway entrance to the project, along Twin Cities Road.

There are approximately 10 Green Wattle Acacia sprouts that have grown together in this location. There are three other stumps close by of other sprouts that were cut down or fell over and were cut down. Birds, squirrels or other rodents probably deposited the seeds here from a nearby tree located on the other side of the neighbor's driveway to the west. They range in size from 2-7" DSH and 14-25 feet high.

These trees are single trunk seedlings that have grown together in a clump. Most have a dramatic lean with excessive end weight over the base. This situation is prone to failure and falling over, as evidenced with several remaining stumps nearby. They have poor foliage size, density, color and growth. There is 40-50% live wood in

the canopy. Dieback and dead tissue are seen on all the trunks from severe drought stress and probably poor drainage. Borer activity is also noted on most trunks. This naturalized, no-irrigated clump of seedlings is in poor condition with poor structure, and it is rated (1) severe decline. Furthermore, these trees are sometimes considered invasive, nuisance and weedy tree species.

The on-site trees of concern are the ten (10) Green Wattle Acacia (*Acacia decurrens*) at the proposed driveway entrance to the project, along Twin Cities Road. These are poor quality, invasive and nuisance trees that are slated for removal for the proposed new driveway entrance.
