Protected Tree Report

**For: Proposed Ararat Home Site Expansion
15105 Mission Hills Road, Mission Hills**

Prepared by: **Greg Applegate, RCA #365
Arborgate Consulting, Inc.
1131 Lucinda Way
Tustin, CA 92780
714/ 731-6240**

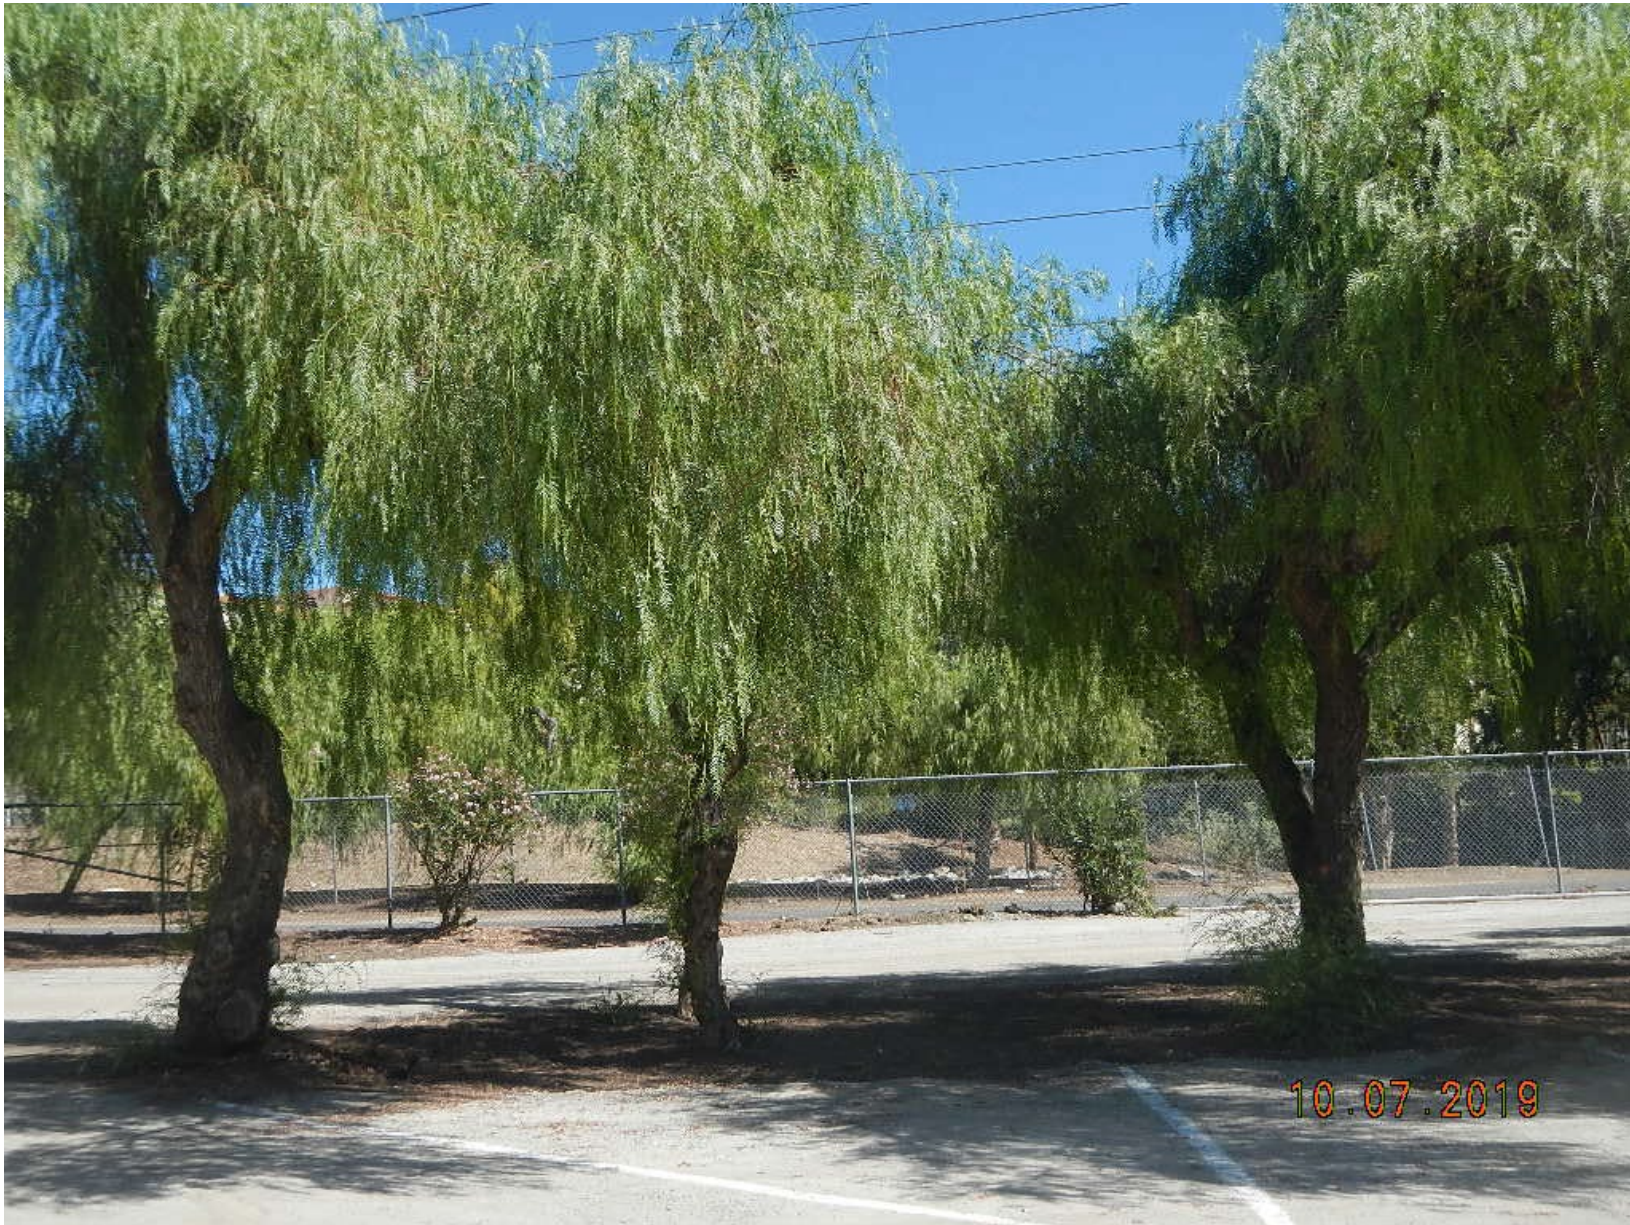
Peppers #3 to 5. The brush of new shoots hides the heading and topping cuts.

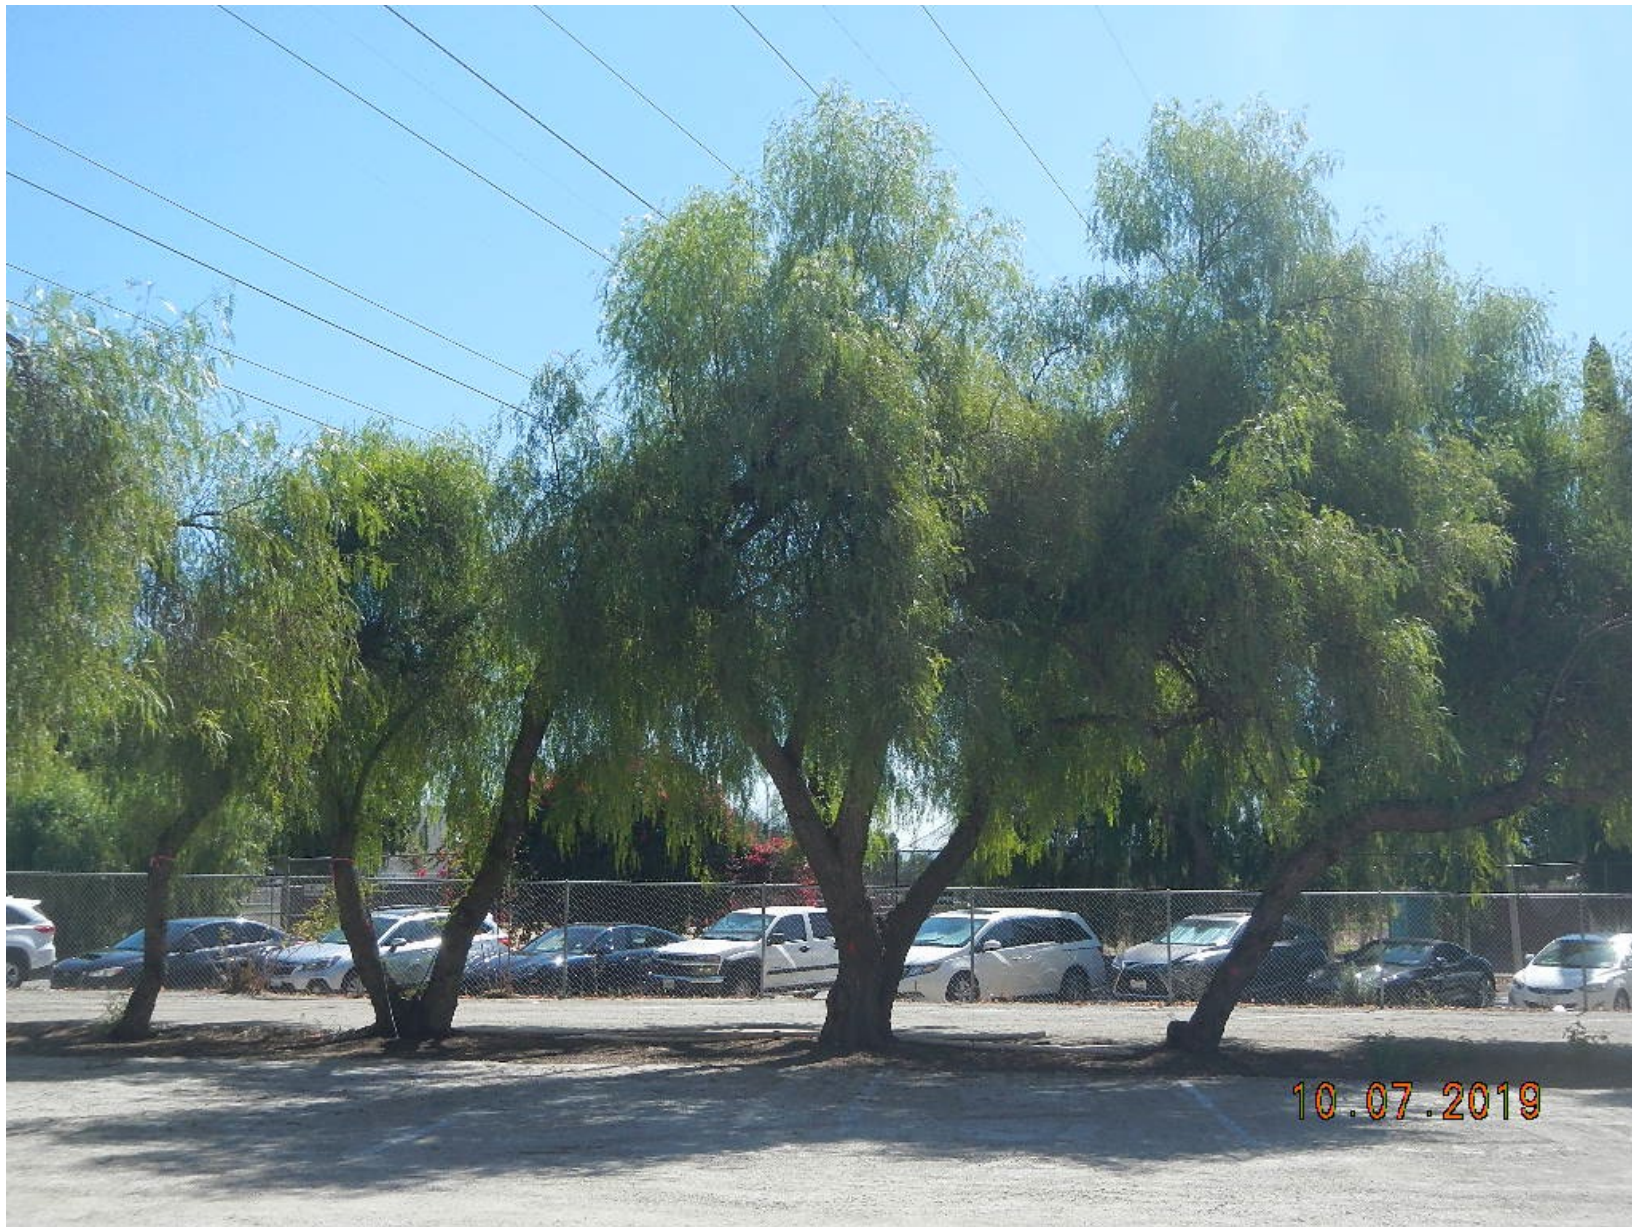
Pepper #15 (far left) to #18 at far right. Note severe lean of #18

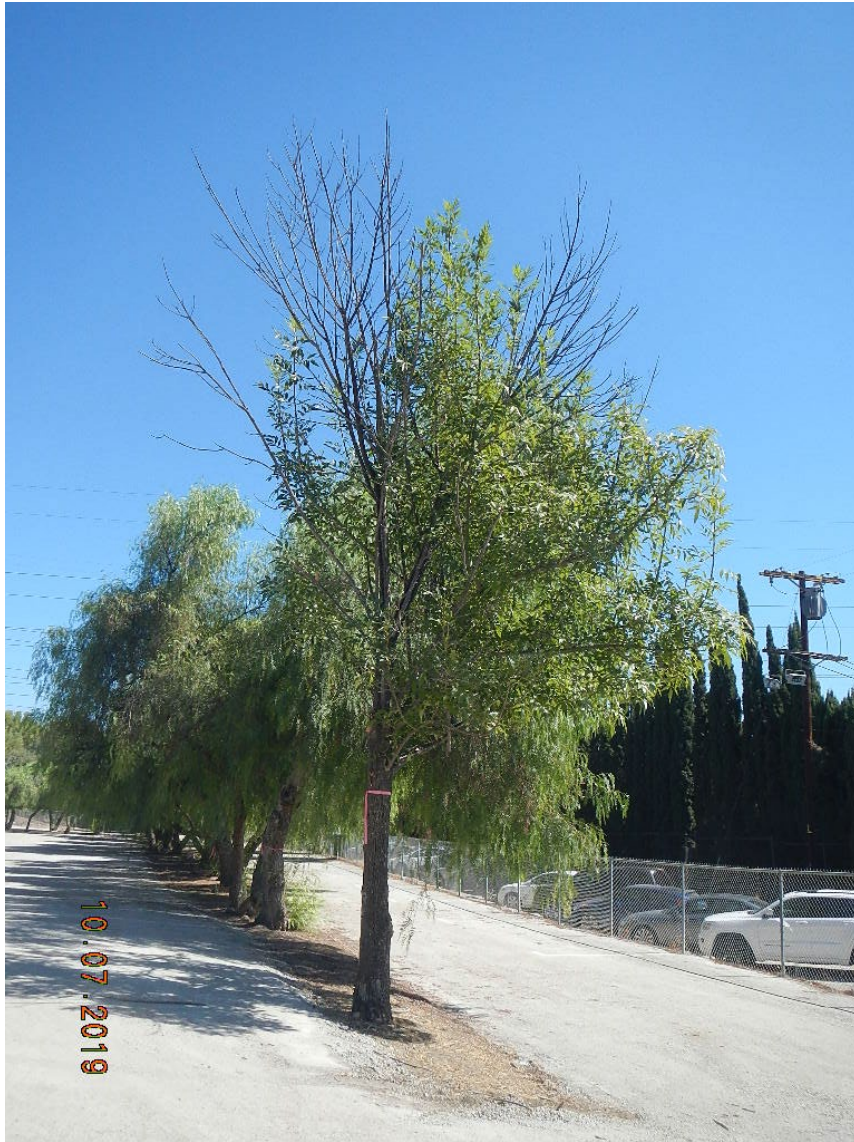
#35 Shamel ash at end of the row – note dieback.

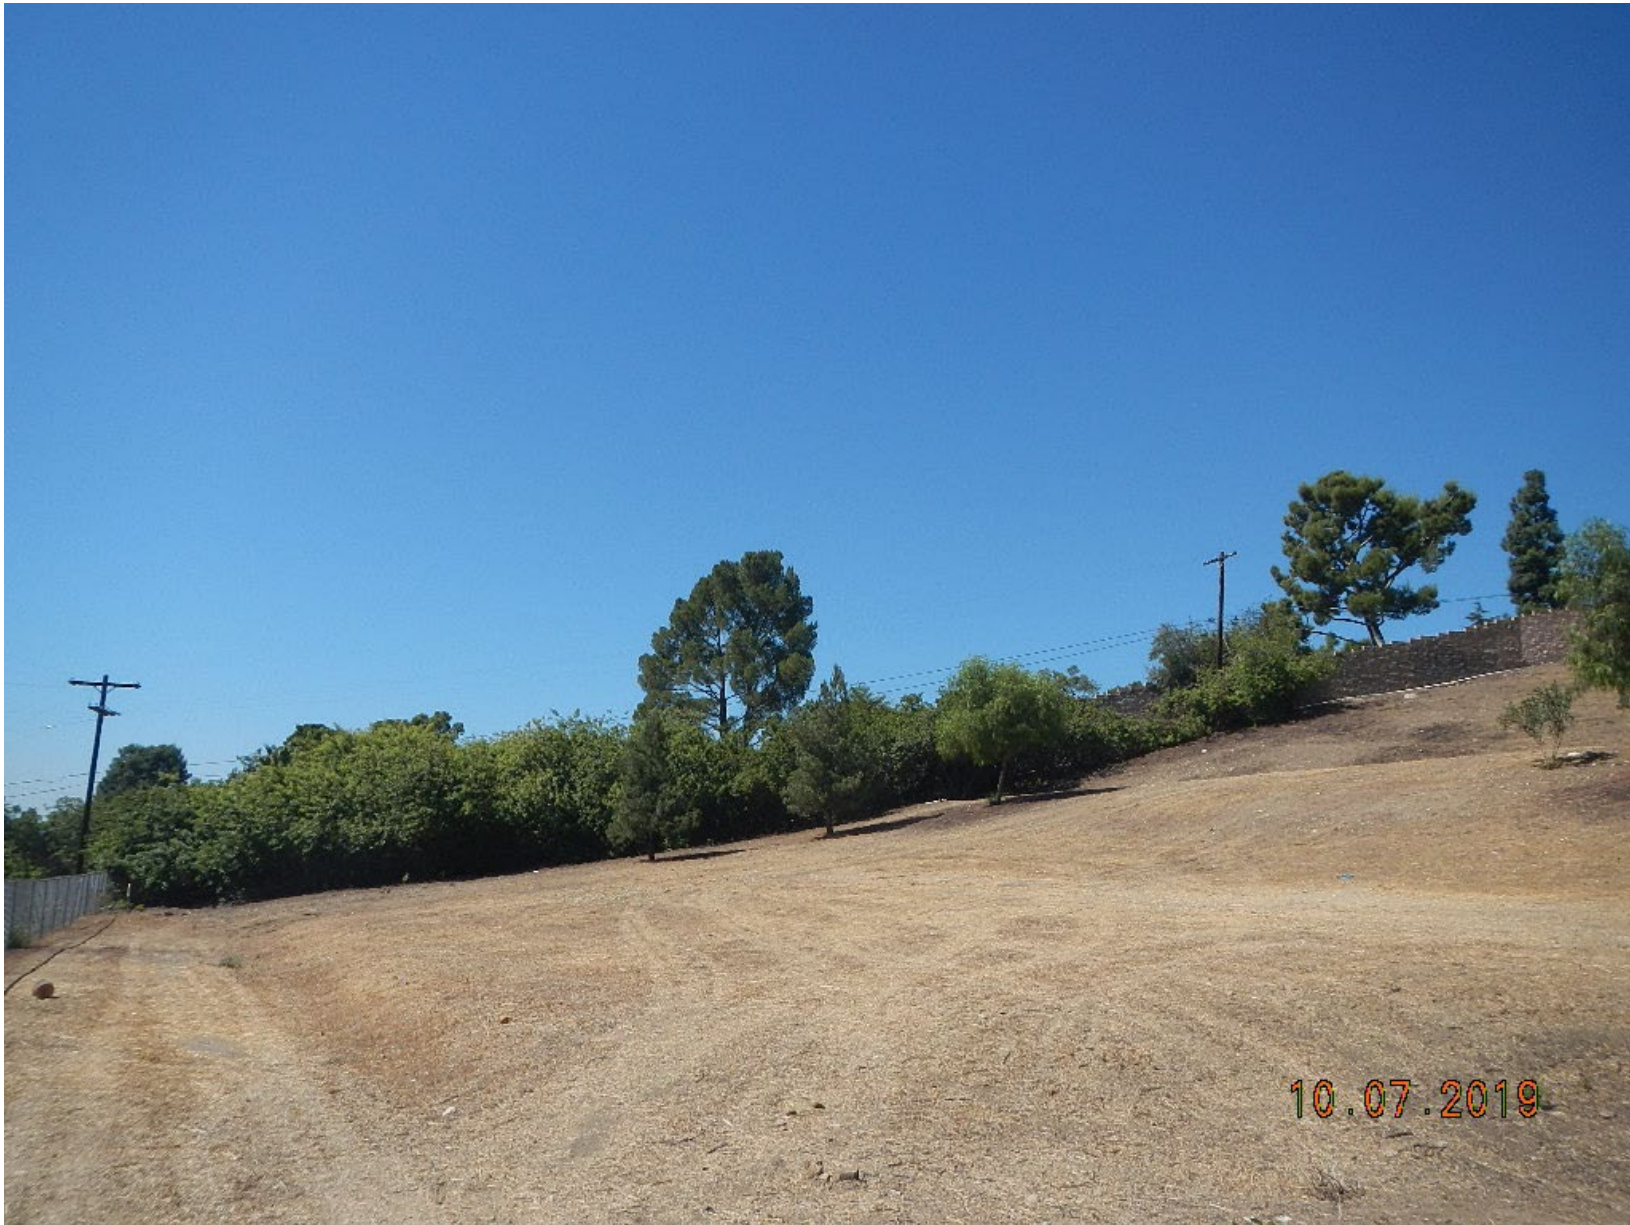
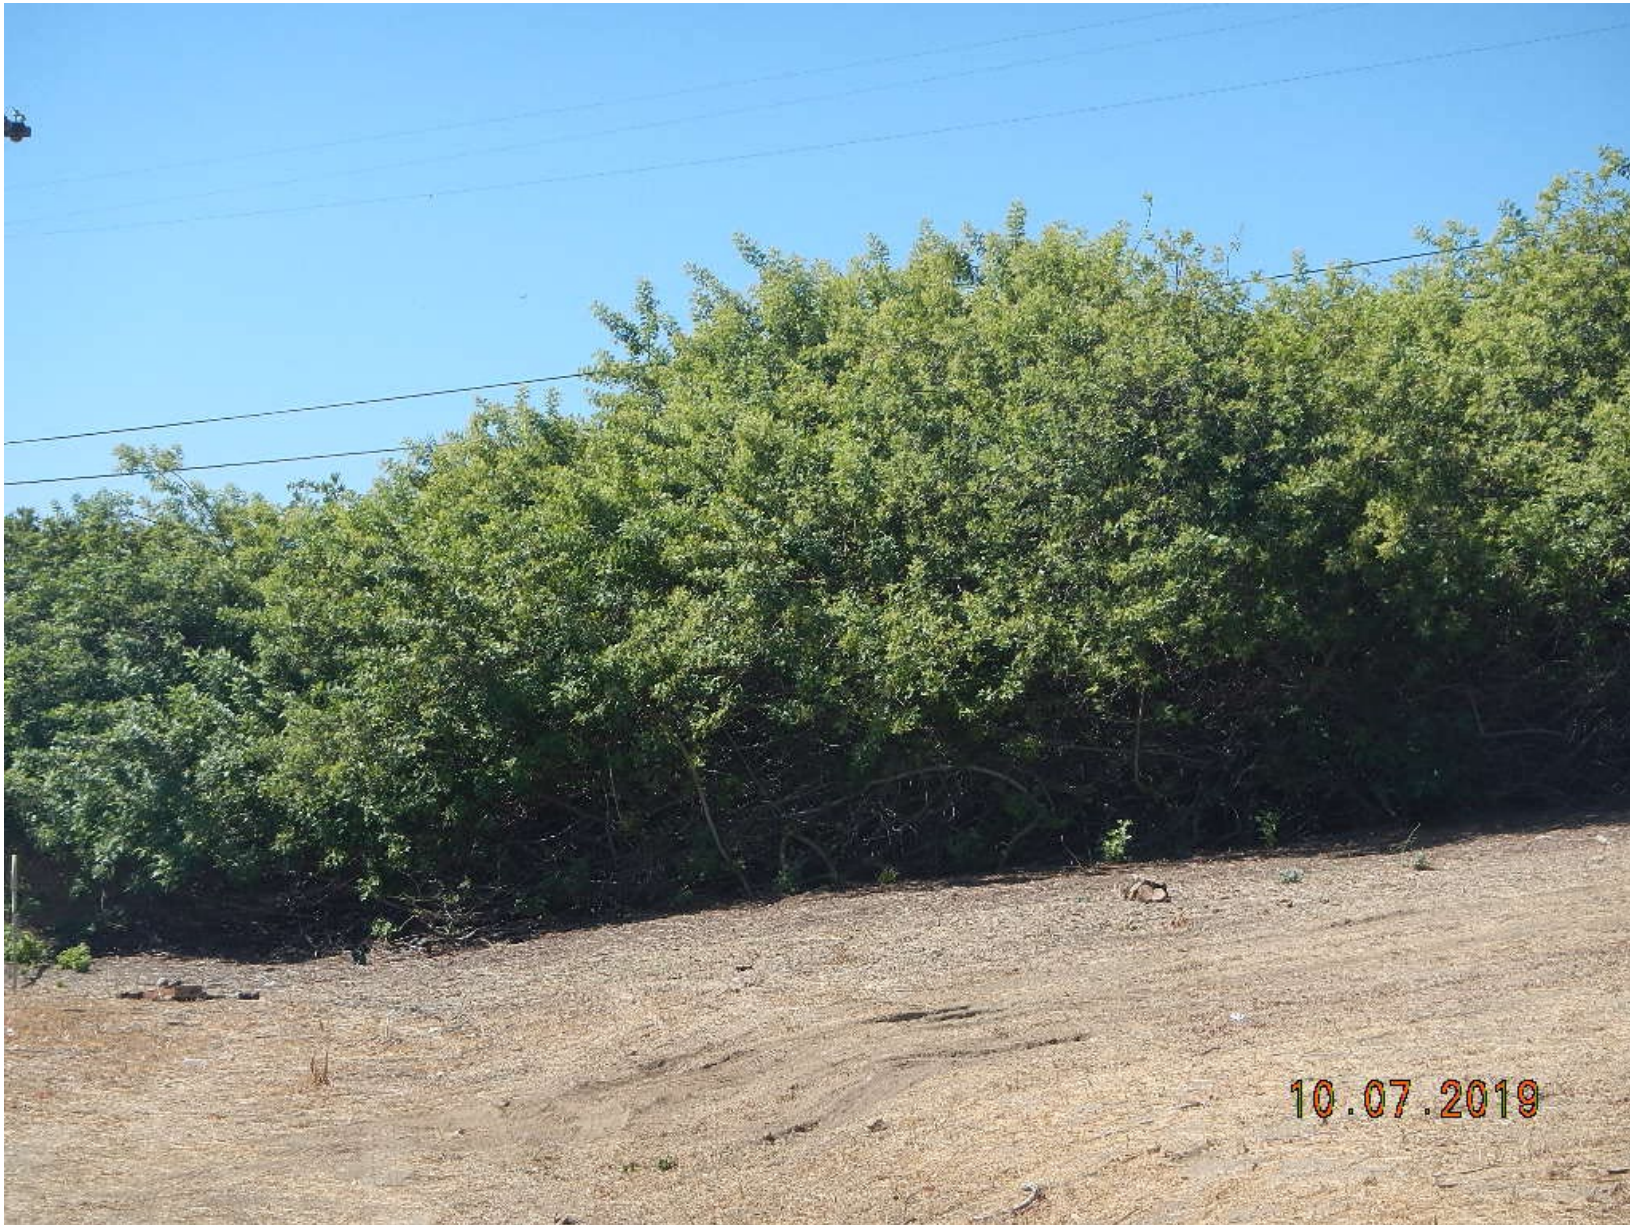
The Brazil peppers, *Schinus terebinthifolius*, on site are in fair health and poor structure, with many root shoots, seedling, and many have broken limbs. Nearly all, except two, are in a row along the lower west wall. This group could only be saved as a large hedge. This is one of the world's most invasive weed trees. They are fairly drought tolerant, real survivors and difficult to get rid of.

Brazil pepper thicket #36 at west wall.

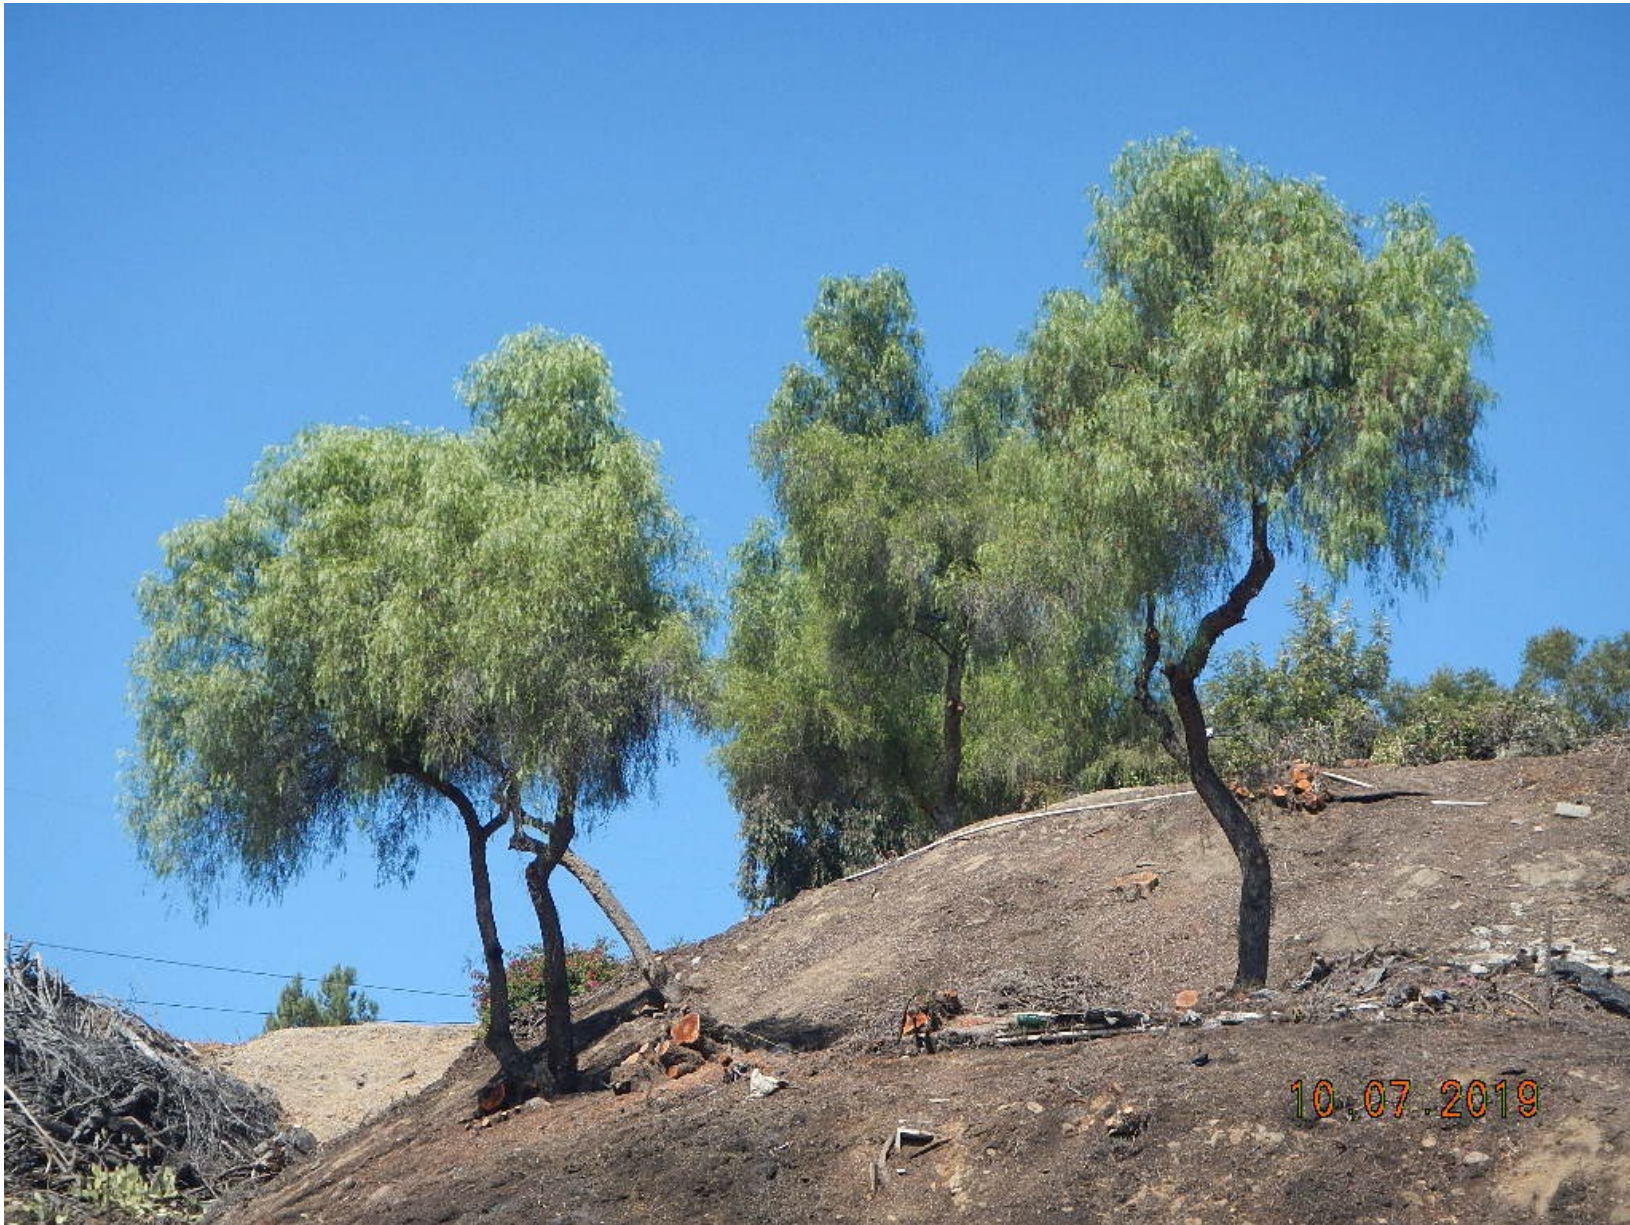
Peppers #42, 43 and 44, left to right. Note stumps of removed trees.

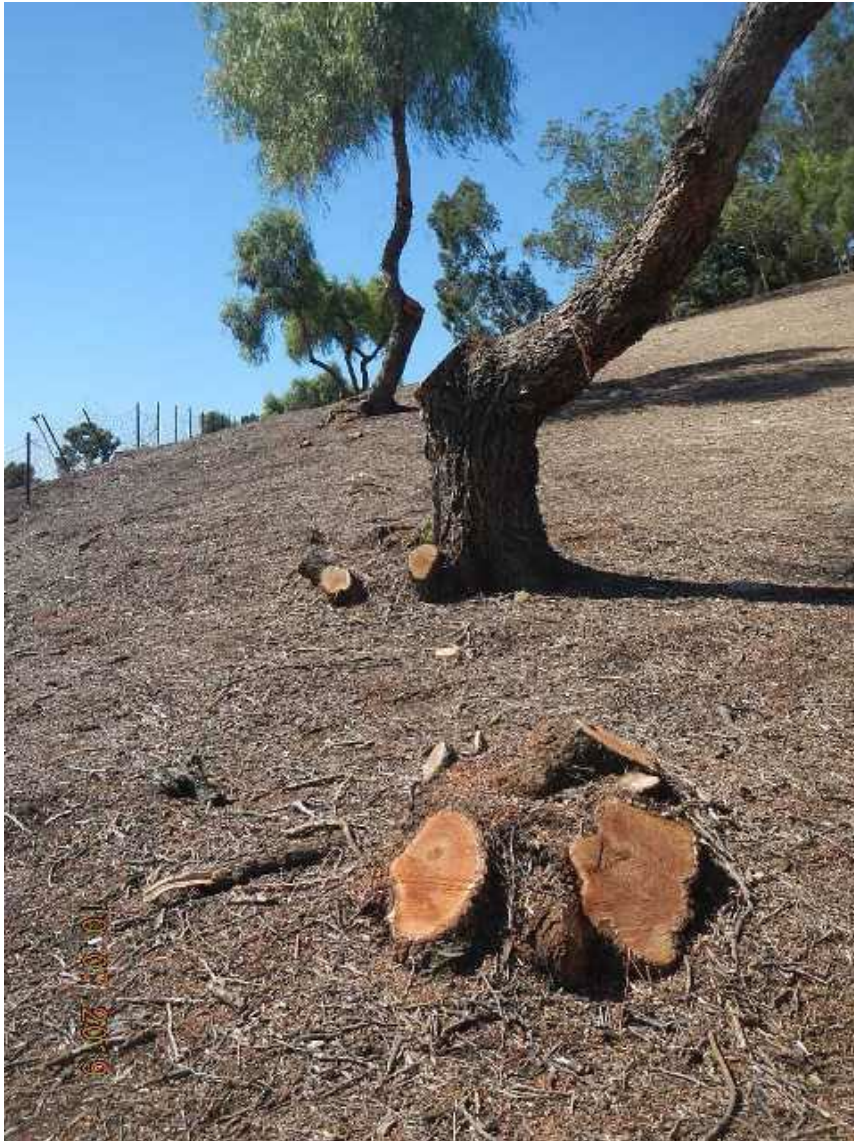
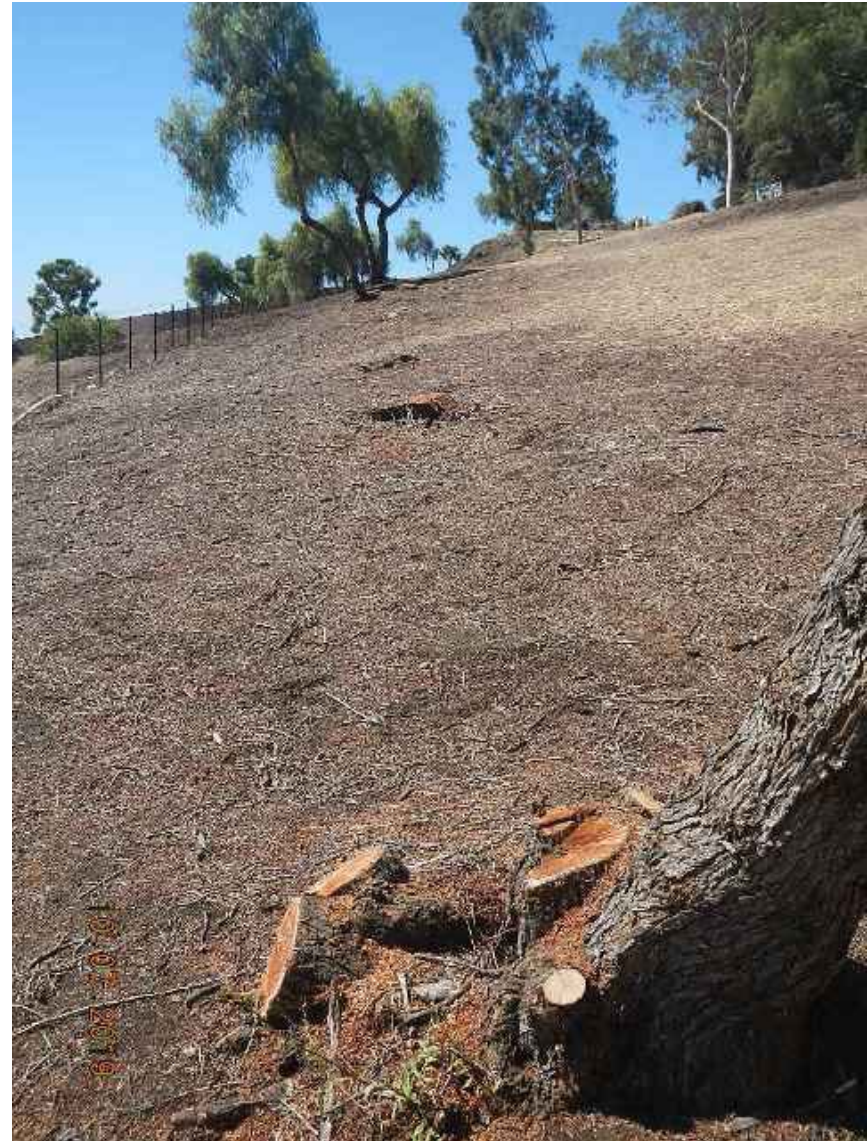
Note stumps between peppers 45 to 51

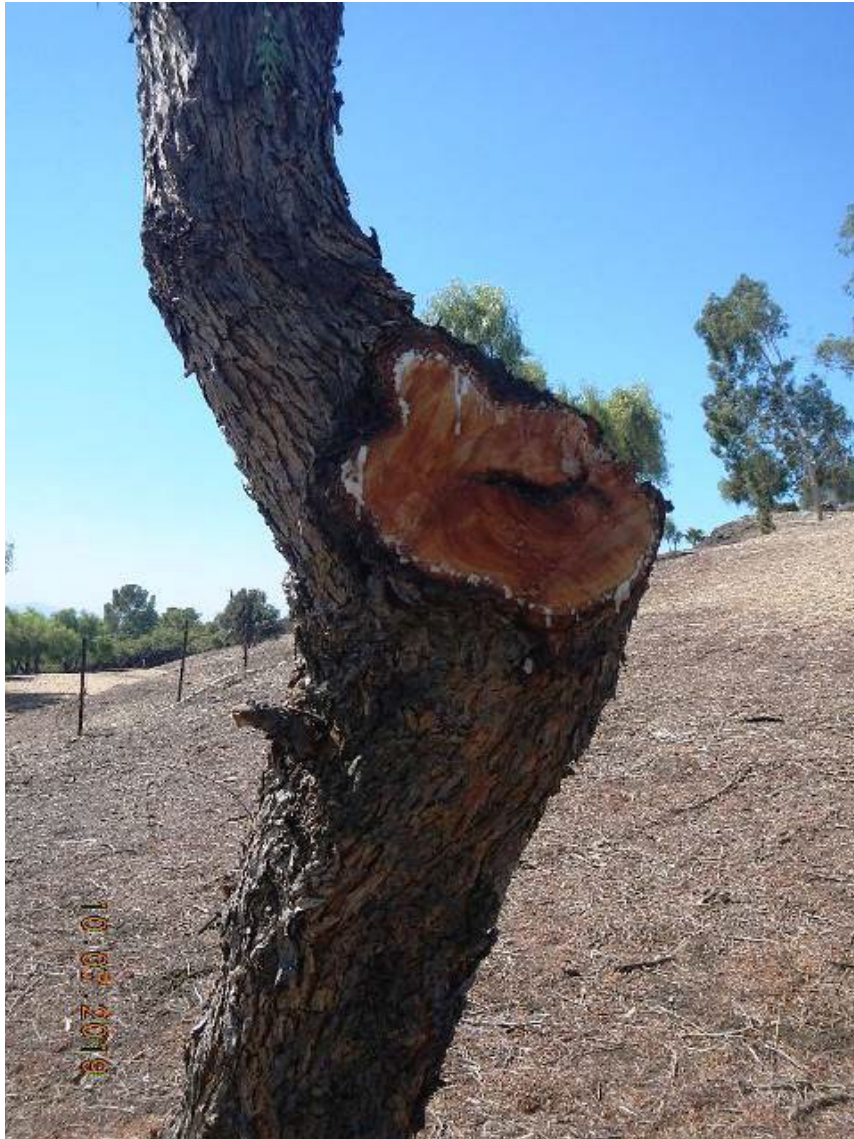
Note old internal crack .

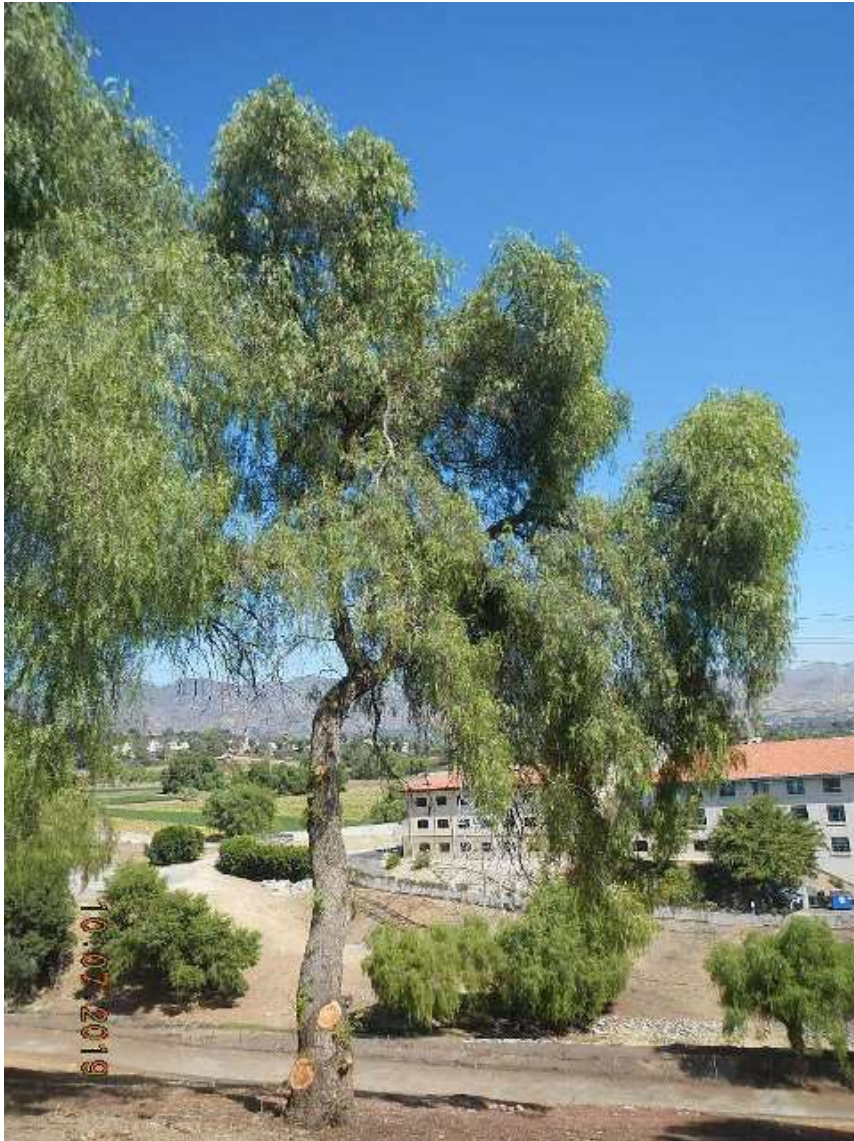
Pepper #53 – note large flush cuts near base.

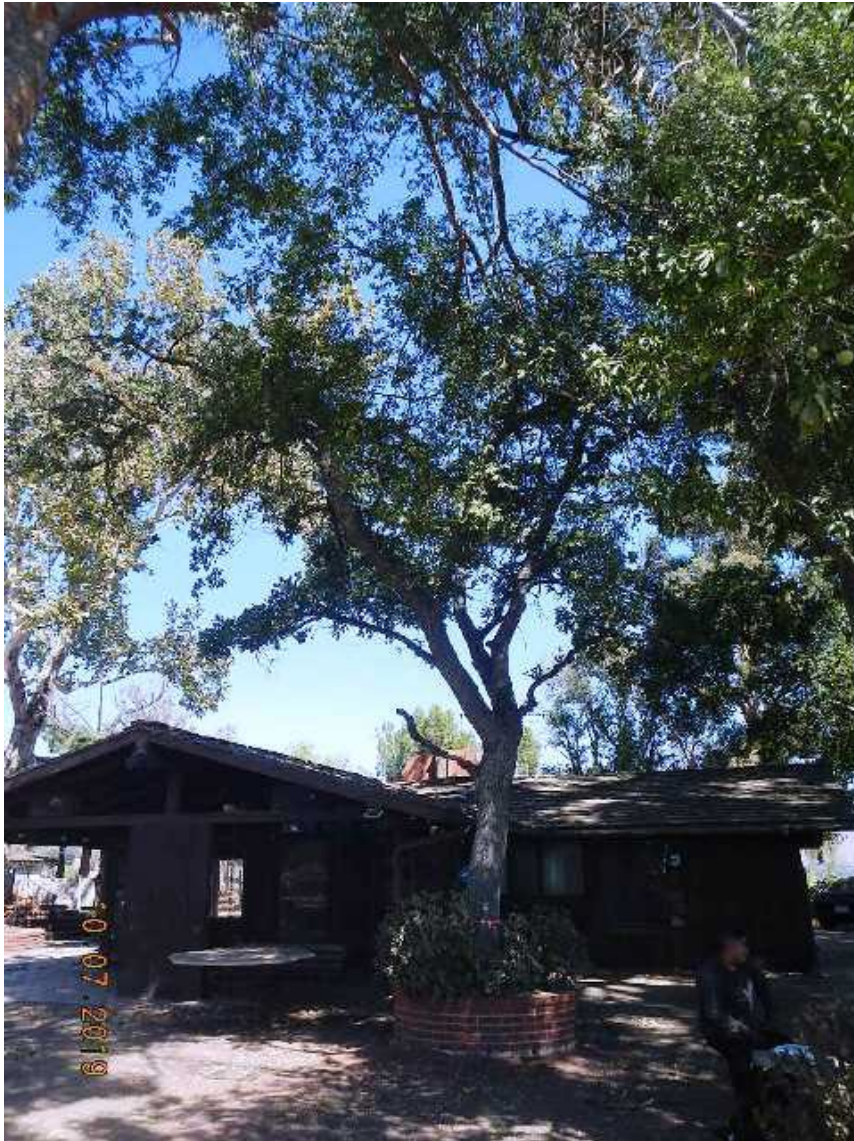
One valley oak (#55) is in a small planter, not much bigger than the trunk. Removal of the brick planter and surrounding paving would either expose roots or bury them under almost 2 feet of fill. This would cause the immediate decline of the tree.

Two valley oaks, *Quercus lobata*, were found on site below the lower home. The larger one (#55) is in a small round raised brick planter. It is a relatively young tree, obviously planted, and has good primary structure. It is partly suppressed by a large Chinese elm tree. The foliage is sparse. I doubt it could survive transplanting, but grading, removal of the brick planter and surrounding paving would kill it otherwise. It can’t last as it is, and it can’t last in the coming site use.

Valley oak #55 – note brick planter.

Tag#	Species	DBH	Ht.	Wd.	Clearance	Health	Structure	Pruning	Other recommendations
55	Quercus lobata	15	35	40	N/A	C-	B	N/A	Remove & mitigate
56	Platanus racemosa	25	50	40	N/A	C	C-	N/A	Remove & mitigate
57	Pinus halepensis	24	60	45	N/A	C	C-	N/A	Remove - condition
58	Pinus halepensis	18"b	35	30	N/A	C	D	N/A	Remove - work
59	Cupressus sempervirens	8.5	40	4	N/A	A	B	N/A	Remove - work
60	Cupressus sempervirens	8	35	4	N/A	A	B	N/A	Remove - work
61	Thuja orientalis	3+3+6	12	8	N/A	C	C	N/A	Remove - work
62	Juniperus chinensis cv	8"b	10	9	N/A	C	C	N/A	Remove - work
63	Juniperus chinensis cv	6"b	4	7	N/A	C	C	N/A	Remove - work
64	Schinus molle	9 @ 2'	16	16	N/A	B	B	N/A	Remove - work
65	Schinus molle	5.2	14	9	N/A	C	D	N/A	Remove - work
66	Schinus molle	13	25	25	N/A	B	C	N/A	Remove - work
67	Schinus molle	17 @ 3'	28	35	N/A	B	D	N/A	Remove - work
68	Schinus molle	18 @ 3'	26	30	N/A	C	D	N/A	Remove - work
69	Eucalyptus sideroxylon	15	40	30	N/A	B	C	N/A	Remove - work

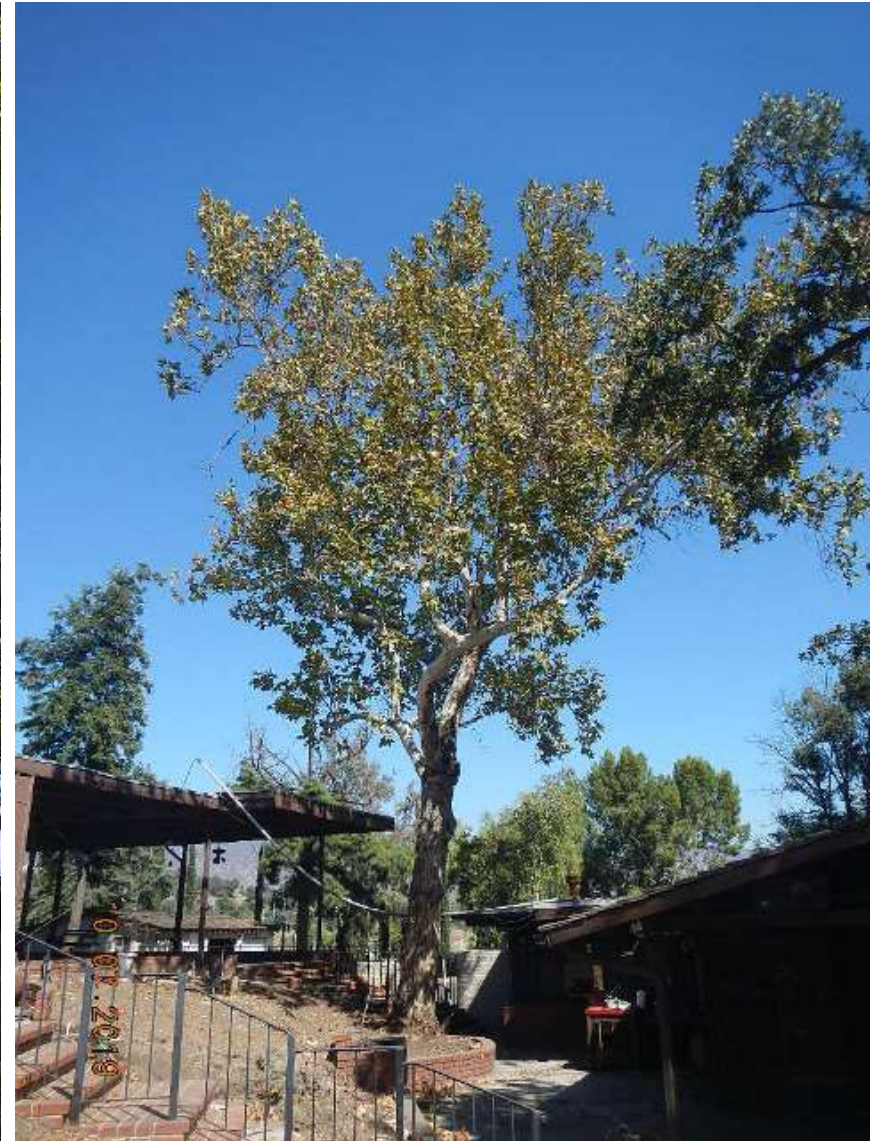
Sycamore #56 – note planter at base of slope

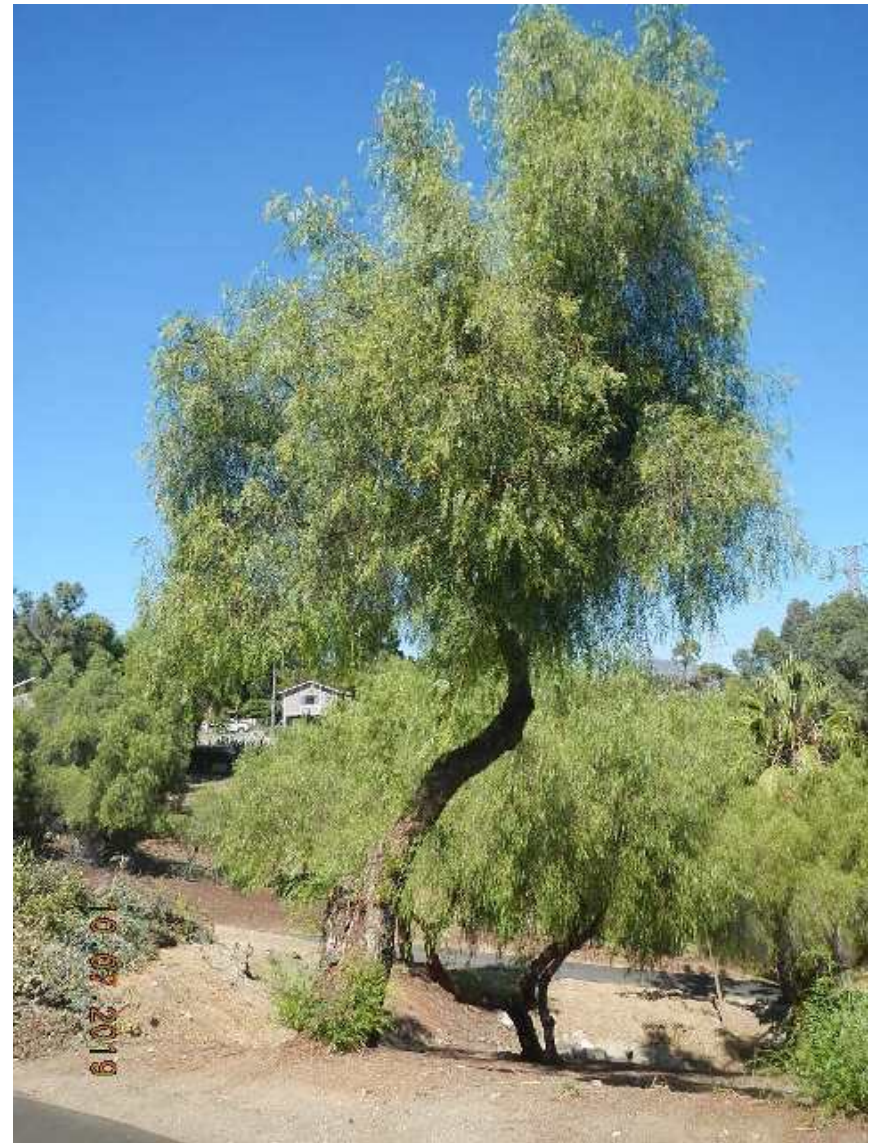
Pepper #68 has a split base

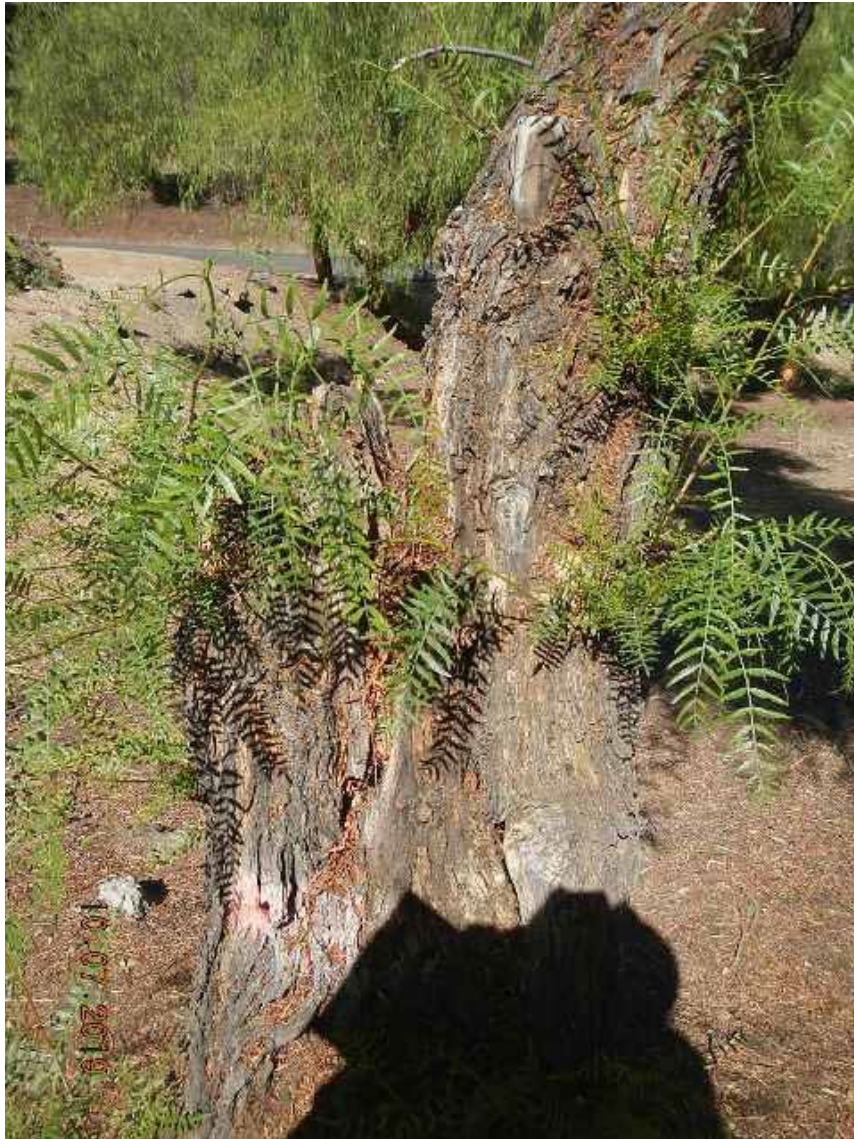
The base of pepper #68.

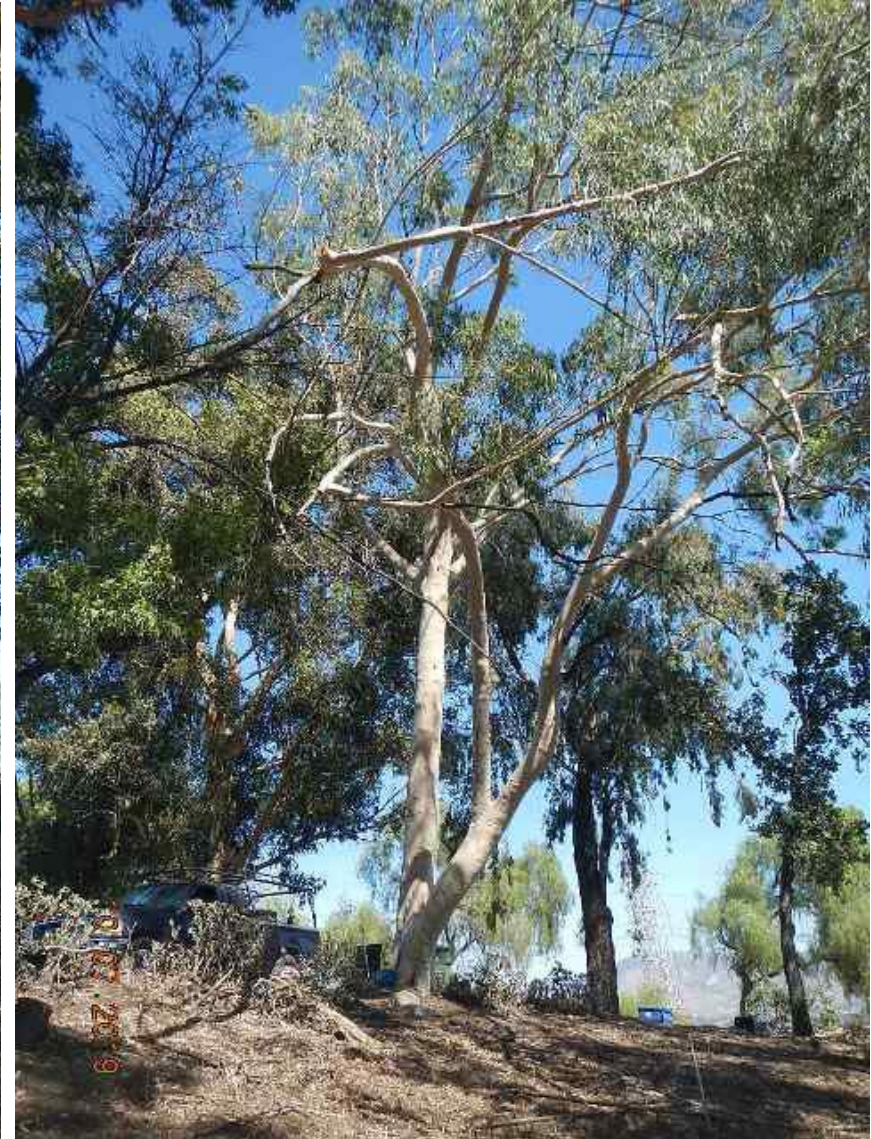
Large deformed lemon gum.

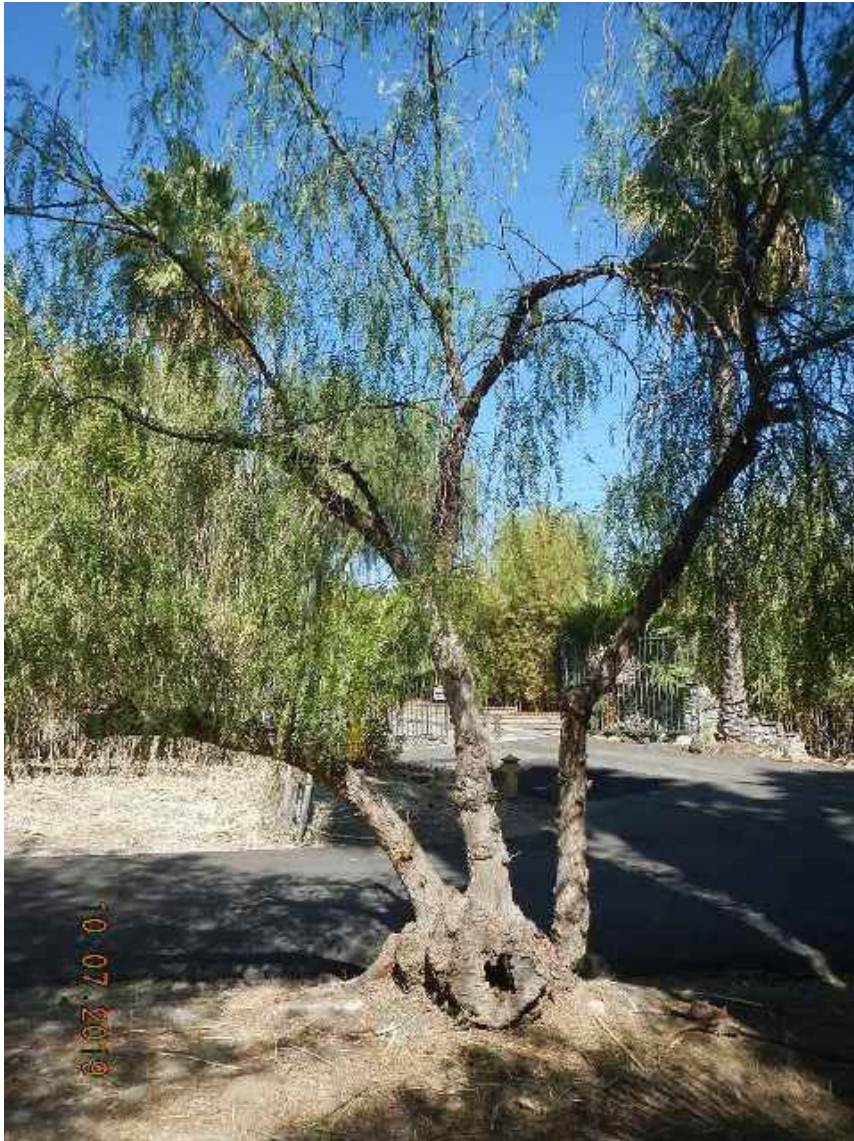
Pepper #74 – note decayed base.
