Protected Tree Report

**For: Proposed Ararat Home Site Expansion
15105 Mission Hills Road, Mission Hills**

Prepared by: **Greg Applegate, RCA #365
Arborgate Consulting, Inc.
1131 Lucinda Way
Tustin, CA 92780
714/ 731-6240**

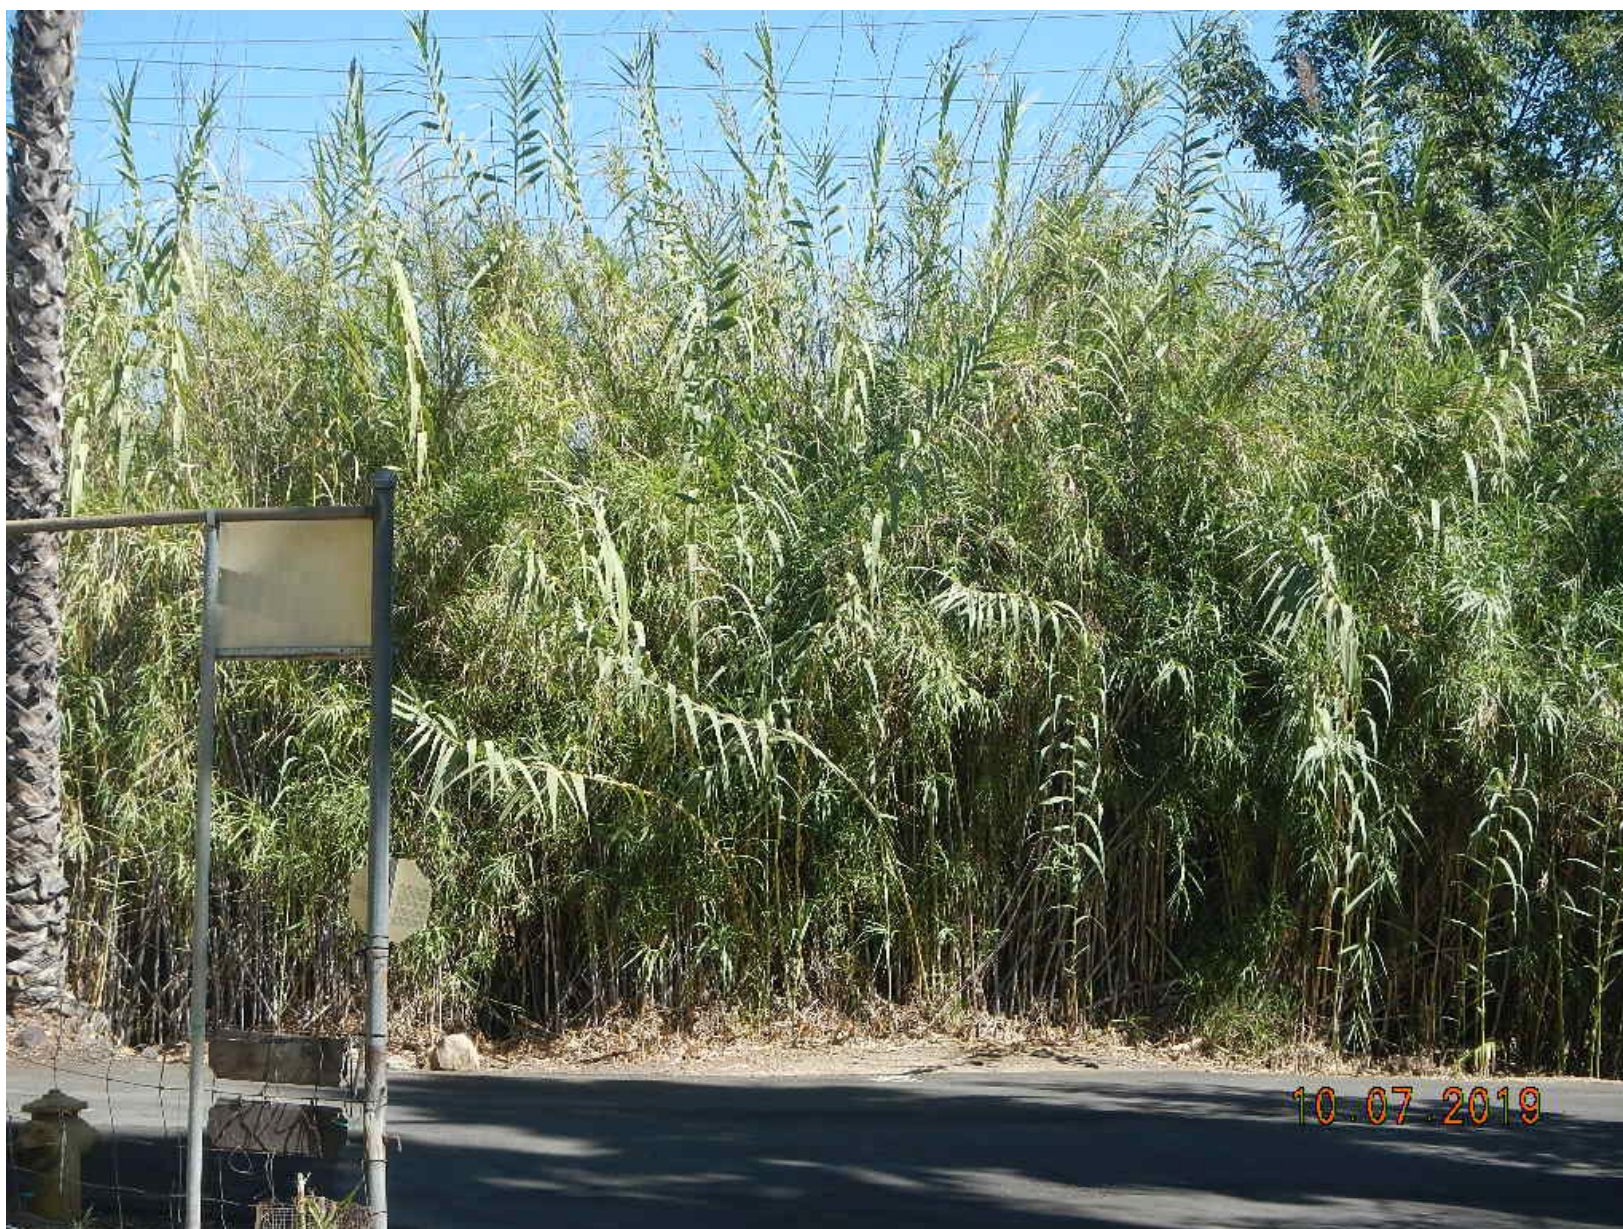
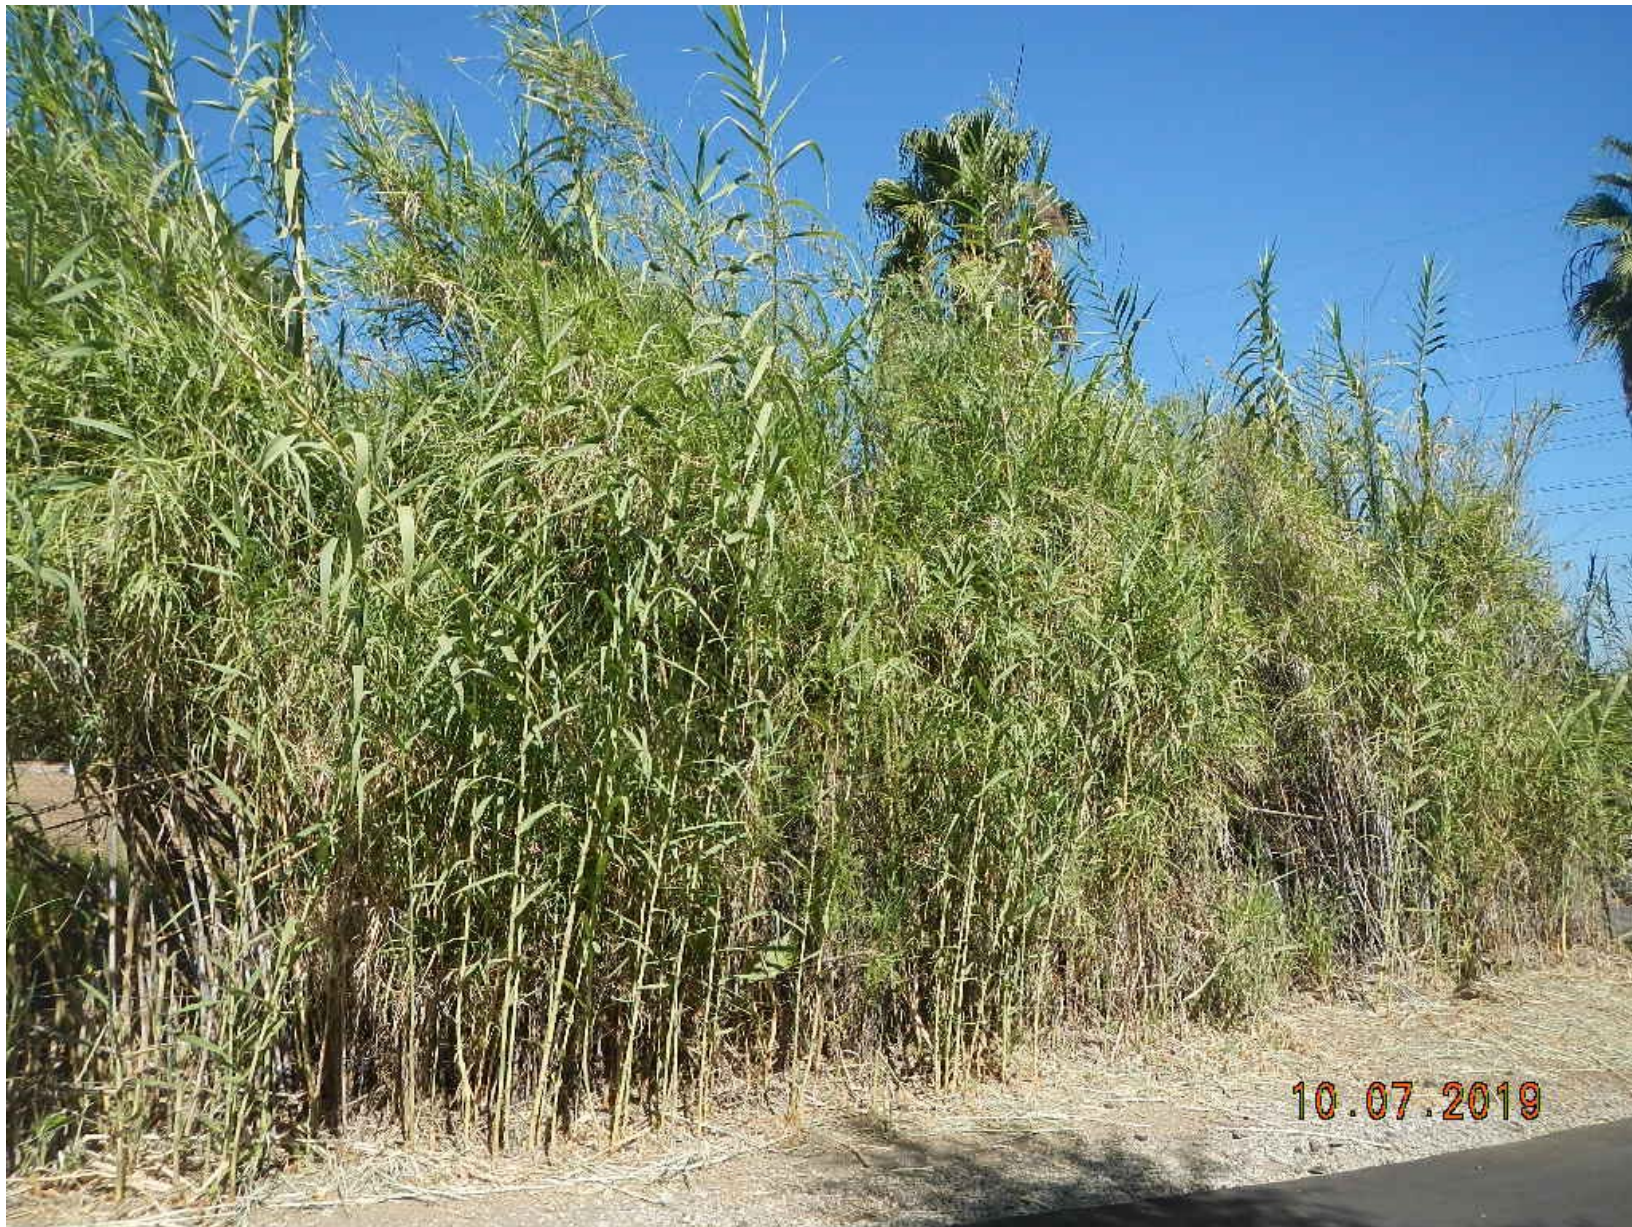
Mixture of two aggressive weeds, golden bamboo and giant reed, *Arundo donax*.

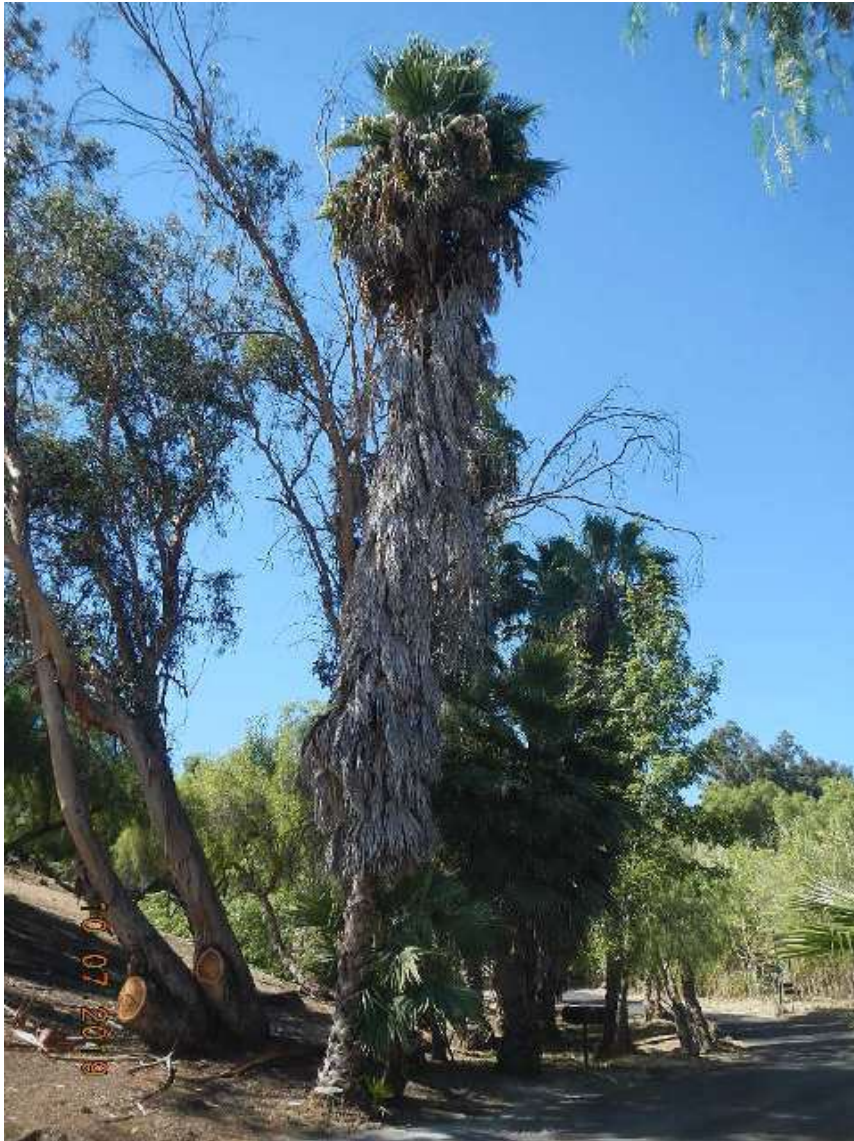
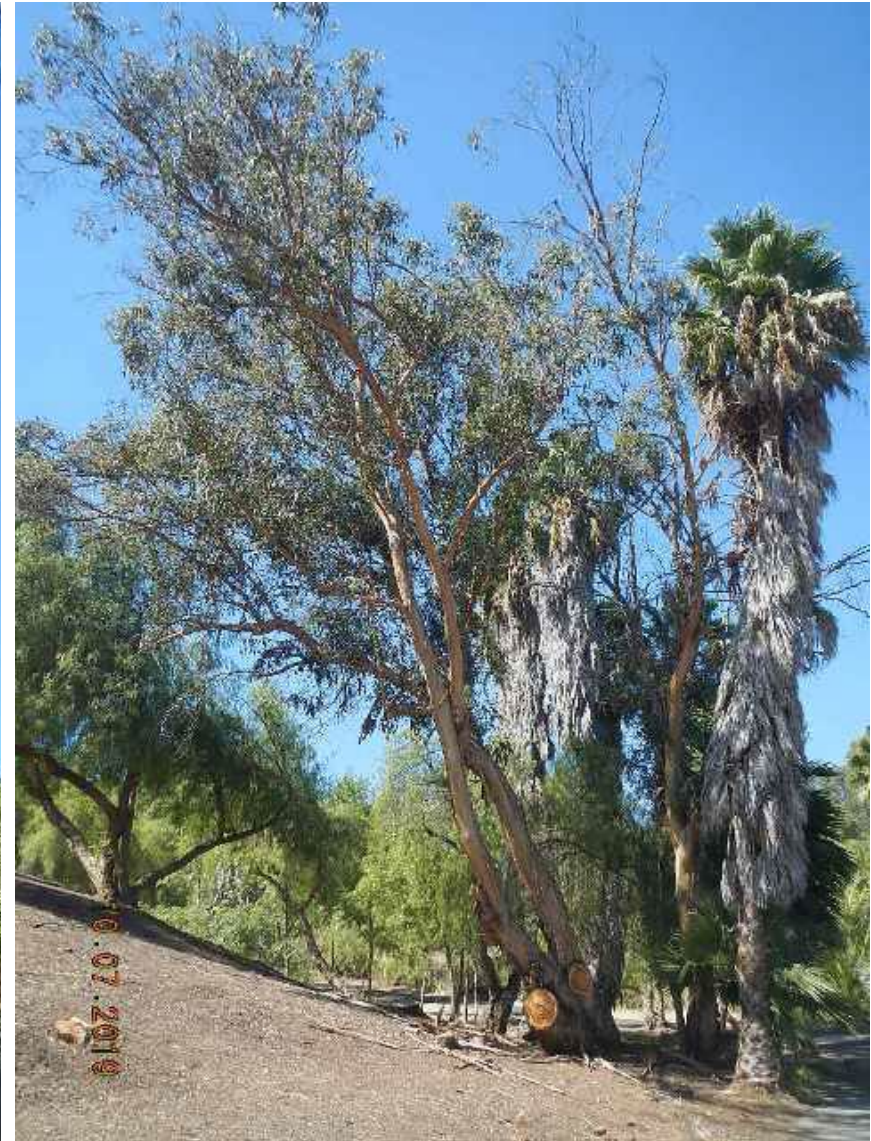
Several different species of eucalypts occur across the property, though none are found on the lower slopes and only a few listed for inclusion on the upper site. Only one included tree was a really good specimen, though several included ones near the lower residence have adequate appearance to be worth saving if they were not in the way or suppressing protected species. Most are one-sided or leaning due to crowding. The demolition and grading of the patio area will probably prevent keeping most of them. The two blue gums on the lower driveway are in poor condition and should be removed.

Blue gums #84 and 85, right to left.

Tag#	Species	DBH	Ht.	Wd.	Clearance	Health	Structure	Pruning	Other recommendations
83	Washingtonia robusta	50'th	50'th	10	N/A	A	A	N/A	Remove - work
84	Eucalyptus globulus	18	50	30	N/A	D-	D	N/A	Remove - work
85	Eucalyptus globulus	30+30	60	40	N/A	C	D	N/A	Remove - work
86	Quercus lobata	9	35	15	N/A	C	B	N/A	Remove & mitigate
87	Schinus molle	20+7+5	28	26	16.5	B	C-	N/A	Remove - work
88	Schinus molle	10+10+10	24	35	N/A	B	C-	N/A	Remove - work
89	Schinus molle	10+11+20	30	40	N/A	B	B	N/A	Remove - work
90	Schinus molle	7	22	14	N/A	B	C-	N/A	Remove - work
91	Schinus molle	10+12	28	35	N/A	B	C	N/A	Remove - work
92	Schinus molle	10+10	25	28	N/A	C	C	N/A	Remove - work
93	Schinus molle	10+8	24	28	N/A	C	C-	N/A	Remove - work
94	Schinus molle	10	24	22	N/A	C	C	N/A	Remove - work
95	Schinus molle	8+12	24	28	N/A	B	C	N/A	Remove - work
96	Schinus molle	14 @ 2'	26	28	N/A	B	D	N/A	Remove - work
97	Schinus molle	5+10	26	16	N/A	B	C-	N/A	Remove - work
