Protected Tree Report

1185 Sunset Blvd.
Los Angeles, CA 90026

August 31, 2023

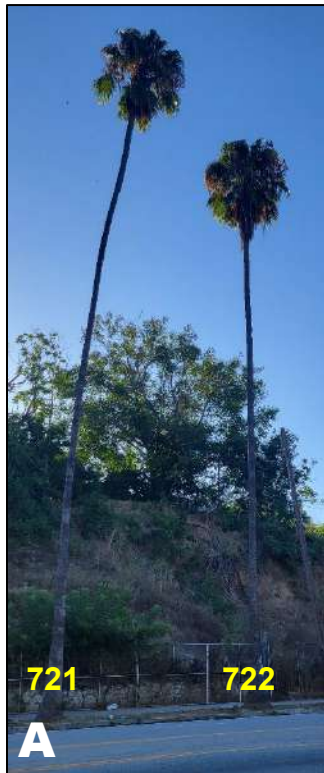
Tree #	Scientific Name Common Name	Photo	Size	Cond.	Comments
1	721	<i>Washingtonia robusta</i> Mexican fan palm	A	DBH: 20" Hght: 100' Wt.: 10'	Fair	Curved trunk. Mechanical damage. Graffiti on trunk.
2	722	<i>Washingtonia robusta</i> Mexican fan palm	A	DBH: 19" Hght: 100' Wt.: 10'	Fair	Graffiti on trunk. Adventitious roots.
3	723	<i>Washingtonia robusta</i> Mexican fan palm	B	DBH: 19" Hght: 100' Wt.: 10'	Fair	Curved trunk. Mechanical damage. Graffiti on trunk.
4	724	<i>Washingtonia robusta</i> Mexican fan palm	B	DBH: 18" Hght: 100' Wt.: 10'	Fair	Curved trunk. Graffiti on trunk. Adventitious roots.
5	725	<i>Washingtonia robusta</i> Mexican fan palm	B	DBH: 19" Hght: 100' Wt.: 10'	Fair	Curved trunk. Graffiti on trunk. Cavity in lower trunk.
6	726	<i>Washingtonia robusta</i> Mexican fan palm	C	DBH: 19" Hght: 100' Wt.: 10'	Fair	Curved trunk. Graffiti on trunk. Small palm growing at base of tree.
7	727	<i>Washingtonia robusta</i> Mexican fan palm	C	DBH: 20" Hght: 100' Wt.: 10'	Fair	Curved trunk. Mechanical damage. Hourglass trunk width.

Photo A, facing southeast, showing Trees 721 and 722 at the northern end of the property.

2. Remove small palm from the base of Tree 726.
3. For aesthetics, the developer may want to consider removing graffiti from palm trunks.
4. The project arborist will be on-site when the tree protection fencing is installed and if any excavation, drilling, demolition, or backfilling takes place within the fenced enclosures of the three street trees. The project arborist will also make periodic site visits to ensure the tree protection fencing is in place and to monitor the condition of the trees.

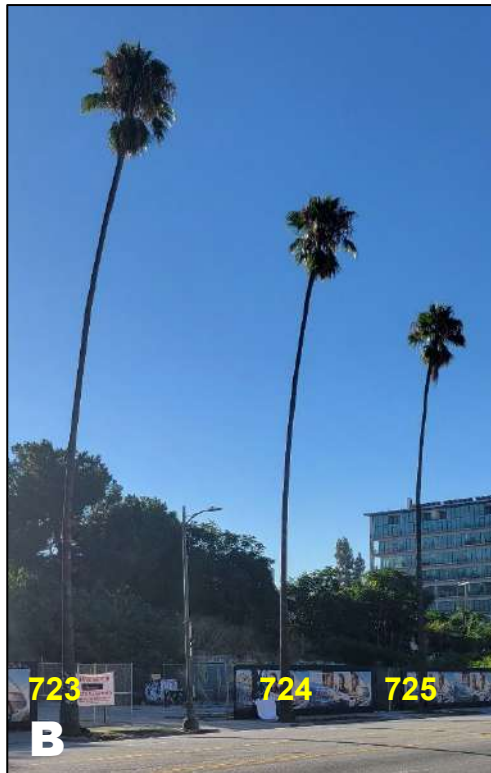
Photo B, facing southeast, showing Trees 723, 724, and 725 in the middle of the property.

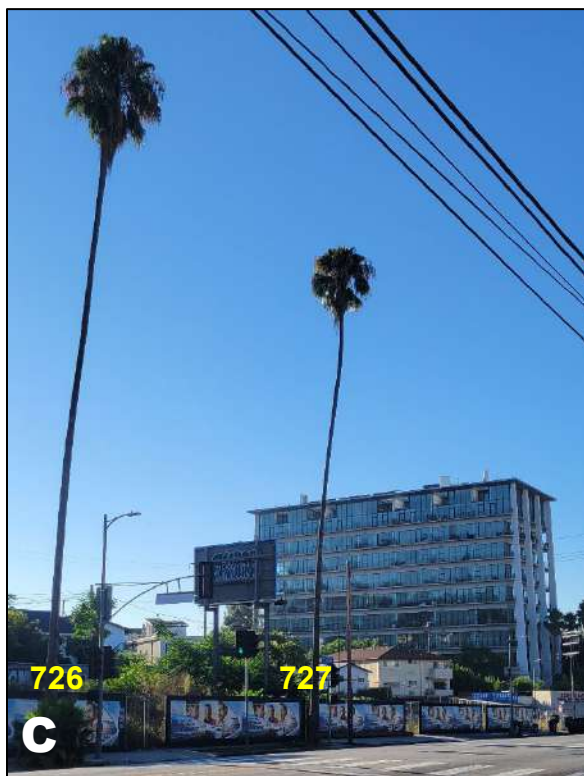
Photo C, facing southeast showing Tree 726 on the northeast corner of Sunset Boulevard and Marion Avenue, and Tree 727 on the southeast corner of Sunset Boulevard and Marion Avenue.
