Preliminary Arborist Report

5200 Patrick Henry Drive
Santa Clara, CA

PREPARED BY:
HortScience | Bartlett Consulting
325 Ray Street
Pleasanton, CA 94566

April 2022

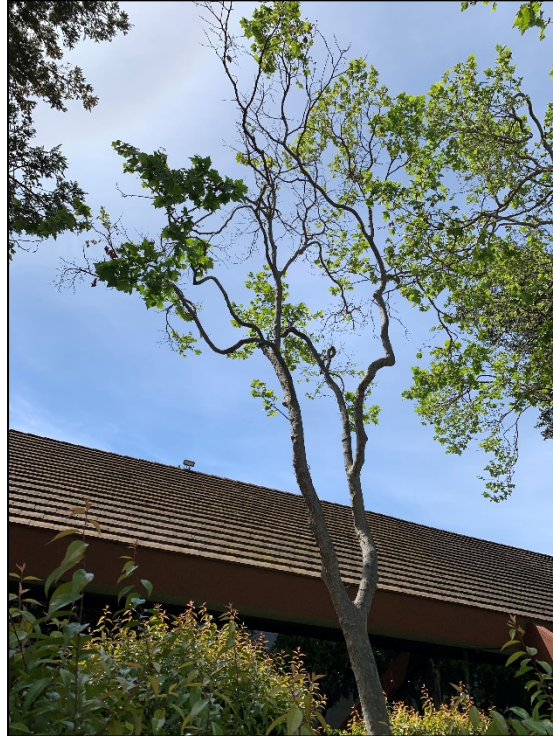
Of the 38 London planes assessed, 27 were in poor condition and 11 were in fair condition. These trees were generally young to semi-mature, ranging from 5 to 15 inches with an average of 9 inches. London planes in poor condition often had pervasive twig and branch dieback with narrow, suppressed crowns (Photo 1).

Photo 1: London plane #89 had pervasive twig and branch dieback and a narrow, suppressed crown.

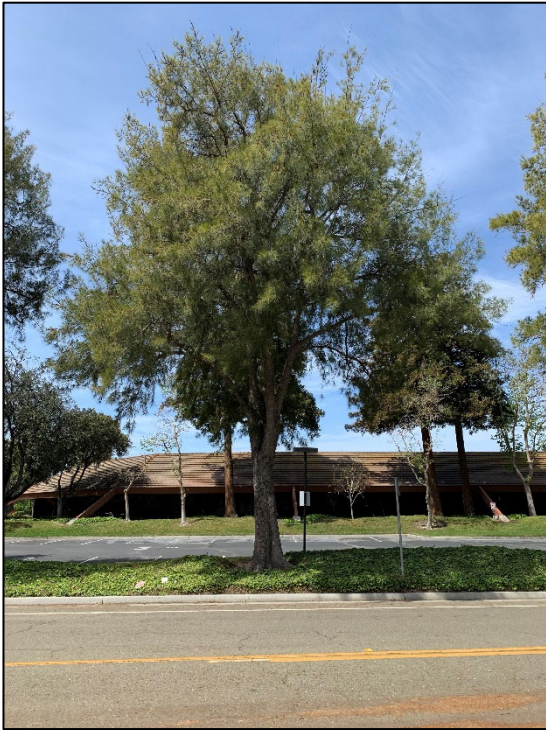
Photo 2: River she-oak #59 was growing along Patrick Henry Drive. The tree had multiple stems arising from 11 feet.

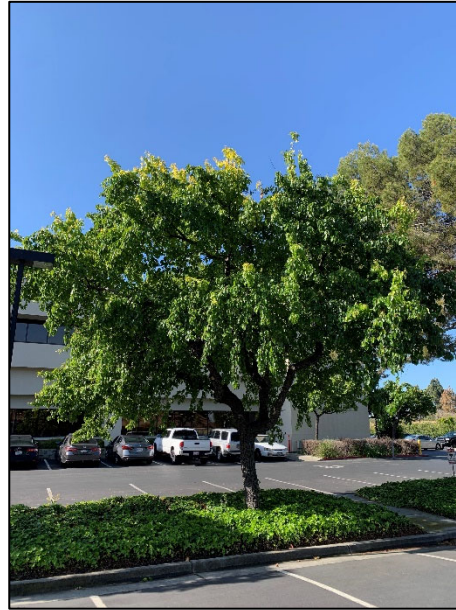
Photo 3: Evergreen pear #42 was in good condition with a vigorous crown and multiple attachments at approximately 6 feet.

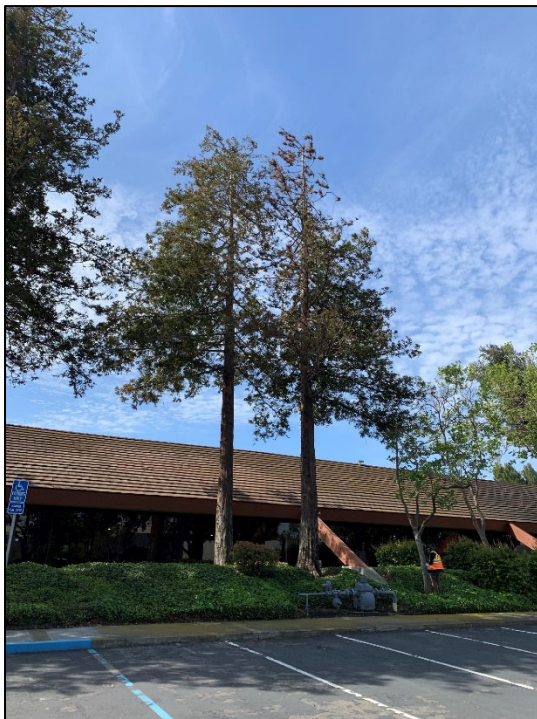
Photo 4: Coast redwoods #80 and #81 were planted too close together. Each had a thin crown, evidencing drought stress.

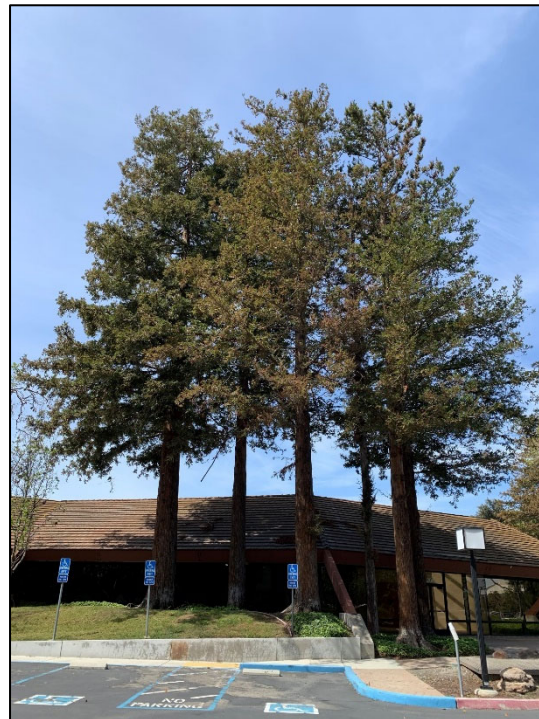
Photo 5: Coast redwoods #139 - #143 were planted too close together and had suppressed, asymmetric crowns. Redwood #142 (second from right) was stunted, heavily suppressed, and in poor condition as a result.
