## Arborist Report

455 Hickey Blvd  
Daly City, CA 94015

Inspection Date:  
May 13, 2021

Prepared by: Chris Stewart  
Project Arborist: Michael Young  
contractors license # 755989  
certified arborist WC ISA #623  
certified tree risk assessor

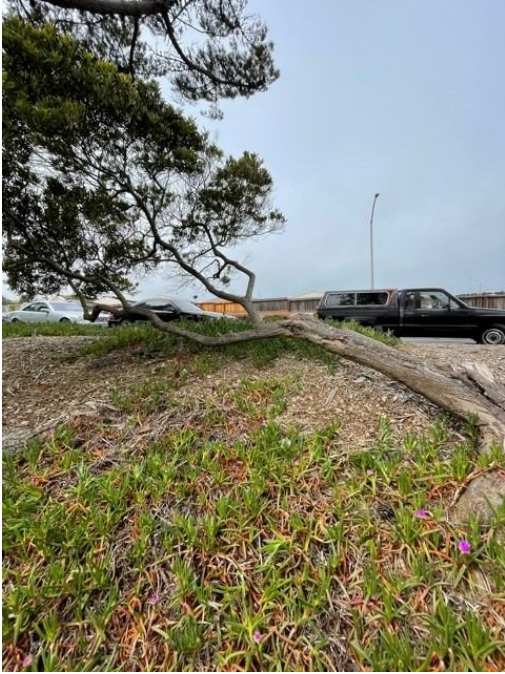
**Tree #312** is a Black acacia (*Acacia melanoxylon*)

Tag no	Common Name	Diameter at Breast Height"	H'/W'	HEALTH	STRUCTURE	PROTECTED (X)	RECOMMENDED REMOVAL (X)	RECOMMENDED PROTECTED REMOVAL (XX)	NOTES, RECOMMENDATIONS
302	Mangrove	10/8/6.5	18'/30'	f	fp				Recommend EWR, DWR, SP, multiple leaders at base
303	Monterey pine	34	65'/40'	f	f	x			Recommend EWR, DWR, thin canopy
304	Black acacia	7.5	15'/12'	fp	p				Recommend EWR, DWR, leaning
305	Black acacia	4.5/5/3.5	12'/12'	f	fp				Recommend EWR, DWR, SP, multiple leaders at base
306	Monterey pine	38.5	50'/55'	f	f	x			Recommend EWR, DWR, thin canopy
307	Black acacia	4/3.5/2/2/2	12'/10'	f	fp				Recommend EWR, DWR, SP, multiple leaders at base
308	Black acacia	9	12'/10'	f	f				Recommend EWR, DWR, SP
309	Monterey pine	39	70'/50'	f	f				Recommend EWR, DWR, thin canopy
310	Monterey pine	7	20'/15'	f	fp				Recommend EWR, DWR, thin canopy
311	Monterey pine	34	50'/40'	f	f				Recommend EWR, DWR, thin canopy
312	Black acacia	8	8'/12'	f	p		x		Recommend removal, heavy lean, no hope for recovery

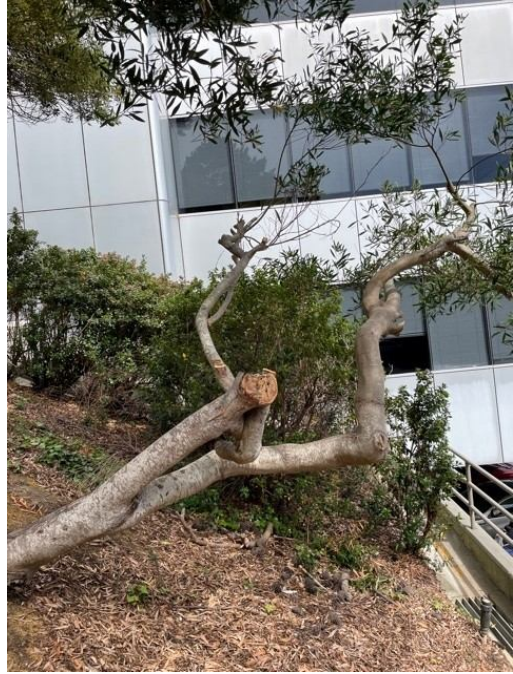
**Tree #323** is a Black acacia (*Acacia melanoxylon*)

313	Monterey pine	24	48'/35'	f	f				Recommend EWR, DWR, thin canopy
314	Monterey pine	31	55'/40'	f	fp				Recommend EWR, DWR, codominant leaders at 12'
315	Black acacia	7.5/5/4/4	14'/15'	f	fp				Recommend EWR, DWR, SP, multiple leaders at base
316	Black acacia	10	15'/18'	f	f				Recommend EWR, DWR, SP
317	Black acacia	6	12'/15'	fg	fp				Recommend EWR, DWR, SP, leaning into tree 318
318	Monterey pine	27	45'/30'	f	f				Recommend EWR, DWR, thin canopy
319	Monterey pine	39	55'/35'	f	fp				Recommend EWR, DWR, codominant leaders at 7'
320	Laurel	5/4/4/3.5	15'/18'	fg	fp				Recommend EWR, DWR, SP, multiple leaders at base
321	Black acacia	10.5	20'/20'	f	fp				Recommend EWR, DWR, SP, leaning
322	Black acacia	9	16'/15'	f	fp				Recommend EWR, DWR, SP, leaning
323	Black acacia	8.5 @ 2.5'	10'/6'	fp	p		x		Recommend removal, heavy lean, thin canopy, no hope for recovery
324	Paperbark tree	4.5	12'/7'	f	fp				Recommend EWR, DWR, SP, leaning

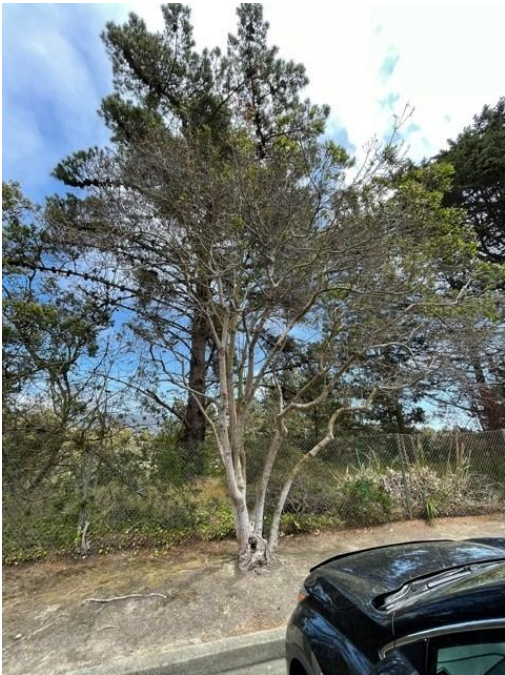
**Tree #330** is a Black acacia (*Acacia melanoxylon*)

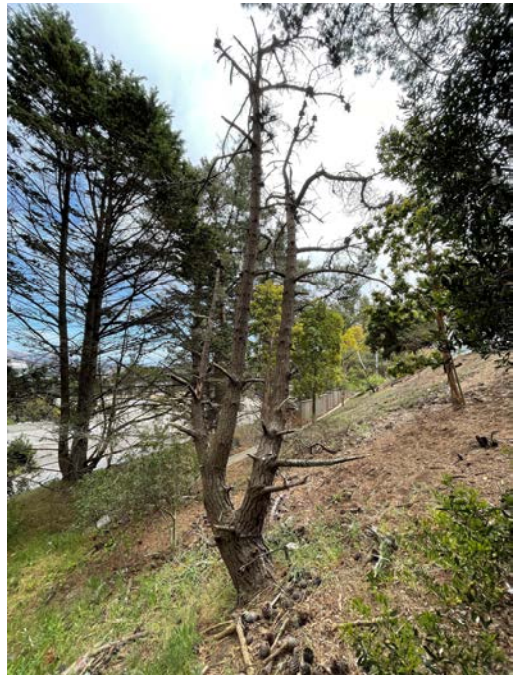
**Tree #339** is a Monterey pine (*Pinus radiata*)

336	Black acacia	6	12'/8'	f	f				Recommend EWR, DWR, SP
337	Monterey pine	39.5	65'/50'	f	f				Recommend EWR, DWR, thin canopy
338	Monterey pine	31	50'/35'	f	fp				Recommend EWR, DWR, thin canopy, codominant leaders at 8'
339	Monterey pine	24 @ 2'	38'/15'	p	p	x		xx	Recommend removal, tree is dead
340	Monterey pine	33	45'/30'	p	p	x		xx	Recommend removal, tree is dead
341	Monterey pine	31	48'/30'	f	f				Recommend EWR, DWR, thin canopy
342	Pohutukawa	4	12'/7'	fg	f				Recommend EWR, DWR, SP
343	Pohutukawa	5	14'/10'	fg	f				Recommend EWR, DWR, SP
344	Vinegar tree	5.5	22'/8'	fg	f				Recommend EWR, DWR, SP
345	Pohutukawa	6.5	13'/10'	fg	f				Recommend EWR, DWR, SP
346	Pohutukawa	7	14'/16'	g	f				Recommend EWR, DWR, SP
347	Vinegar tree	3.5	16'/6'	fg	f				Recommend EWR, DWR, SP
348	Vinegar tree	5.5	20'/8'	fg	f				Recommend EWR, DWR, SP
349	Vinegar tree	4	18'/6'	fg	f				Recommend EWR, DWR, SP

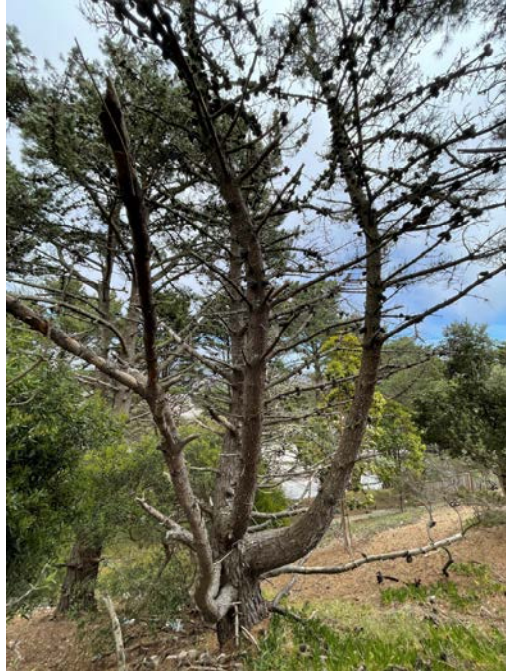
**Tree #340** is a Monterey pine (*Pinus radiata*)
