**SEISMIC RISK ASSESSMENT
PROBABLE MAXIMUM LOSS (PML) REPORT**

Mercado Apartments

**2001 Newton Avenue
San Diego, CA 92113**

Report Date: July 8, 2020

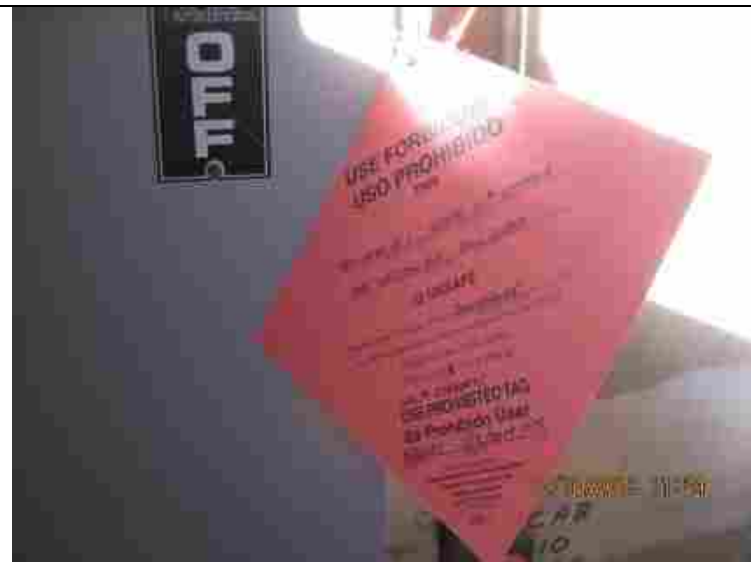
19- Elevator Equipment - Use Prohibited Tag

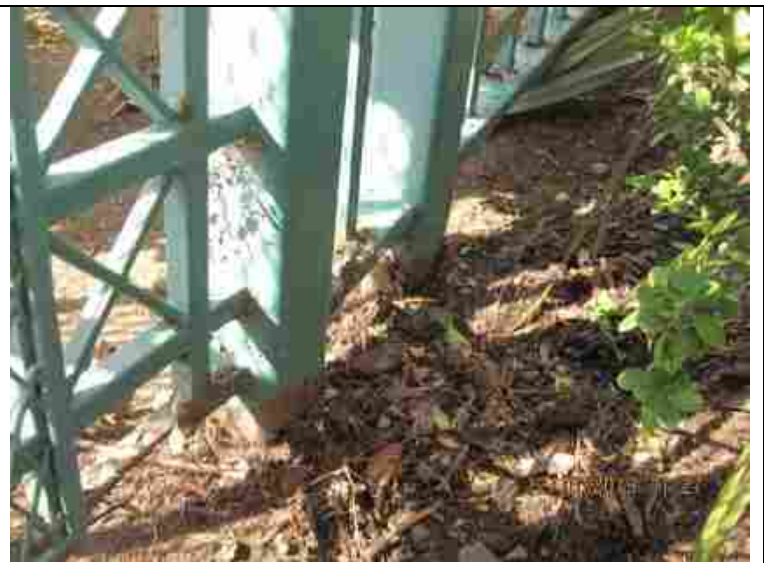
20- Rust and Corrosion _ Wrought Iron Gates

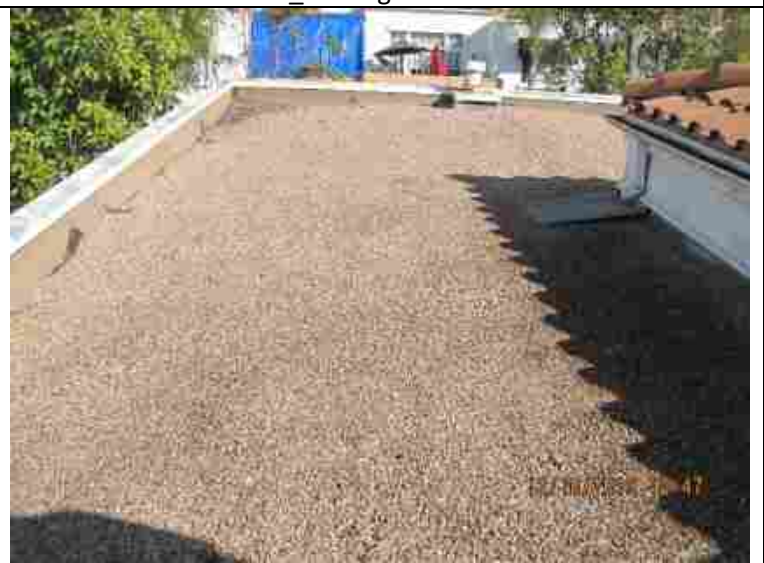
22- Typical Roof

- The roof system has passed the end of its expected useful life and based on current active and frequent reported roof leaks; the system should be replaced.
- Power washing the building's exterior walls, repairing damaged stucco areas, sealing and painting should follow roof replacement.
- Termite treatment including subterranean and unit Termifoam treatment.

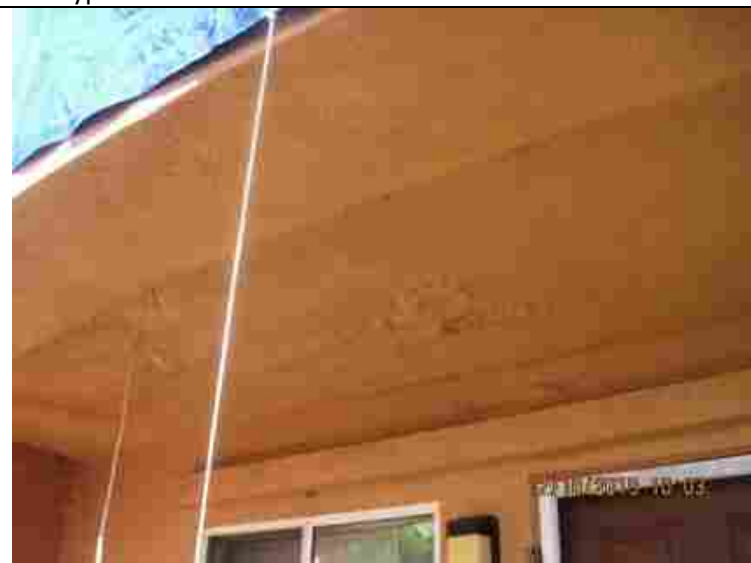
23- Blistering Stucco Ceiling

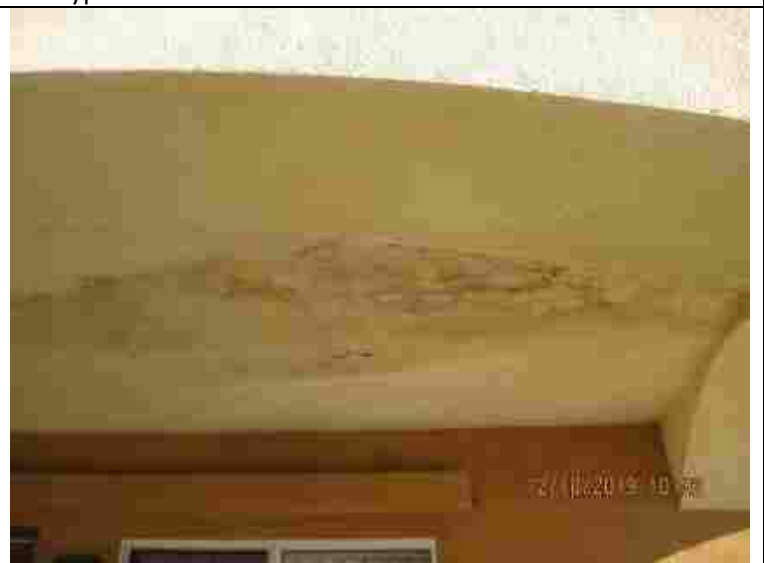
Overall, the subject property appears to be in average condition and preventative maintenance level appeared to be average. No significant cracking that may be the result of foundation settlement or stress was observed at the buildings. Generally, all finished exterior surfaces are in fair condition, with evidence of bubbling and blistering stucco areas which are indicative of water intrusion, in addition to parallel cracks and staining at horizontal soffit surface and other areas. This needs to be repaired.

24- Stucco Soffit surface - Water Damage

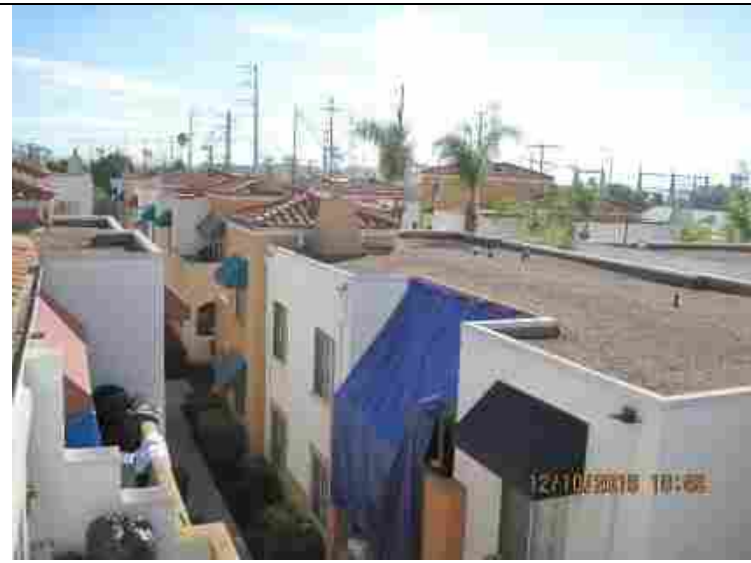
25- Blue Tarp Covering Balcony

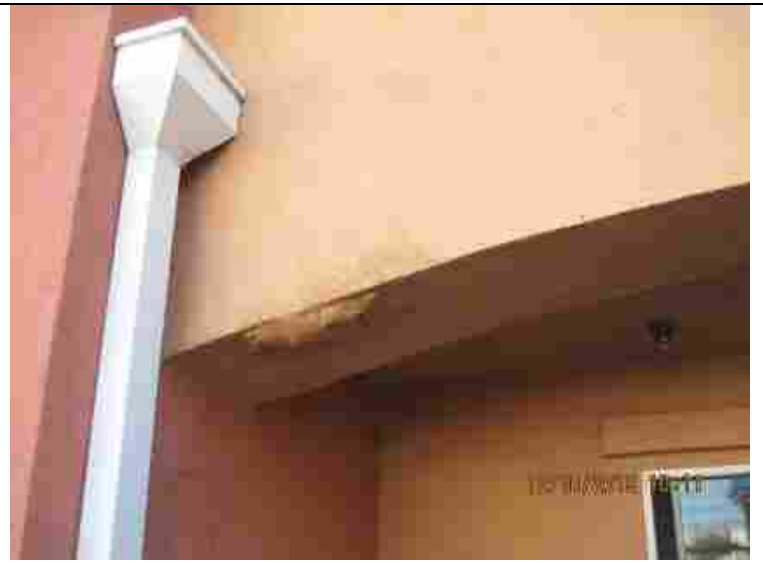
26- Stucco Damage

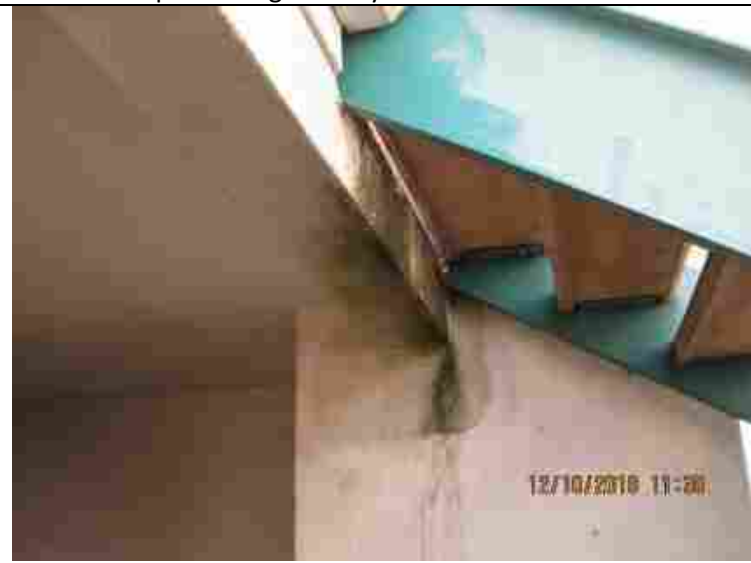
27- Stucco Damage

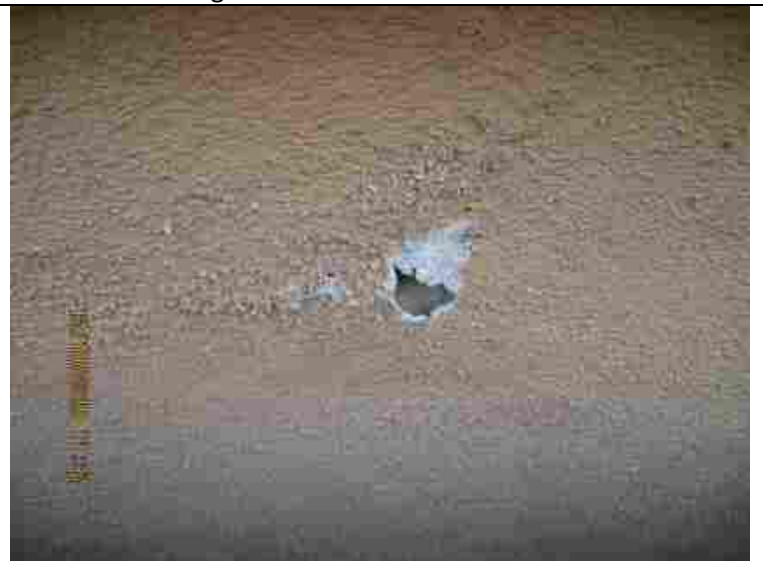
28- Stucco Damage

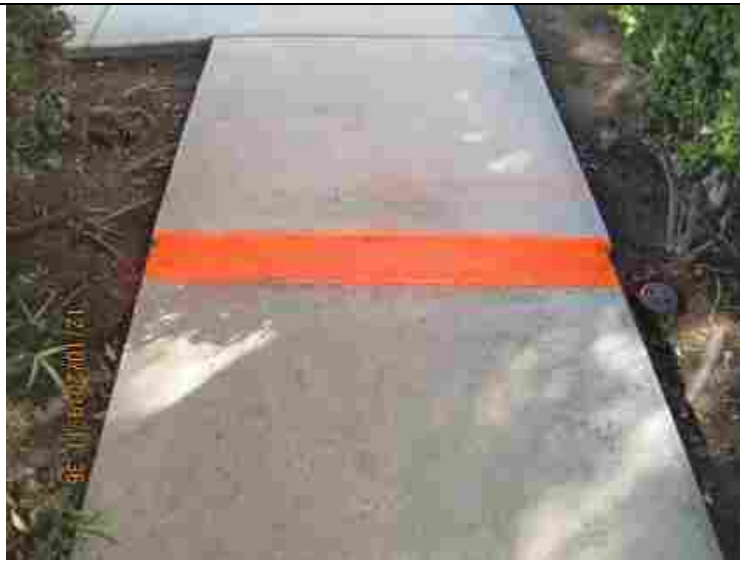
43- Concrete Repairs in Progress

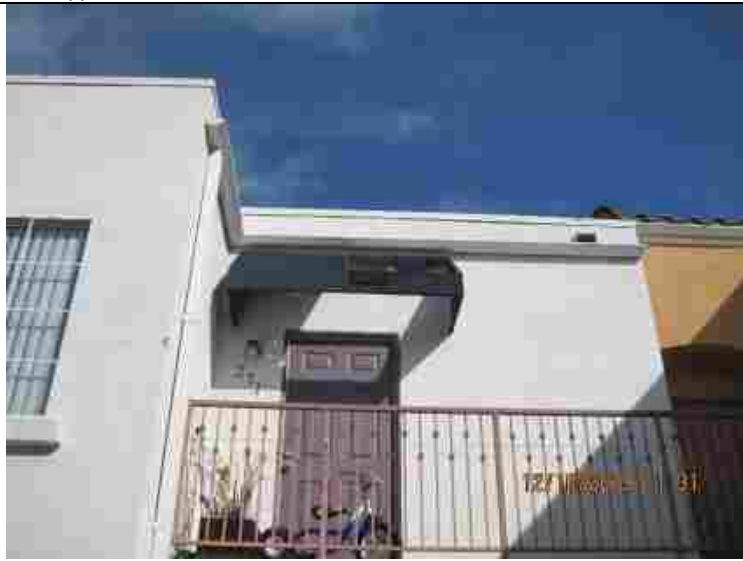
51- Damaged Awning

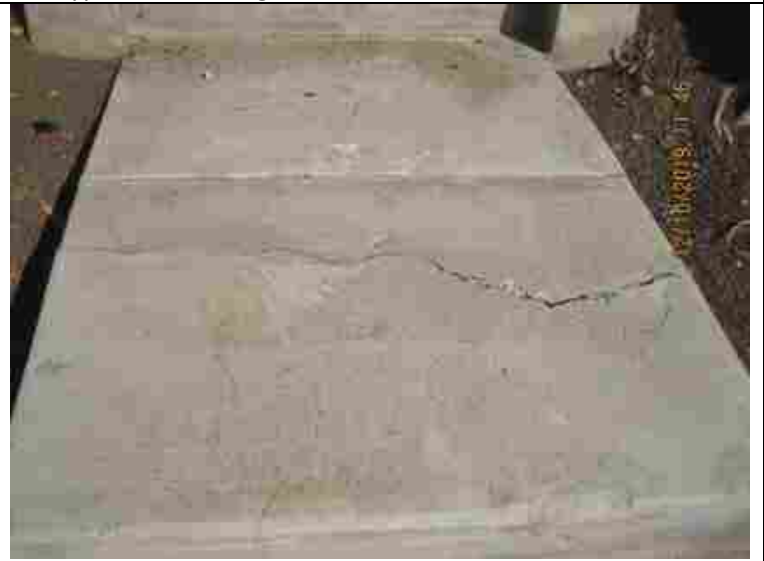
52- Typical Concrete Cracking
