Marione Drive Cell Tower Project

Arborist Report

APN: 283-0242-003
Address: 5204 Marione Drive Carmichael, CA 95608

October 2024 | 04331.00043.001

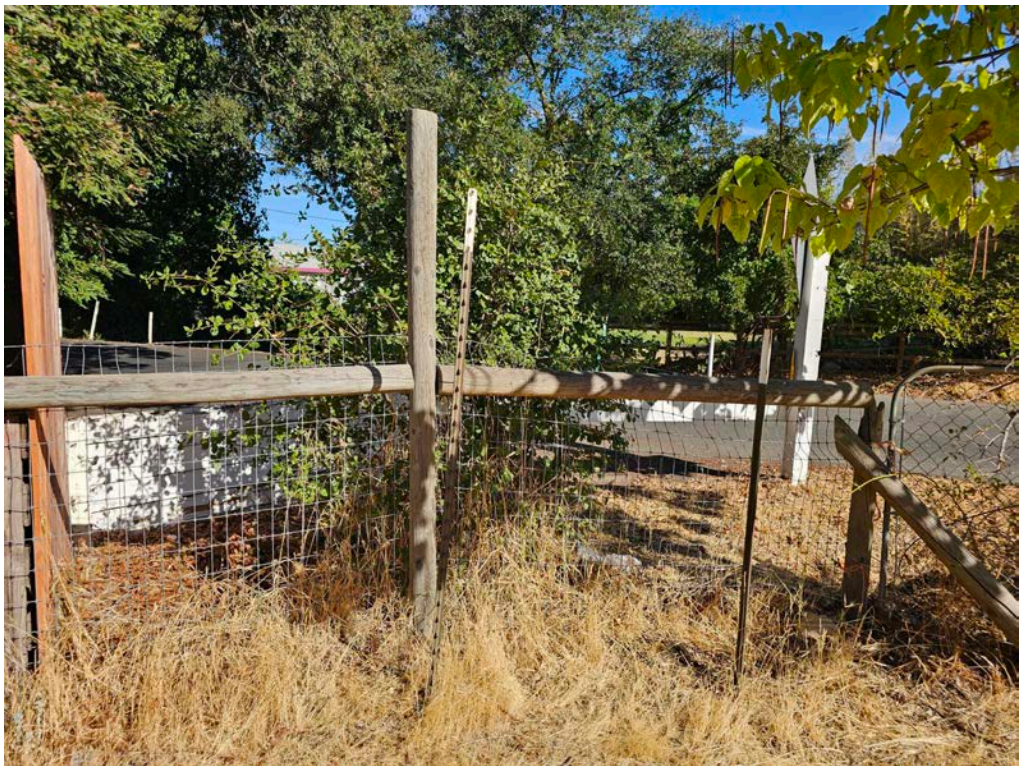
Photograph 1: Image of tree #102, a protected interior live oak. Date: 9/9/2024. Photographer: Marisa Britts

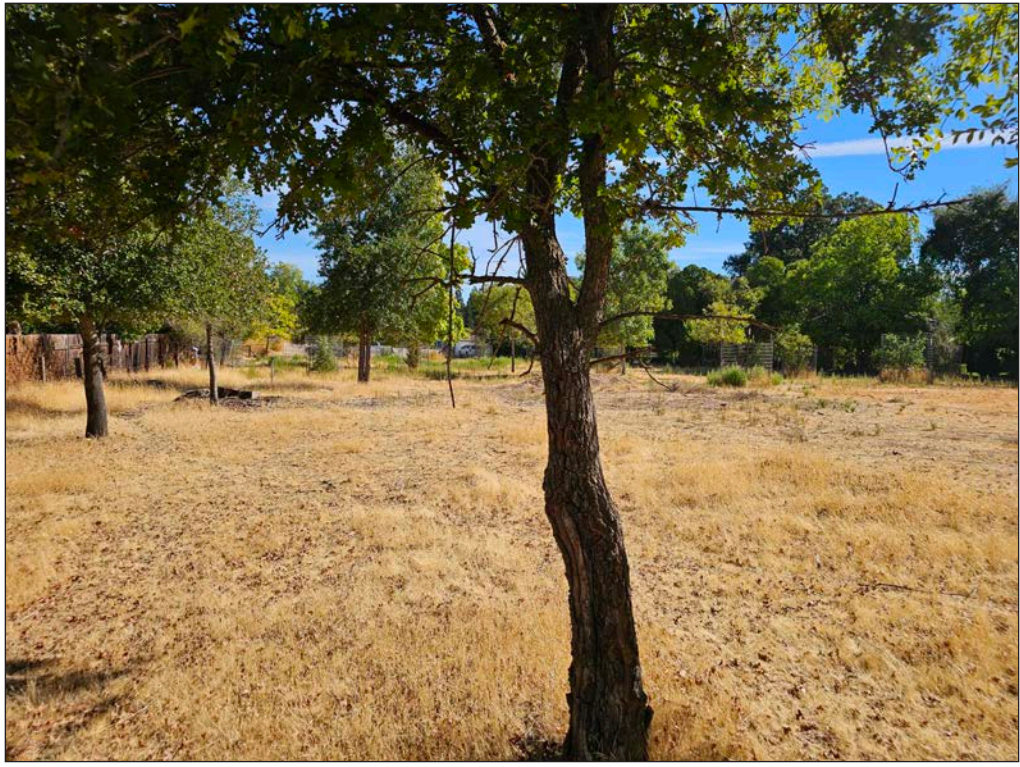
Photograph 2: Image of tree #111, a protected valley oak. Date: 9/9/2024. Photographer: Marisa Britts

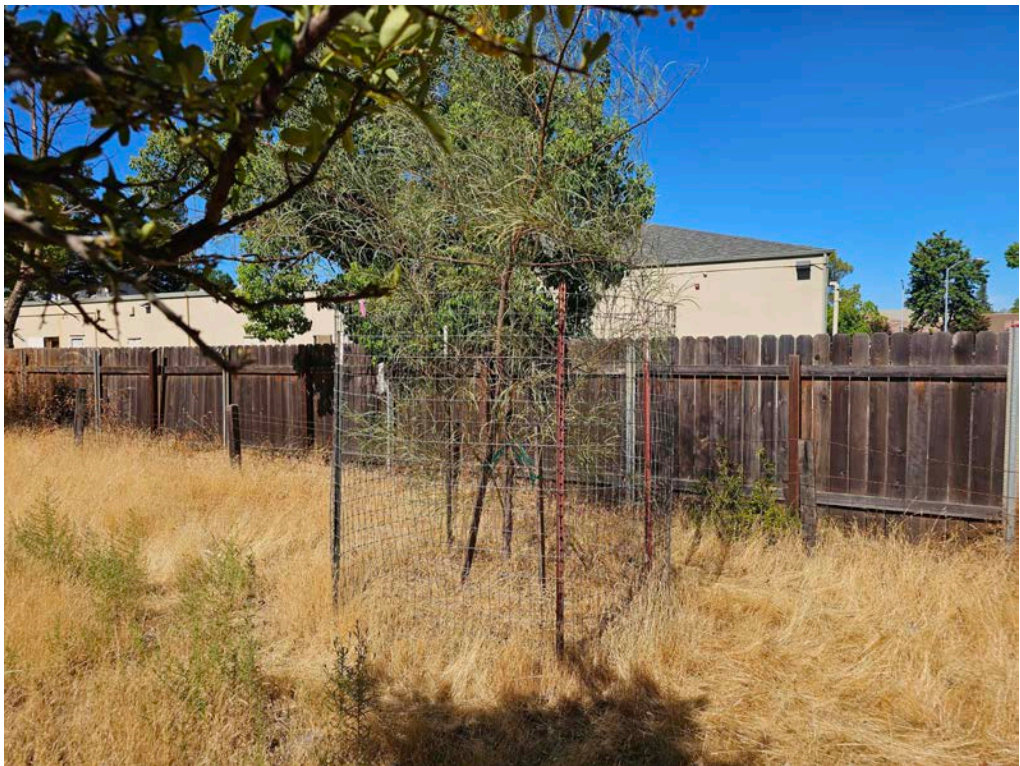
Photograph 3: Image of tree #116, a swamp wattle that is likely protected.
Date: 9/9/2024. Photographer: Marisa Britts

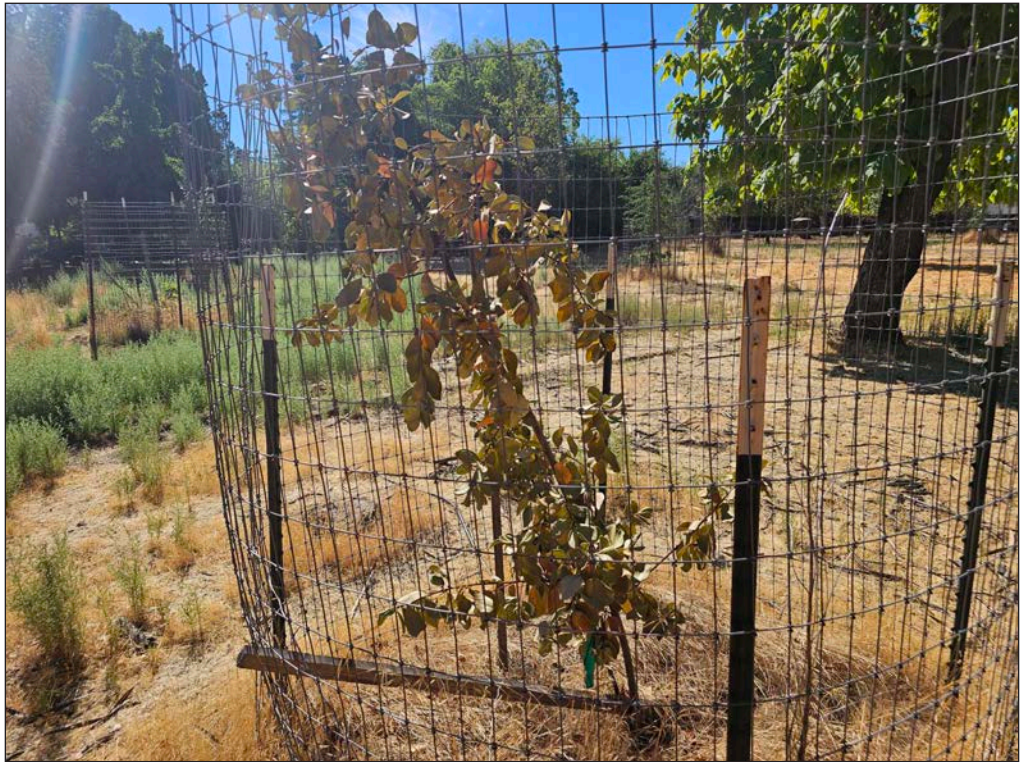
Photograph 4: Image of tree #118, a dying laurel recommended for removal.
Date: 9/9/2024 Photographer: Marisa Britts

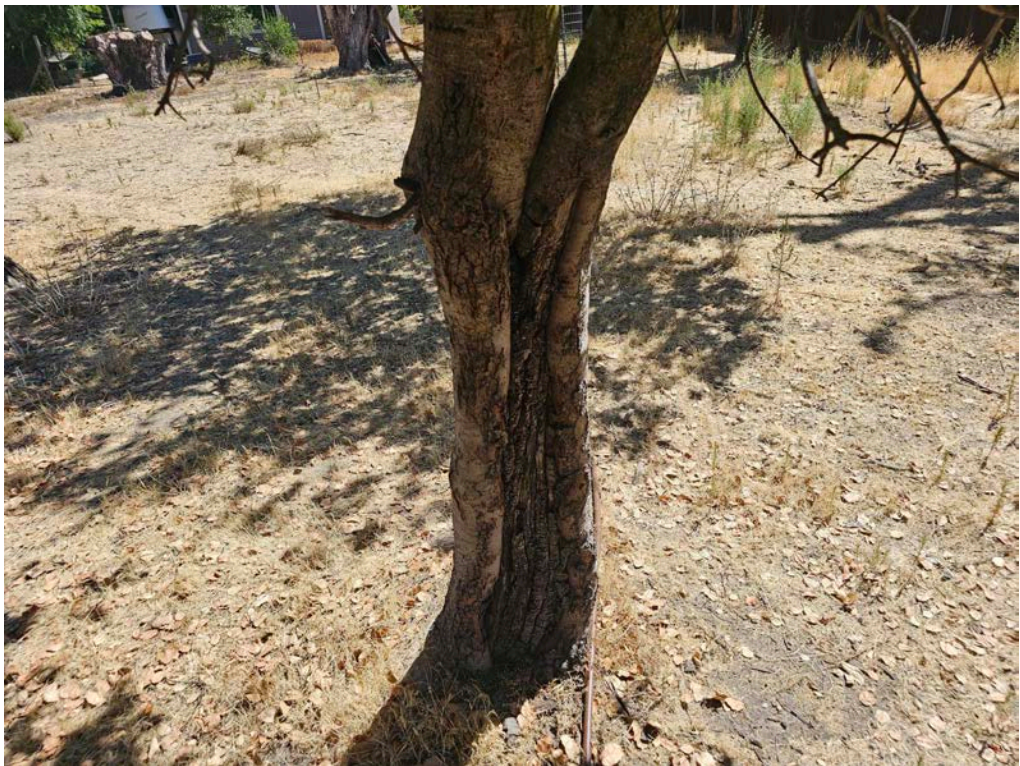
Photograph 5: Image of tree #129, a protected interior live oak. Date: 9/9/2024. Photographer: Marisa Brilts

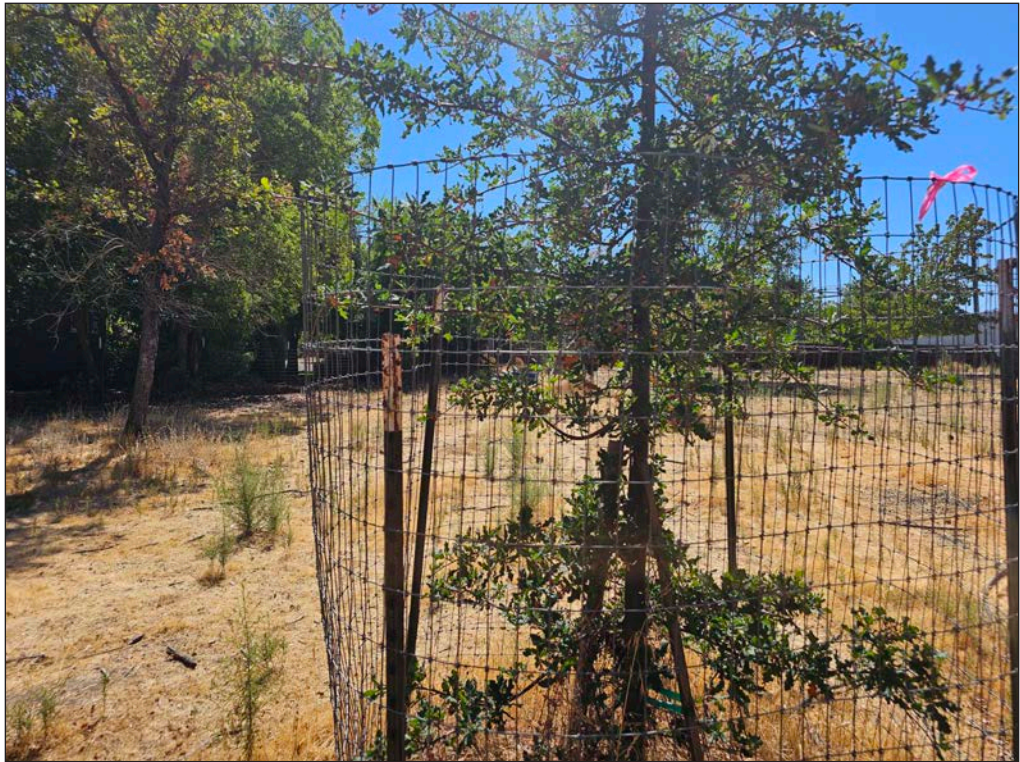
Photograph 6: Image of tree #140, a small valley oak that may not be protected due to small size. Date: 9/9/2024. Photographer: Marisa Brilts
