Appendix A
Tree Assessment Report

Tree Assessment Report

For: 3822 Figueroa

Arborgate Consulting, Inc.
Greg Applegate, RCA #365
1131 Lucinda Way
Tustin, CA 92780
714/ 731-6240

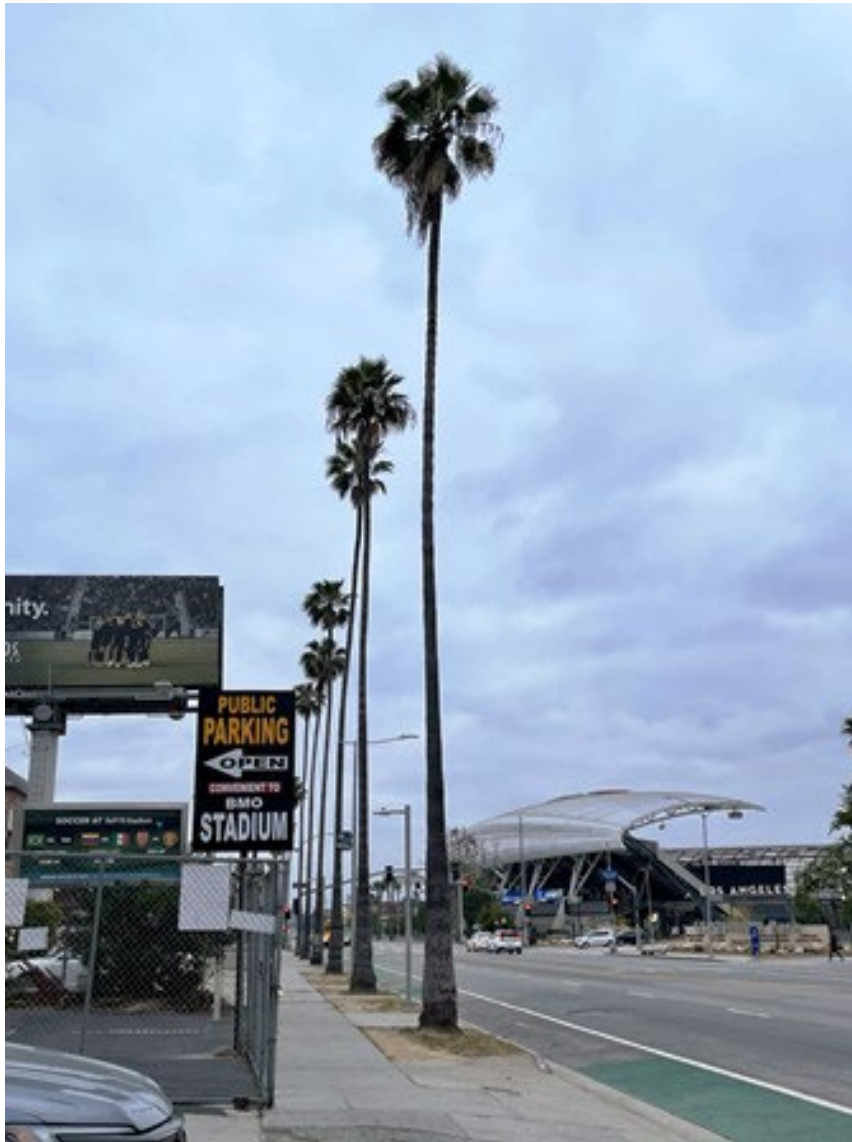
#1 Mexican fan palm on Figueroa

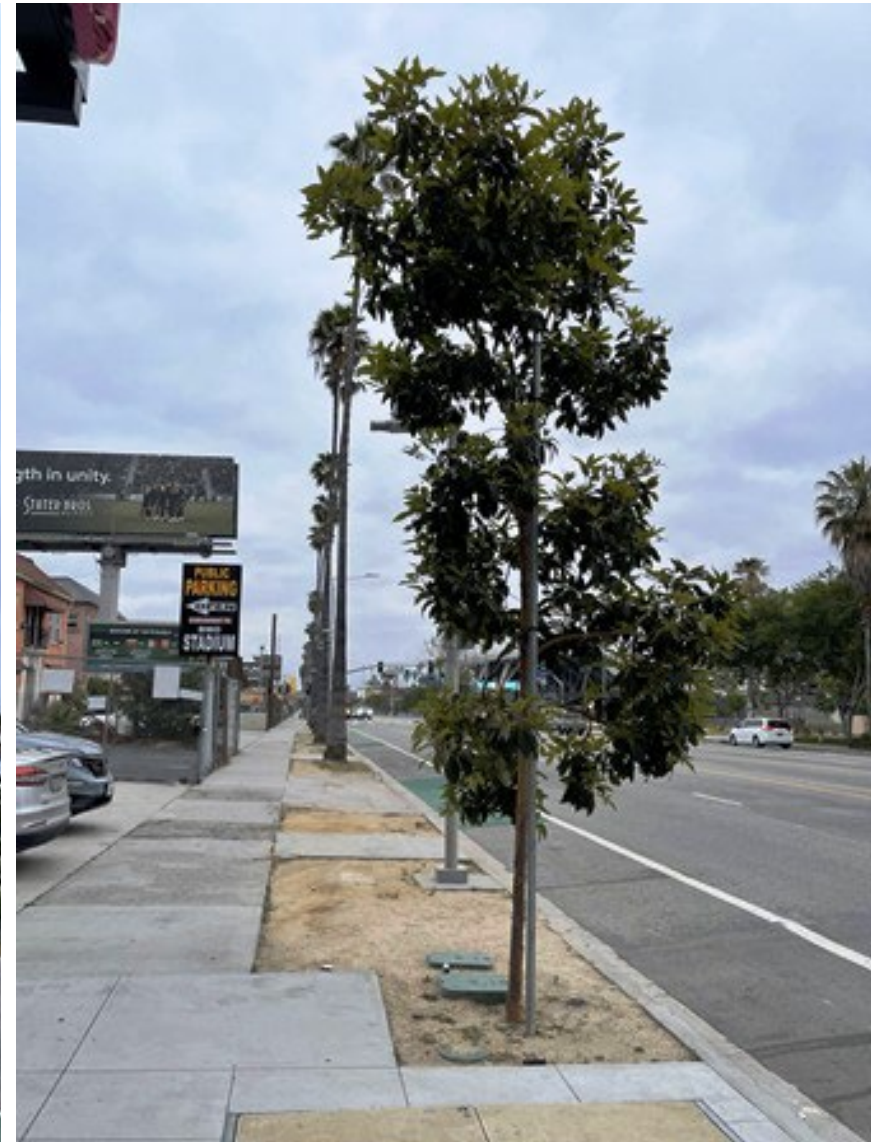
#2 Brisbane box on Figueroa

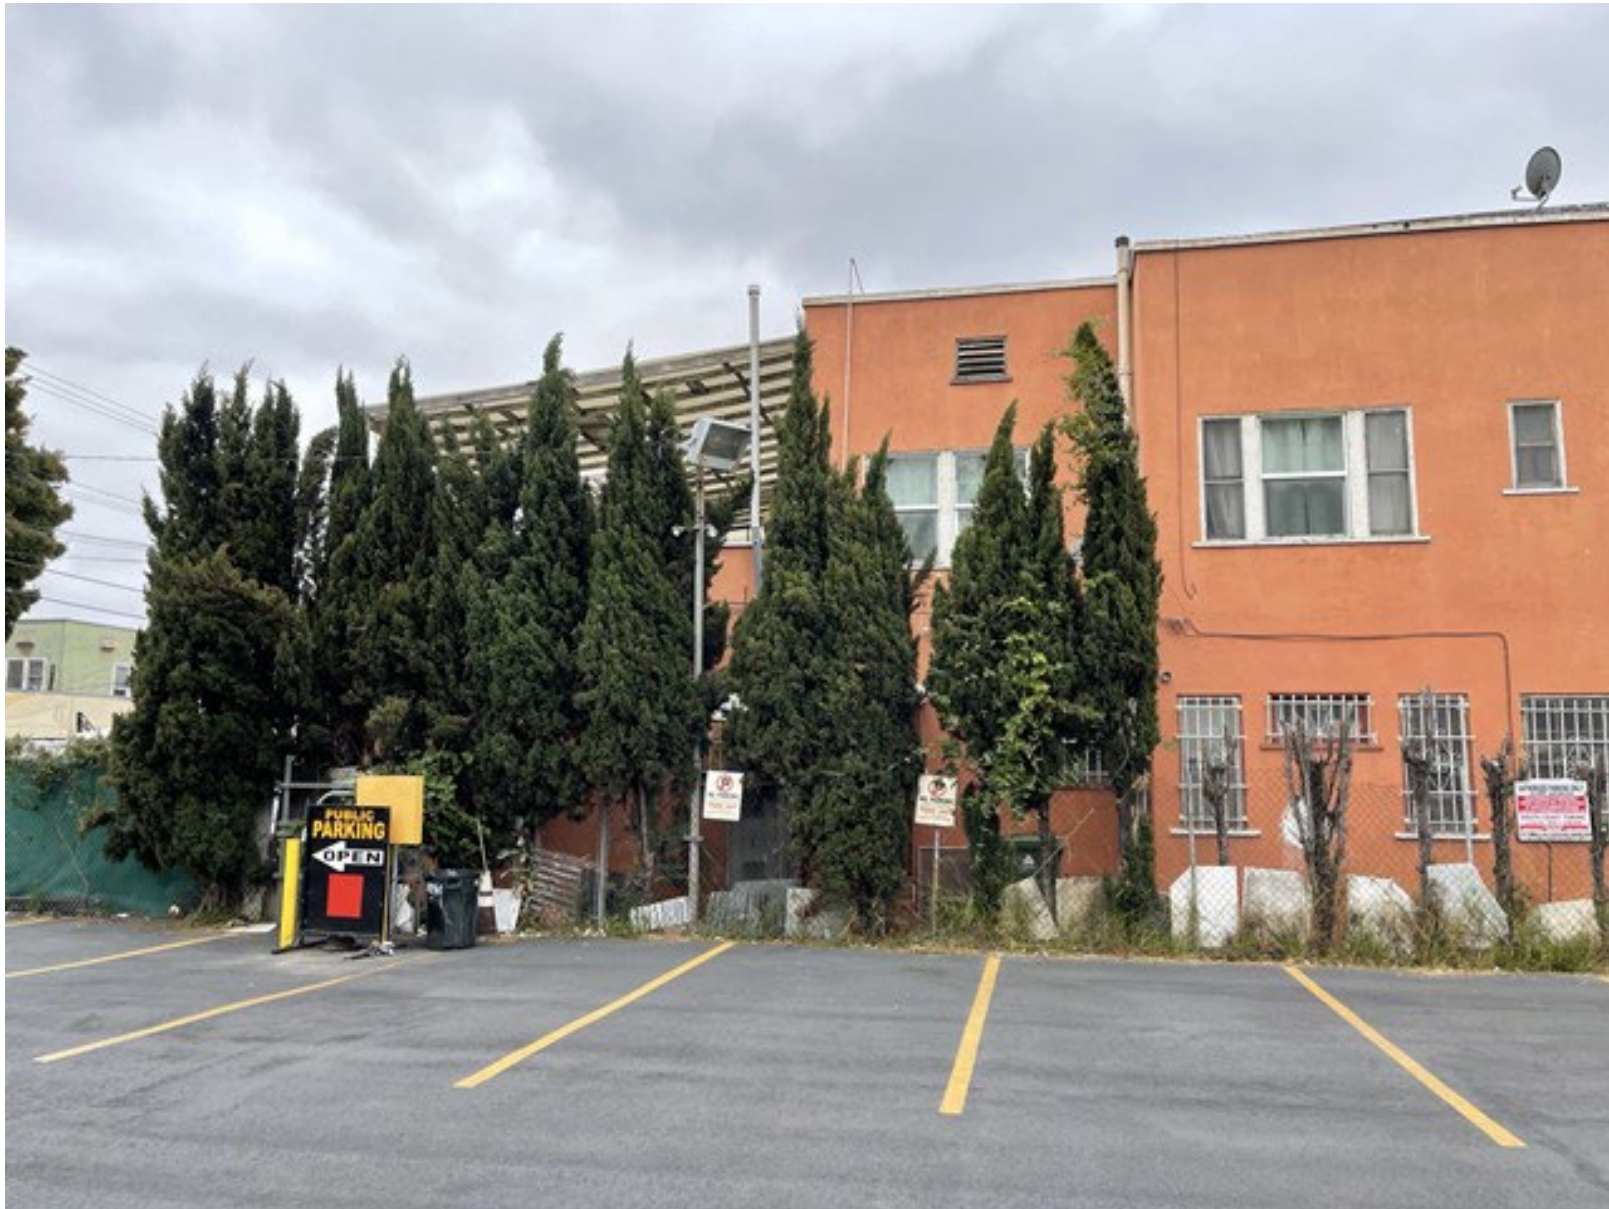
There are a dozen small Italian cypress that were planted along the neighbor's north property line on Figueroa. They are in mixed health and condition and less than 3" caliper. Construction is likely to require their removal.

Off-site Italian cypress on the south side of the 3822 Figueroa lot.

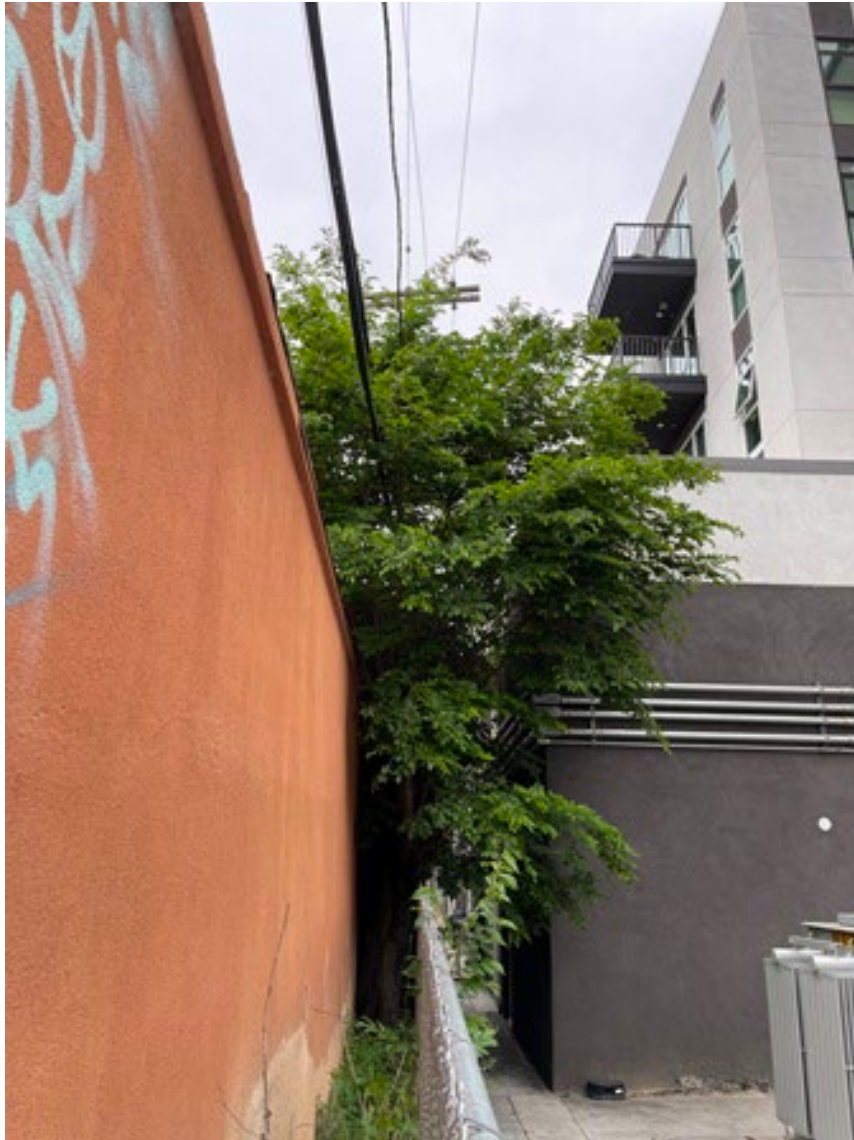
#3 Chinese elm between the new building and 3800 S. Flower.

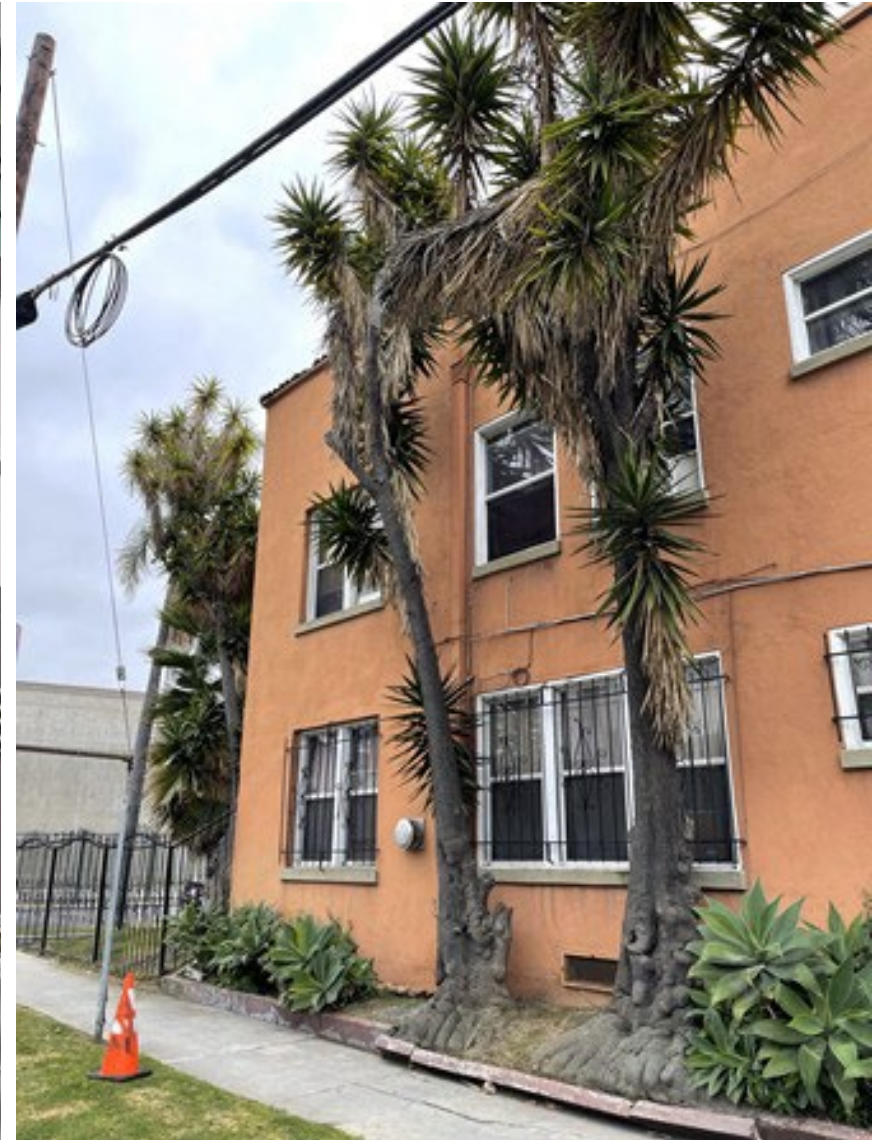
#4 & 5 Yuccas with #6 around the corner. Note root damage.

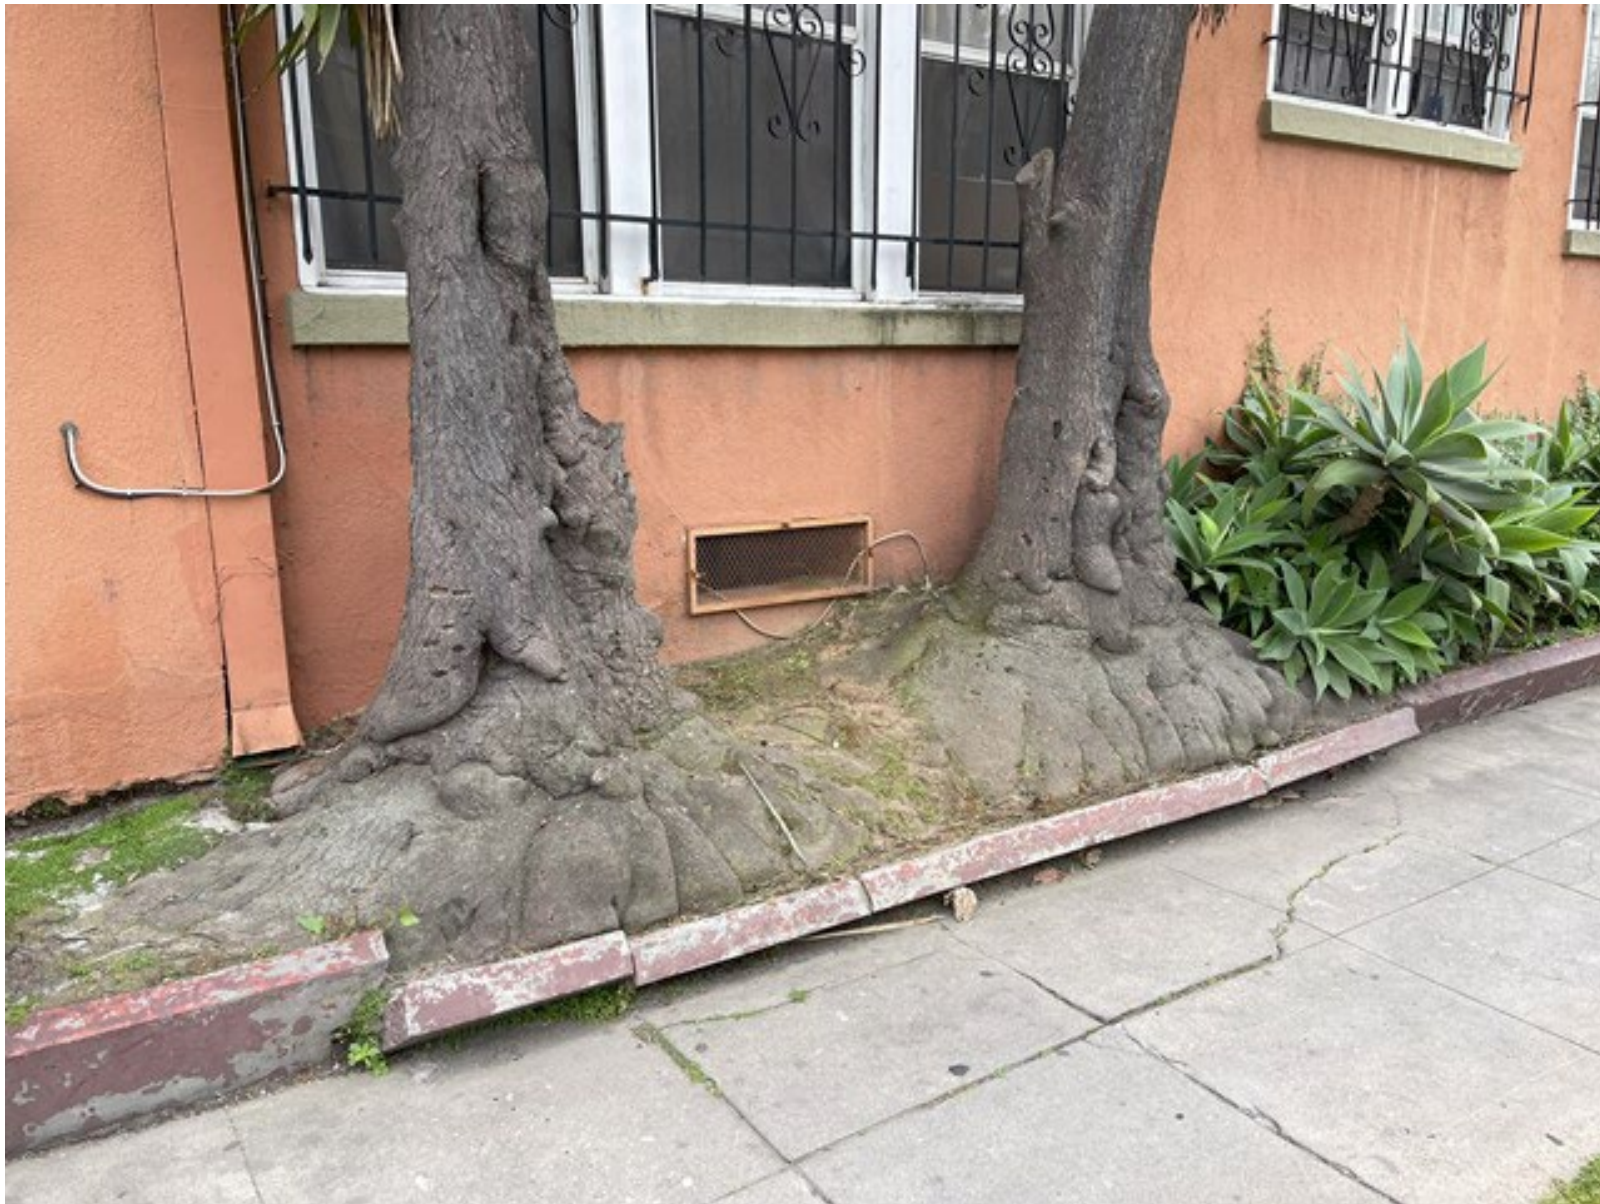
#4 & 5 Yuccas. Note root damage

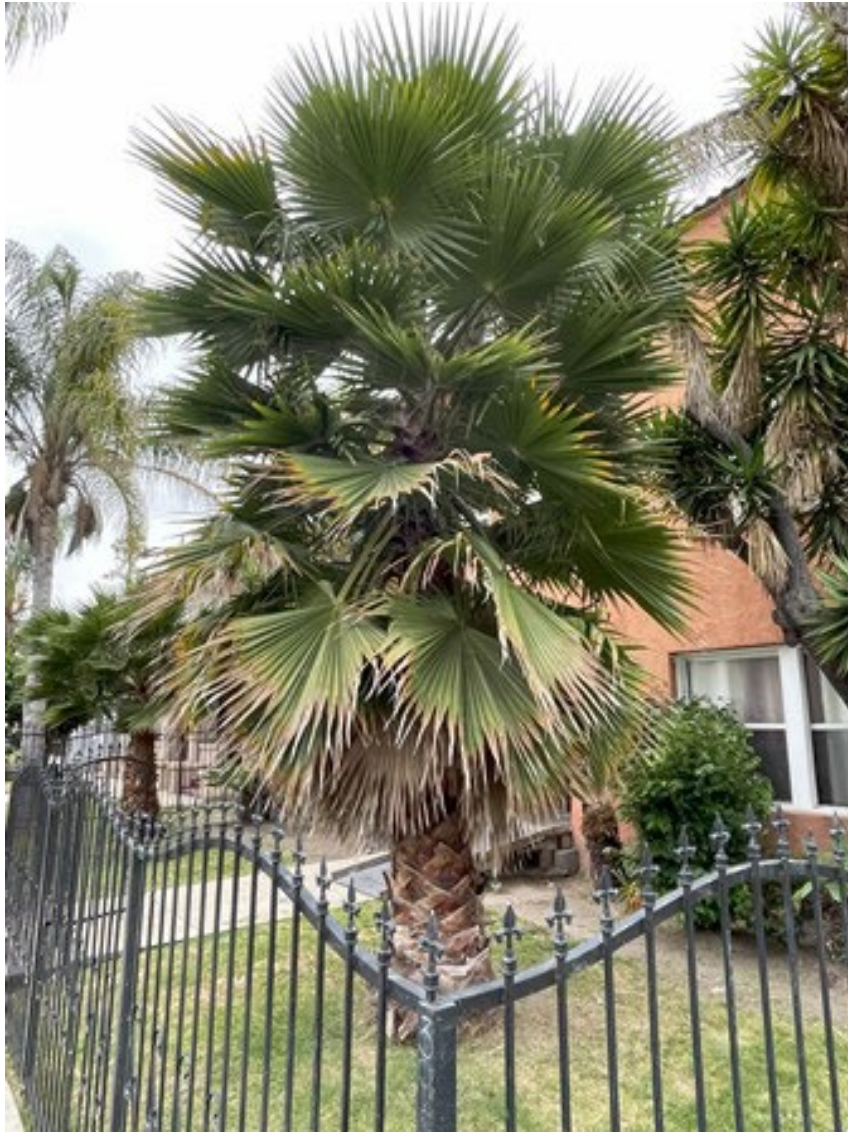
#7 Mexican fan palm

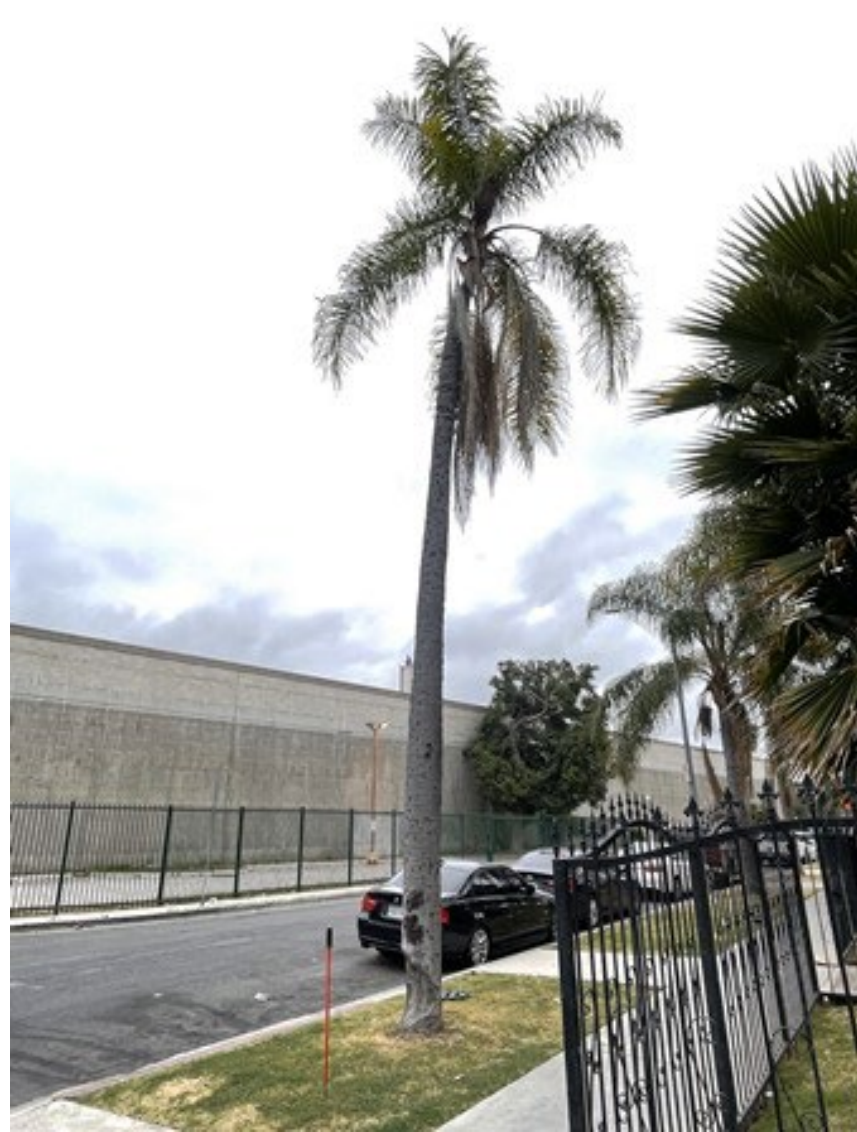
#8 Queen palm – note trunk decay

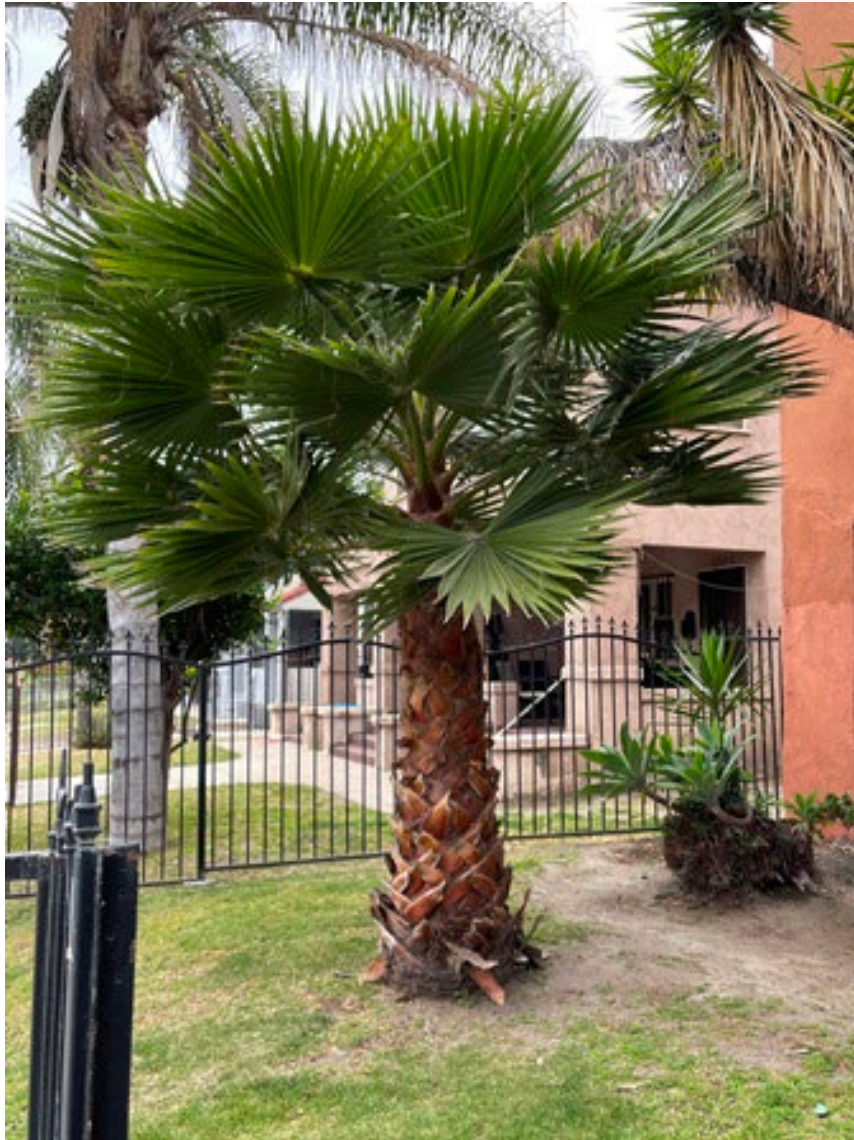
#9 Mexican fan palm

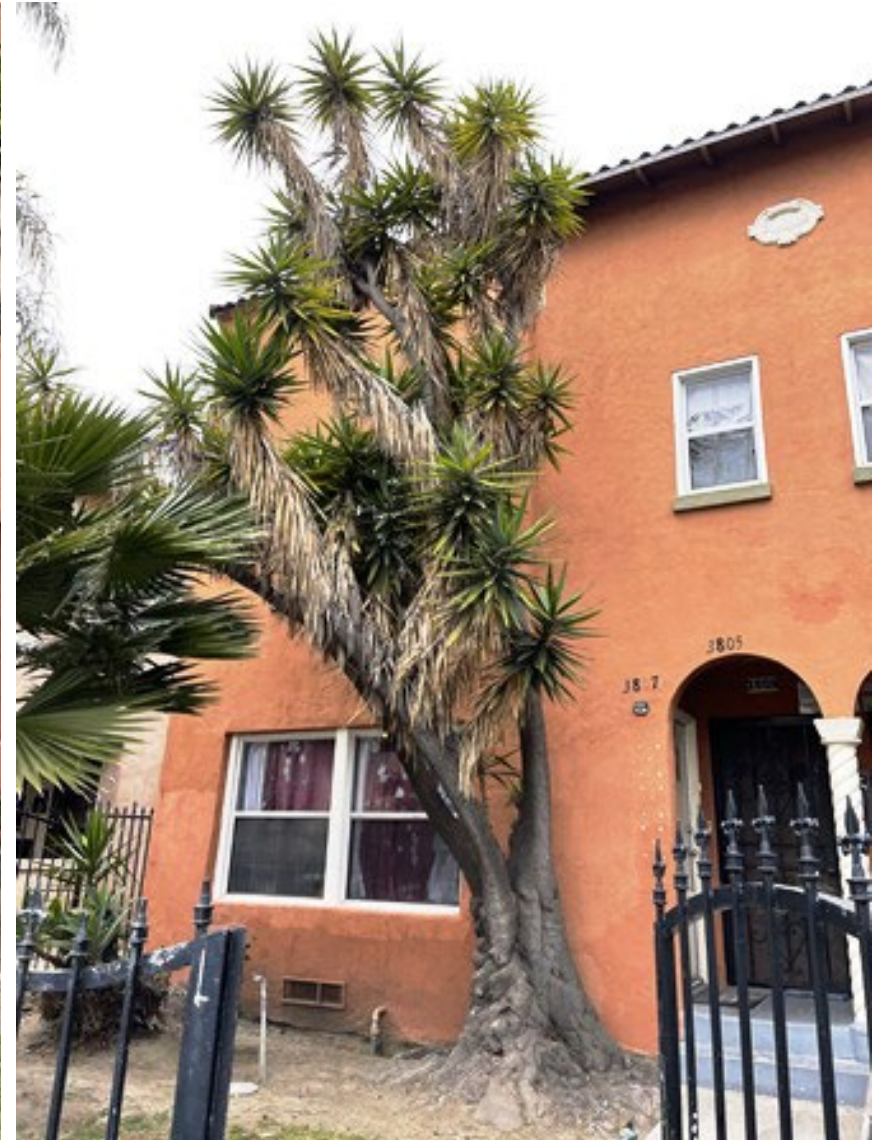
#10 Yucca

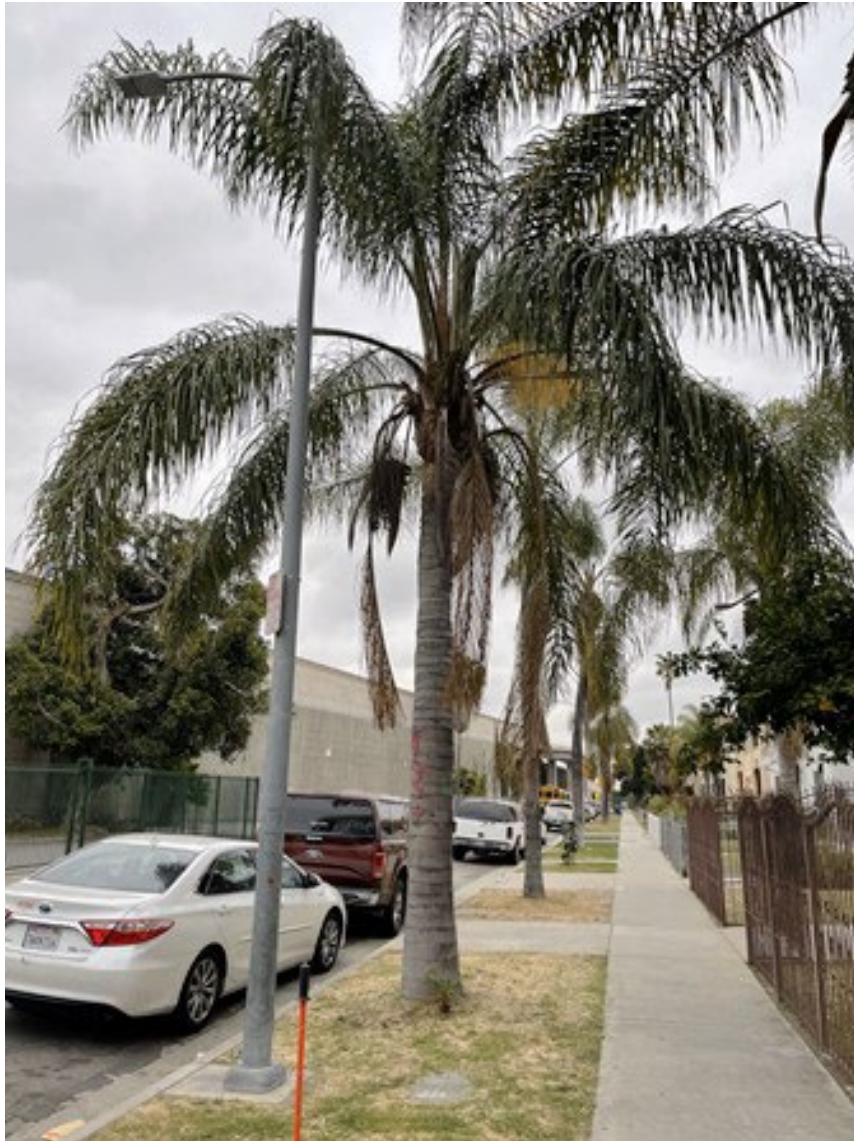
#11 Queen palm, one good street palm, with #14 behind

Protected and retained the two street trees on Figueroa. If possible, protect and retain street palm #11 on South Flower. All site trees should be removed entirely, unless the better queen palms can be transplanted, stored and replanted as street trees. However, the Urban Forestry Division may require a new street tree for Flower Drive.

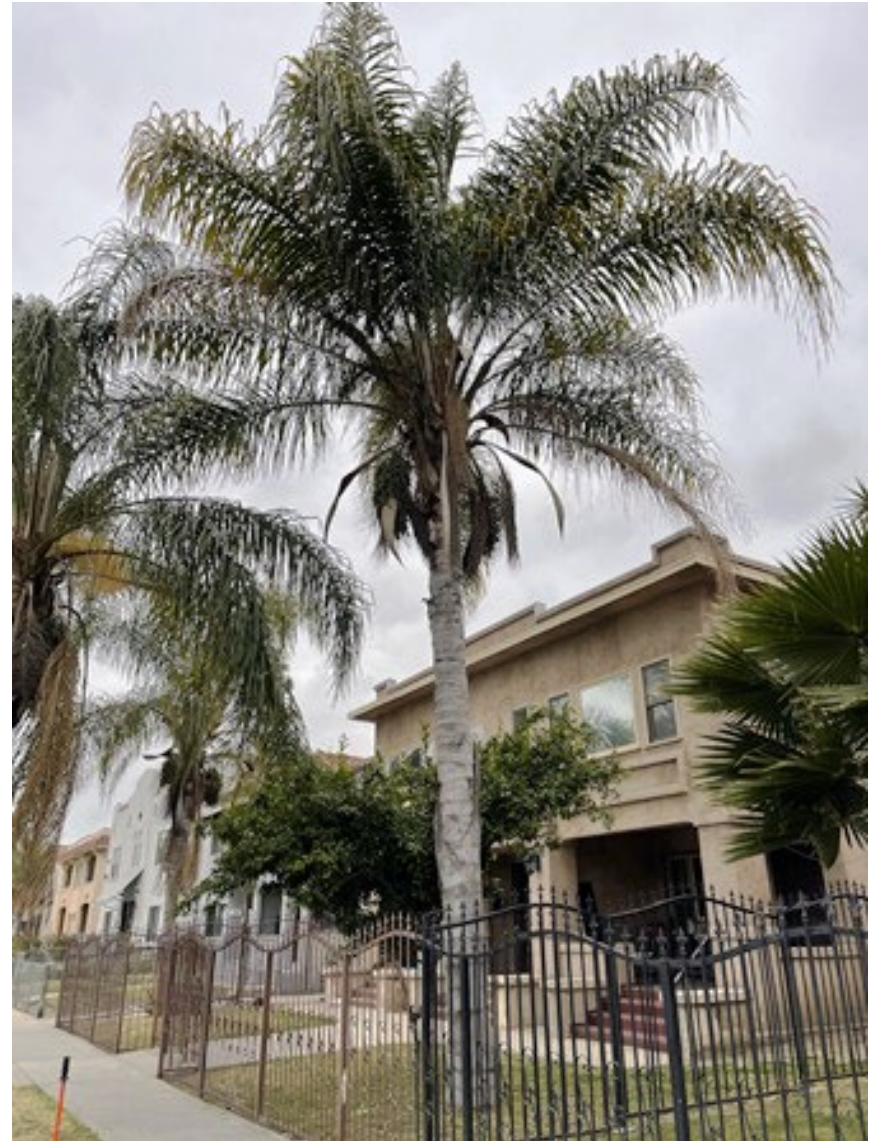
#12 Queen palm

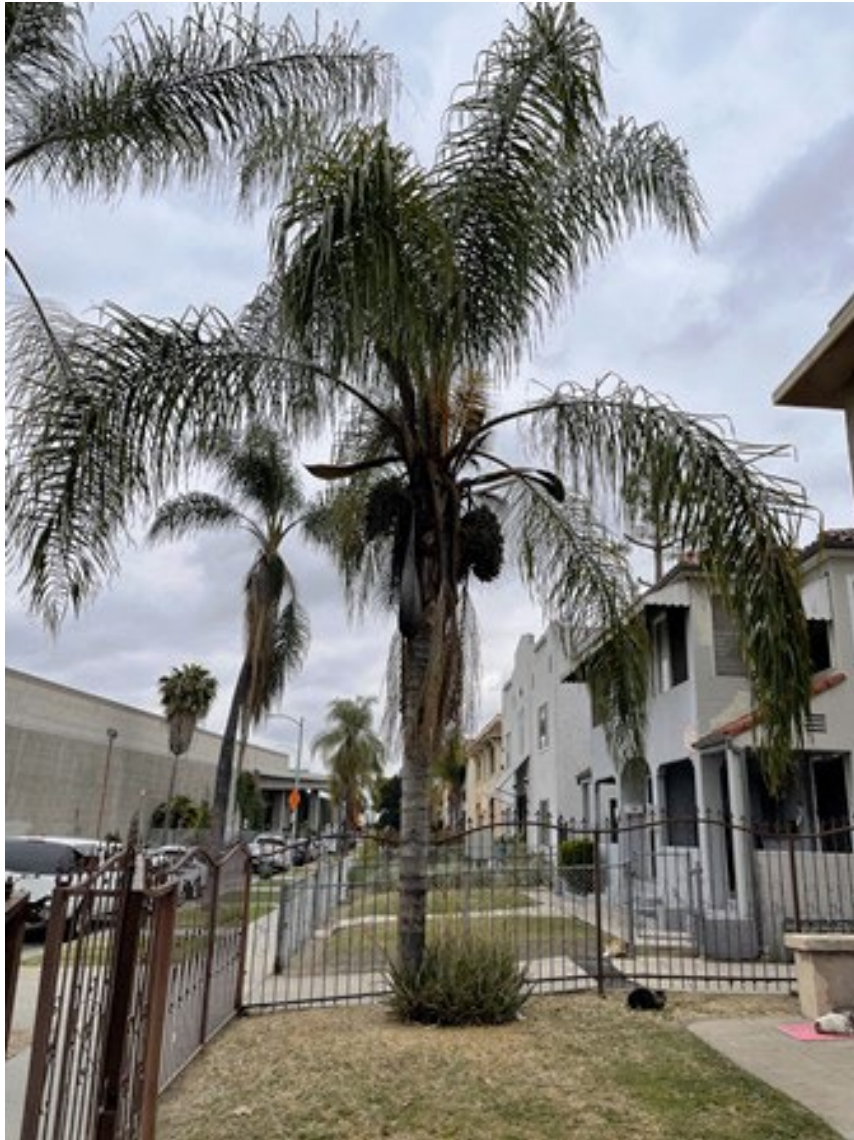
#13 Queen palm

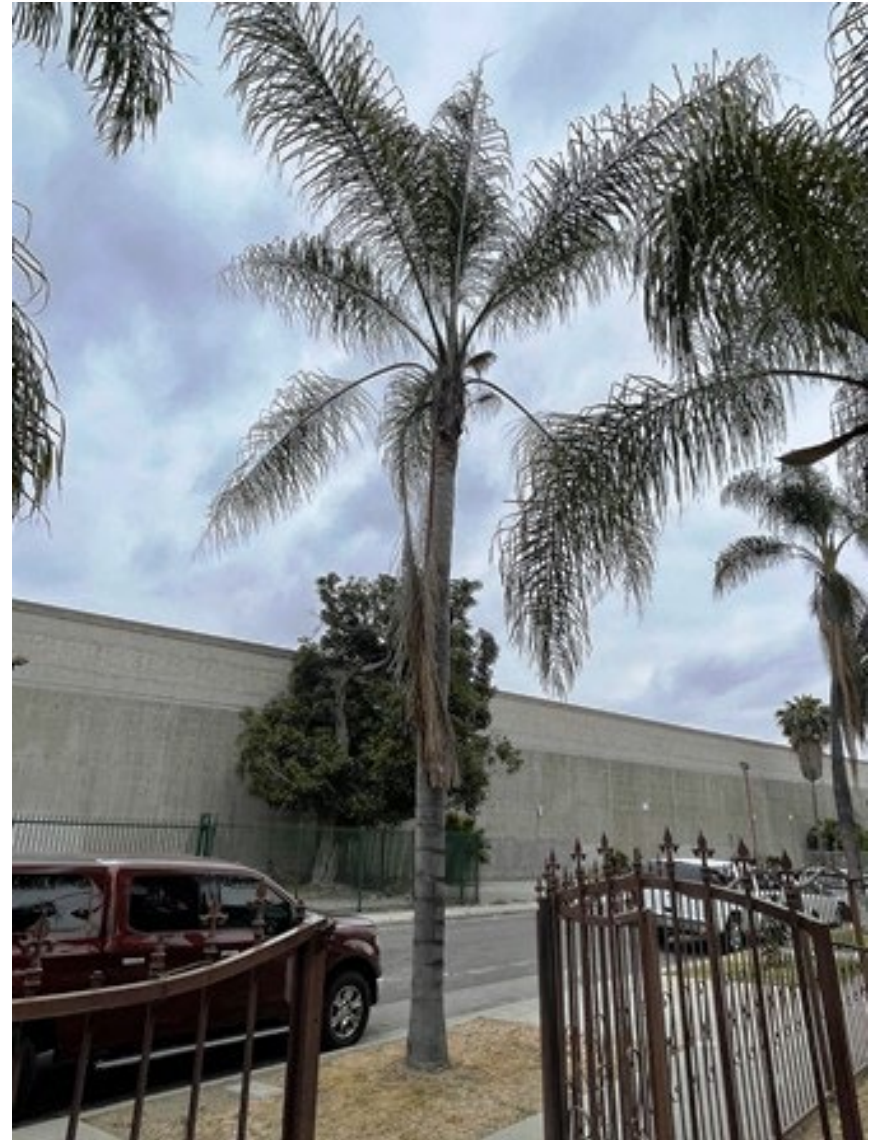
#14 Queen palm, another good street palm

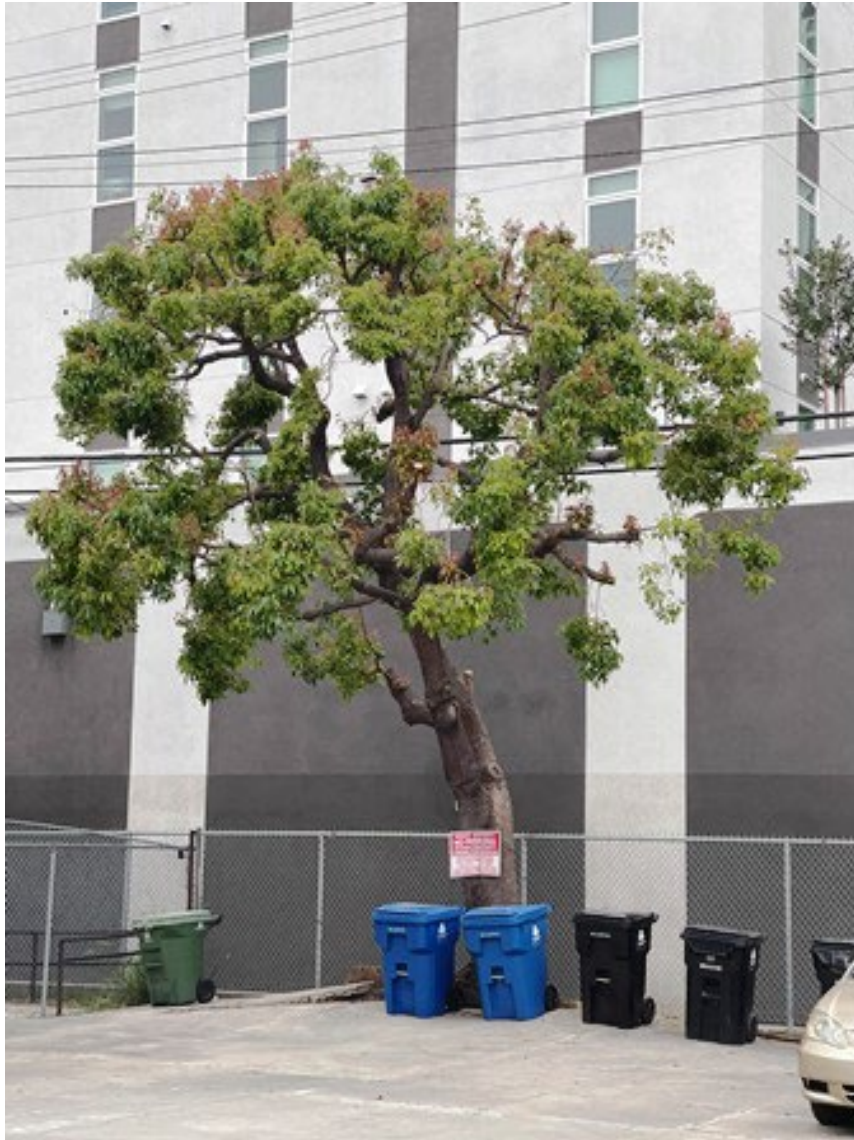
#15 Camphor is leaning forward.

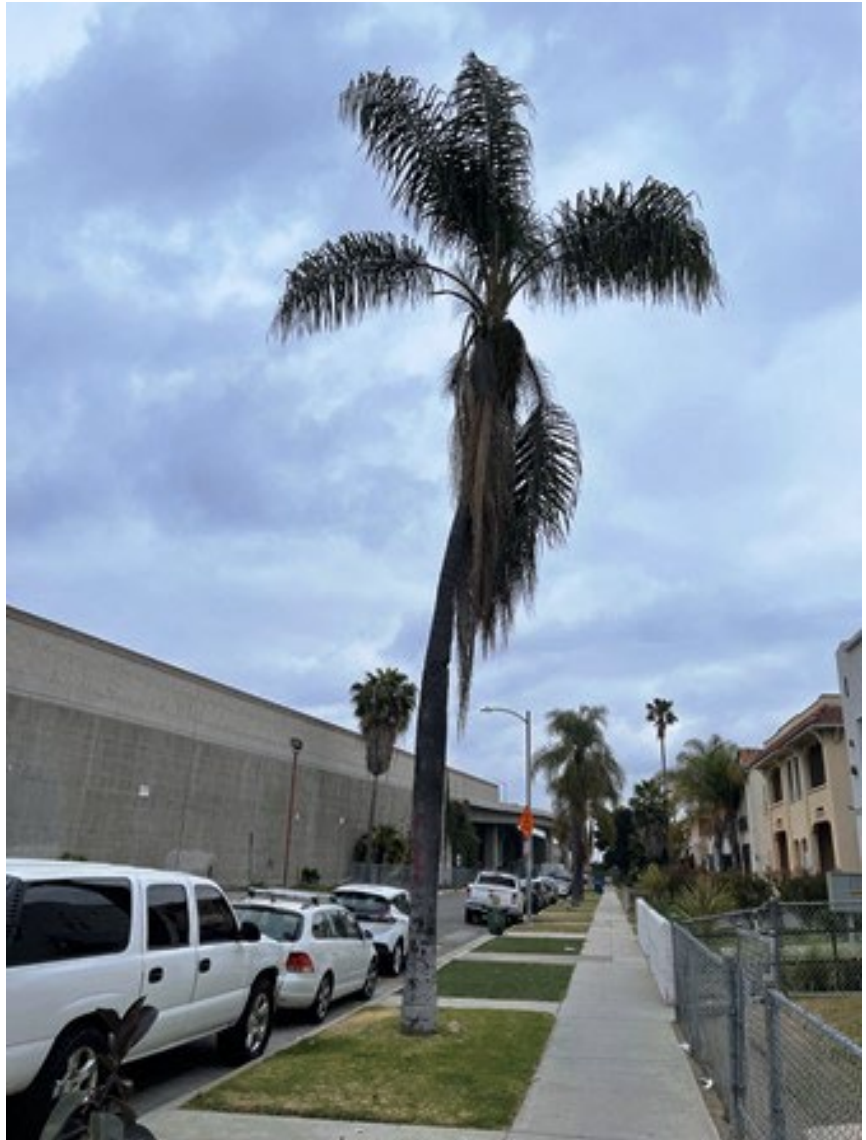
#17 Queen palm

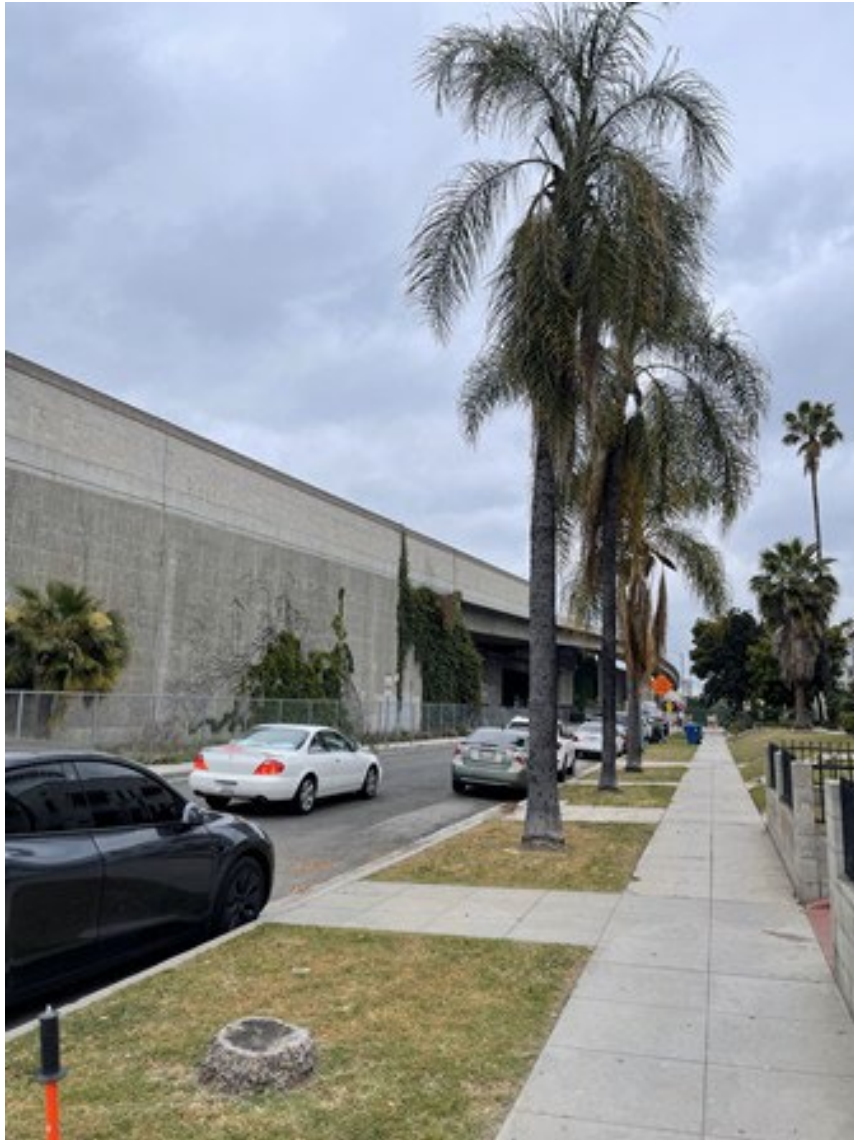
#18 Queen palm

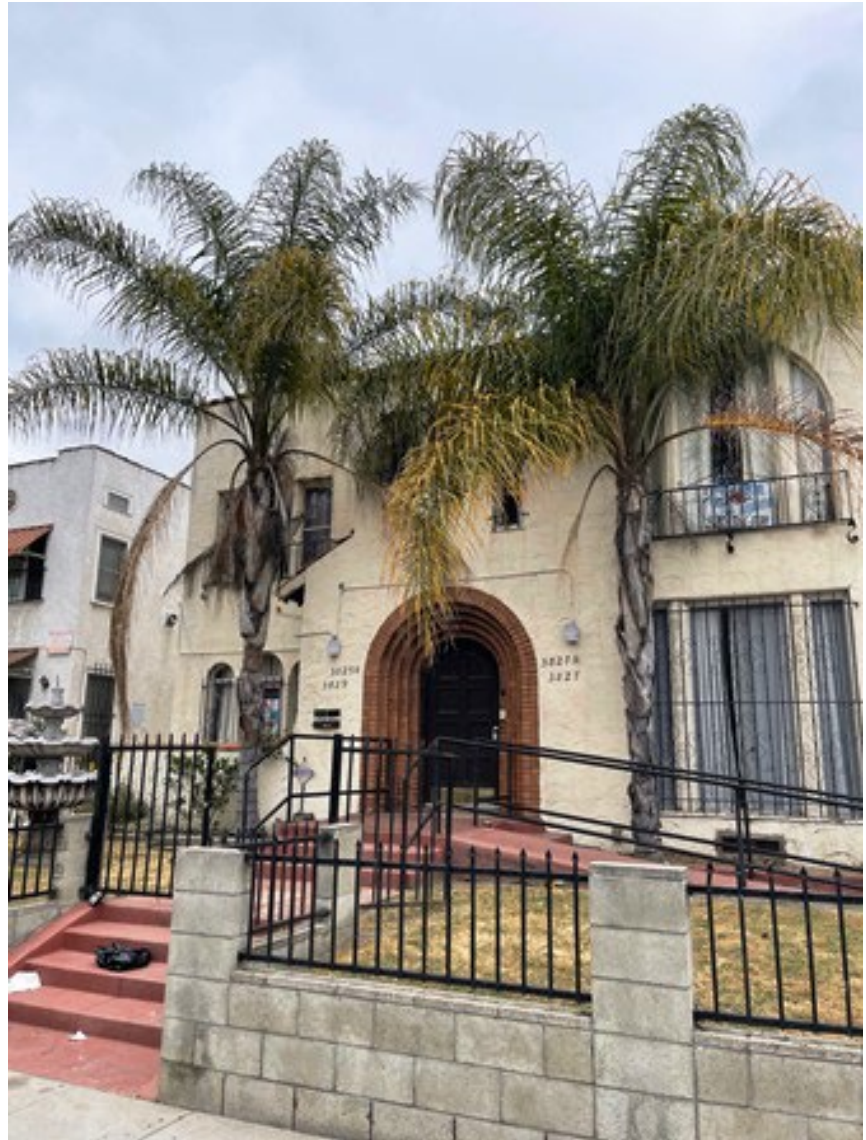
#19 & 20 Queen palms

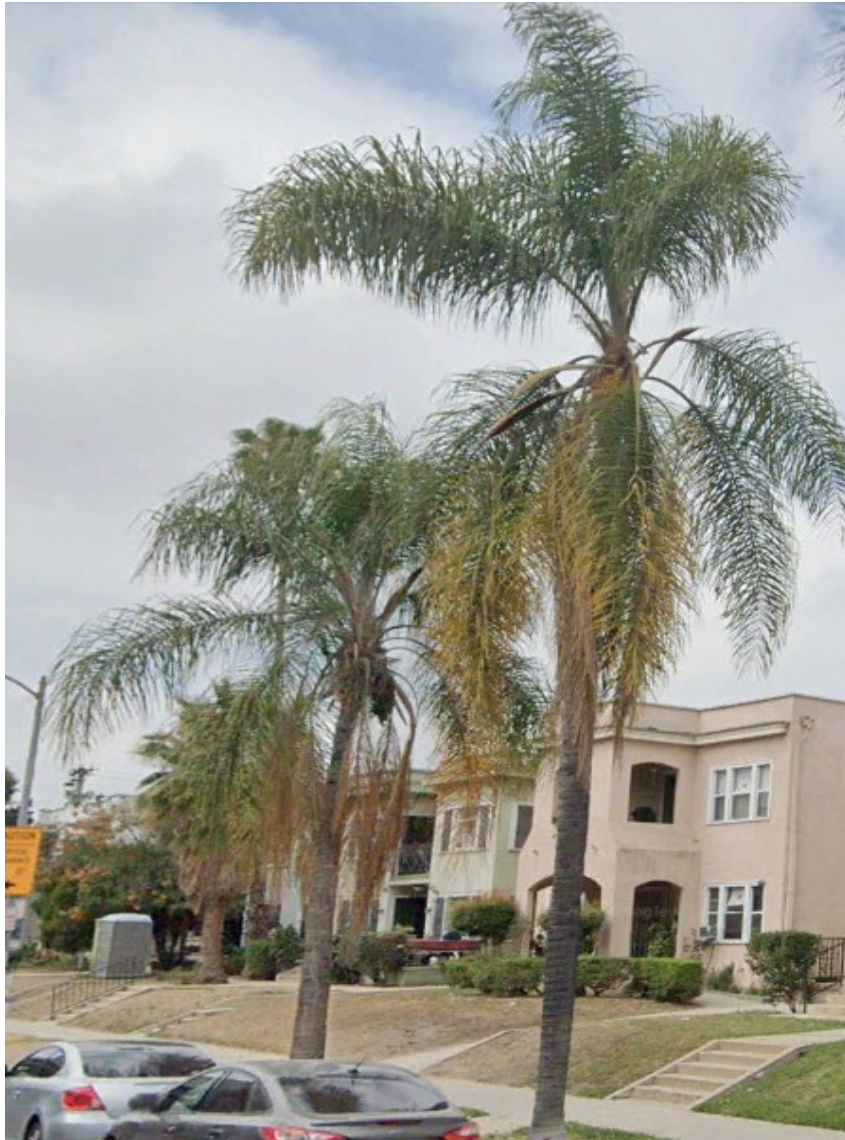
It is important to again state that the street tree queen palm at 3833 Flower is a hazard. Over 50% of the trunk is decayed and rotted away just below the fronds. It is most likely to fall toward the street. The portion of the trunk that is likely to fall is large and heavy enough to cause significant damage or injury.

Palm #22 has a severely decayed trunk just below the fronds. About 50% of the cross-section of the trunk is gone. The decay is mostly on the street side, so that side is the most at risk of being impacted by a failure. However, a strong wind from the east could change that. The whole head of fronds is likely to fall and the weight would be sufficient for significant damage or injury.

#21 & 22 Queen palms - #22 on the left needs to be removed ASAP

Remove this palm immediately.

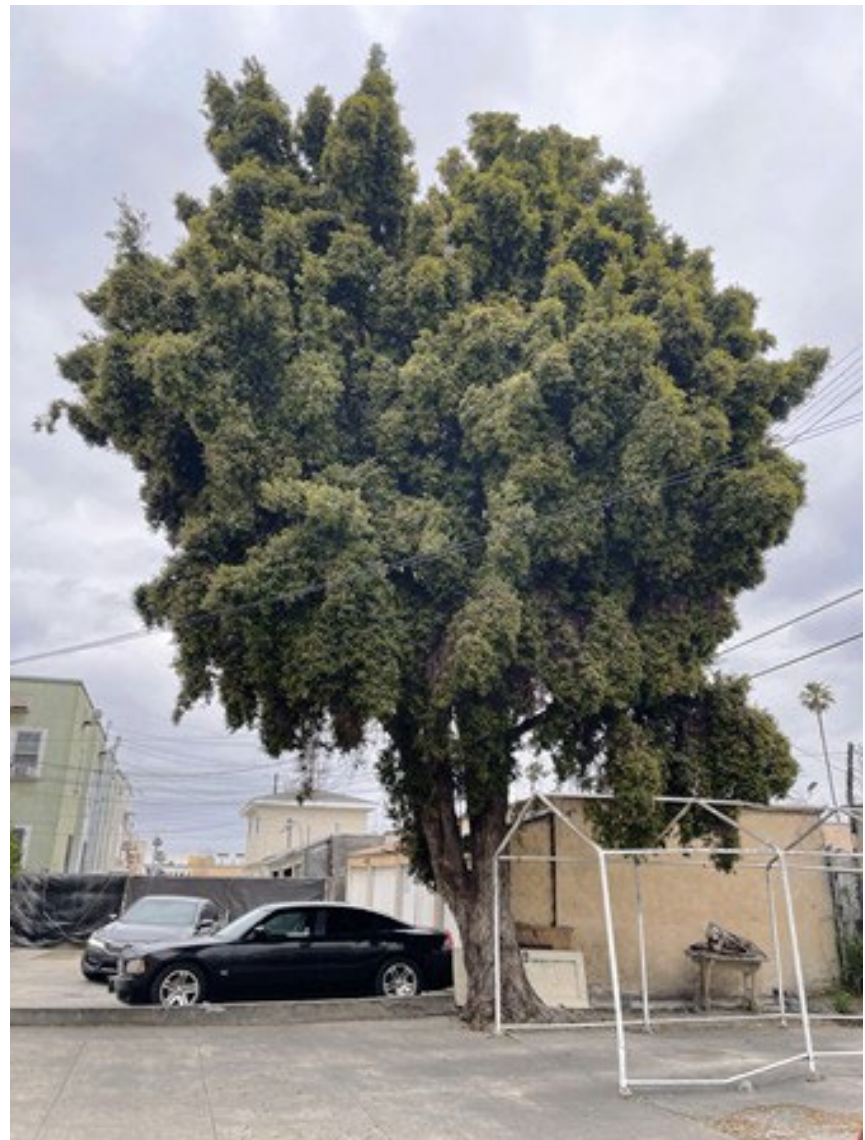
#23 Brush cherry. Note proximity of paving.
