**PHASE II  
LIMITED SUBSURFACE INVESTIGATION REPORT**

**FORMER GAS STATION  
15901 Main Street  
Hesperia, California 92345**

**Date Issued: December 12, 2007  
Project Number: 07-54108.3**

**Re: Phase II Limited Subsurface Investigation Report  
Former Gas Station  
15901 Main Street  
Hesperia, California 92345  
Project No.: 07-54108.3**

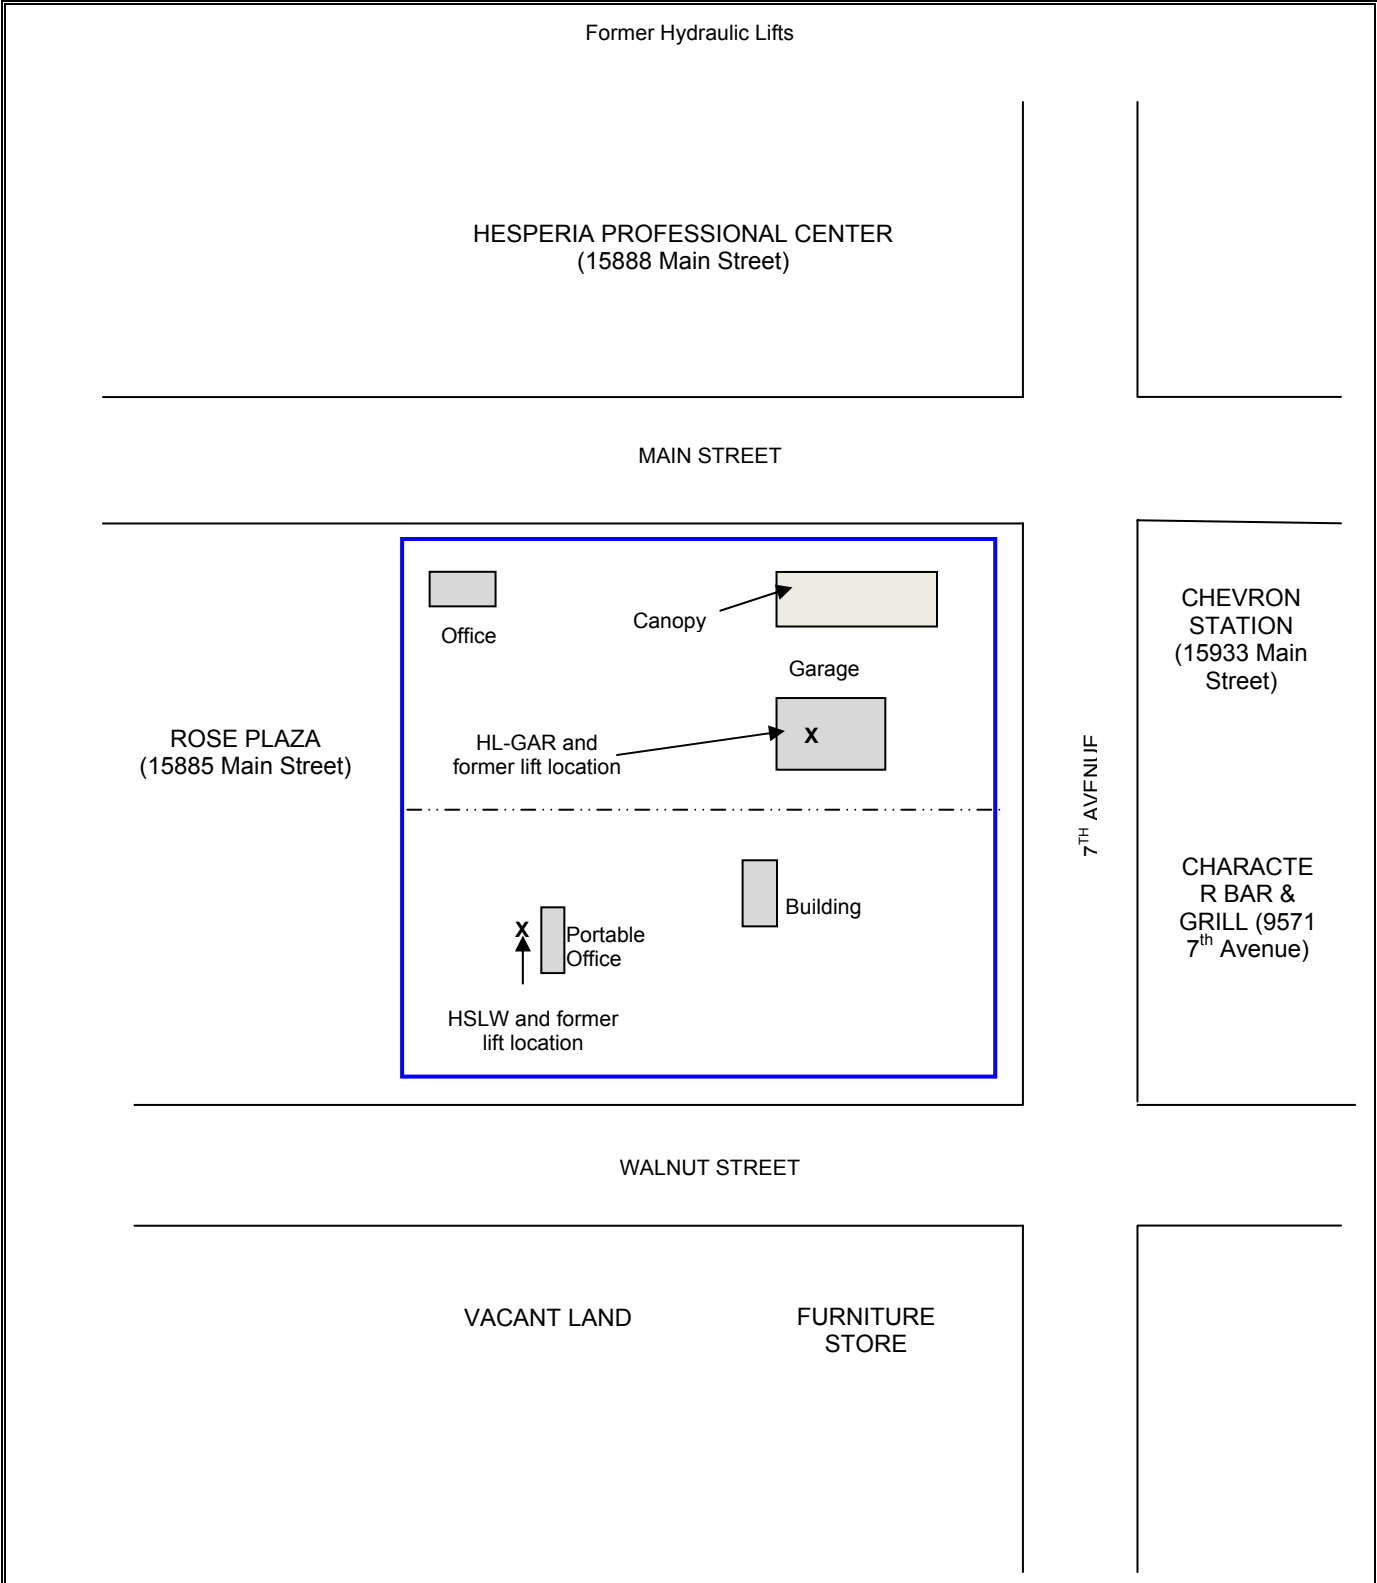
**FIGURE 2  
SAMPLE LOCATION MAP**

Following removal of the lifts, soil samples HLSW and HL-GAR were collected by LAC from the bottom of the excavated areas at a depth of approximately eight feet below ground surface. Sample HLSW was collected from the lift excavation near the southwestern corner of the property and sample HL-GAR was collected from the lift excavation within the garage. The former hydraulic lift locations and sampling locations are illustrated on Figure 2.

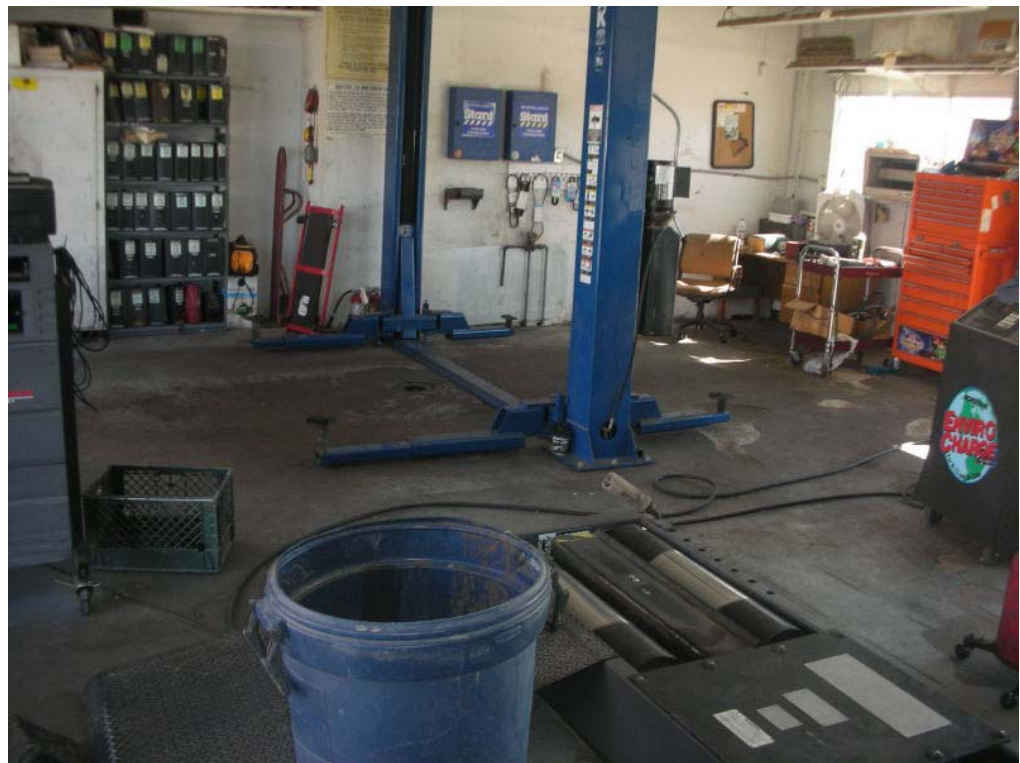
Photograph Number 2: Garage interior before removal of hydraulic lift (center of photo)

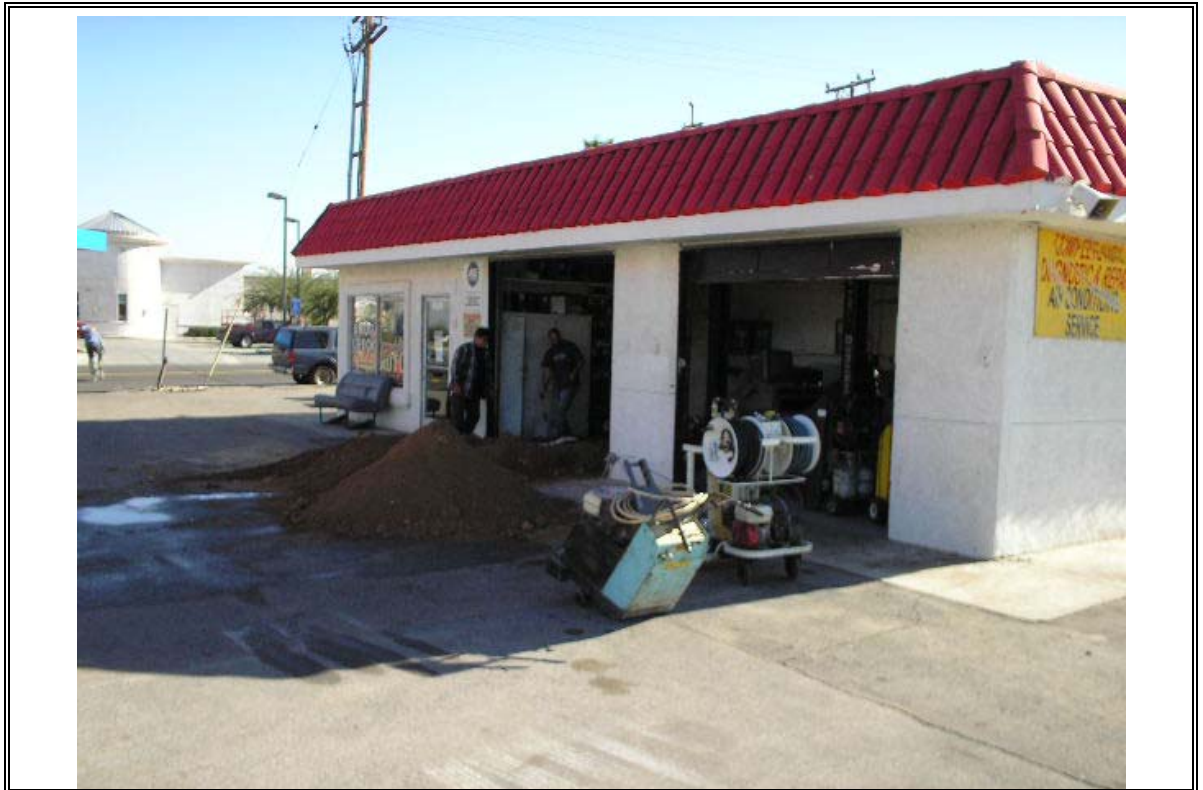
Photograph Number 3: Garage building following removal of hydraulic lift

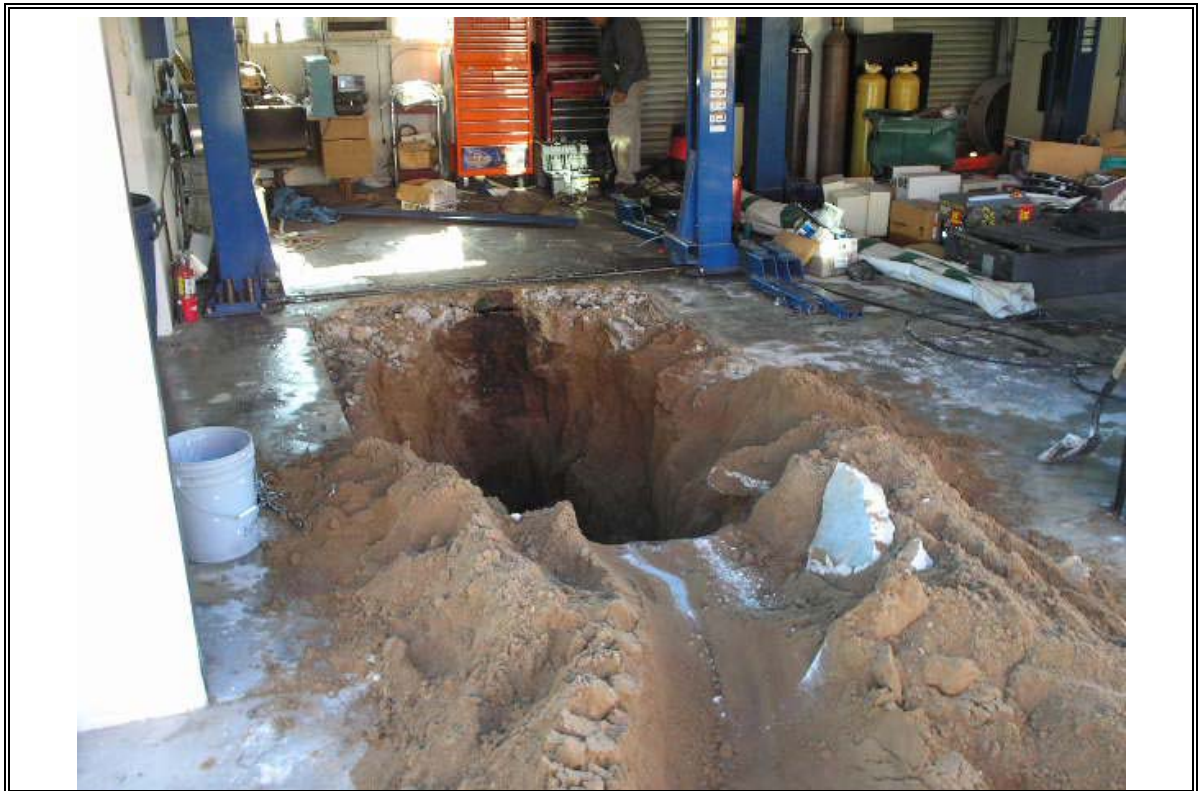
A small quantity of stained soil was removed from the upper three feet of soil adjacent to the lift that was removed from the garage. However, there were no indicators of impact in soil deeper than three feet in this area, and there were no contaminants in the soil sample that was collected at the approximate bottom of the lift. Therefore, LAC concludes that the limited impact around this lift has been removed and is not a concern. Also, there were no indicators of impact in soil adjacent to the lift located near the portable office trailer and no contaminants were detected in the soil sample that was collected at the approximate bottom of this lift.

Photograph Number 4: Hydraulic lift removal excavation in Garage

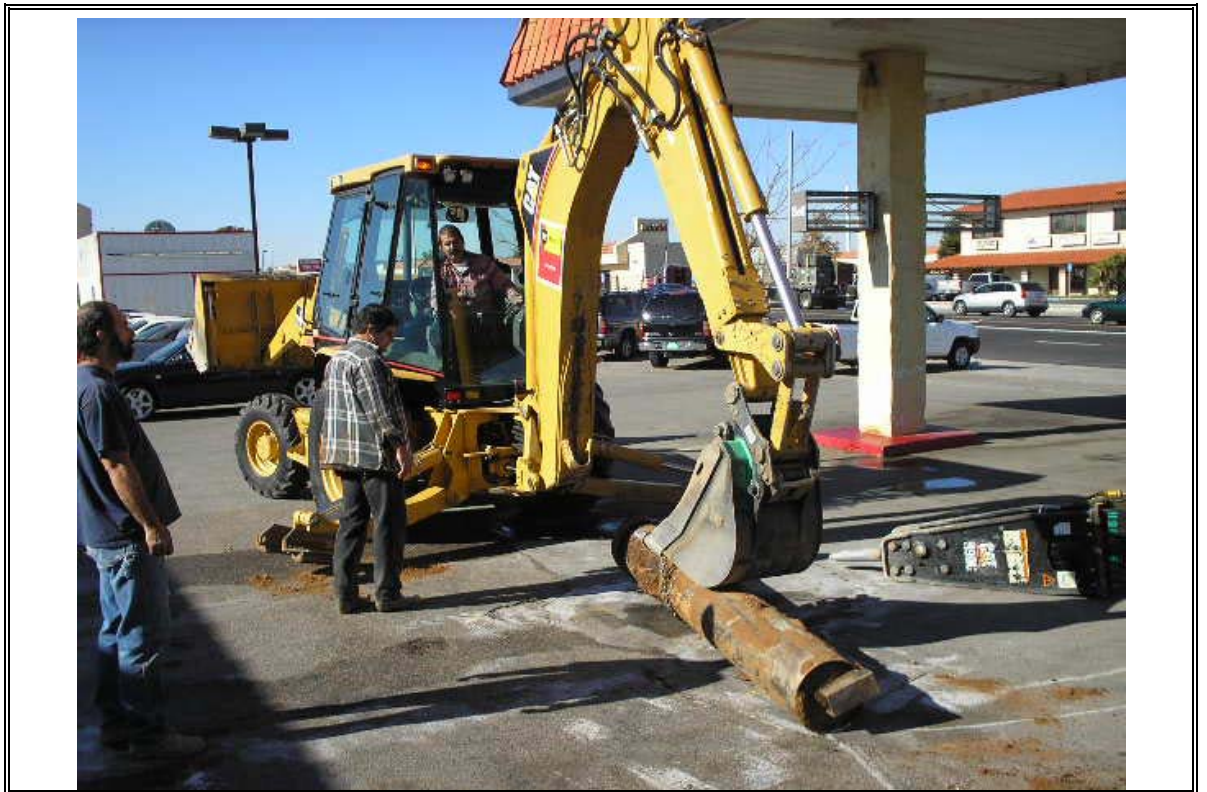
The lift removal and Phase II Limited Subsurface Investigation was conducted on December 5, 2007. When LAC arrived at the property, the two underground hydraulic lifts were being removed with a backhoe. The removed hydraulic lifts did not exhibit evidence of leaking fluid. Photographs of the excavation and removed equipment are provided in Appendix I.

Photograph Number 5: Hydraulic lift cylinder removed from garage

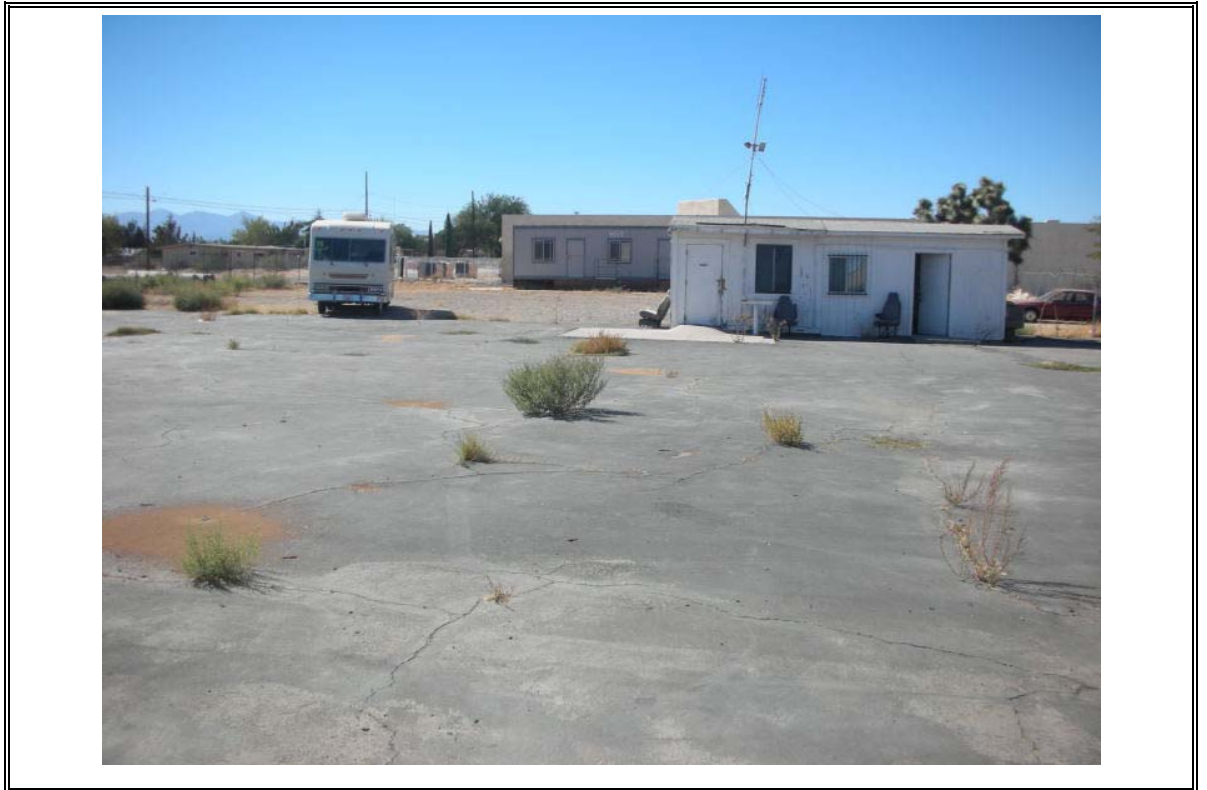
Photograph Number 6: View west of buildings on the southern portion of the Site. Hydraulic lift is behind portable office in the background, southwestern corner of Site.

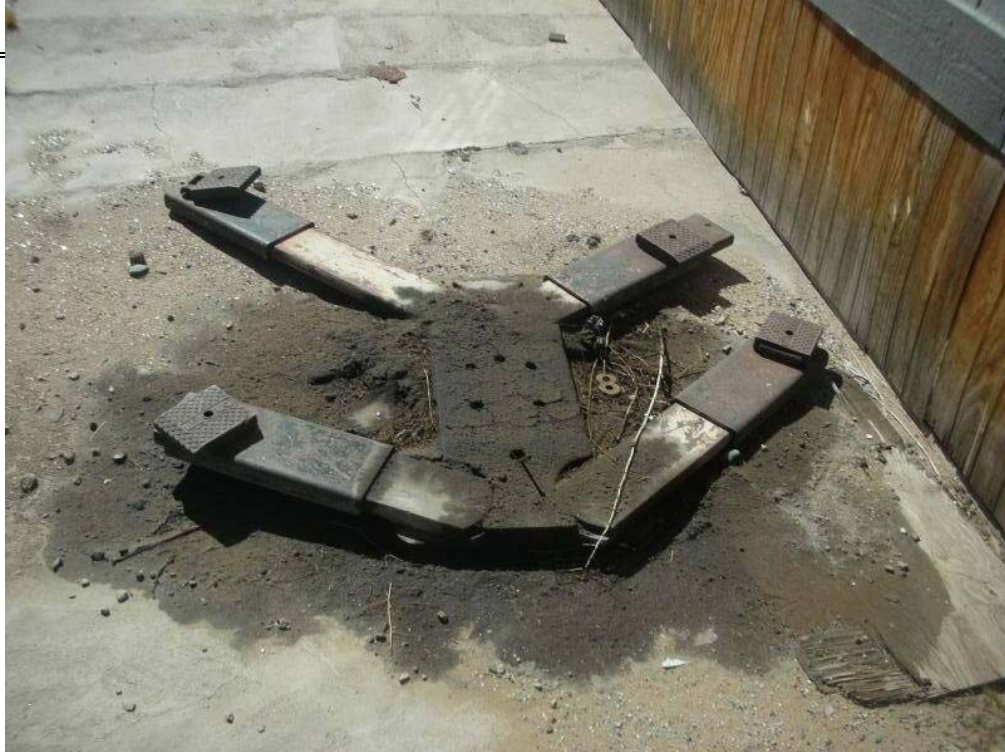
Photograph Number 7: Below-ground hydraulic lift next to the portable building in SW corner before removal

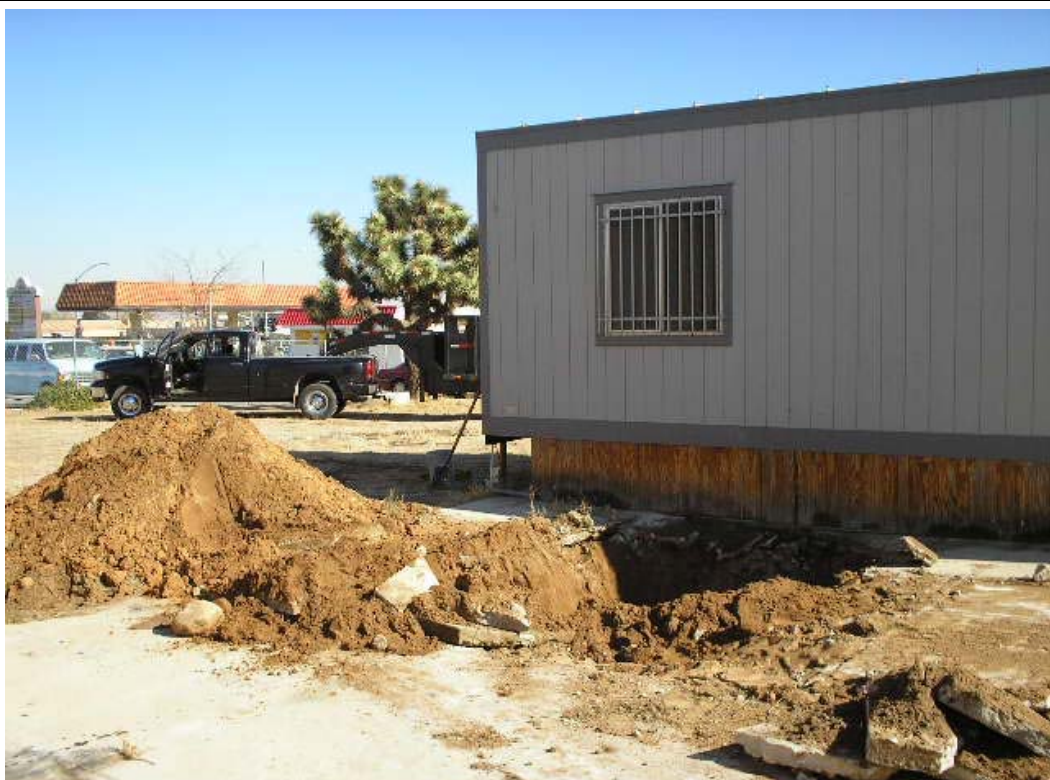
Photograph Number 8: Hydraulic lift removal excavation behind portable building in SW corner.

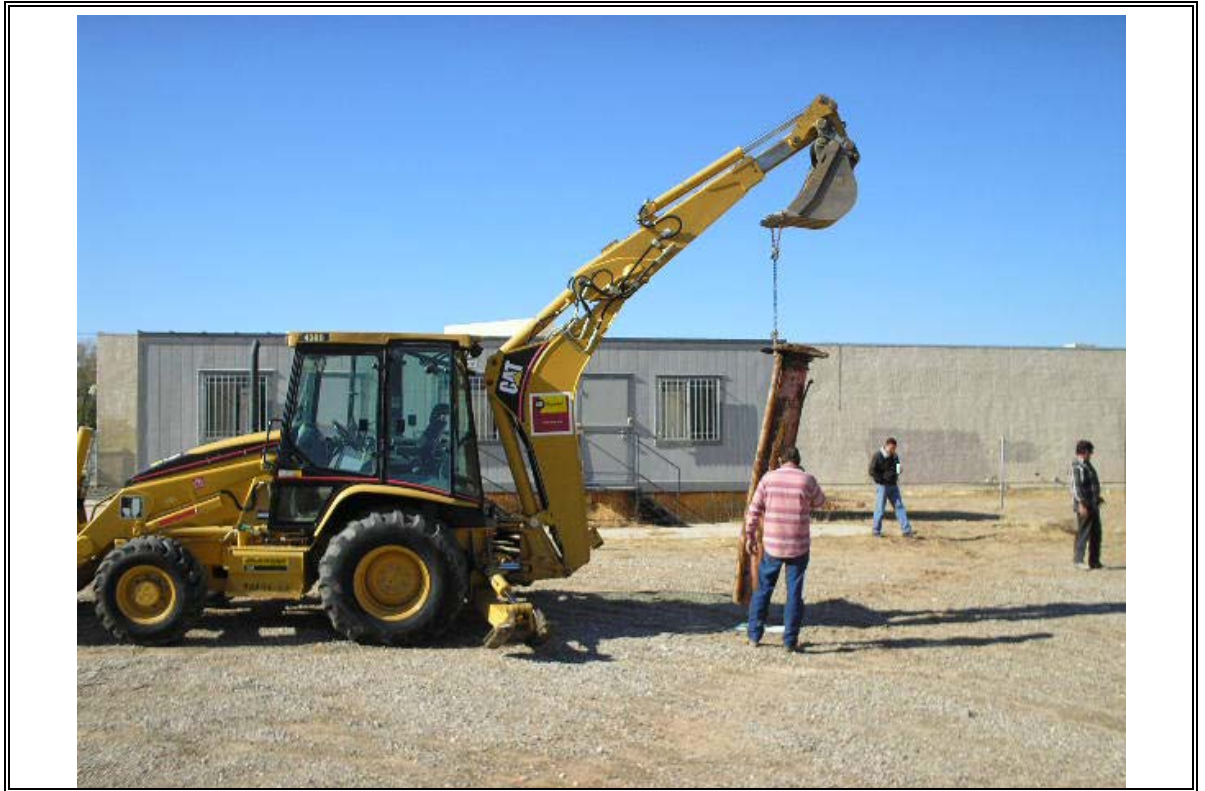
Photograph Number 9: Hydraulic left cylinder in southwest corner after removal
