**Google Caribbean Campus
Construction Office and Parking Site
Arborist Report**

Proposal #9274

H. T. Harvey & Associates
Matt Pollock
ASCA Registered Consulting Arborist #631
ISA-Certified Arborist WE-11610A

March 30, 2018

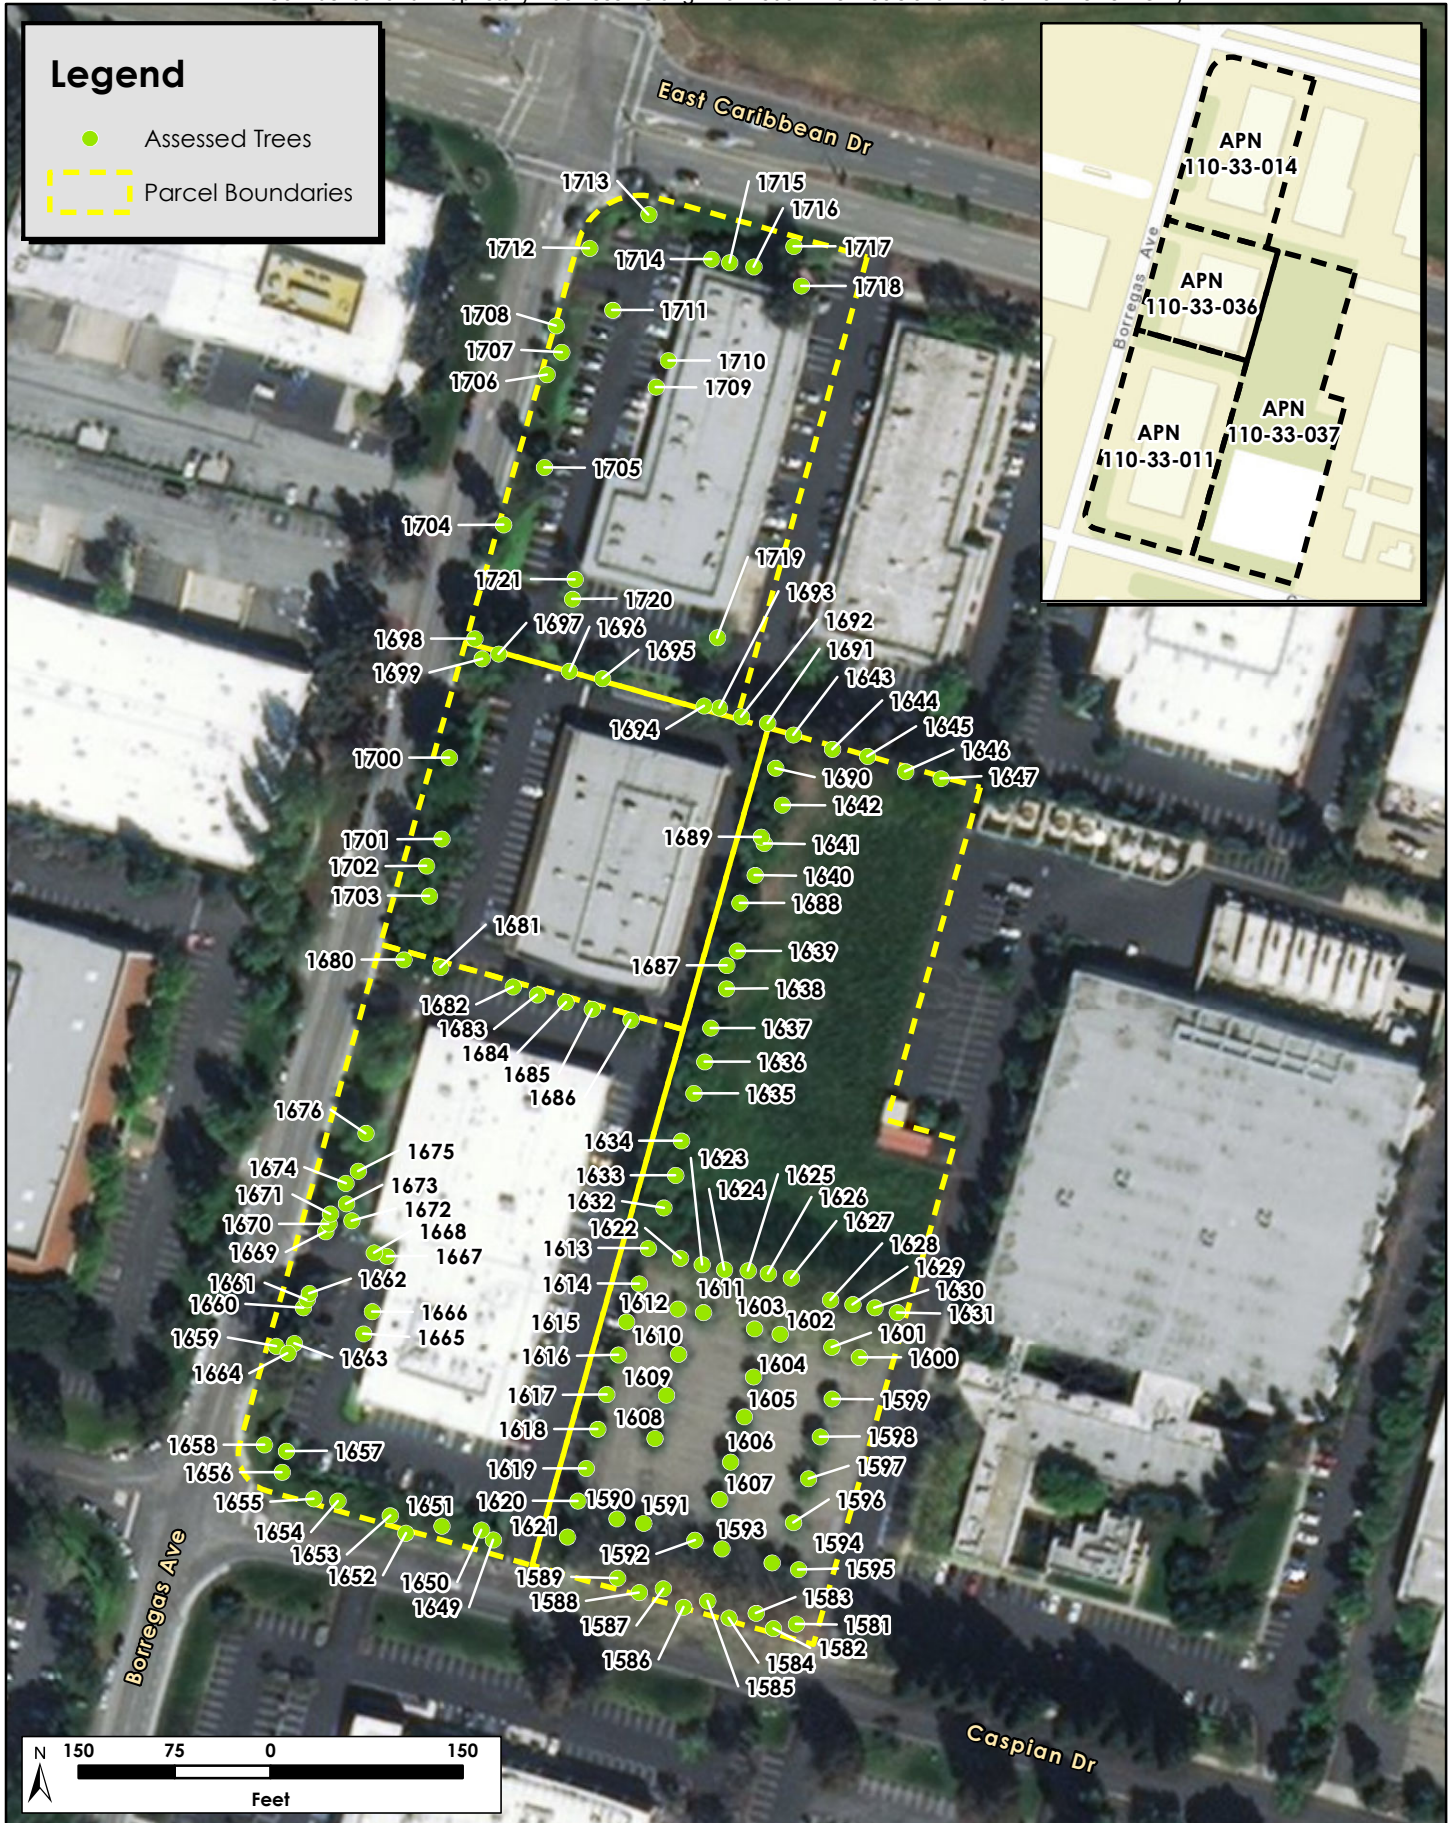
Figure 1. Locations of Existing Trees
Google Caribbean Campus Construction Office and Parking Site
Arborist Report (Proposal 9274)
March 2018

One hundred and thirty-seven trees were identified on the property (Figure 1). Descriptions of each tree are included in Appendix C (Tree Assessment), including DBH, height, and tree condition score. A summary of the 137 trees, representing fourteen species, is provided in Table 2. Of the 137 trees located on the property, 72 (53%) meet the City's criteria for protected status (see Section 3.4 below). The most common trees on the site are Southern magnolia (*Magnolia grandiflora*) and shamel ash (*Fraxinus uhdei*).
