PROTECTED TREE REPORT

1830 N. Blue Heights Drive
Los Angeles, CA 90069

September 14, 2016

LISA SMITH, THE TREE RESOURCE
REGISTERED CONSULTING ARBORIST #464
ISA CERTIFIED ARBORIST #WE3782
ISA TREE RISK ASSESSOR QUALIFIED
MEMBER OF AMERICAN SOCIETY OF CONSULTING ARBORISTS
P.O. BOX 49314, LOS ANGELES, CA 90049
T 310-663-2290 E queenpalm@earthlink.net

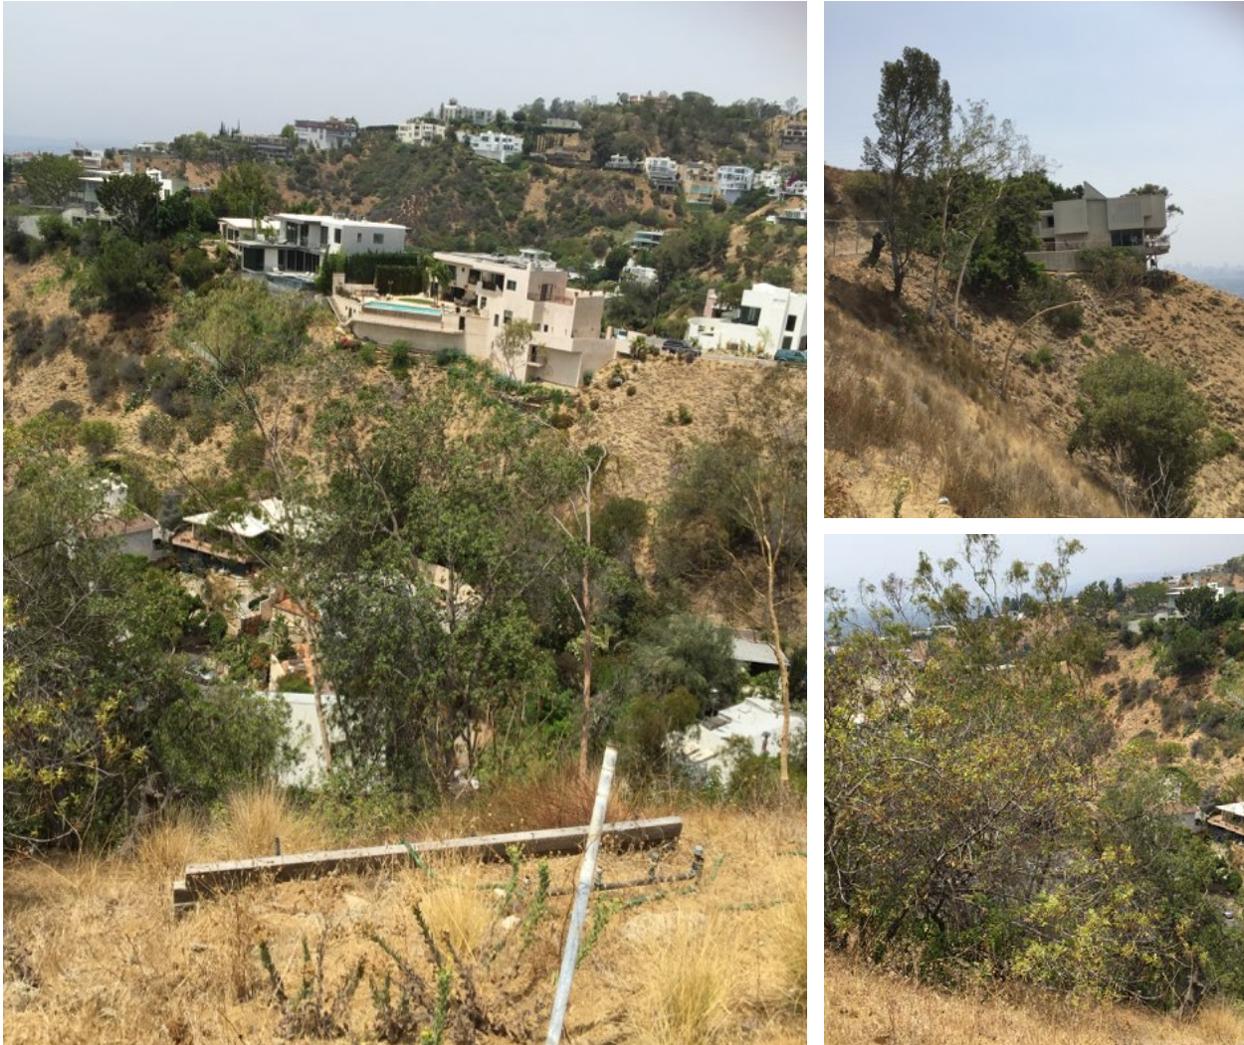
PHOTO 1. Shows views of the subject property. Clockwise from left: looking southwest down the central slope, with the main collection of eucalyptus and Brazilian pepper visible; looking to the eastern limit, to a collection of offsite trees adjacent to the neighboring residence; and a view of the two Protected black walnut (*Juglans californica*) trees at the top of the slope near the main peninsula of the property. The seven (7) Non-Protected Trees and two (2) Protected black walnut trees on site will be significantly impacted by the proposed construction and are recommended for removal.

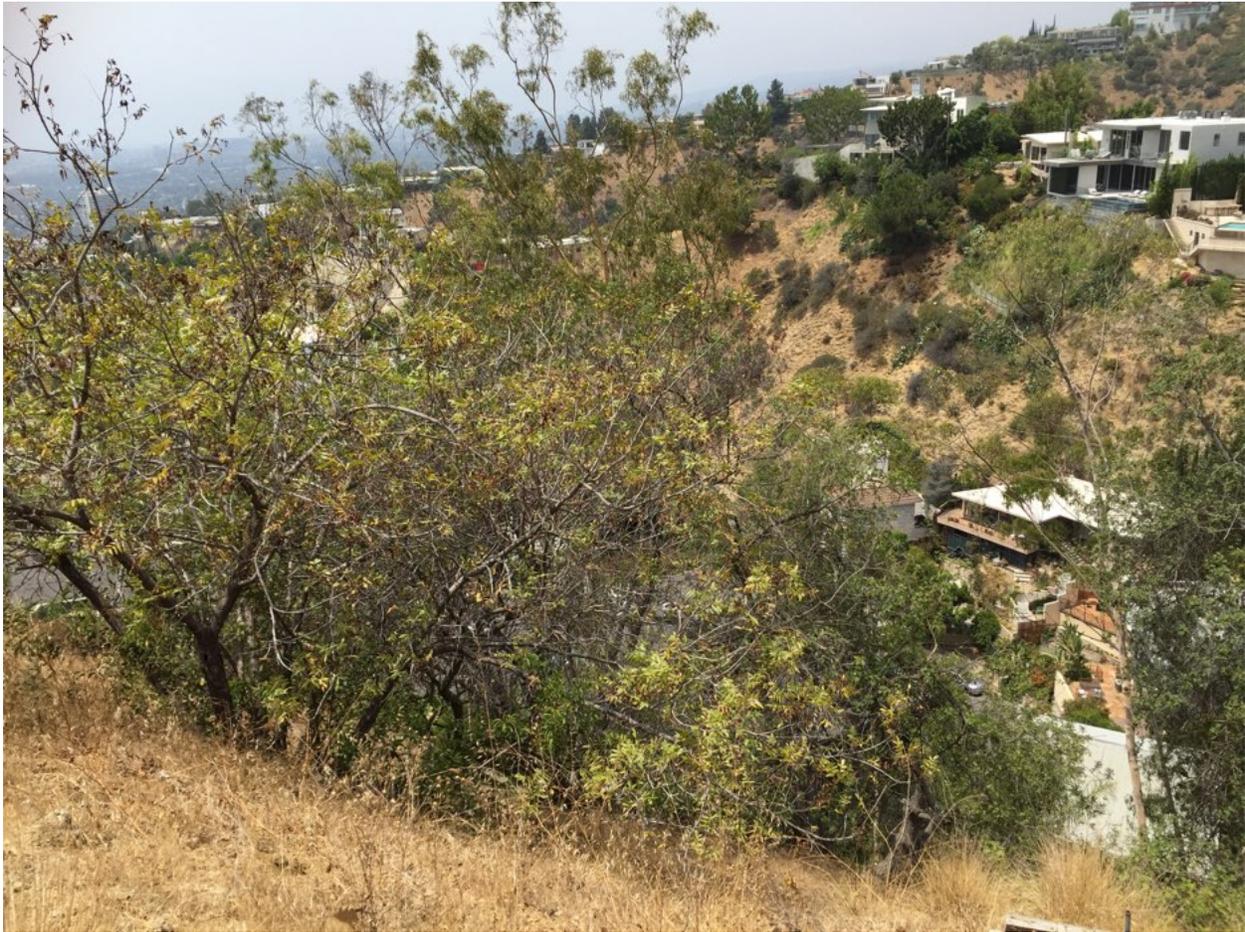
At this time, I observed two (2) black walnut (*Juglans californica*) trees on the property. These two trees are on the upper portion of this steeply sloping lot well within the construction zone. These trees are drought stressed and in poor condition. They will both be significantly impacted by the proposed construction and are located in the footprint of the proposed residence. They are recommended for removal and mitigation to the satisfaction of the Urban Forestry Division. Due to the steep hillside terrain, they are not tagged, however they are located on the tree location map provided within this report.

PHOTO 2. Shows Protected black walnut (*Juglans californica*) #1 and #2 at the top of the slope near the main peninsula of the property. These two (2) Protected black walnut trees will be significantly impacted by the proposed construction and are recommended for removal and mitigation at a four to one (4:1) ratio, 24” box minimum size, to the satisfaction of the Urban Forestry Division.

The two (2) protected black walnut trees at the top of the slope are within the footprint of the new residence and are recommended for removal and mitigation to the satisfaction of the City of Los Angeles, Urban Forestry Division, at a four to one (4:1) ratio, minimum 24 inch box size. A total of eight (8) native trees will be planted on site.
