# ARBORIST REPORT

November 15, 2022  
Rev. January 25, 2024  
6520.00

Project Terraine  
San Jose, CA

Westbank

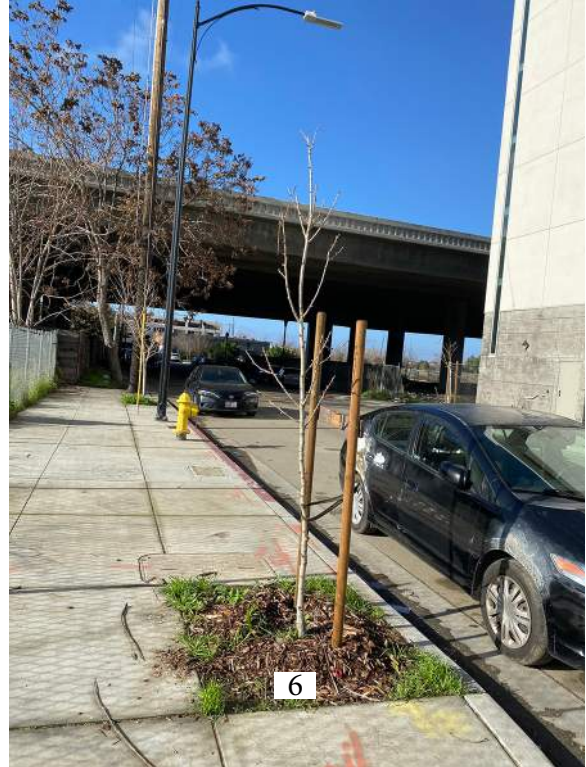
Most of the street trees are in good shape and health. Tree 3 has the primary stem broken and therefore will not develop the ideal form. Tree 6, 7 & 8 were removed. Tree 6 was a dead Ginkgo and has now been replaced with a new tree. Trees 7 & 8 were *Ailanthus altissima* that were growing in the same tree well as 6 and have been removed. There are 3 additional newly planted street trees with new tree wells, Trees 10 – 12. They are all in good shape and health.

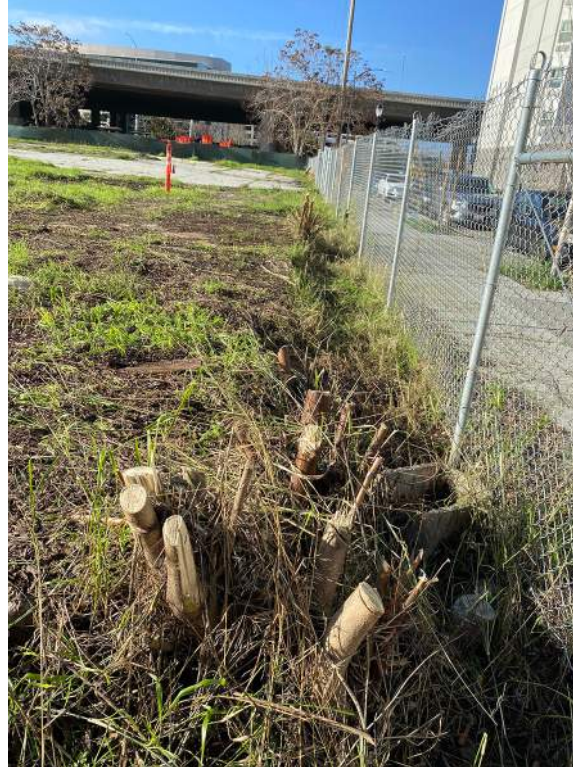
When the arborist report field work was performed originally 11/10/22 there were several *Ailanthus altissima* shrubs on site. These have been removed, but several remaining stumps were observed. *Ailanthus altissima* are categorized as invasive by the California Invasive Plant Council and spread aggressively as rhizomes through the ground. It is recommended that the root systems are completely removed to ensure new colonies don't take hold.

FROM CORNER OF TERRAINE ST. AND BASSETT ST. LOOKING DOWN BASSETT - SHOWING STUMPS OF REMOVED SHRUBS

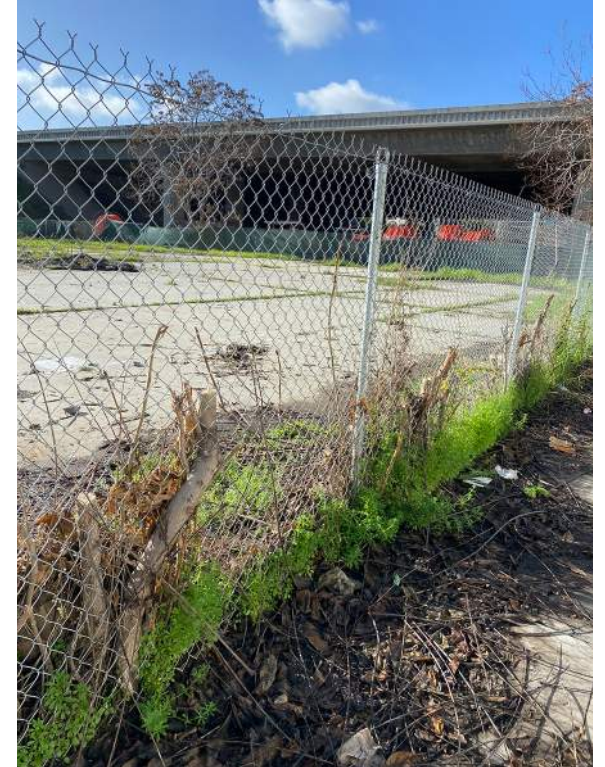
FROM BASSETT ST. LOOKING TOWARD SITE - SHOWING STUMPS OF REMOVED SHRUBS

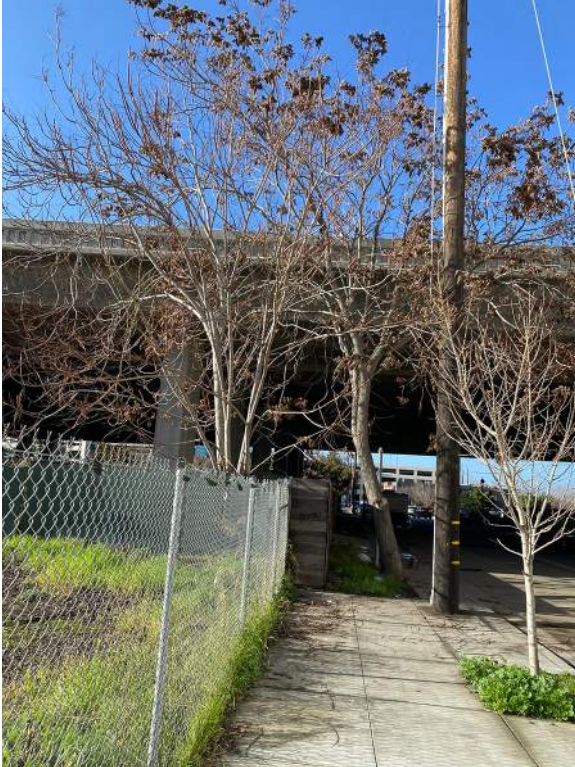
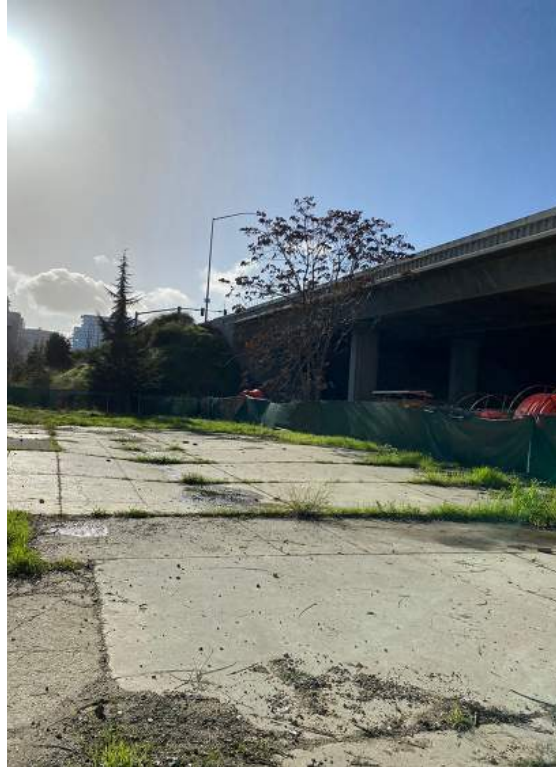
There were three large *Ailanthus altissima* (Tree of Heaven) that were not onsite but are categorized as invasive by the California Invasive Plant Council. It is recommended that these trees are removed, including the root system.

FROM BASSETT ST. LOOKING  
TOWARD 87 GUADALUPE PARKWAY  
- SHOWING OFFSITE INVASIVE  
AILANTHUS ALTISSIMA
