Geology and Soils Evaluation

Boulder Brush Facilities

San Diego County, California

July 10, 2019 | Project No. 108619001

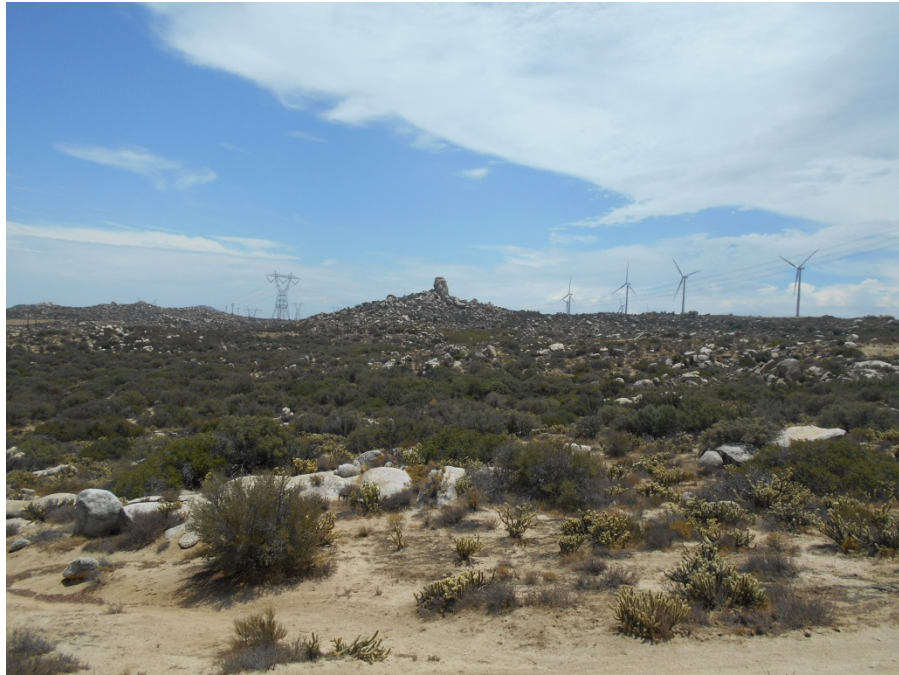
Photograph 1: Overall view of project area.

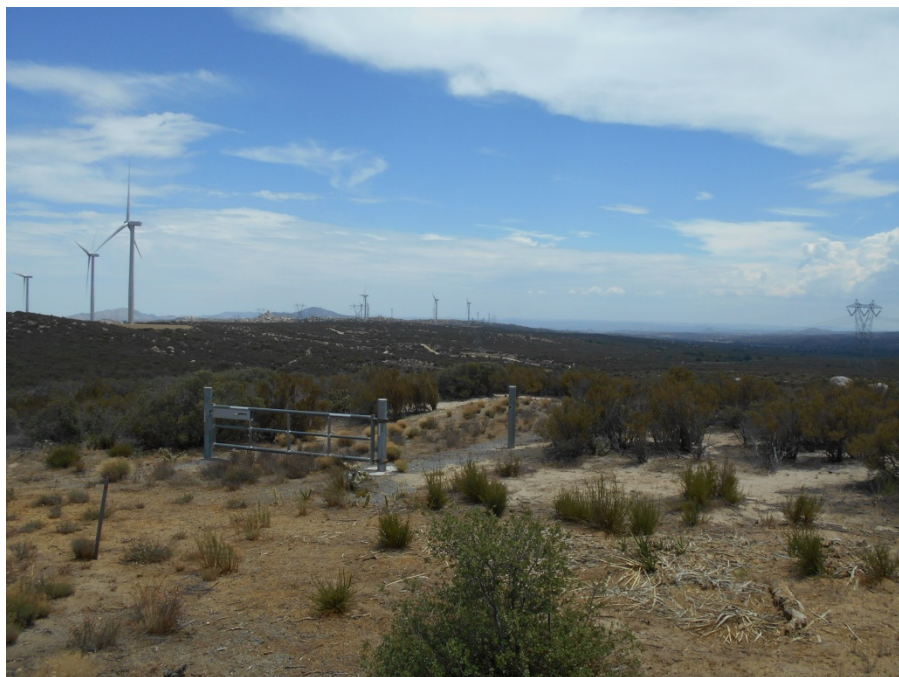
Photograph 2: McCain Valley looking south.

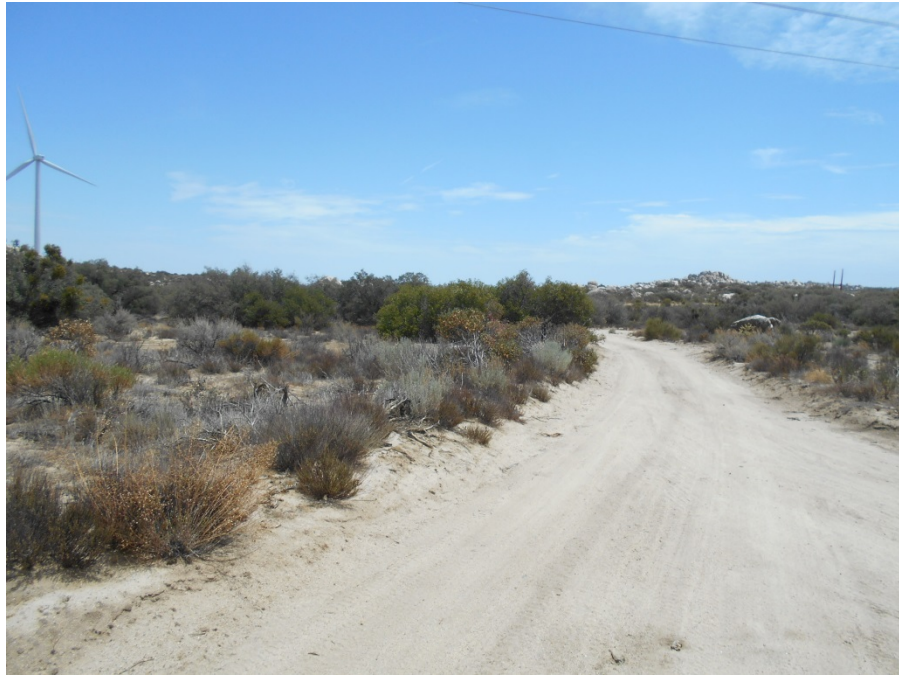
Fill soils were observed at the Project Site along the unpaved roads as well as in graded slopes. We anticipate these fills are relatively shallow and generally composed of locally derived, reworked decomposed granitic rock. Alluvium is anticipated in areas of drainages, creeks, and springs. Granitic rock at the site consists of the Tonalite of La Posta. Outcrops of resistant granitic corestones and boulders were observed scattered across the Project Site (Photographs 1 through 4).

Photograph 3: Typical unpaved access roads through project area.

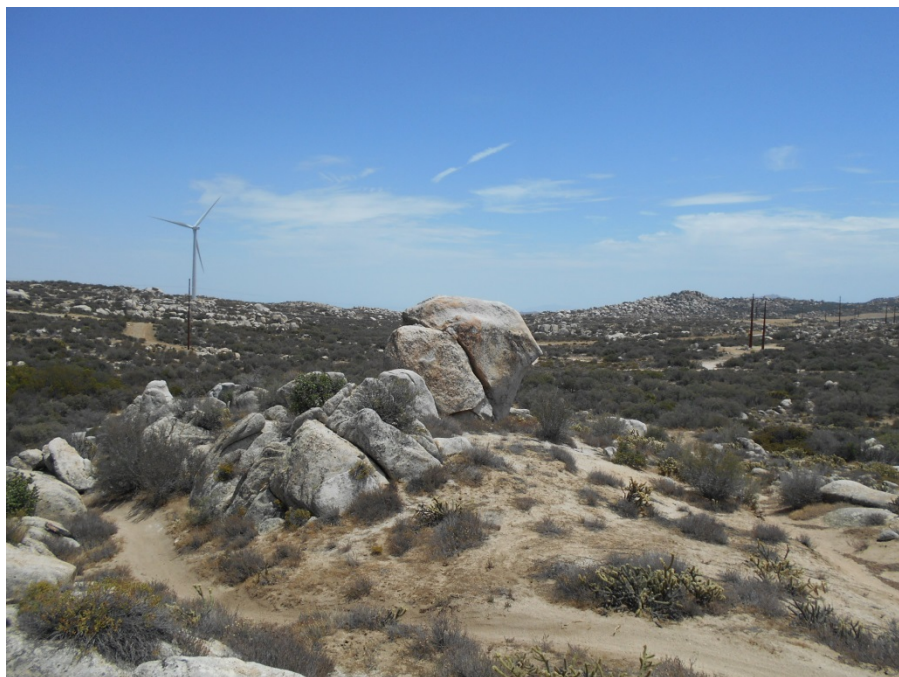
Photograph 4: Granitic rock outcrops on project site.

Near-surface fill and alluvial soils are generally compressible and considered unsuitable in their current condition for structural support. In general, excavation of the fill and alluvial material should be achievable with earthmoving equipment in good operating condition. While shallow excavation of granitic materials should also be achievable with earthmoving equipment in good operating condition, some areas underlain by less weathered rock and/or corestones may require heavy rock breaking.
