Advanced Tree Care

Veterans Memorial Building/Senior Center

October 9, 2018

Tree Survey

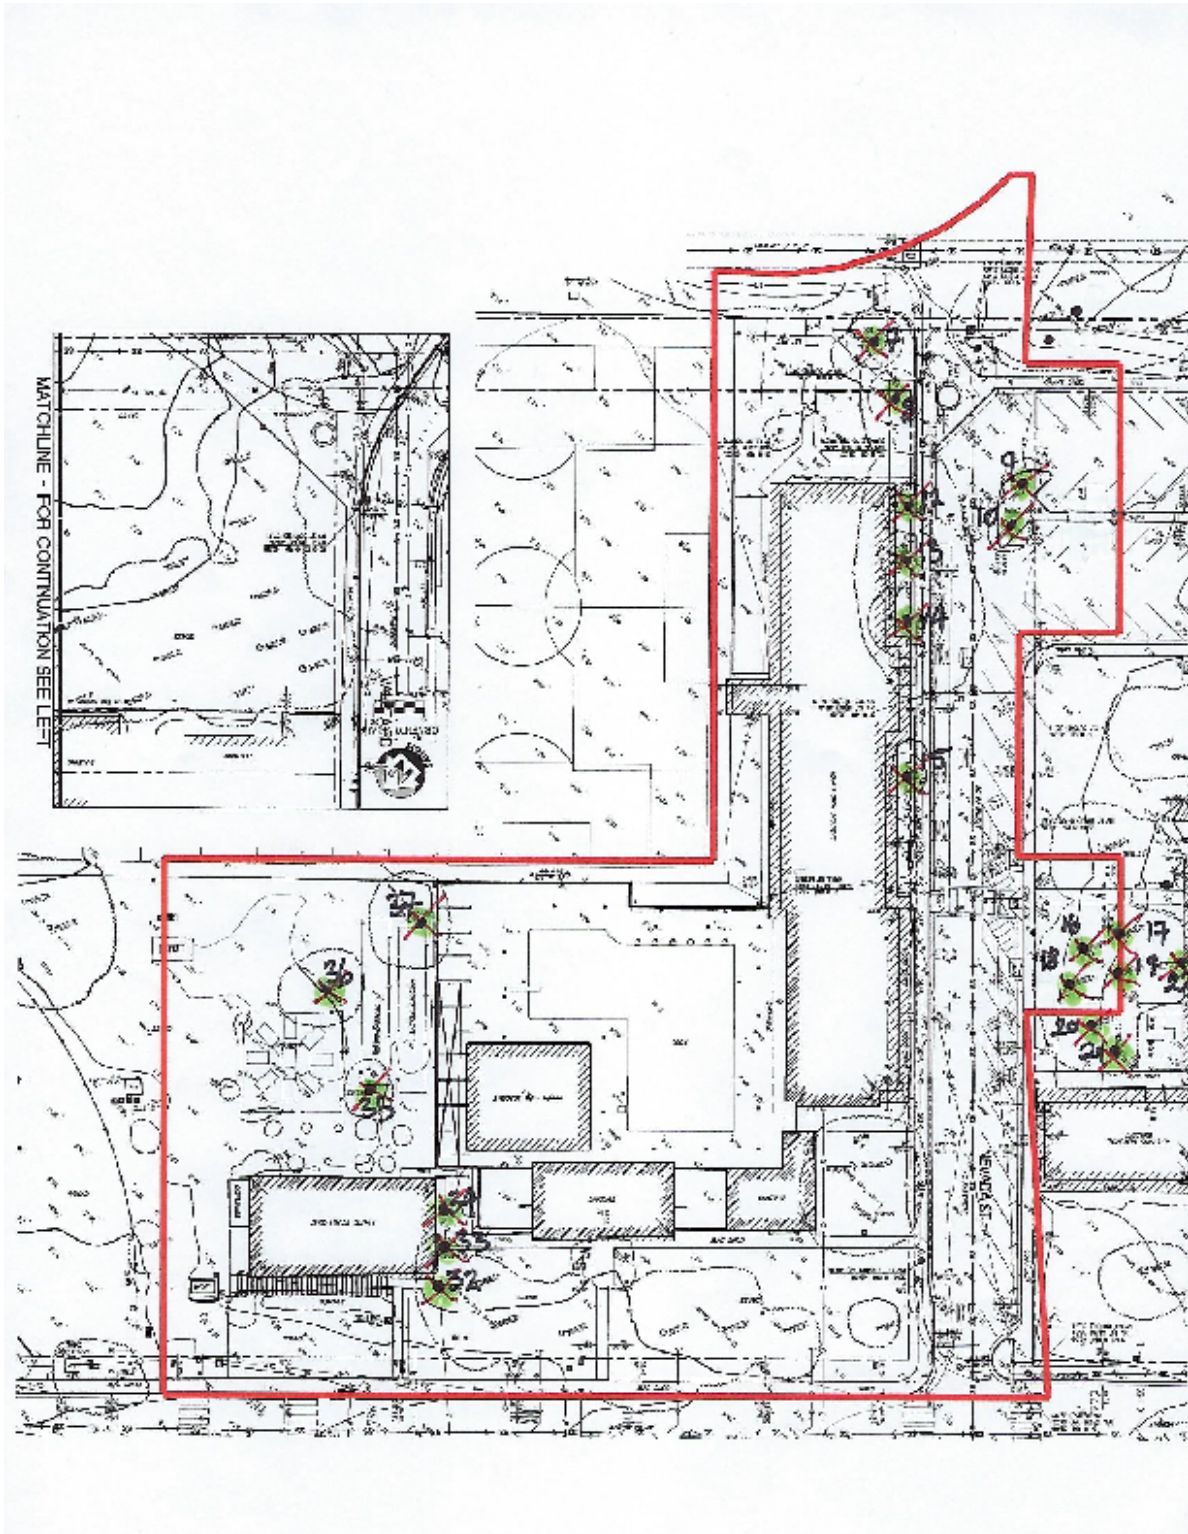
Location of proposed Tree Removals

Twenty one trees will be removed: Tree #s 7, 8, 9, 10, 12, 13, 14, 15, 16, 17, 18, 19, 20, 21, 22, 32, 33, 34, 35, 36 and 37. All the tree removals will be around the King Swim Center

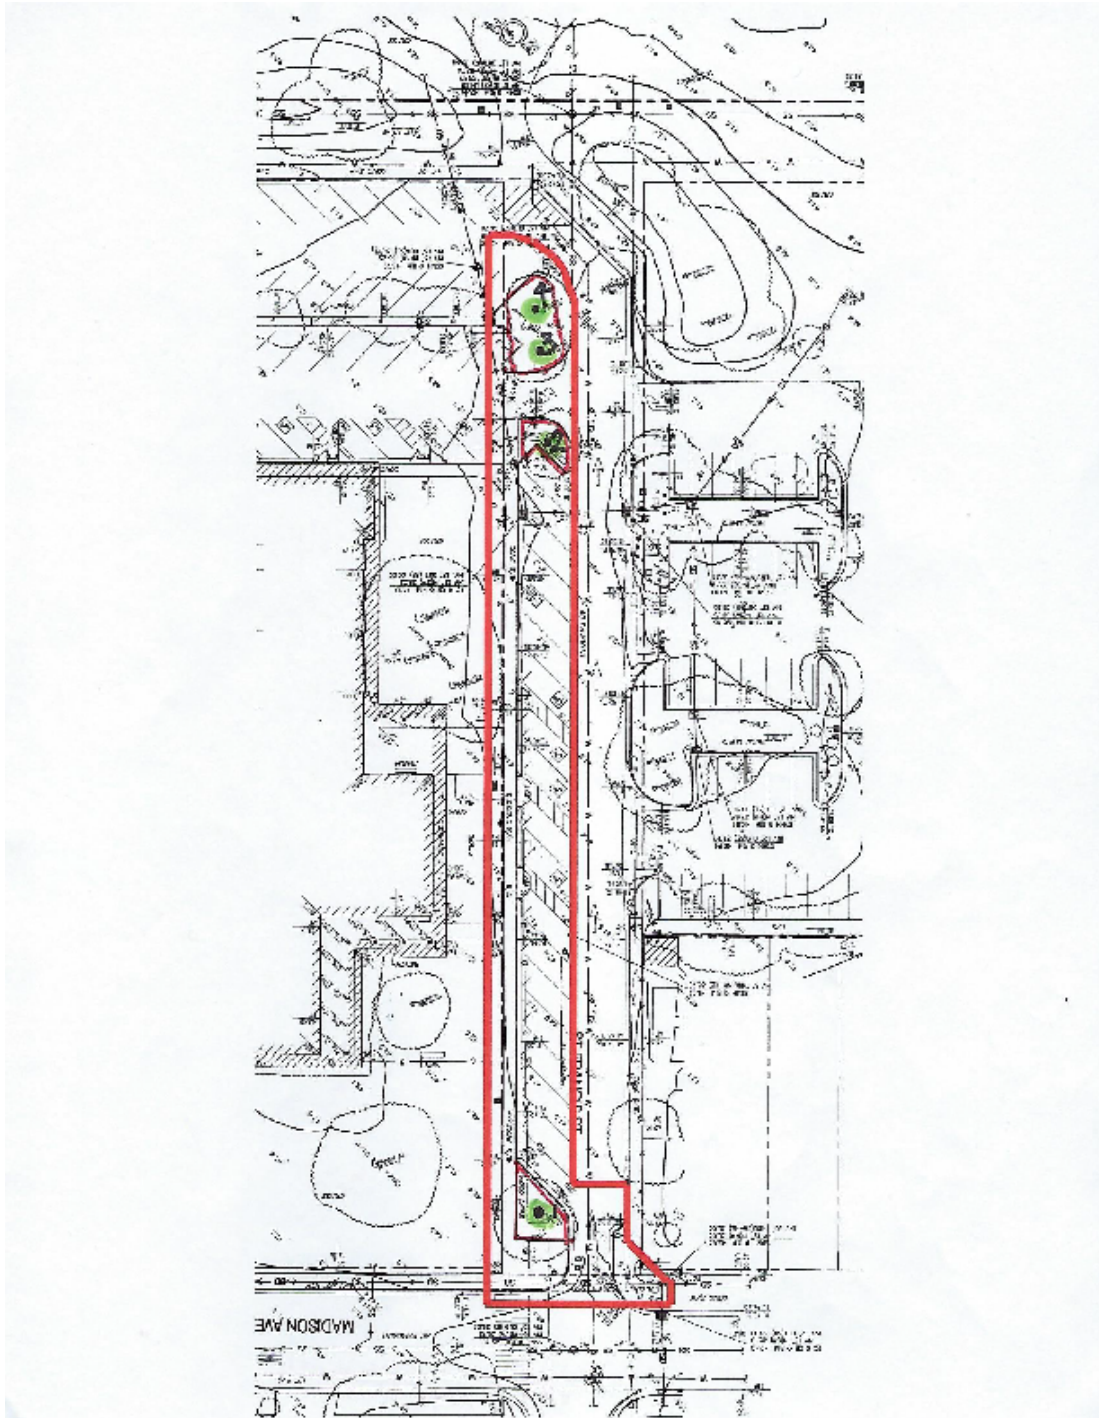
Location of Protected Trees around St Francis Street Parking Area
and their Tree Protection Zones

12. All 5 trees are exhibiting some signs of drought stress. It may be advisable to deep root fertilize/water all 5 trees prior to construction and provide supplemental irrigation through the duration of construction in the warmer months.

1. The Tree Protection Zone (TPZ) should be defined with protective fencing. This should be cyclone or chain link fencing on 1 1/2" or 2" posts driven at least 2 feet in to the ground standing at least 6 feet tall. Normally a TPZ is defined by the dripline of the tree. I recommend the TPZ's as follows:-

Tree #s 1, 2, 3, 4 and 11 are located in the median next to the parking strip along St Francis Street and in an existing parking lot. The parking strip will be realigned to accommodate more vehicles. All 5 trees are quite small and already have a restricted root system from the existing curb. Tree protection fencing should be placed as close to the existing curb as possible to allow for safe removal and replacement of the curb in accordance with Type II Tree Protection as outlined below and illustrated in image 2.15-3 ⁽⁶⁾.

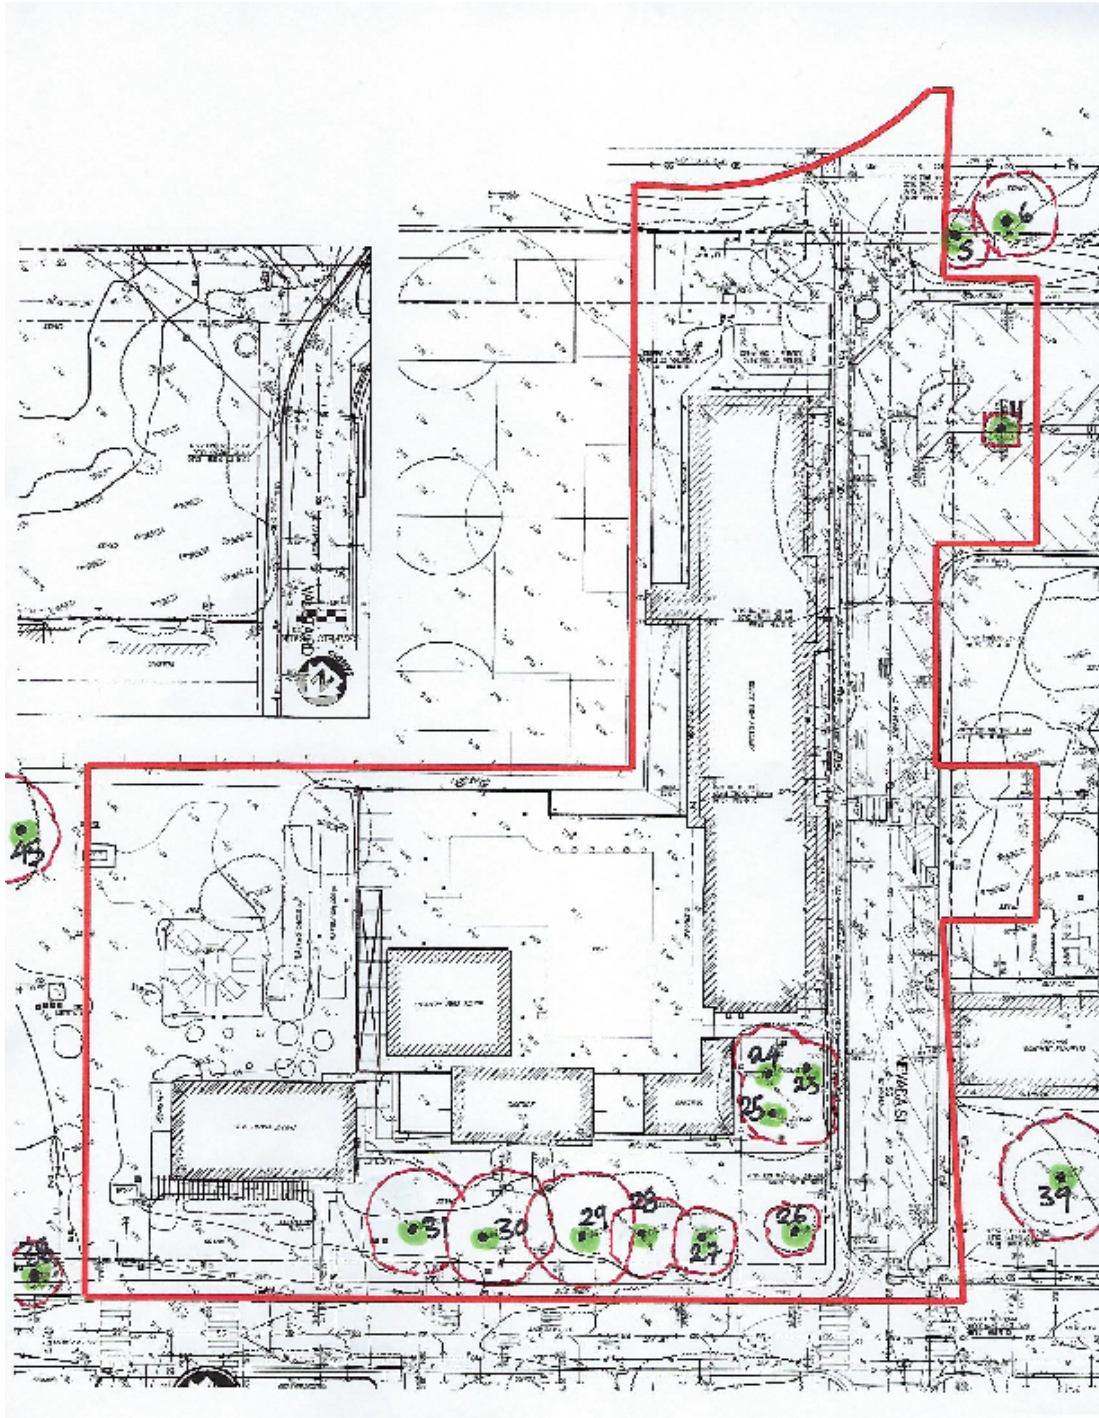
Location of Protected Trees around Kings Swim Academy
and their Tree Protection Zones

12. Many of the trees located around the King Swim Academy are dependent on supplemental irrigation from the existing turf. If this turf is to be removed and the irrigation terminated, the root zone within the TPZs should be protected with 4 inches of wood chip and supplemental irrigation should be provided to these trees during the warmer months. Supplemental irrigation could be done by hand or by laying soaker hoses beneath the layer of wood chips within the TPZs and running the hoses every couple of weeks.

1. The Tree Protection Zone (TPZ) should be defined with protective fencing. This should be cyclone or chain link fencing on 1 1/2" or 2" posts driven at least 2 feet in to the ground standing at least 6 feet tall. Normally a TPZ is defined by the dripline of the tree. I recommend the TPZ's as follows:-

Tree # 5: TPZ should be at 10 feet from the trunk closing on the curb line in accordance with Type I Tree Protection as outlined and illustrated in image 2.15-1 and 2 ⁽⁶⁾

Tree # 6: TPZ should be at 20 feet from the trunk closing on the curb line in accordance with Type I Tree Protection as outlined and illustrated in image 2.15-1 and 2 ⁽⁶⁾

Tree #s 23, 24 and 25: TPZ should be at 20 feet from the trunk closing on the curb line in accordance with Type I Tree Protection as outlined and illustrated in image 2.15-1 and 2 ⁽⁶⁾

Tree # 26: TPZ should be at 10 feet from the trunk closing on the curb line in accordance with Type I Tree Protection as outlined and illustrated in image 2.15-1 and 2 ⁽⁶⁾

Tree #s 27 and 28: TPZ should be at 15 feet from the trunk closing on the curb line in accordance with Type I Tree Protection as outlined and illustrated in image 2.15-1 and 2 ⁽⁶⁾

Tree #s 29, 30 and 31: TPZ should be at 20 feet from the trunk closing on the curb line in accordance with Type I Tree Protection as outlined and illustrated in image 2.15-1 and 2 ⁽⁶⁾

Tree # 38: TPZ should be at 10 feet from the trunk closing on the curb line in accordance with Type I Tree Protection as outlined and illustrated in image 2.15-1 and 2 ⁽⁶⁾

Tree # 39: TPZ should be at 25 feet from the trunk closing on the curb line in accordance with Type I Tree Protection as outlined and illustrated in image 2.15-1 and 2 ⁽⁶⁾

Tree # 45: TPZ should be at 20 feet from the trunk closing on the curb line in accordance with Type I Tree Protection as outlined and illustrated in image 2.15-1 and 2 ⁽⁶⁾
