**PRELIMINARY GEOTECHNICAL INVESTIGATION REPORT
VALLEYS EDGE MULTI-USE DEVELOPMENT
DOE MILL/HONEY RUN SPECIAL PLANNING AREA
CHICO, CALIFORNIA**

Updated February 27, 2019

February 27, 2019
File: 1679

**Subject: Preliminary Geotechnical Investigation Report
Valleys Edge Multi-Use Development
Doe Mill/Honey Run Special Planning Area, Chico, California**

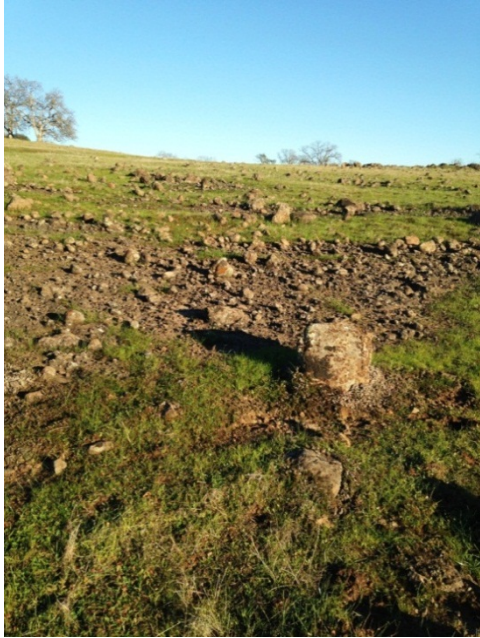
Photo 1: Typical gentle to moderate slope with scattered lahar surface exposures among thin soil cover areas with grass, and scattered surface cobble and boulder. Photo taken at Section 118

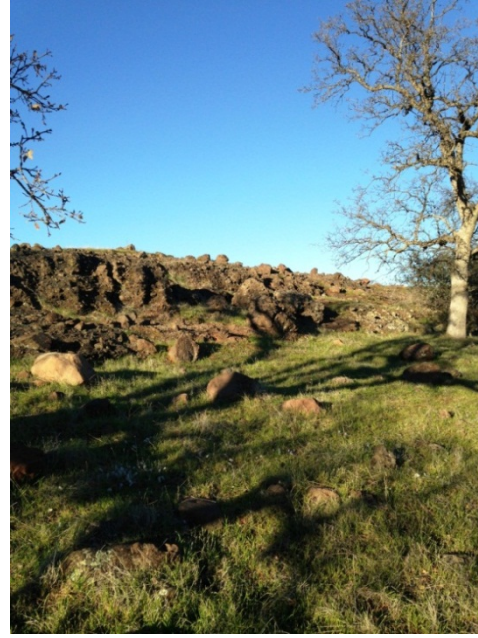
Photo 2: Lahar ledge outcrop at break from gentle to moderate slope. The ledge pictured, located between Sections 115 and 118, is 3- to 4-feet high.

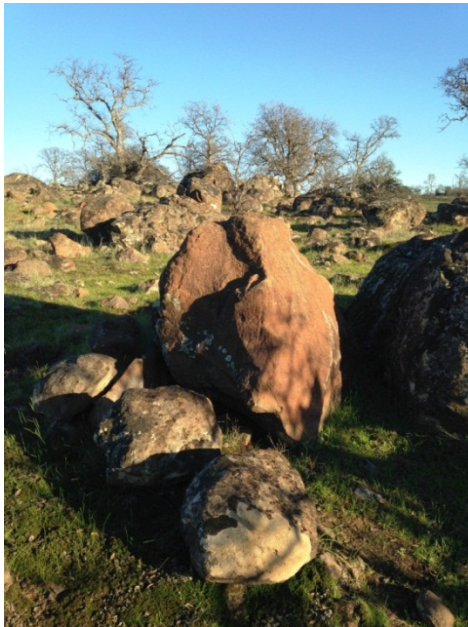
Photo 3: Boulder field at slope break on south side of Section 118. Boulders are up to 7-feet nominal dimension.

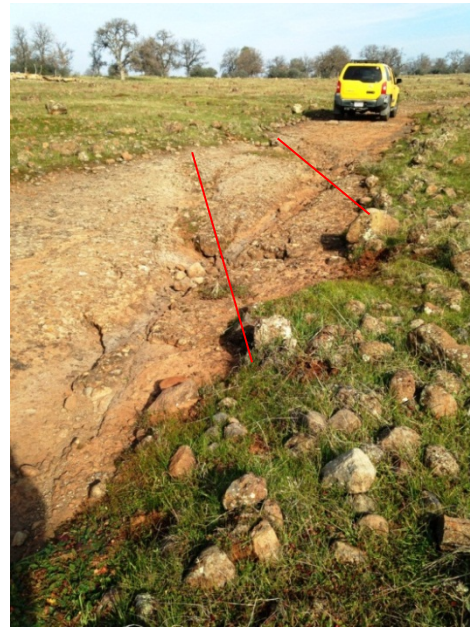
Photo 4: Doe Mill Road at Section 232. Lahar has been exposed by removing 2 to 5 inches of soil. Red lines demark two NNE trending, near vertical fractures within the lahar that are common to the site and vicinity.

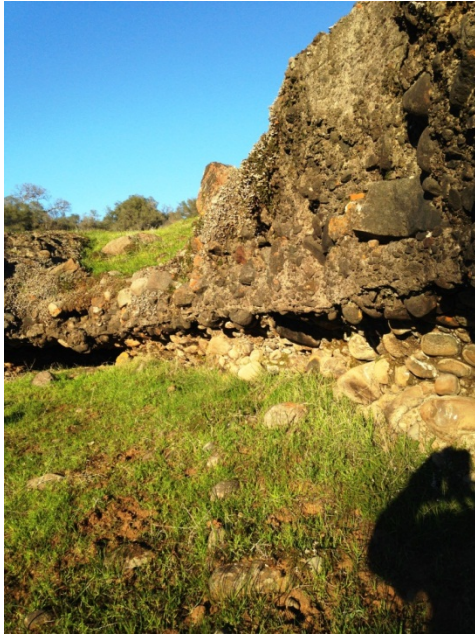
Photo 5: 3 foot thick conglomerate lens beneath 4 foot thick lahar layer at ravine within Section 118. More lahar underlies conglomerate lens, which is of limited lateral extent. Note the rounded cobble in the conglomerate vs the more angular clasts within the lahar.

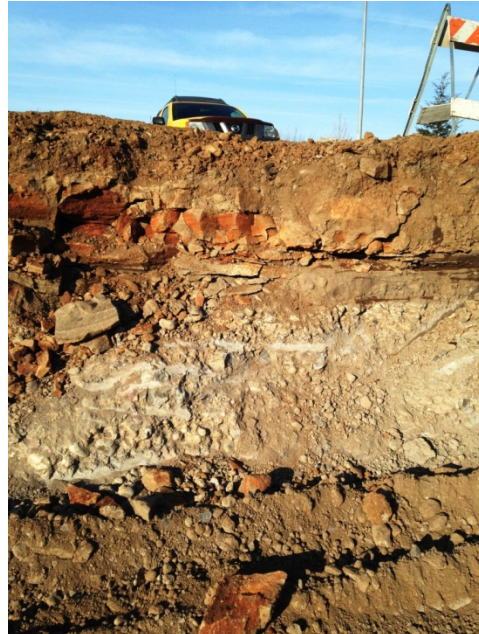
Photo 6: 6 foot thick section of sandstone and conglomerate within storm drain trench exposure at the end the existing paved Doe Mill Road (Section 226). Per the trenching contractor, very hard lahar underlies the conglomerate at the bottom of the photo.

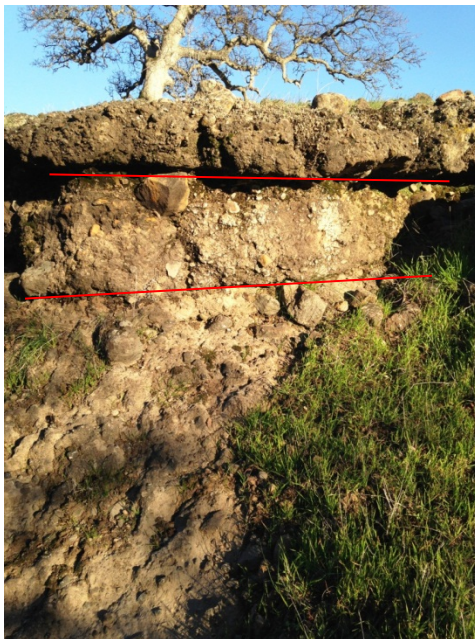
Photo 7: 3 layers within lahar unit likely representing multiple pulses of flow at ravine within Section 118. Red lines demark the top and bottom of the middle layer.

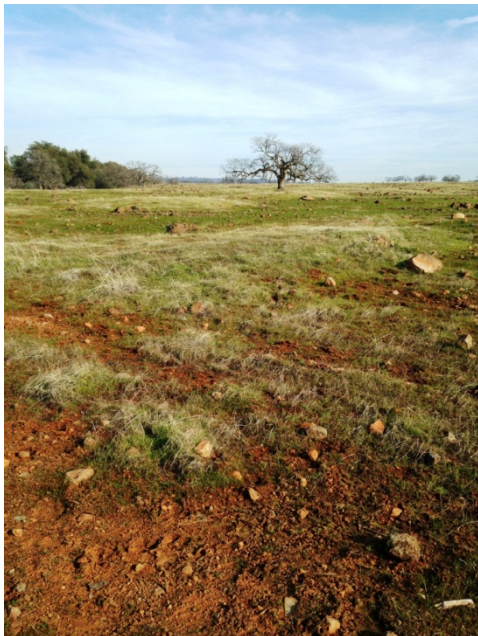
Photo 8: Soil mounds on gently sloping lava cap terrain at Section 110/111. Mounds are evident by the taller and lighter colored grass.

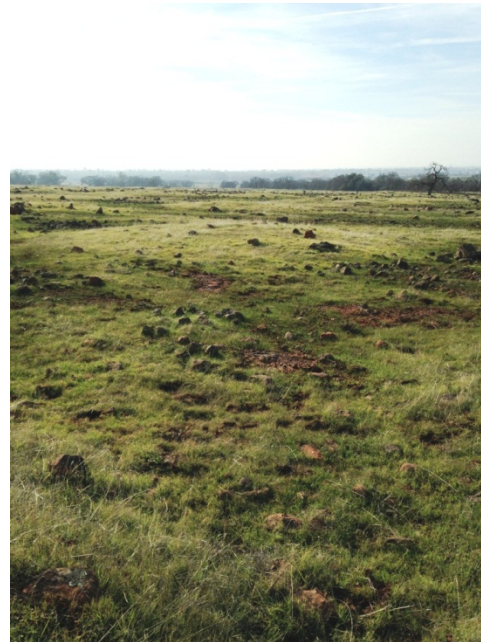
Photo 9: Soil Mounds on gently sloping lava cap terrain at Section 204
