CANYON VIEW ESTATES (TENTATIVE TRACT MAP 74650)
(APNS 2826-020-012, 2826-020-013 AND 2826-020-061)
Oak Tree Survey Report

Prepared for
Jemstreet Properties
1435 Reynolds Court
Thousand Oaks, California 91362
Contact: Mr. Rick Coop

September 2017

Greg Ainsworth
ISA Certified Arborist #WE-3437A
ISA Qualified Tree Risk Assessor

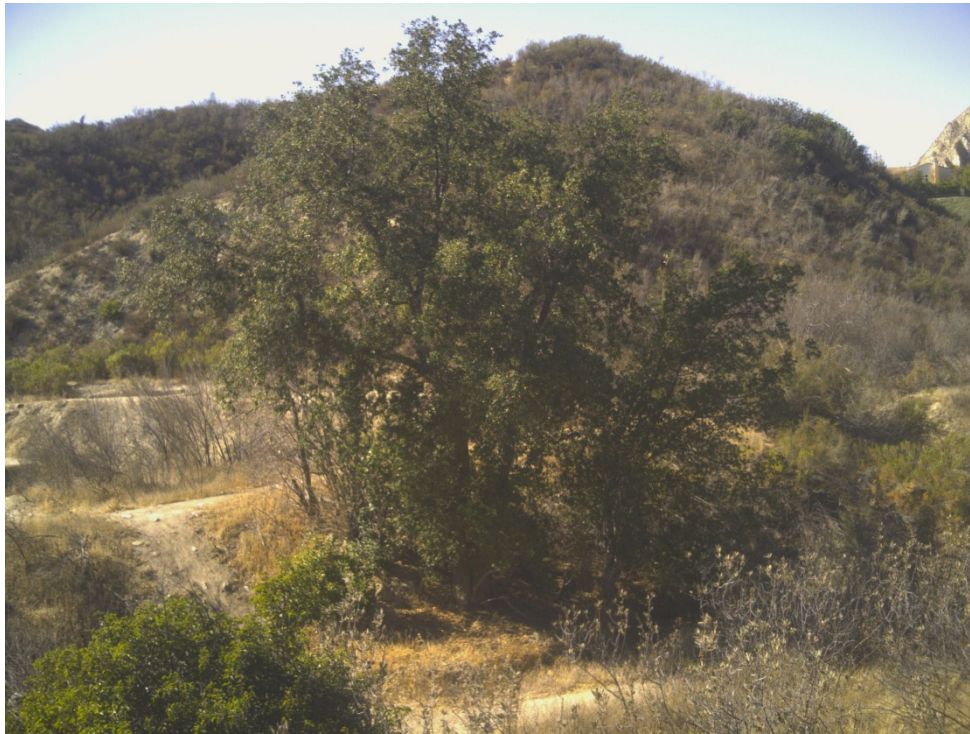
Tree #1	Tree #2	Tree #3	Tree #4	Tree #5
Species	Coast Live Oak	Coast Live Oak	Coast Live Oak	Coast Live Oak	Hybrid Scrub Oak
Project Impacts	Avoided	Avoided	Avoided	Avoided	Removed
Trunk Diameter (DBH)	13.8, 12.9, 8.0	8.3, 5.4	15.5	18.7, 13.5	6.1, 5.9
Height	35	20	25	40	18
Canopy Spread (N)	12	16	10	21	16
Distance to Ground (N)	1	3	6	3	9
Canopy Spread (NW)	12	15	12	18	9
Distance to Ground (NW)	2	1	3	3	9
Canopy Spread (W)	12	20	12	21	6
Distance to Ground (W)	1	1	2	1	8
Canopy Spread (SW)	20	4	12	21	5
Distance to Ground (SW)	1	2	1	1	8
Canopy Spread (S)	15	4	10	20	15
Distance to Ground (S)	6	2	1	1	5
Canopy Spread (SE)	16	8	2	18	16
Distance to Ground (SE)	3	6	4	1	2
Canopy Spread (E)	21	10	5	18	15
Distance to Ground (E)	4	3	3	1	5
Canopy Spread (NE)	19	16	12	22	13
Distance to Ground (NE)	2	1	5	1	3
Ailments	weak crotch, exfoliating bark, leaf chlorosis	leaf chlorosis, insect damage	fire scar, exfoliating bark, excessive leaf drop, leaf chlorosis, broken/dead limbs	excessive leaf drop, leaf chlorosis, broken/dead limbs	fruiting bodies, insect damage

Health	C	B	C	C	B
Vigor	B	B	D	C	B
Aesthetics	C	C	D	C	B
Balance	C	C	C	B	C

Comments	trunks separate low	heavy chlorosis, leaf drop throughout	horizontal boring insect hole rows
-----------------	------------------------	--	---------------------------------------

Photograph 1 (NW): Depicts Oak Tree #1 (right) and Oak Tree #2 (left) in the northeastern portion of APN 282-602-0012.

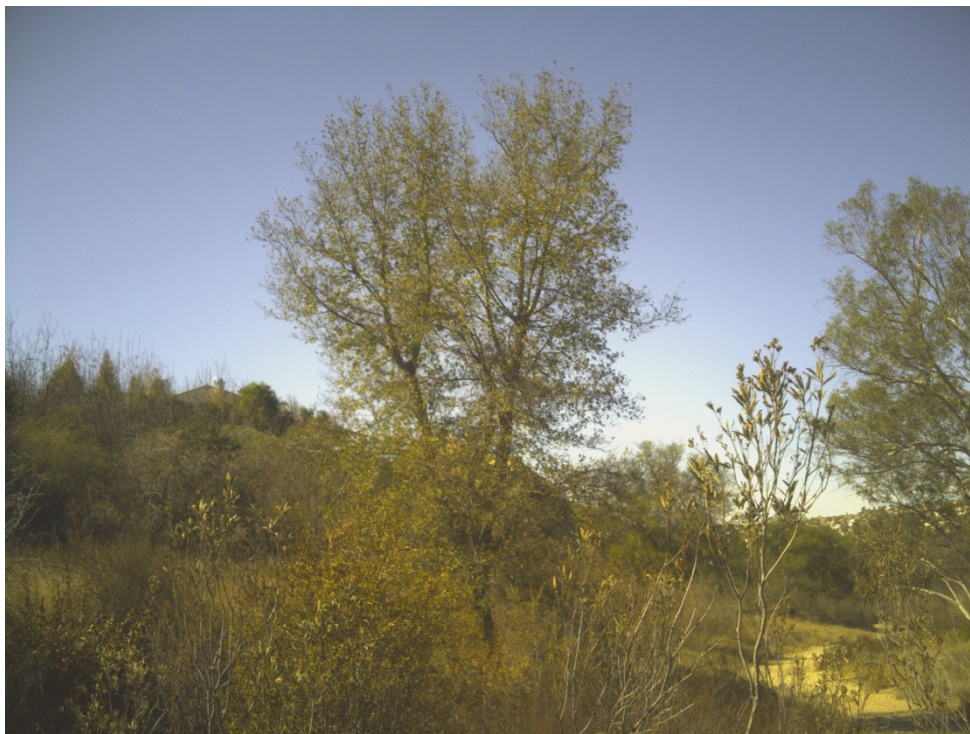
Photograph 2 (NW): Depicts Oak Tree #3 in the northern portion of APN 282-602-0012.

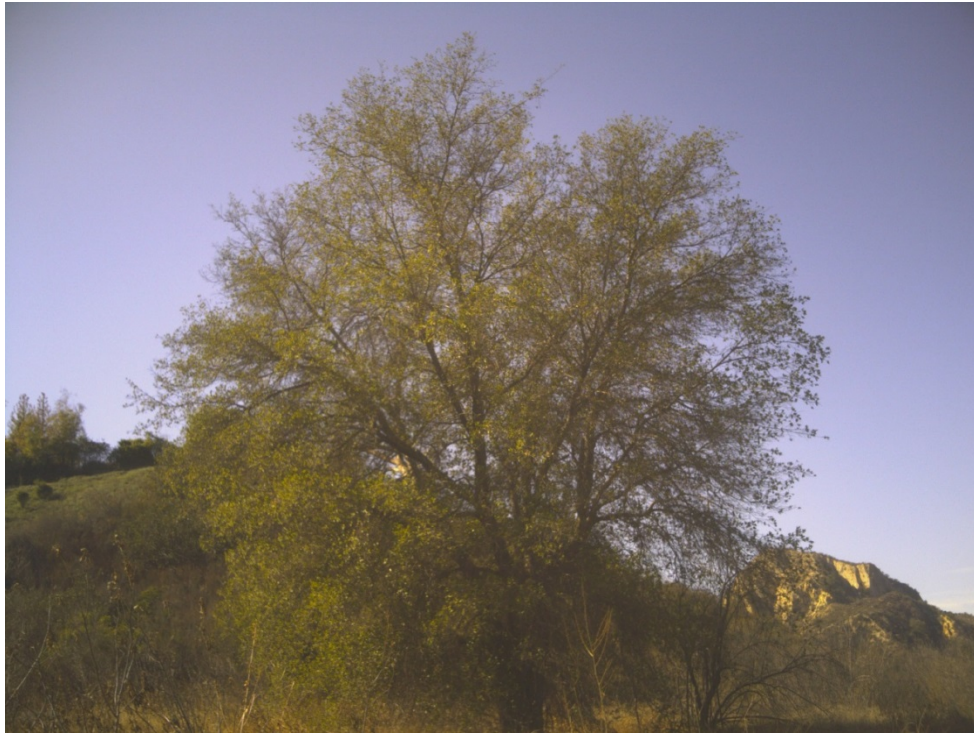
Photograph 3 (W): Depicts Oak Tree #4 in the northern boundary of APN 282-602-0012.

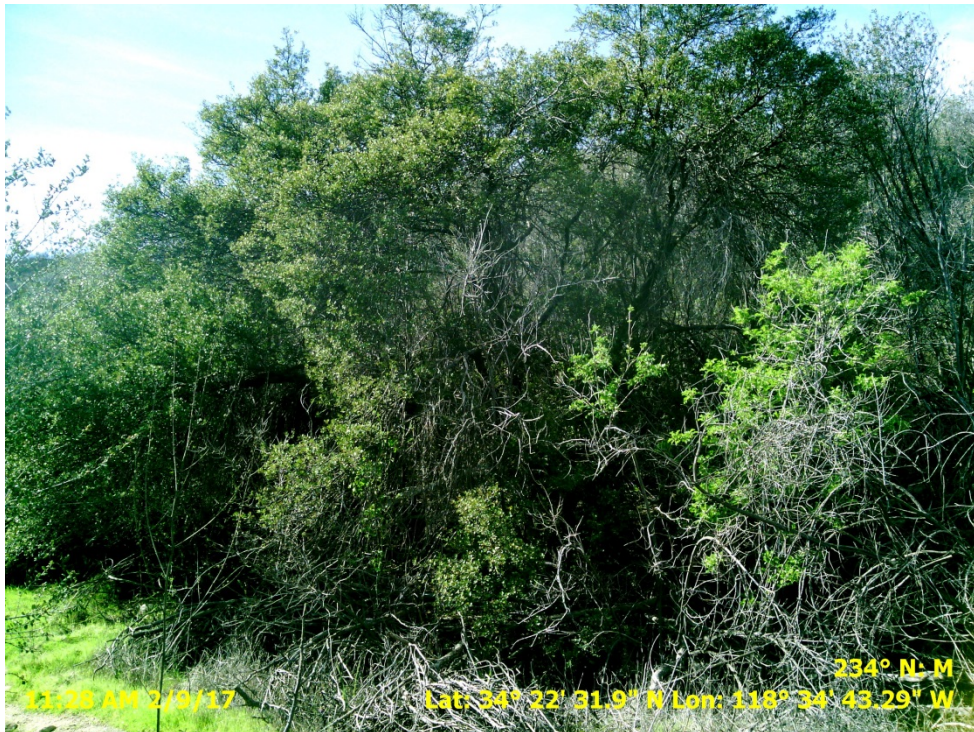
Photograph 4 (SW): Depicts Oak Tree #5 in the southern boundary of APN 282-602-0012.

Project construction activities will result in the removal of one hybrid scrub oak tree. The construction also has the potential to negatively affect all four of the coast live oak trees that would be preserved on the property. Project related activities that may negatively affect the root system of preserved trees includes excavation, trenching, soil compaction, change of grade and site drainage, pruning, mechanical damage from construction equipment, landscaping, and irrigation. The protection measures outlined below shall be implemented to ensure that all preserved trees within or adjacent to the property will be protected and preserved during construction activities, as well as in perpetuity following completion of construction activities.
