Appendix D2
Creek Enhancement Report

Google Downtown San Jose Los Gatos Creek Enhancement Project Site Assessment Summary Report

H. T. Harvey Proposal #10170
March 5, 2020

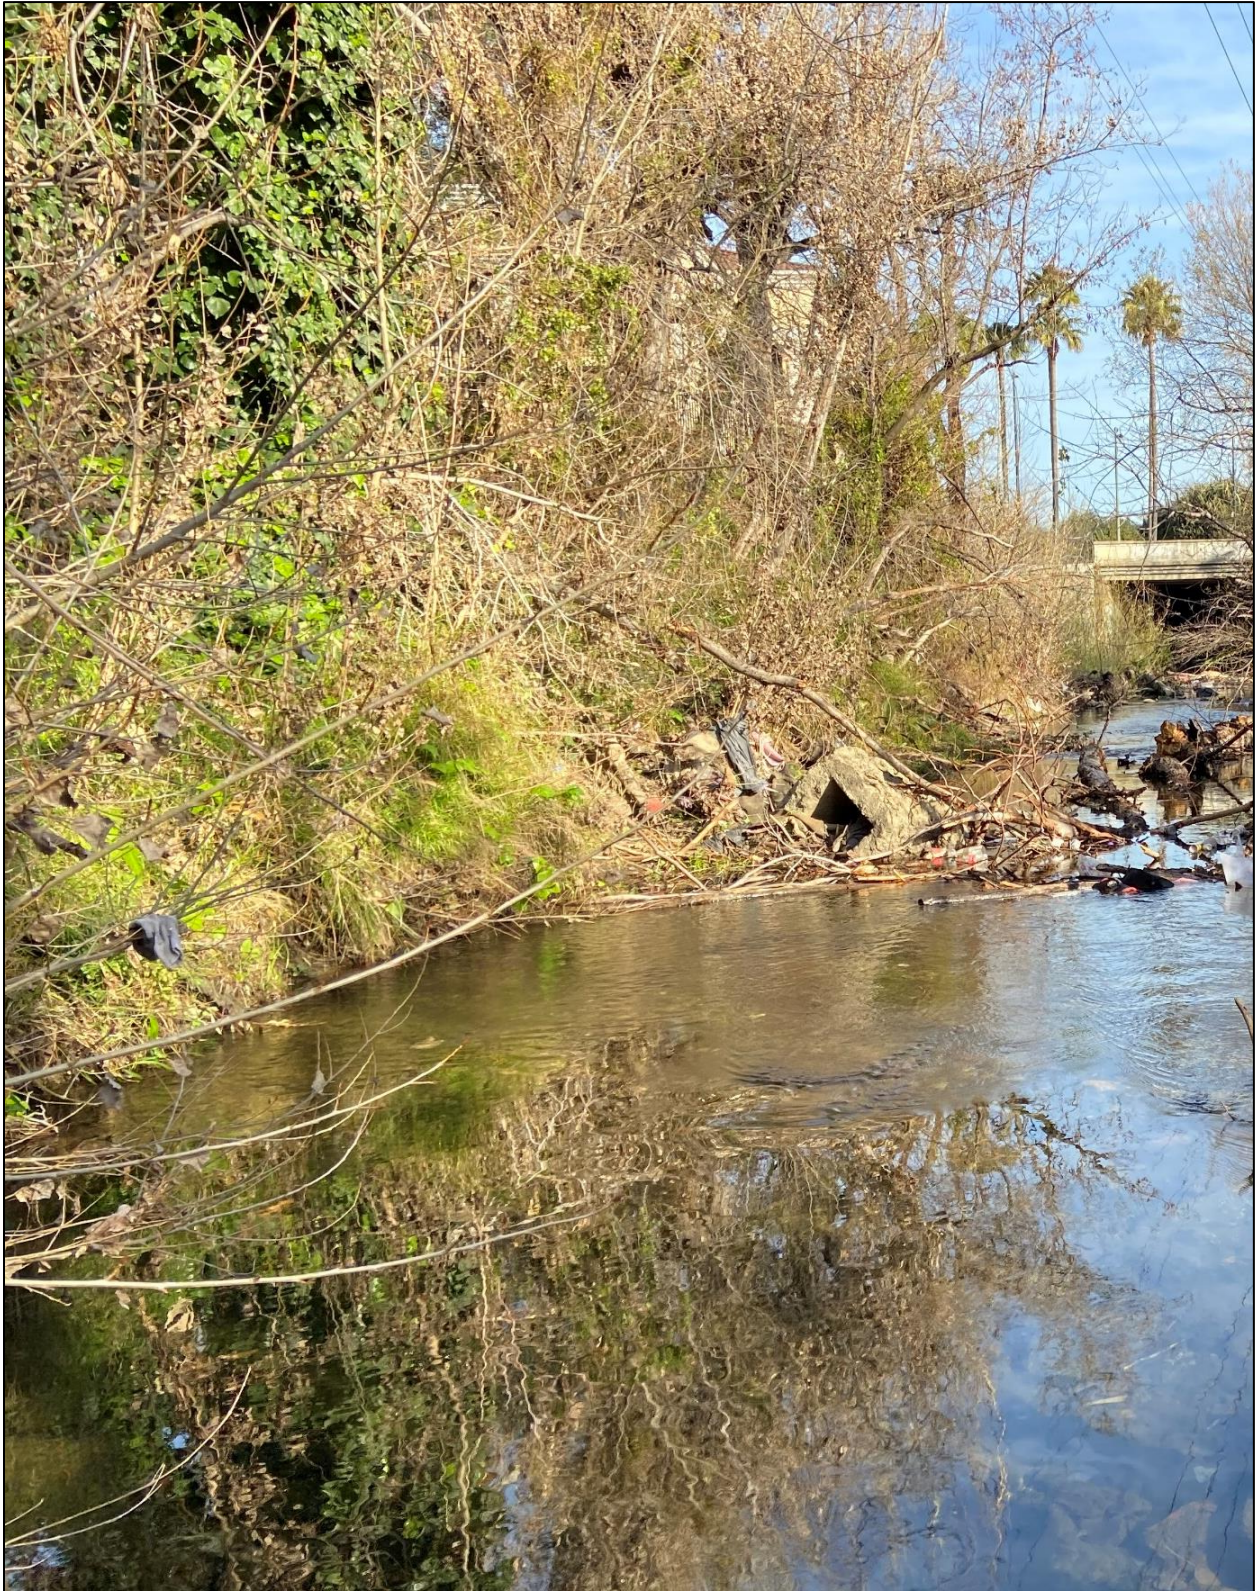
Photo 1. Standing Live Trees

A small number of nonnative and native trees may be removed (Table 1 and Figures 1-4). Live trees over 6 inches dbh should be mitigated at a minimum of 3:1 for native trees and 2:1 for nonnative trees, but no mitigation is proposed for invasive tree species. Live trees 2-6 inches dbh should be mitigated at a minimum of 1:1 for native trees and no mitigation for nonnative trees. In future design efforts it may be necessary to find locations for planting mitigation trees near the channel to mitigate loss of channel shading. Dead trees should be replaced by planting 1 native riparian tree for each dead tree removed. While dead trees can provide valuable habitat for birds, this reach of the creek has ample dead large branches on existing native trees to remain, so this resource is not considered particularly limited at this site, and a 1:1 replacement with a live tree is adequate mitigation. To the extent feasible all mitigation planting should occur within the project reach, on the channel banks at least 10 feet above the channel bed to avoid creating new flow impediments. Replanting areas within the reach include gaps in existing tree canopy, and areas with pervasive invasive plant species (giant reed, tree of heaven, etc.) that can be removed to provide a planting area.

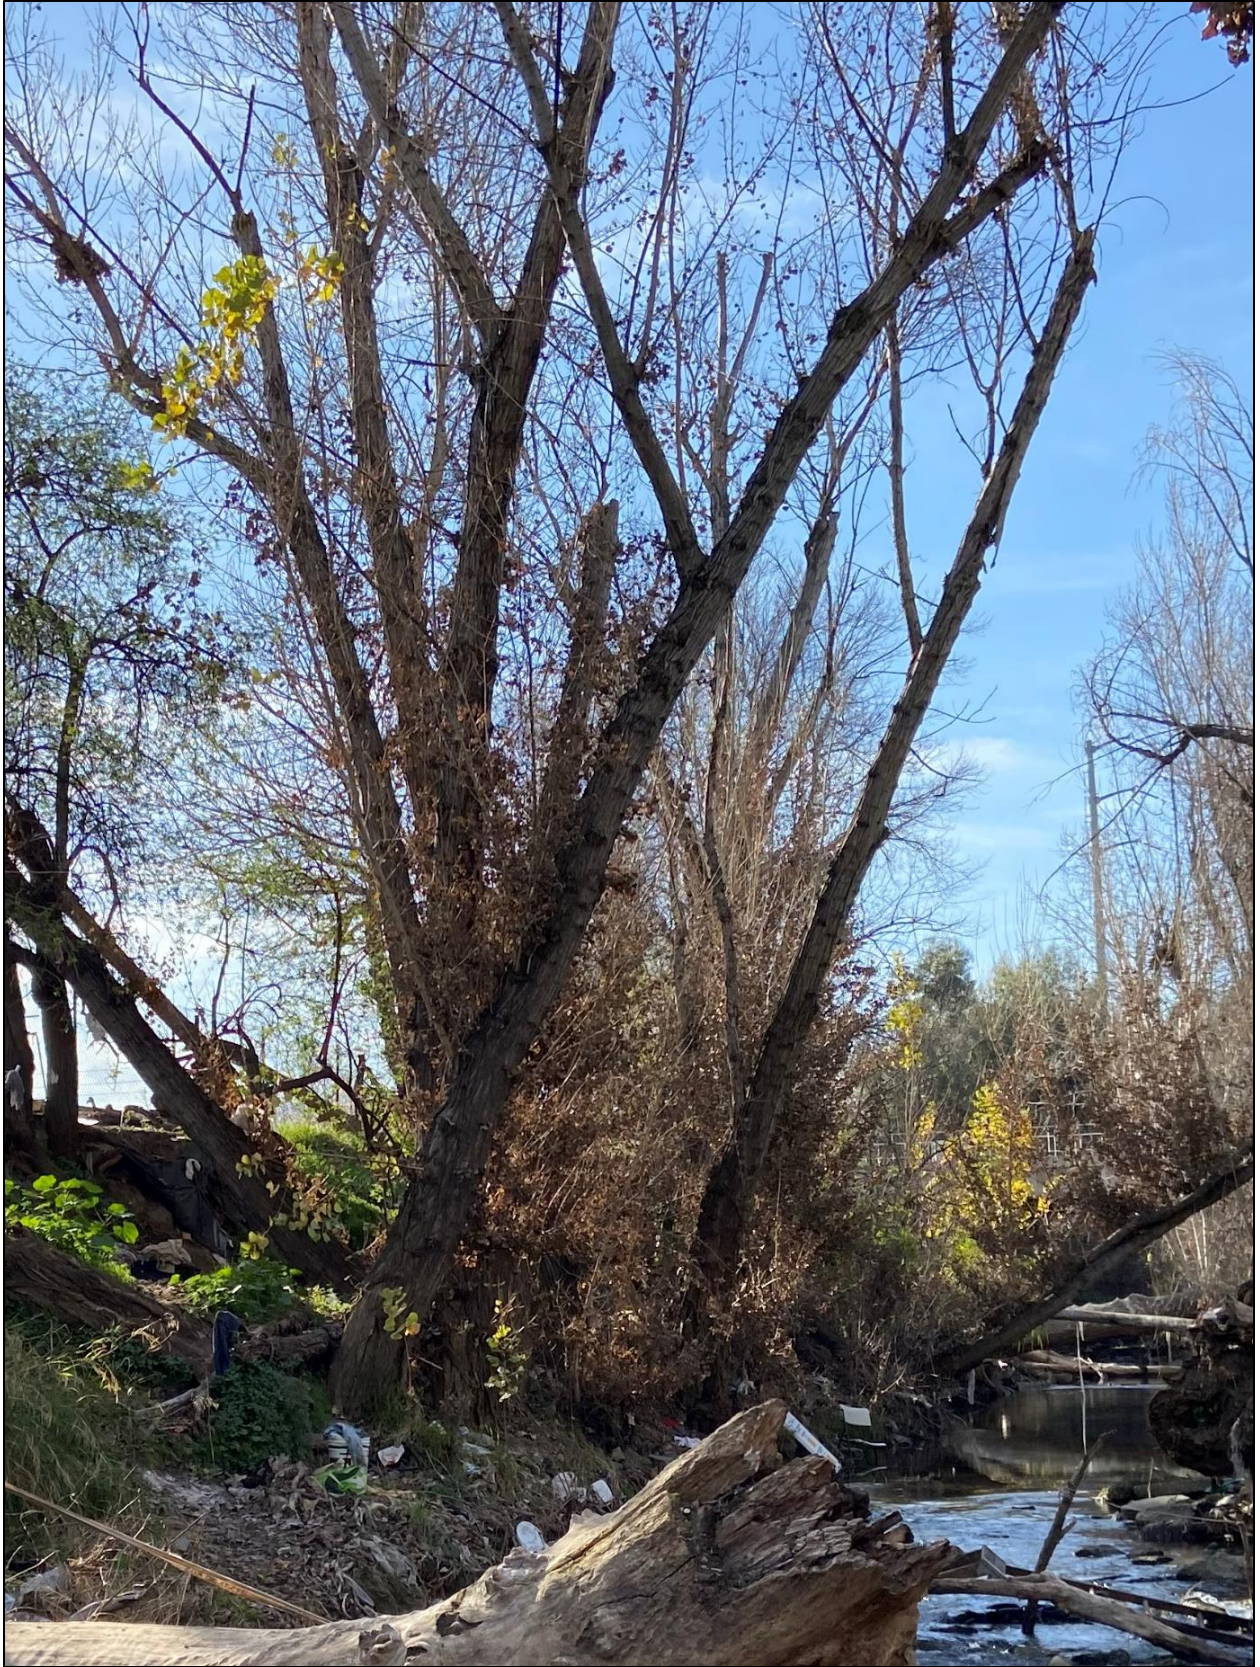
Photo 2. Standing Dead Trees

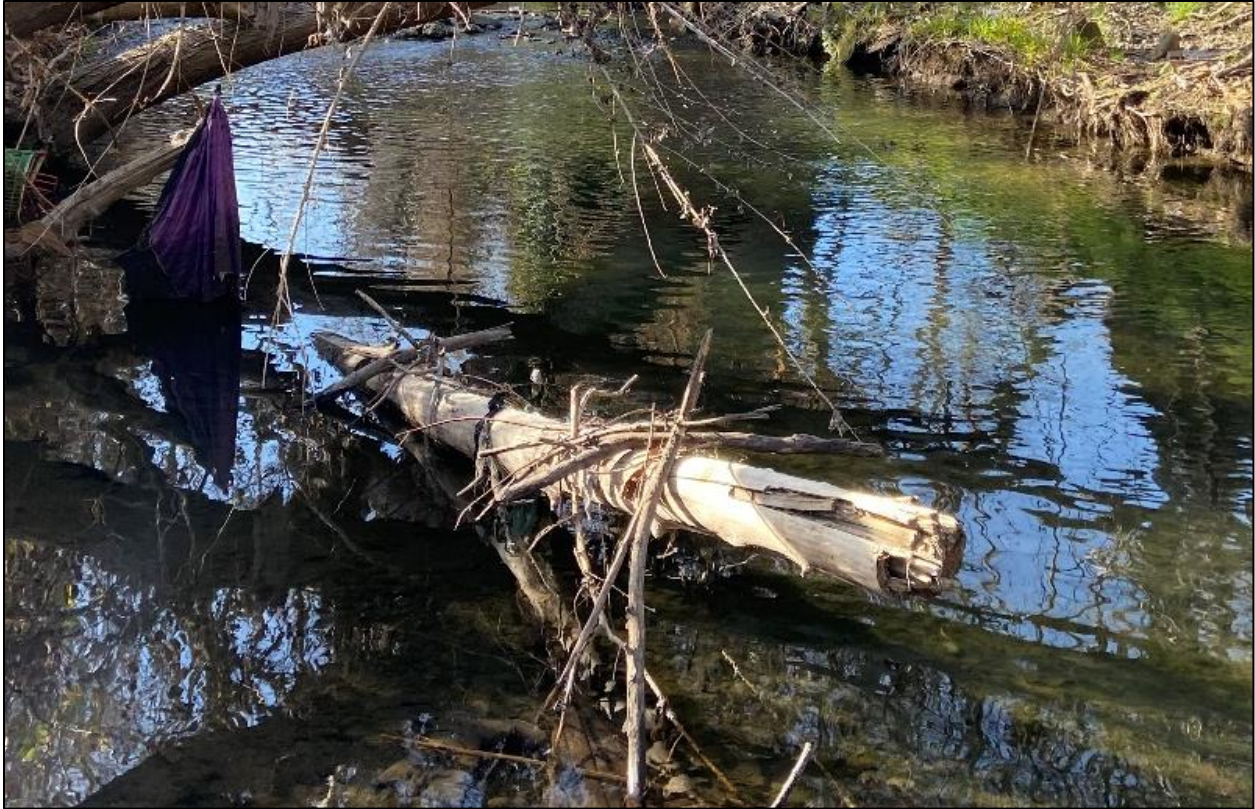
Photo 3. In Channel Single Log

Some of the log jams and single logs in the channel to be removed (Table 2) provide velocity refugia for steelhead moving through this reach during high flows and are thus valuable habitat features. The proposed mitigation approach for these removals is as follows:

1. Design and install engineered fish habitat enhancement log structures (EFHELs) at locations accessible by heavy equipment to create high quality in-channel habitat and velocity refuge
2. Maintain EFHELs over time to ensure that they do not increase flood risk but that they continue to provide high quality habitat.

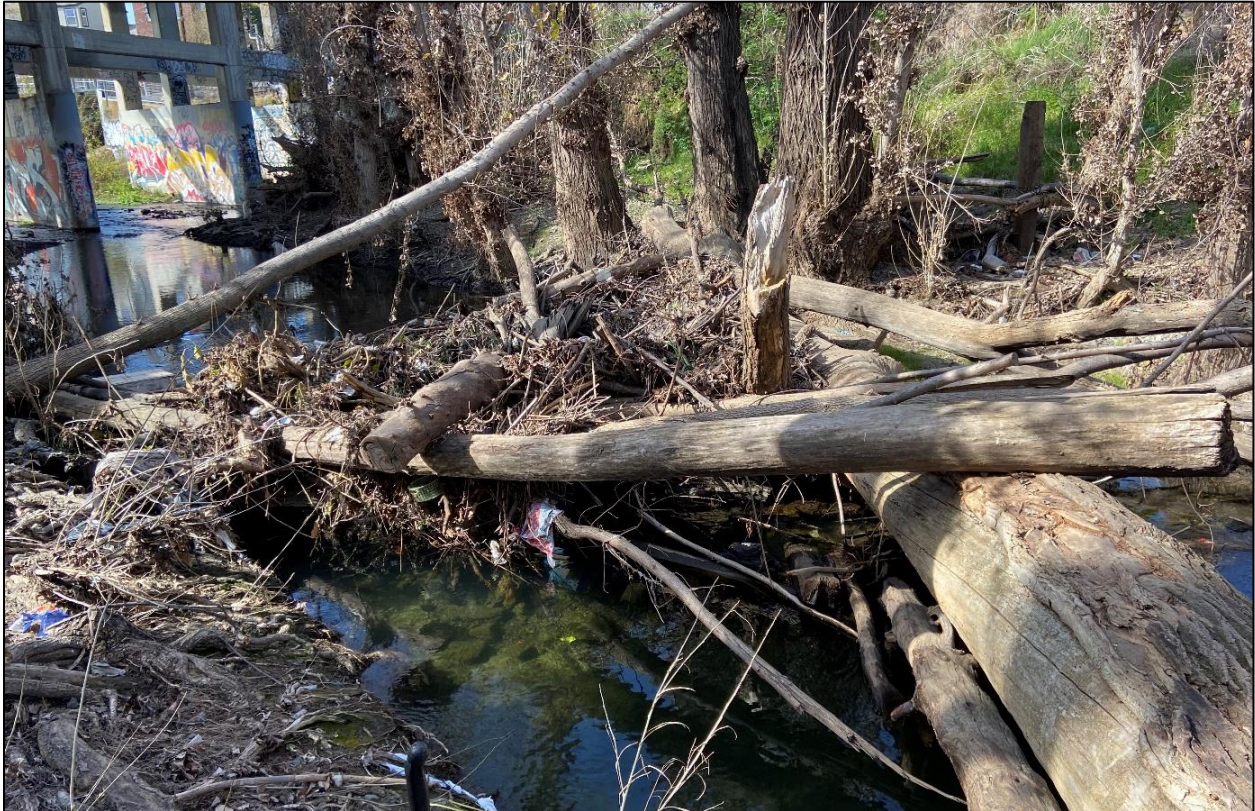
Photo 4. In Channel Log Jam

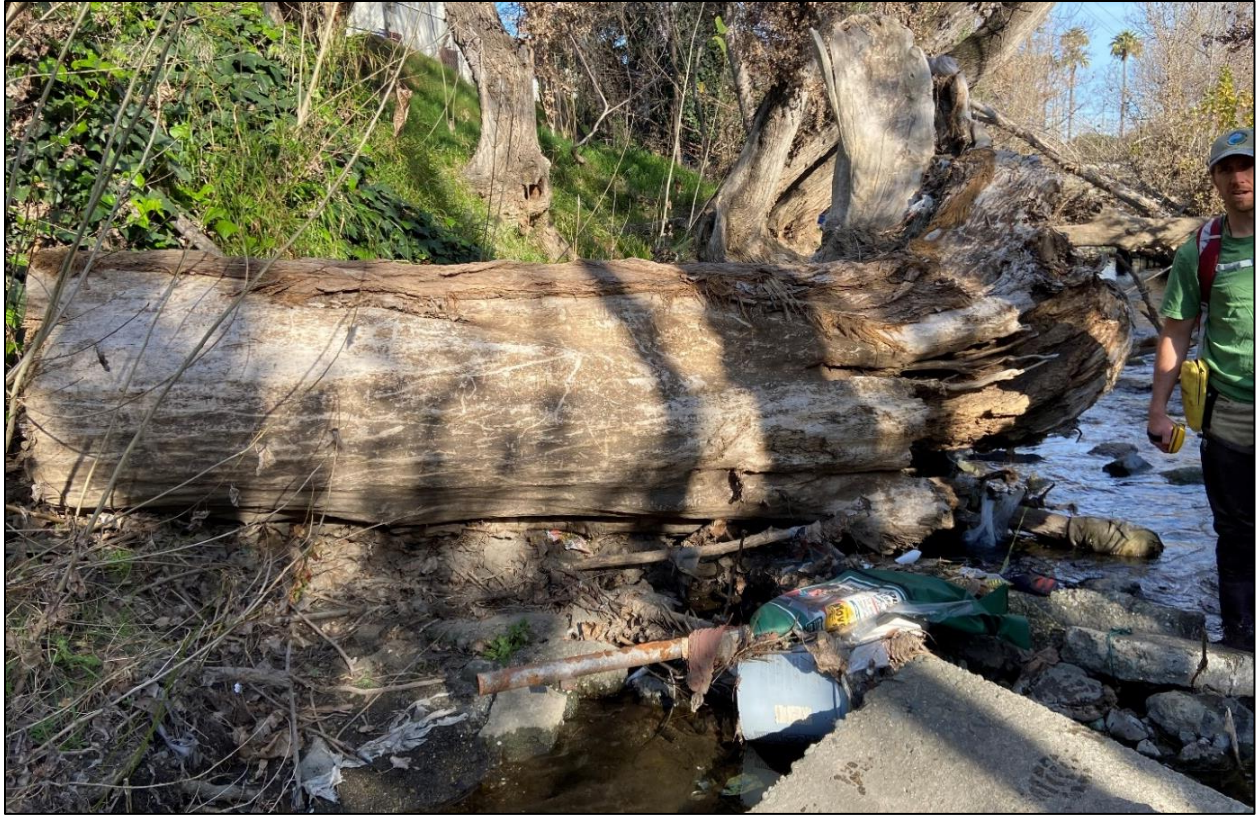
Photo 5. Bank Log

The project also proposes to removal logs situated on the banks of the creek, several feet above base flow. These bank logs do not provide habitat for steelhead, or other special status wildlife species, and minimal habitat value for other wildlife species. Therefore no mitigation is proposed for removal of these obstructions, furthermore downed smaller branches are prevalent in the site and so is a fairly abundant resource.

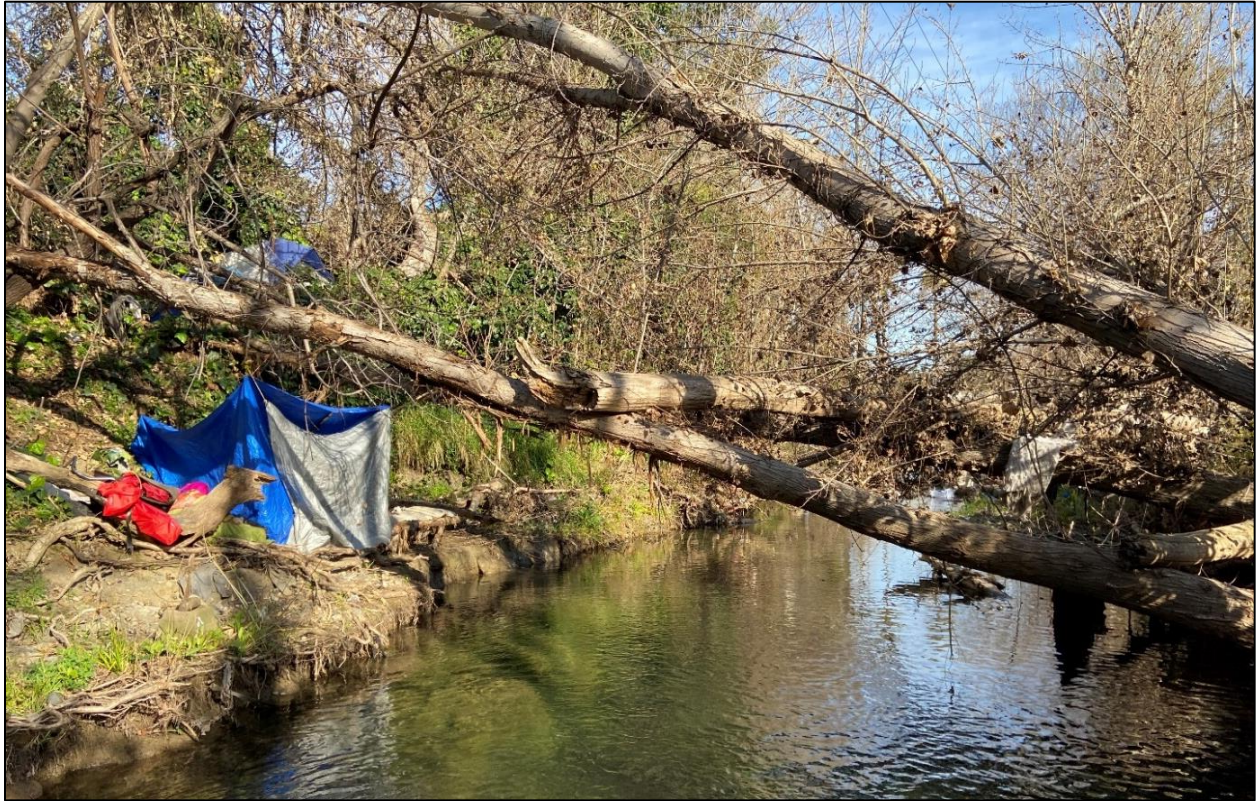
Photo 6. Aerial Log

The project proposes to remove “aerial” logs that have fallen across the channel but remain suspended, generally 4-20 feet above the base flow (Table 2). These aerial logs do not provide habitat for steelhead and minimal habitat value for other wildlife species. Therefore no mitigation is proposed for removal of these obstructions.
