**Blossom Hill Station  
Arborist Report**

**Project #4361-01**

February 19, 2020

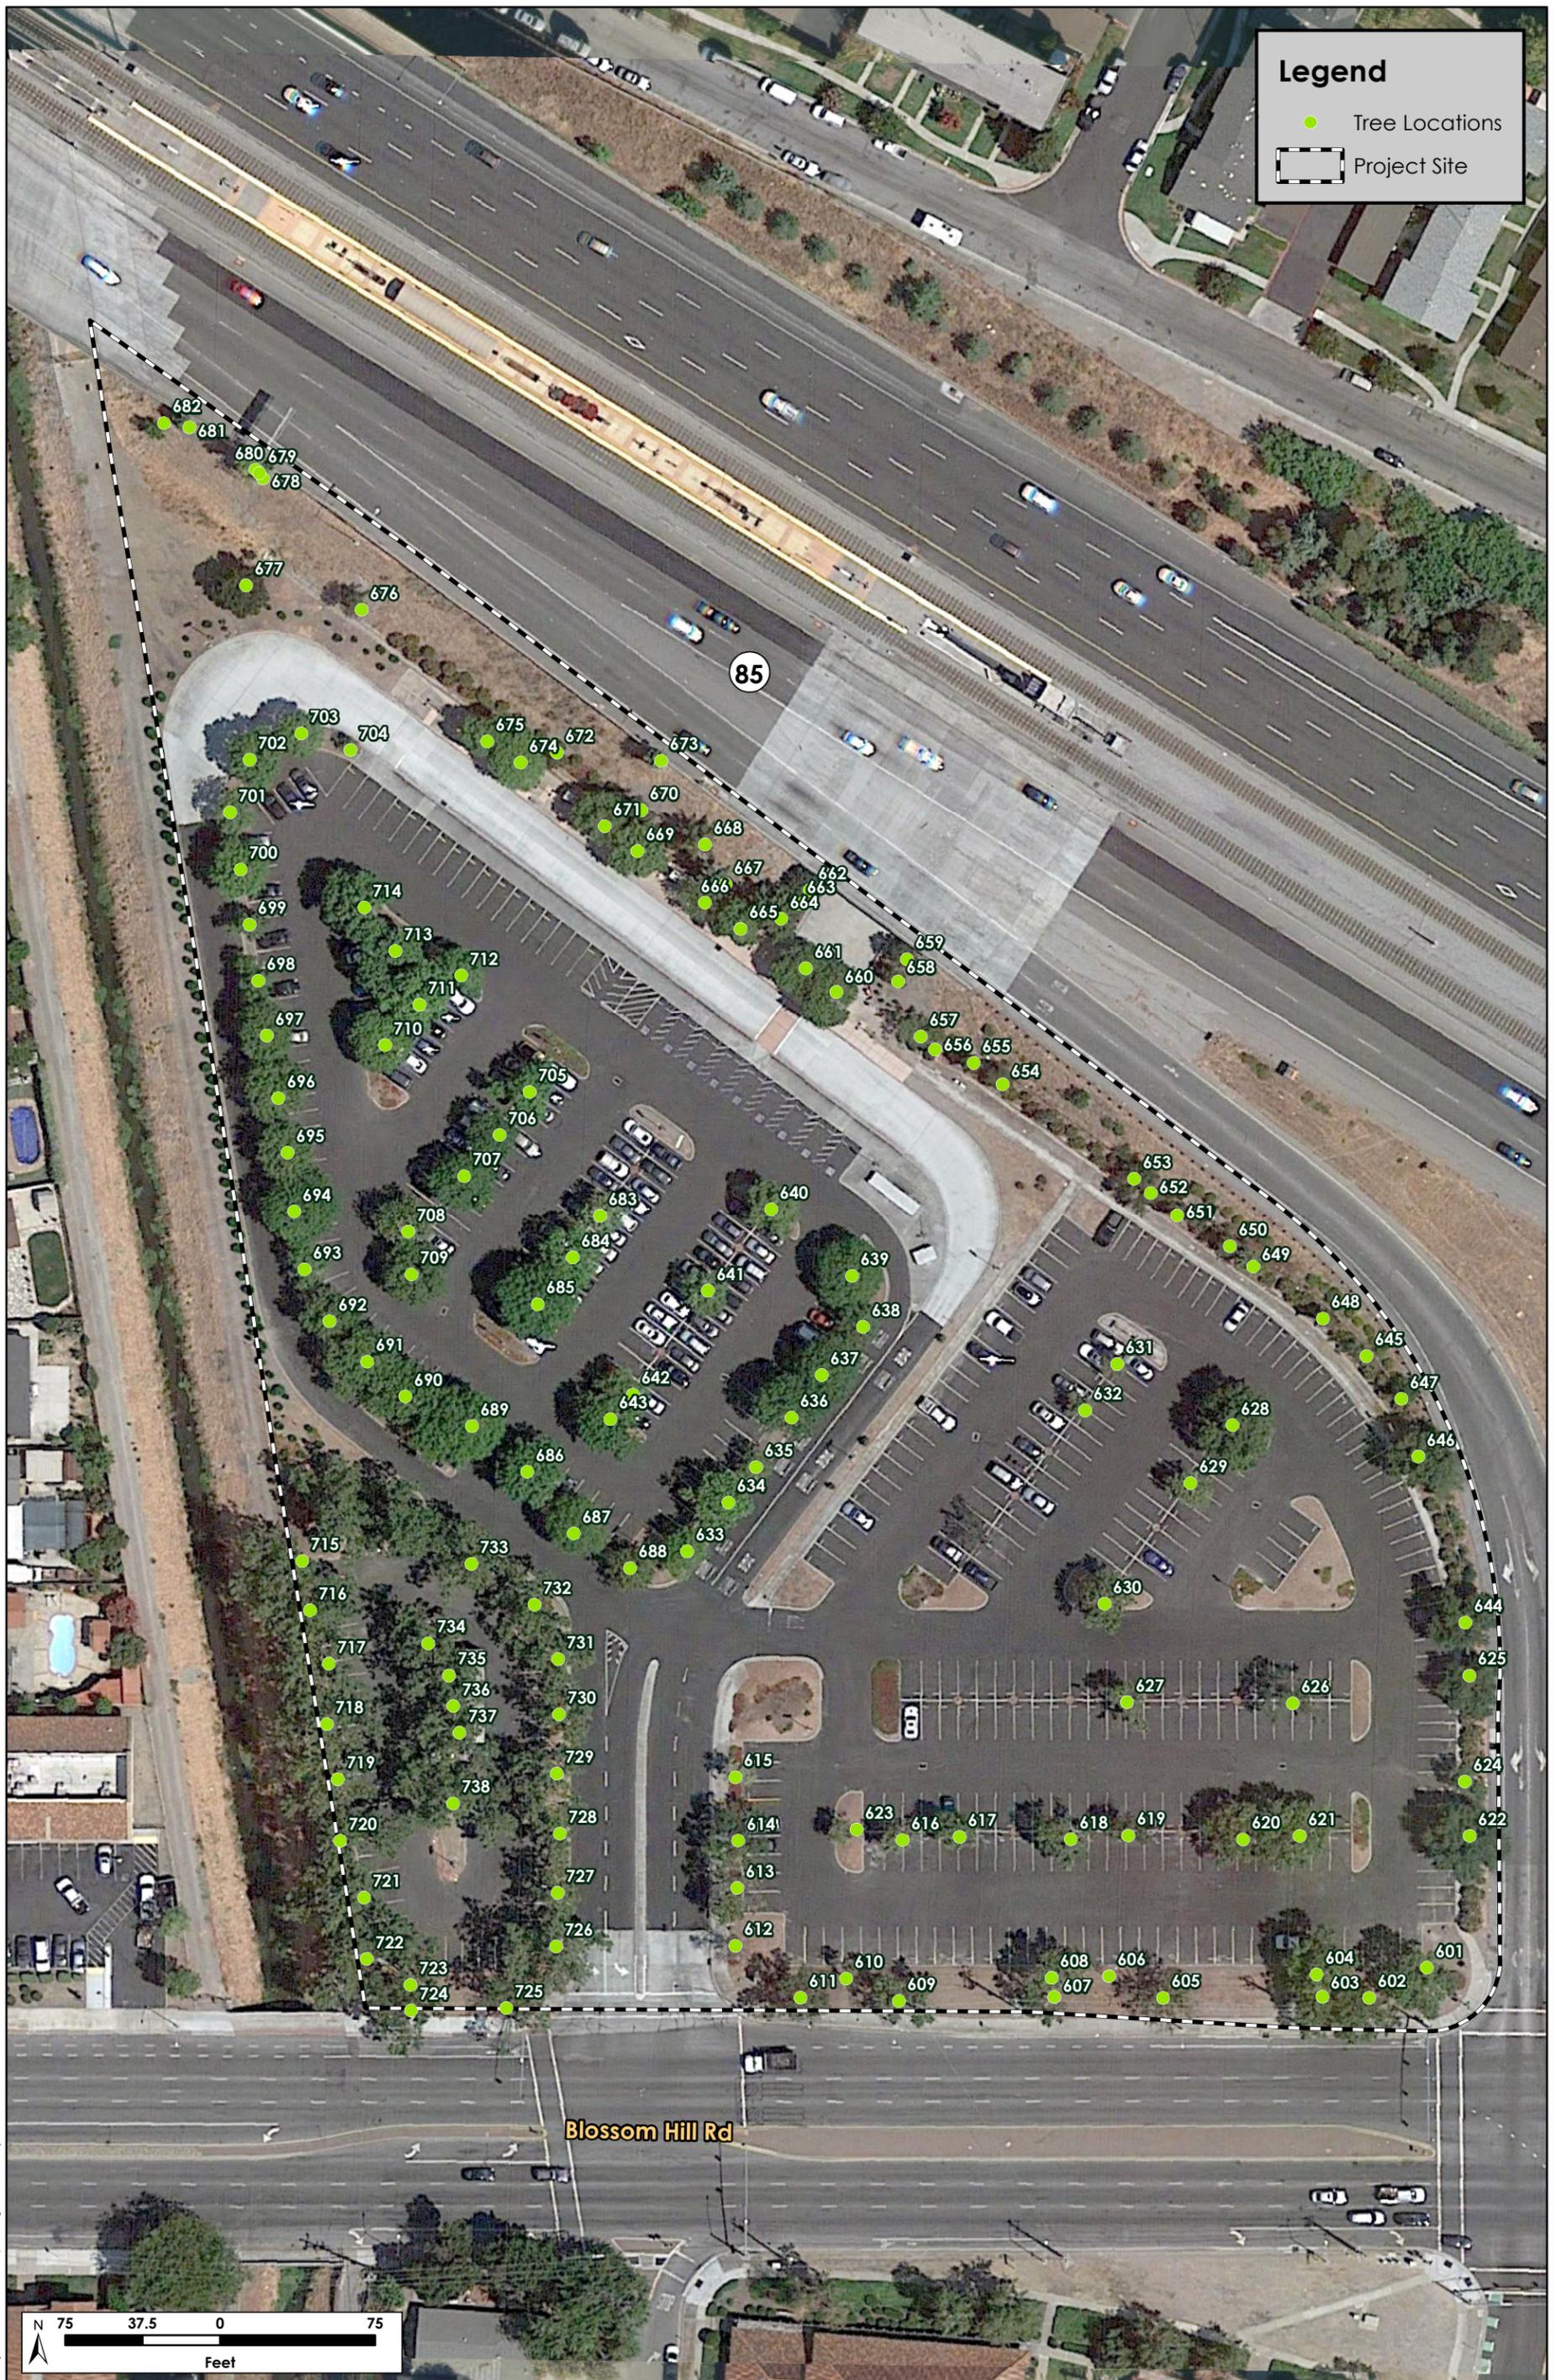
**Figure 2. Locations of Existing Trees**  
 Blossom Hill Station Arborist Report (4361-01)  
 February 2020

One-hundred thirty-eight (138) trees, representing eight species, were identified on the project site (Figure 2). Table 2 provides a summary of the 138 assessed trees. Descriptions of each tree including DBH, health rating, structural rating, tree condition rating, and ordinance-size status are included in Appendix C. Of the 138 trees that were surveyed, 85 (62%) met the City of San José’s criteria for ordinance-size (see Section 4.4 below). The most common species on the site was Chinese pistache (*Pistacia chinensis*) (39%).

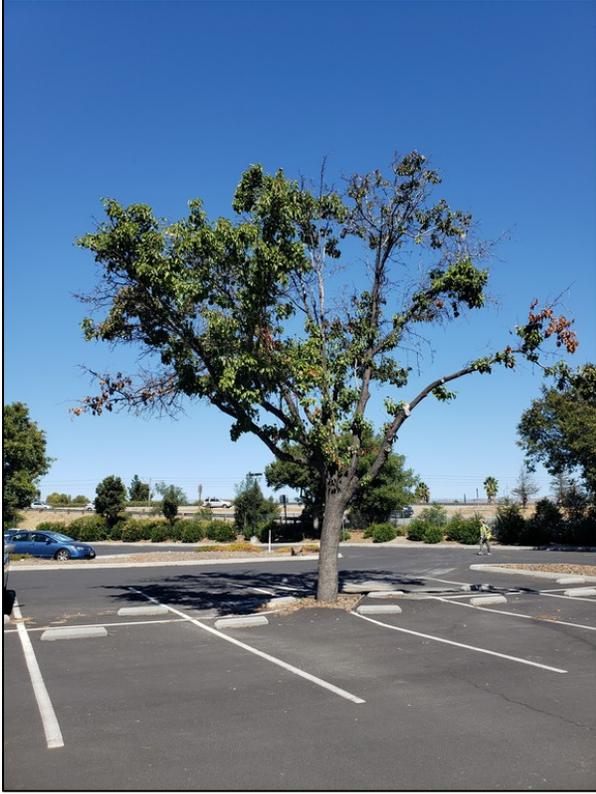
Photo 2. Tree #626, Evergreen pear (*Pyrus kawakamii*)

Eighty (80) trees (58%), including 30 of the 54 Chinese pistache trees, were in good condition, 45 trees (33%) were in fair condition, and 13 trees (9%) were in poor condition (Table 2). Health and vigor scores and condition ratings of each tree are presented in Appendix C. Most trees in poor and fair condition were evergreen pear (*Pyrus kawakamii*) and exhibited canopy dieback such as shown in Photo 2 in Appendix D.

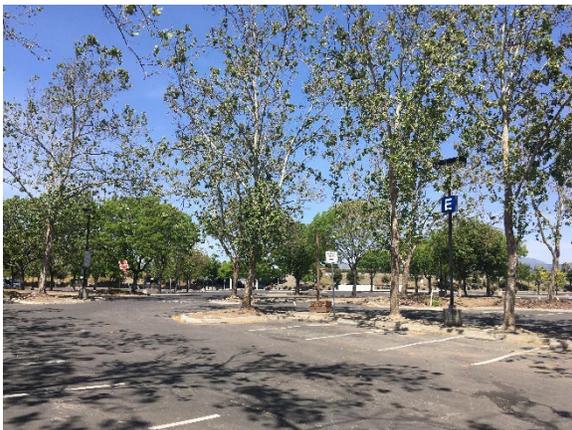
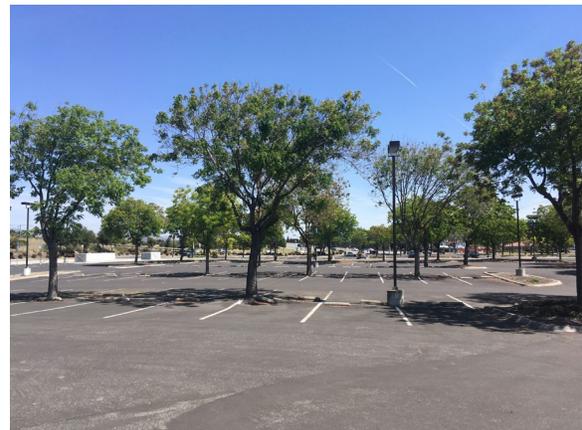
**General Wildlife Use.** Due to the scarcity of vegetation, the project site provides low-quality habitat for wildlife species (Photos 6 and 7). The wildlife most often associated with these areas are those that are tolerant of periodic human disturbances, including introduced species such as the nonnative European starling (*Sturnus vulgaris*), rock pigeon (*Columba livia*), house mouse (*Mus musculus*), and Norway rat (*Rattus norvegicus*). Several common, urban-adapted native species also use this habitat, including the American crow (*Corvus brachyrhynchos*), house finch (*Haemorhous mexicanus*), and raccoon (*Procyon lotor*). Few birds are likely to nest on the site due to the sparseness of vegetation, but common species such as the lesser goldfinch (*Spinus psaltria*), Anna's hummingbird (*Calypte anna*), and bushtit (*Psaltriparus minimus*) may nest in the trees present. Burrows of California ground squirrels (*Otospermophilus beecheyi*) are present along the western edge of the site within the project's impact area. Birds such as the black phoebe (*Sayornis nigricans*) and cliff swallow (*Petrochelidon pyrrhonota*) are expected to nest on the Blossom Hill Road and SR 85 bridges over Canoas Creek immediately adjacent to the site; however, no large colonies of swallows were observed on these bridges during the May 2020 survey.

**Photo 6. The parking areas on the project site are planted with trees that provide limited habitat for wildlife.**

**Photo 7. The parking areas on the project site are planted with trees that provide limited habitat for wildlife.**
