Arborist Letter Report

January 10, 2020

**Subject: Tree Survey for the 1998 Whipple Road New Gas Station and Convenience Store Project, Union City, CA**

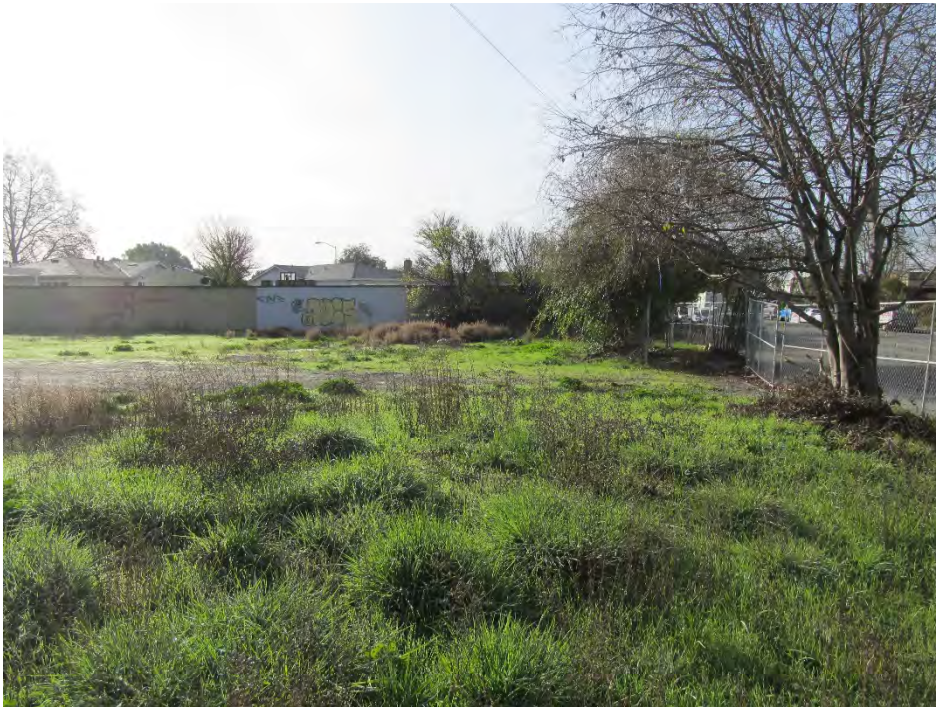
<sup>2</sup>Many co-dominant leaders; crossing limbs; growing into power lines.

All five (5) trees in the site have uncorrectable structural issues. Tree 494 is a Chinese hackberry with six (6) codominant trunks, several of which are crossing and growing into each other; in addition, the tree is growing into overhead power lines. Tree 495 is a Siberian elm with a single main trunk that was topped at approximately 15 feet (likely in order to provide clearance from overhead power lines), which has resulted in formation of two (2) codominant leaders with a poor attachment; subsequently, the tree has

**Photo 1:** Chinese hackberry tree with numerous crossing trunks (Tree #494).  
Photo dated 12/20/2019.

grown into the overhead power lines. Trees 496, 497, and 498 are evergreen pears that have developed a dense, shrubby architecture with numerous stems ranging from 18 inches circumference down to a few inches. Most of the larger stems exhibit sharp bends or nearly horizontal growth, and many stems are crossing and/or fusing into other stems. In addition, all these trees show signs of declining health such as splitting bark and curled, stunted leaves in the upper canopy. Given the poor structure and/or health of the trees, all five (5) trees should be removed.

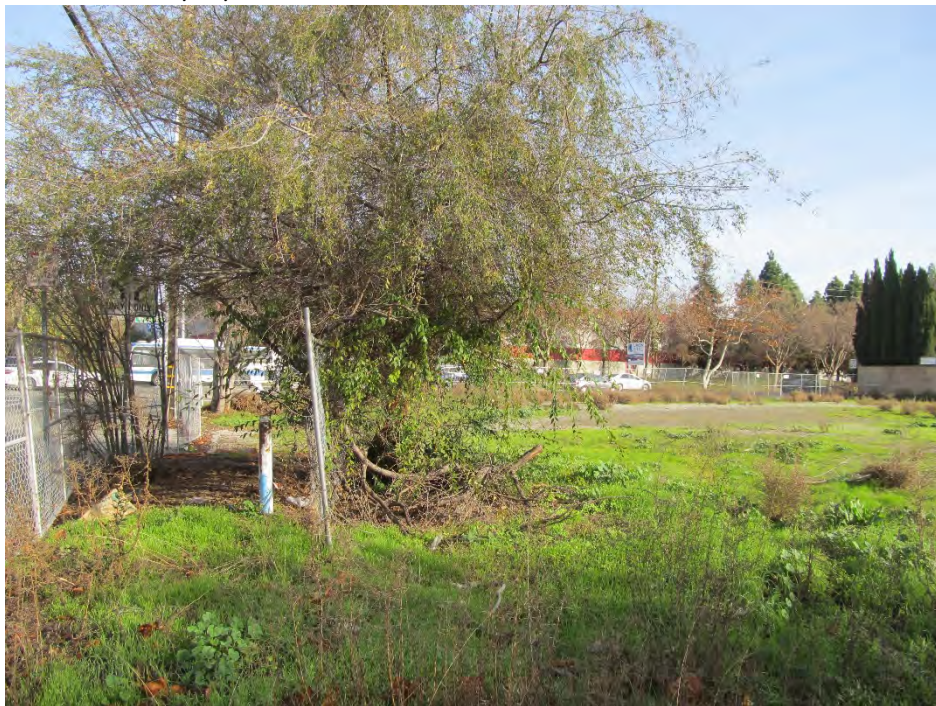
<sup>3</sup>Topped; growing into power lines.

**Photo 2:** Siberian elm tree with a topped main trunk (Tree #495). Photo dated  
12/20/2019.

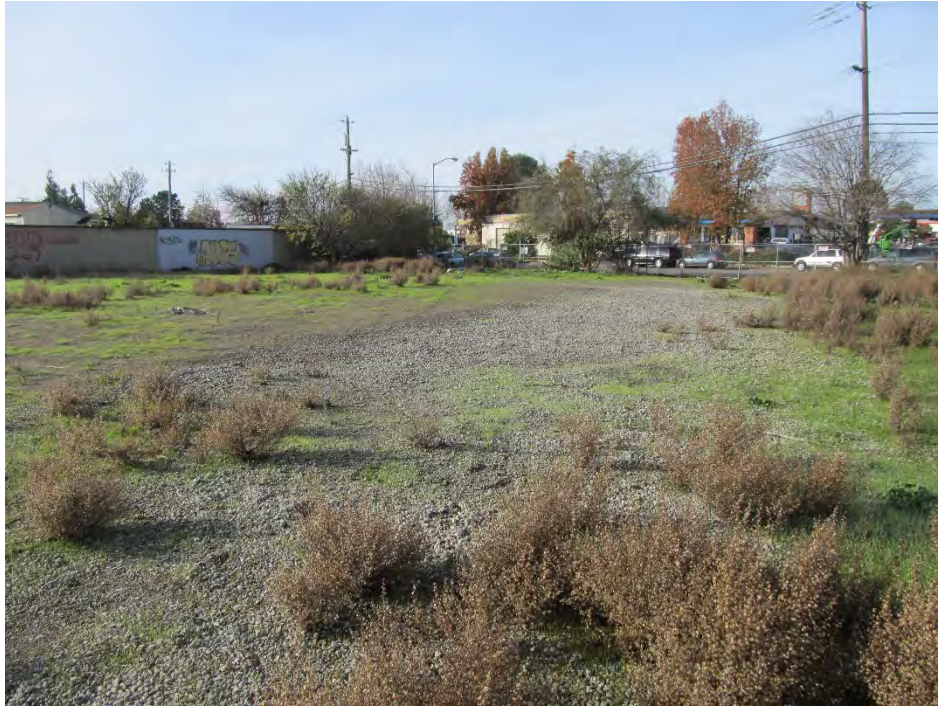
**Photo 3:** View of the site from the northeast corner, showing all the trees in the site. Photo dated 12/20/2019.
