Appendix F

Hazardous Materials Assessment

MEMORANDUM

Subject: Hazardous Materials Assessment for Paseo Montril Project

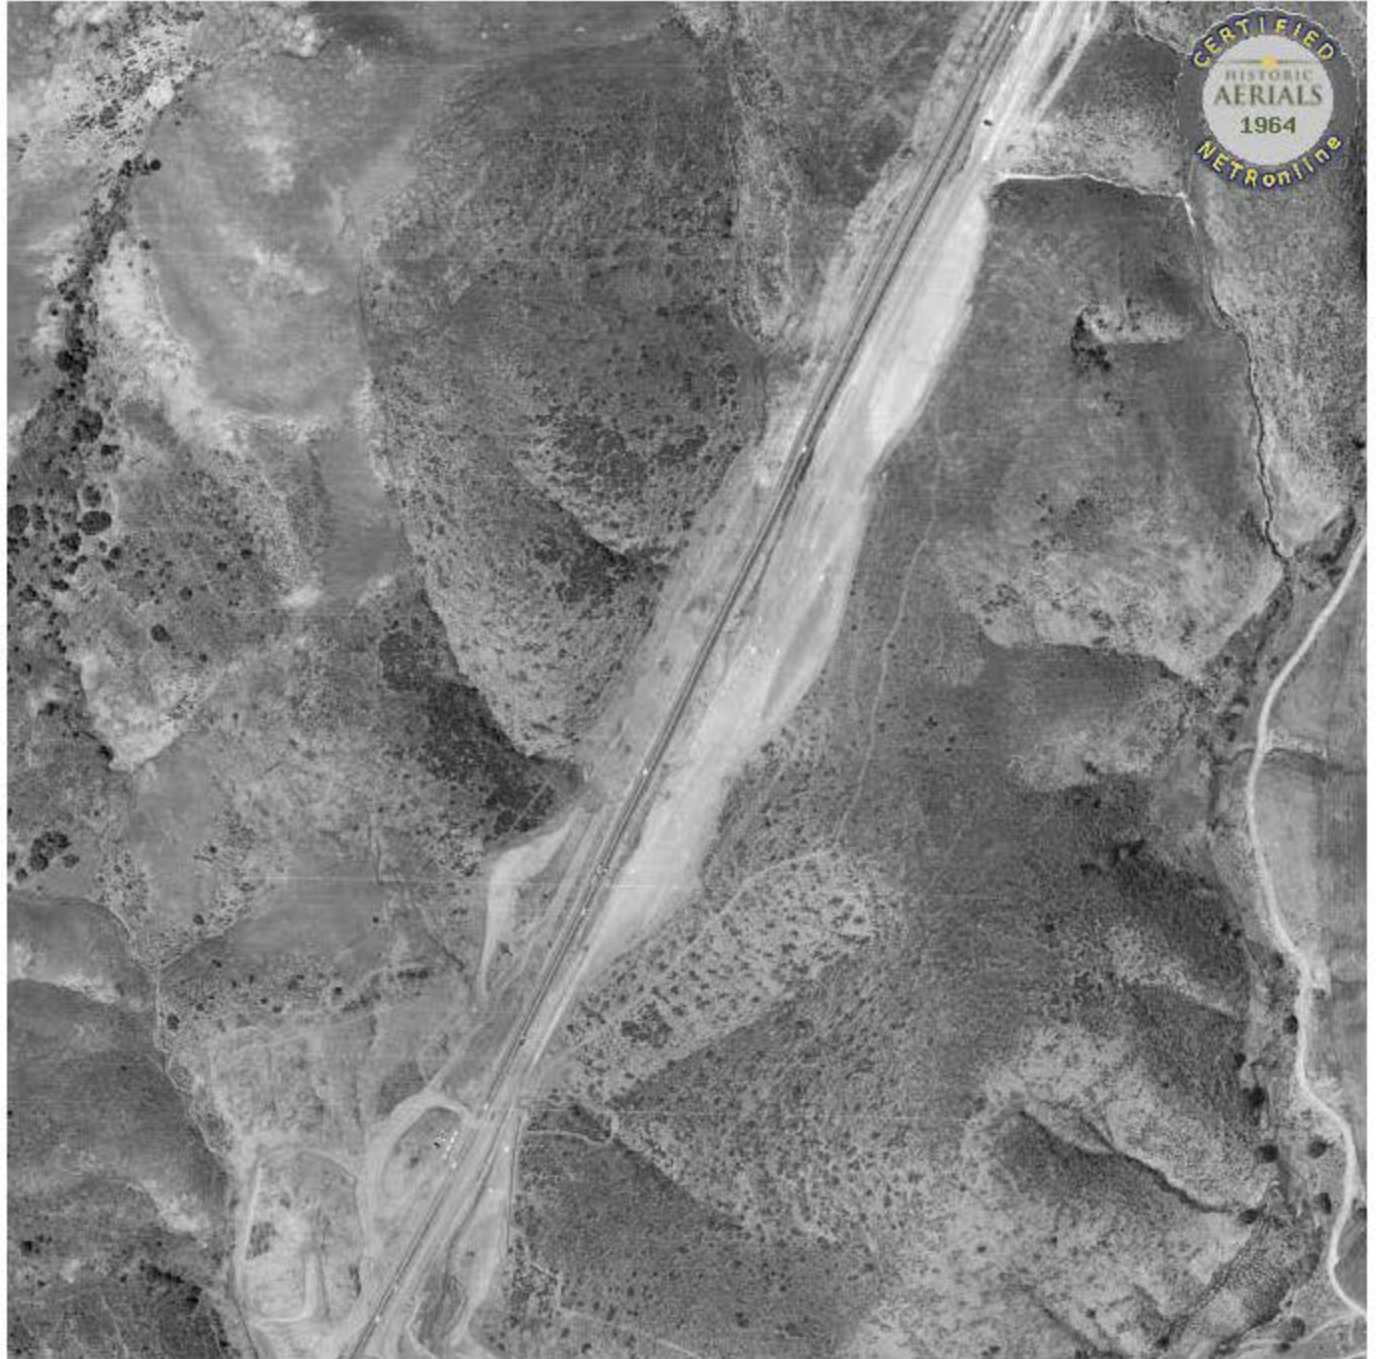
CERTIFIED
HISTORIC
AERIALS
1964
NETRonline

| Date | Observations |
|---|---|
| 1964 | The project site appears vacant and undeveloped. The area to the south of the project site and areas adjacent to the present day Interstate I-15 appears under developments. Adjacent and surrounding properties to the west and north appears vacant and undeveloped. |

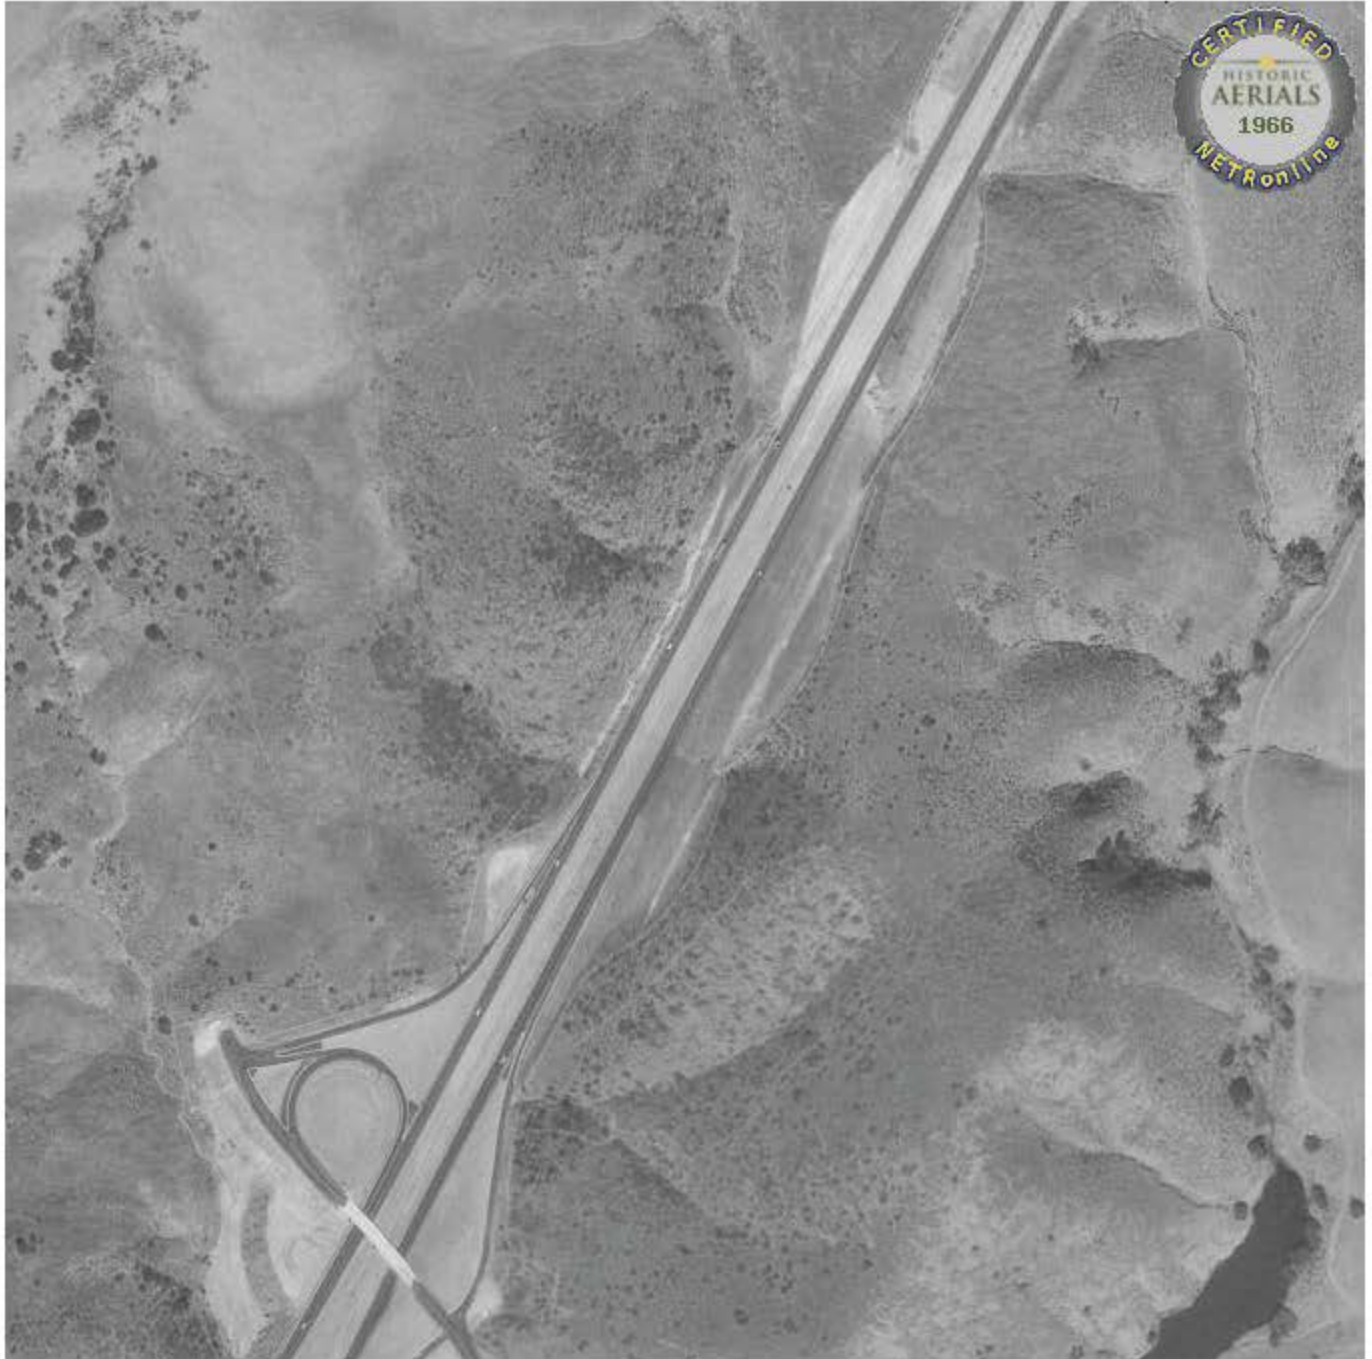
CERTIFIED
HISTORIC
AERIALS
1966
NETRonline

| Date | Observations |
|---|---|
| 1966 and 1967 | No apparent changes are observed on the project site compared to 1964 aerial photograph. The Interstate I-15 appears to be developed as two-way primary highway. A new ramp for the I-15 is now present to the south of the project site. |
