Conejo Community Park and Center Project

Arborist Report

August 2020

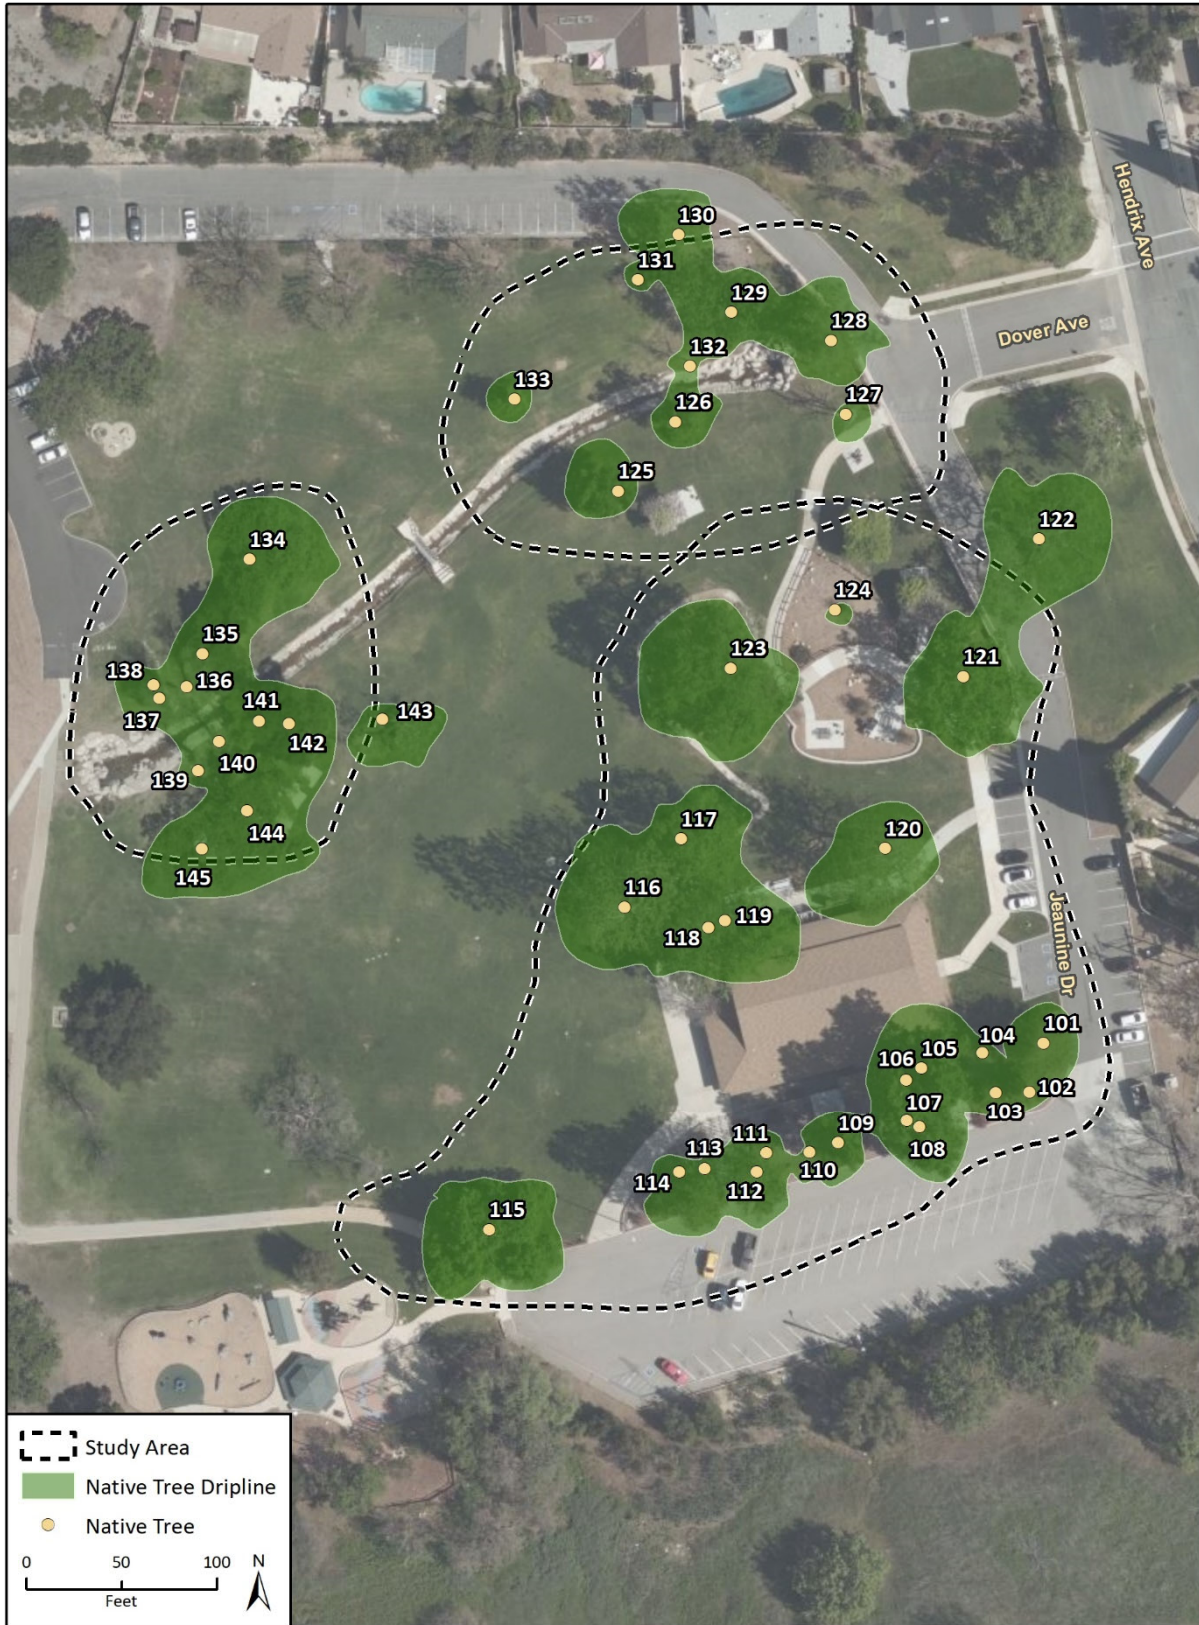
Figure 1 Study Area and Native Trees

A total of 45 trees native to California with at least a portion of their TPZs overlapping the study area were surveyed, as shown in Figure 1.

Tree #115 (valley oak) is growing approximately six feet below grade in a concrete vault, which was likely constructed to protect the tree from a past drastic grade change. This valley oak appears to be healthy and is in Good overall condition.

The sycamore trees within the Study Area all display light anthracnose infections that do not appear to be causing decline of the trees.

One white alder tree (Tree 138) is in Poor overall condition and displays top dieback and dieback through the canopy.
