Technical Memorandum

January 11, 2021

To:	Mr. Joe Cassidy	Ref. No.:	11204665(0201)
From:	Joslyn Curtis, Botanist	Tel:	916 865-5302
	Elizabeth Meisman, Wildlife Biologist	Tel:	707-267-2217
cc:	Genevieve Rozhon, Wildlife Biologist	Tel:	707-267-2298
	Ken Mierzwa, Senior Biologist	Tel:	707-443-8326
	Peter Galloway; Senior Transportation Planner	Tel:	925-262-1903
Subject:	Bally Keal Vineyards – Biological Reconnaissance Site Visit to Support County Land Use Permit

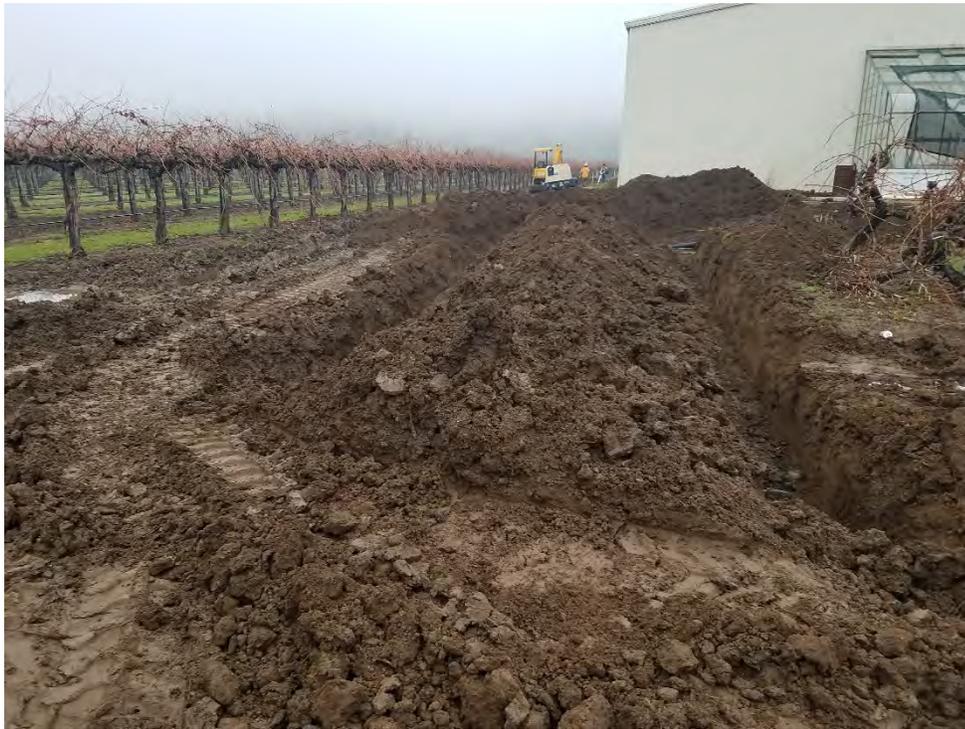
Photo 1 - View facing east, from southeastern corner of Project site, on west side of distillery.

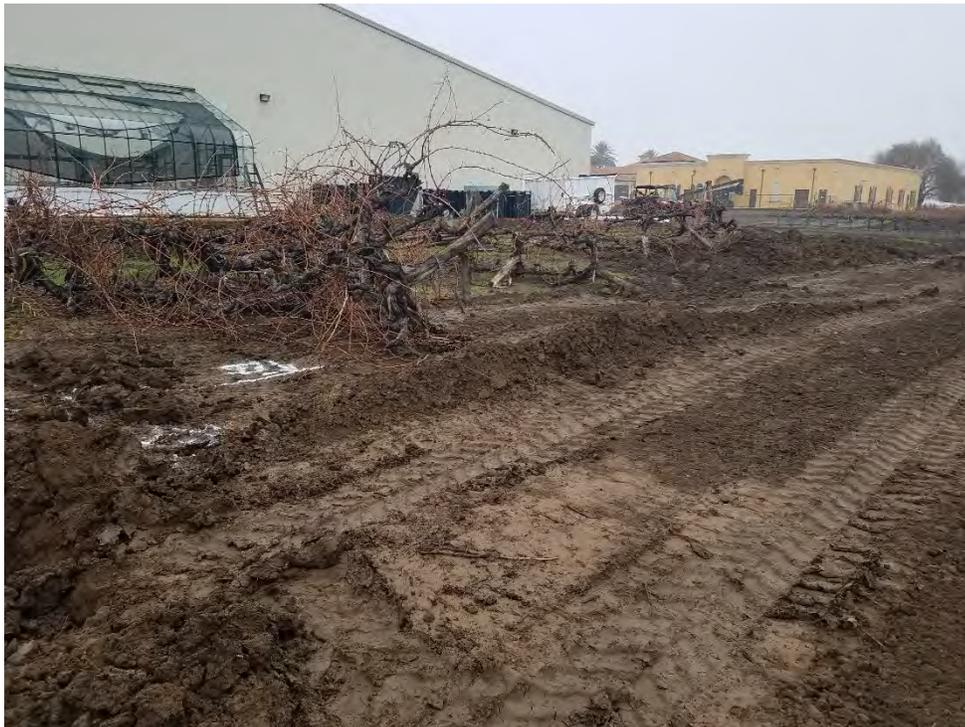
Photo 2 - View facing north, from southeastern corner of Project site, on west side of distillery.

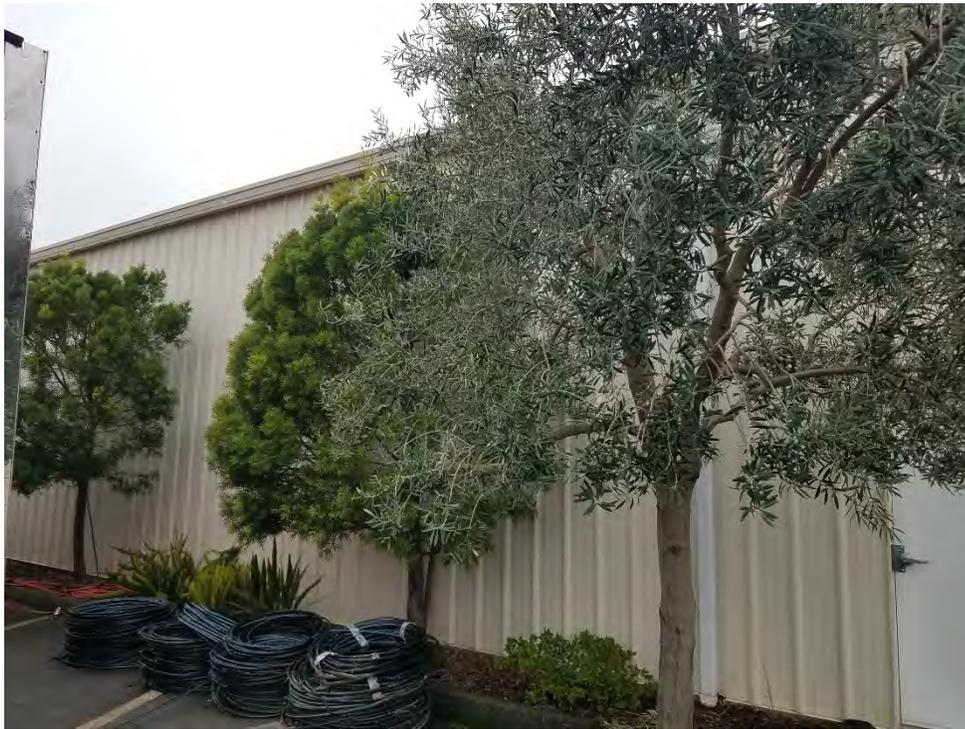
Photo 3 - View facing southeast, looking at several trees along north wall of distillery.

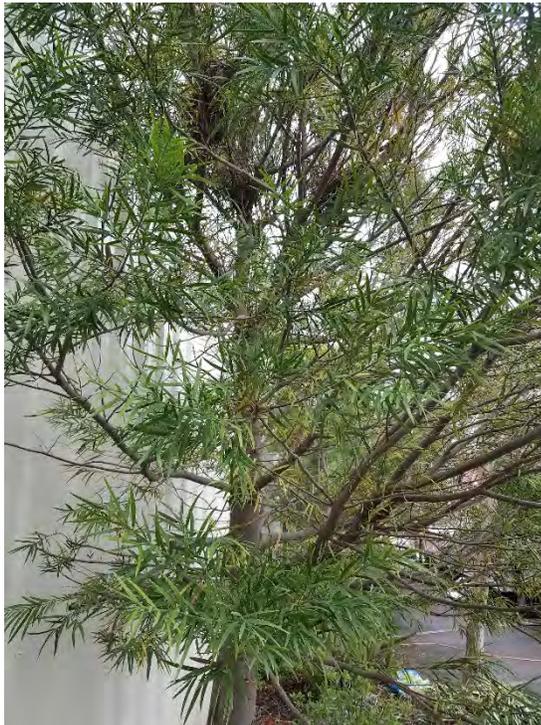
Several nest structures assumed to belong to passerine songbirds were observed during the January 7, 2021 site visit (see **Photo 4 in Section 7**). Additionally, several avian species were observed on-site during the site visit that are protected by the federal Migratory Bird Treaty Act (MBTA), California Fish and Game Code (FGC), and California Migratory Bird Protection Act (MMPA) (see **Section 6, Table 2**). Trees on-site and immediately adjacent to the Project site may provide suitable nesting habitat for migratory bird species.

Photo 4 - View of some small passerine nests in one of the trees along distillery's north wall.

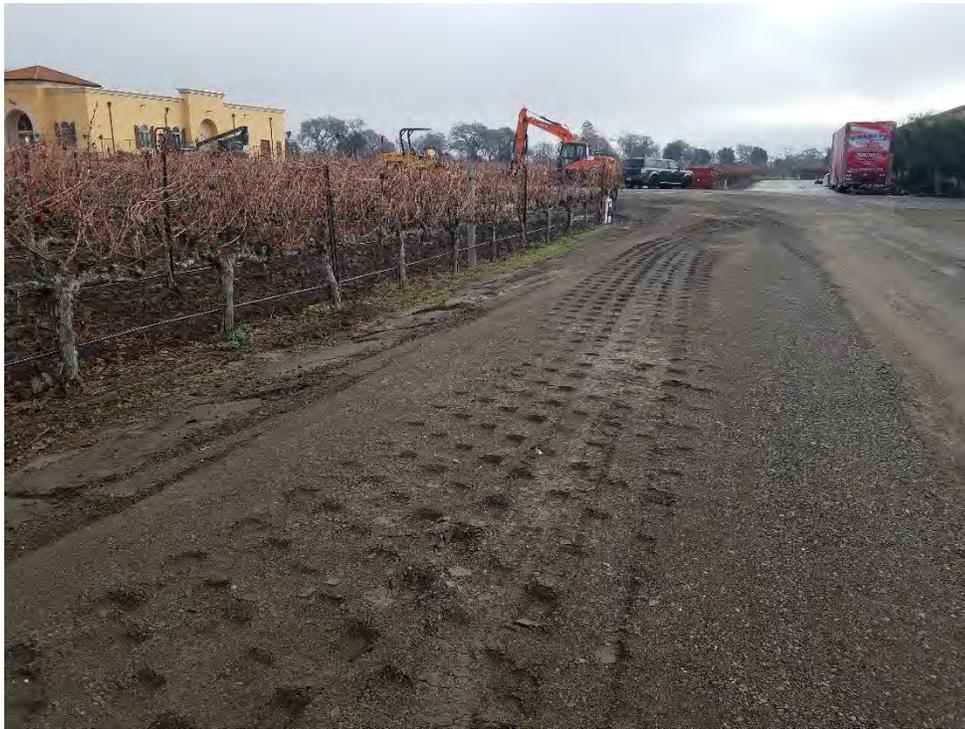
Photo 5 - View facing east, looking at road grading on widened access road.

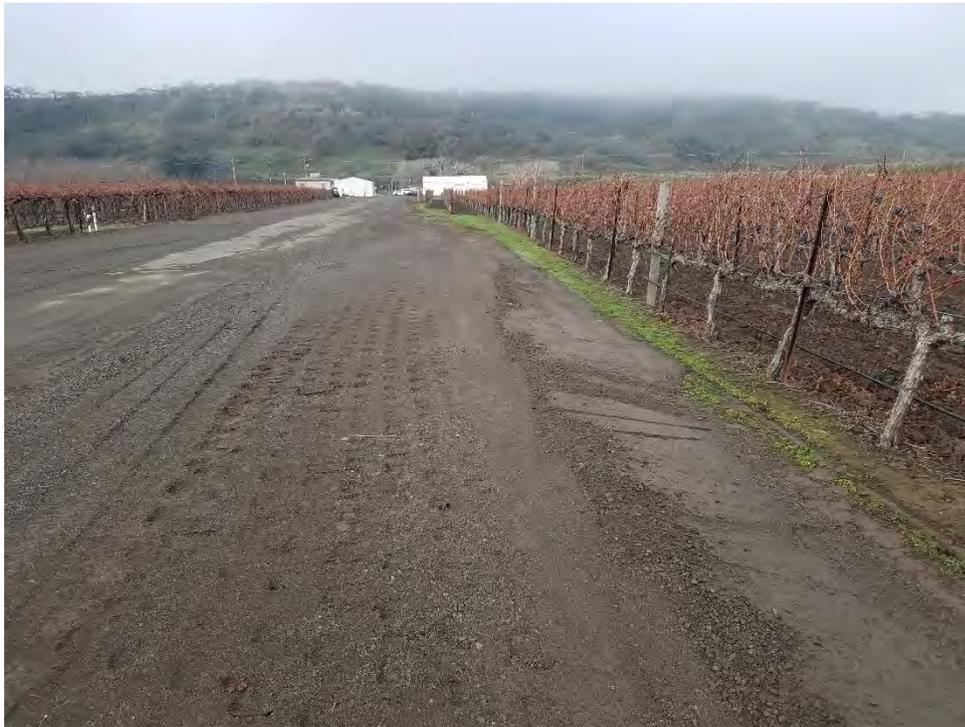
Photo 6 - View facing west, looking at road grading on widened access road.

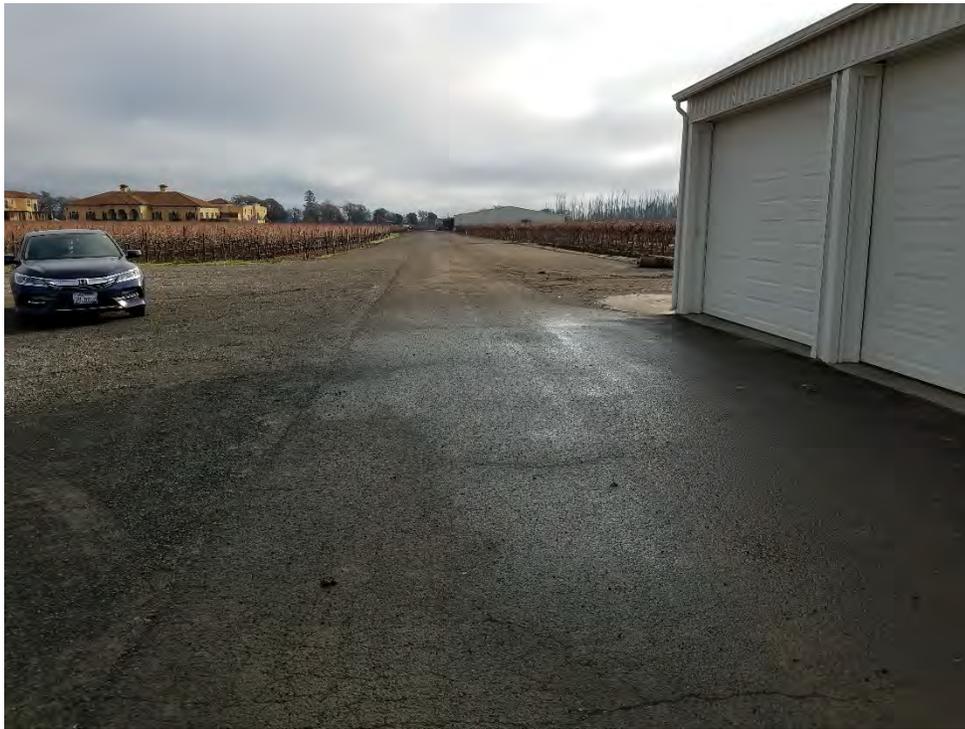
Photo 7 - View facing east, looking up access road from gate at main road.

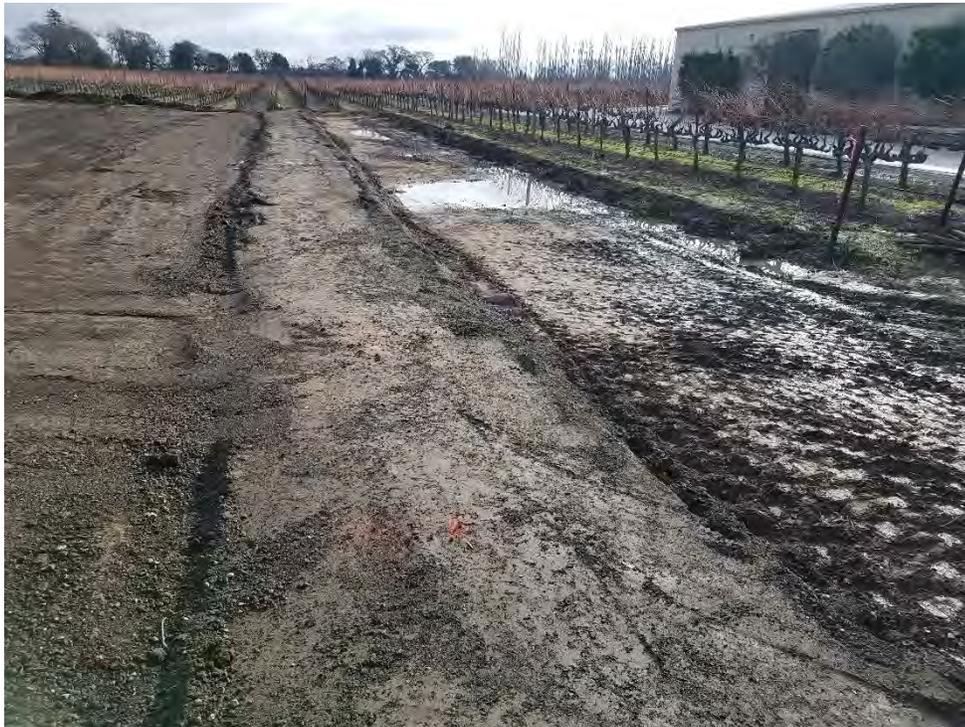
Photo 8 - View facing east, looking from southwest corner at area for proposed parking lot.

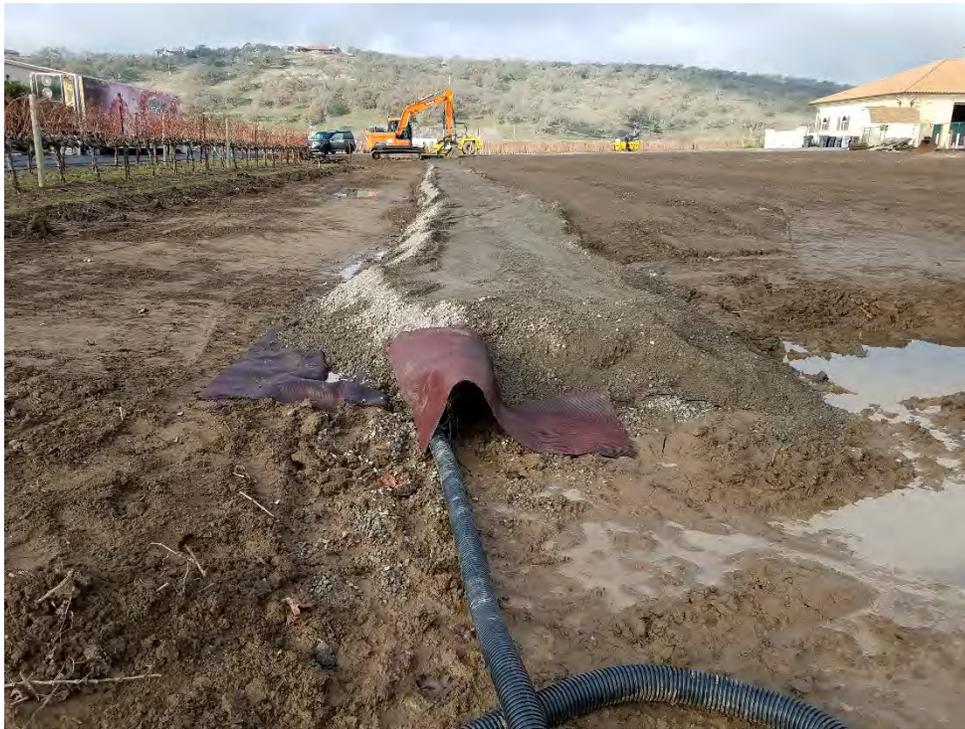
Photo 9 - View facing west, looking from southeast corner at area for proposed parking lot.

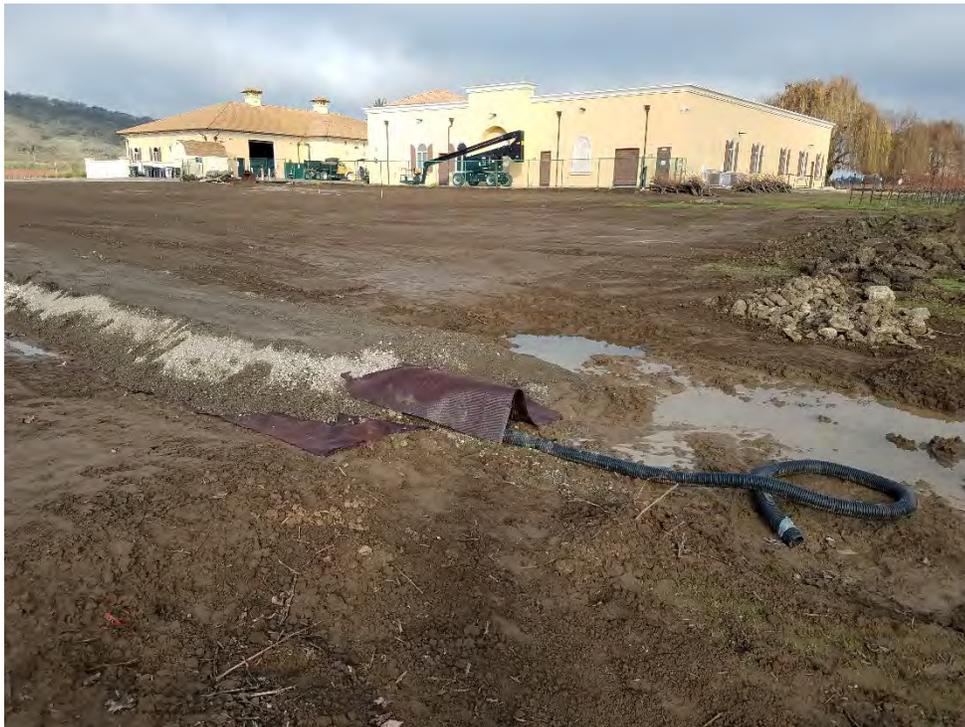
Photo 10 - View facing north, looking from southeast corner at area for proposed parking lot.

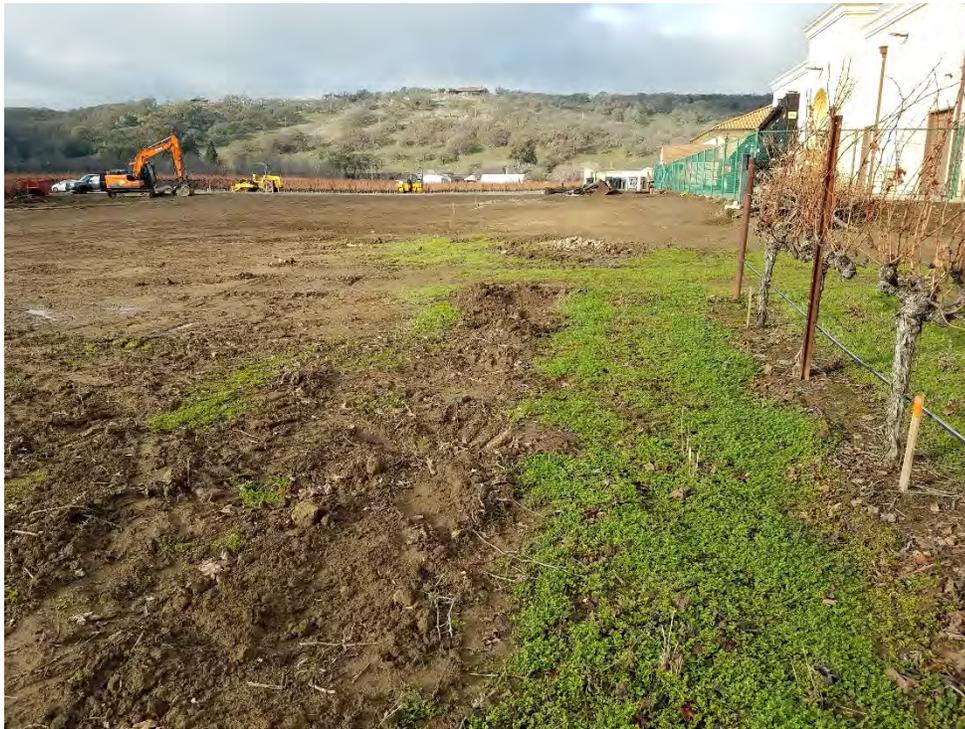
Photo 11 - View facing west, looking from northeast corner at area for proposed parking lot.

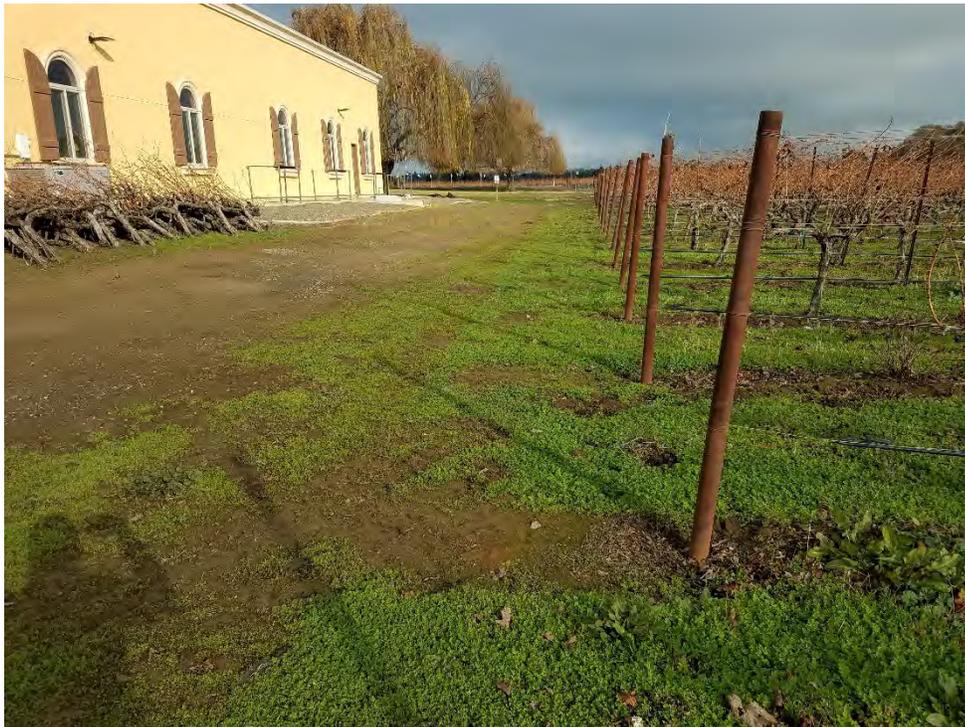
Photo 12 - View facing north, looking from northwest corner at area for proposed parking lot, behind existing event center.

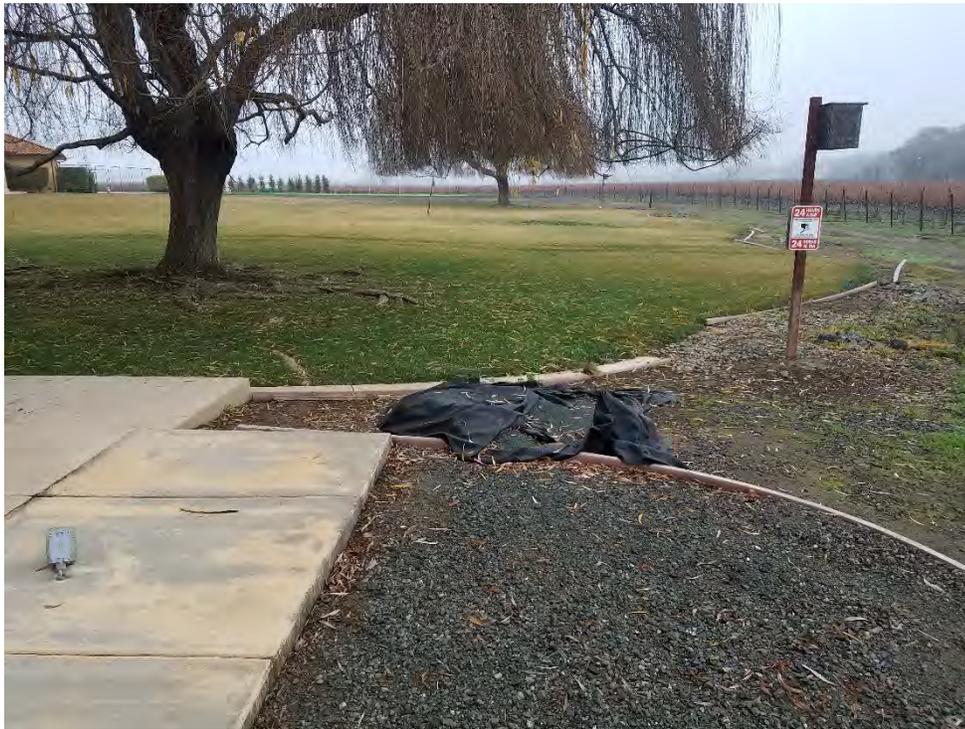
Photo 13 - View facing north, looking across lawn behind the existing residence.

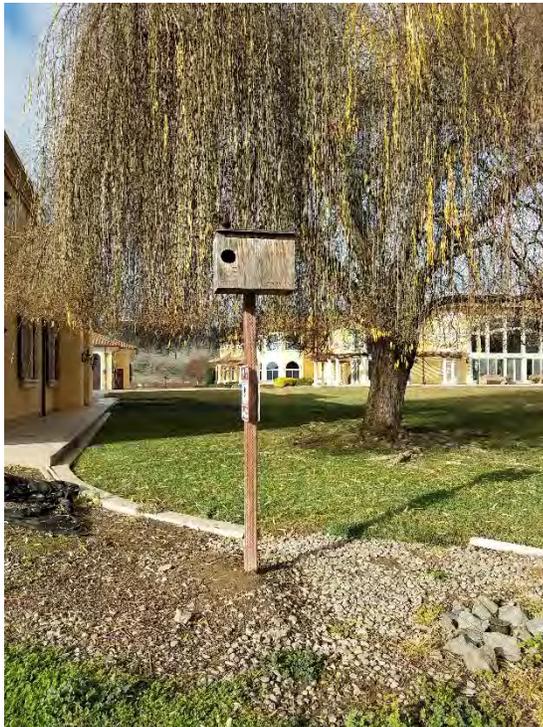
Photo 14 - View facing west, looking at owl box behind existing residence.
