## Preliminary Arborist Report

**Chestnut Square  
Gilroy, CA**

**June 19, 2020**

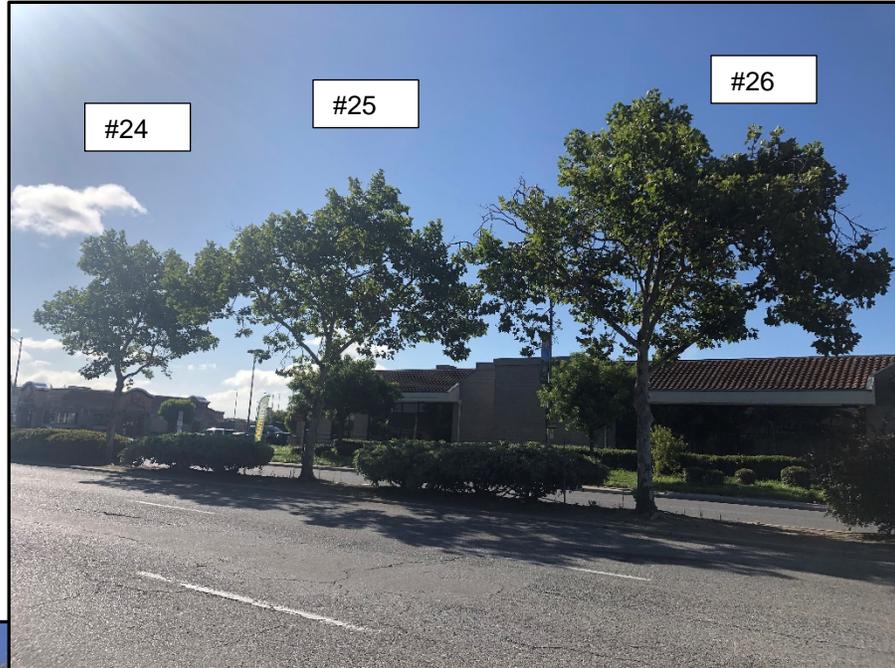
**Photo 1 (right):**  
London planes  
#24-26 were  
semi-mature  
trees growing in  
the median  
between  
Chestnut and  
Alexander.

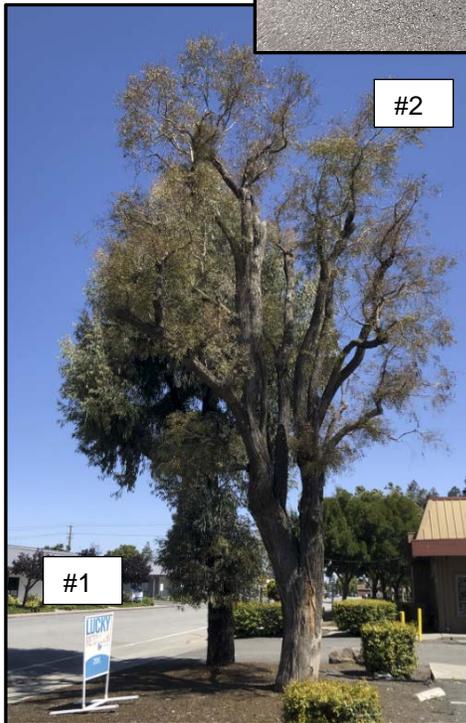
**Photo 2 (left):** – Facing north toward entrance off of Chestnut. Narrow leaf peppermint #2 in the foreground with red iron bark #1 behind it. Narrow leaf peppermint had a thin canopy.

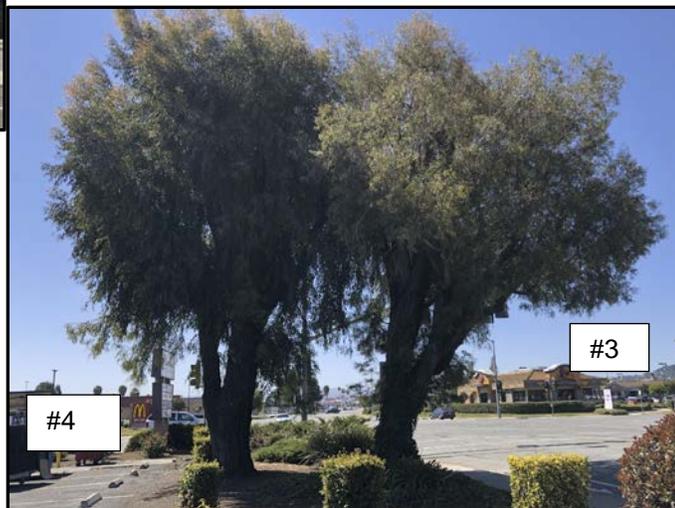
**Photo 3 (lower right):** Facing south toward 10<sup>th</sup> Street. Both #3 & 4 are narrow leaf peppermints and both were topped. Topping is not an acceptable pruning practice because it produces many weak branches in response.
