# Joshua Tree Inventory

Tentative Tract Map TTM 61678/CUP 20-05

Lancaster, California

Joshua Tree Inventory for TTM 61678/CUP 20-05, Lancaster, California

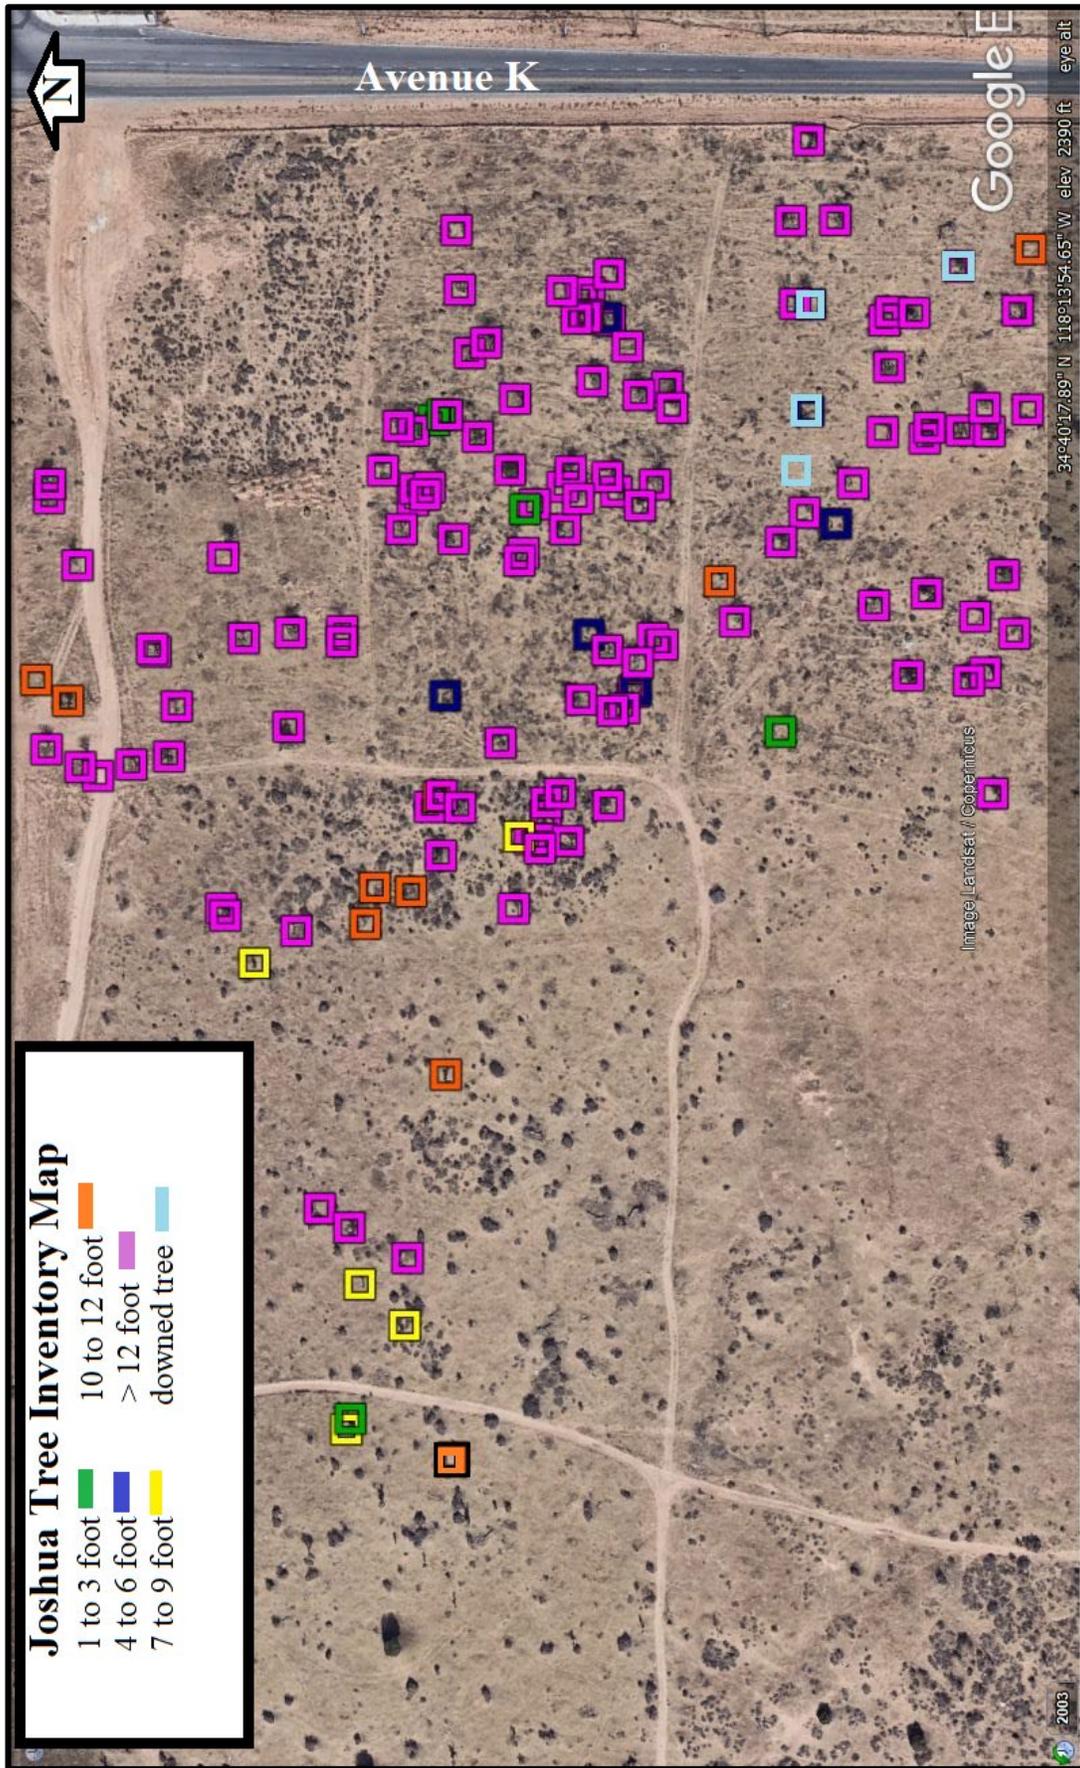
Figure 1. Joshua Tree Inventory Map

A total of 143 Joshua trees were counted during the line transect survey (Table 1, Figure 1). A total of 58 Joshua trees were considered to be in good to fair+ condition. A total of 51 Joshua trees were considered to be in fair condition and another 34 were considered to be in poor condition. An example of good, fair and poor condition is portrayed in photographs (Figures 2 to 4). Overall health of the Joshua trees in the northwestern portion of the project site appeared to be poor increasing in health to the east of the site. The size class of Joshua trees at this project site is skewed to older (>12 foot) individuals which is unusual in the Antelope Valley area. Multiple Joshua tree studies over the last 30 years in the Antelope Valley have shown the typical distribution of size classes for Joshua trees, particularly in Palmdale, have lower numbers in the 1 to 3 and > 12 foot classes, with the highest representation between 4 to 12 foot. Four >12 trees were down and uprooted. These four trees did have green limbs but were discounted.

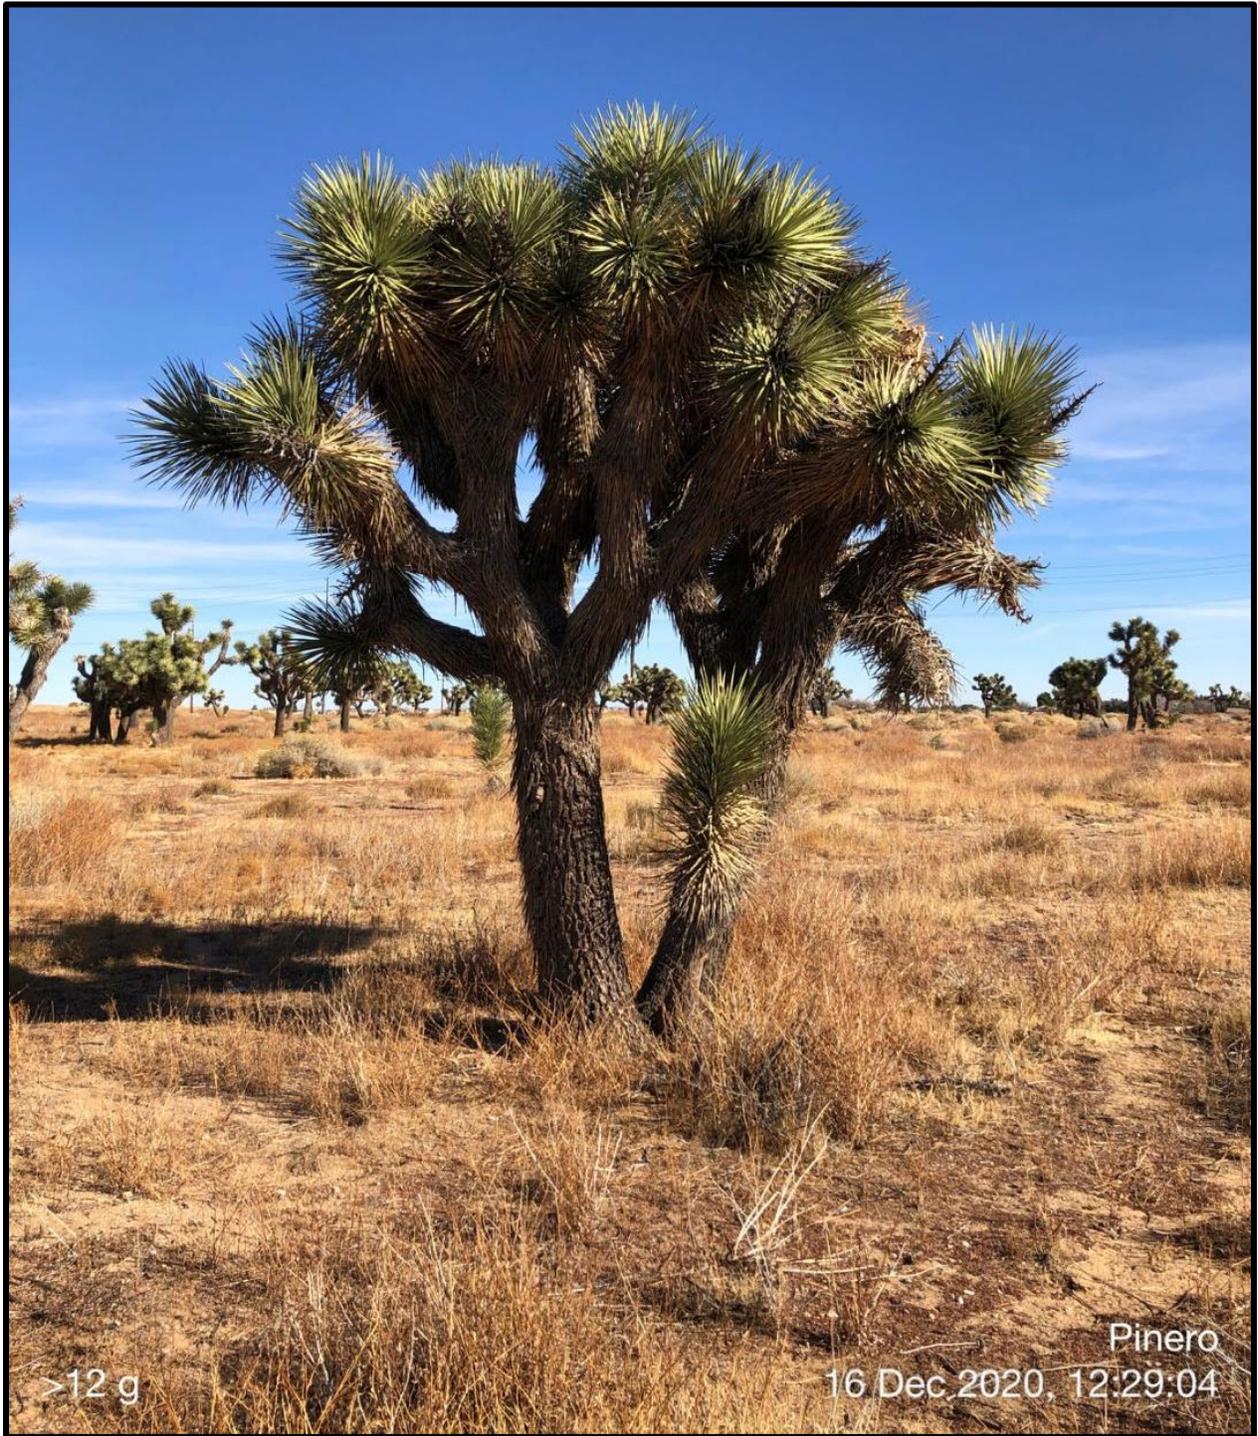
Good: No outward sign of damage, appears healthy, good transplant survivability.

Figure 2: Example of a good condition Joshua tree.

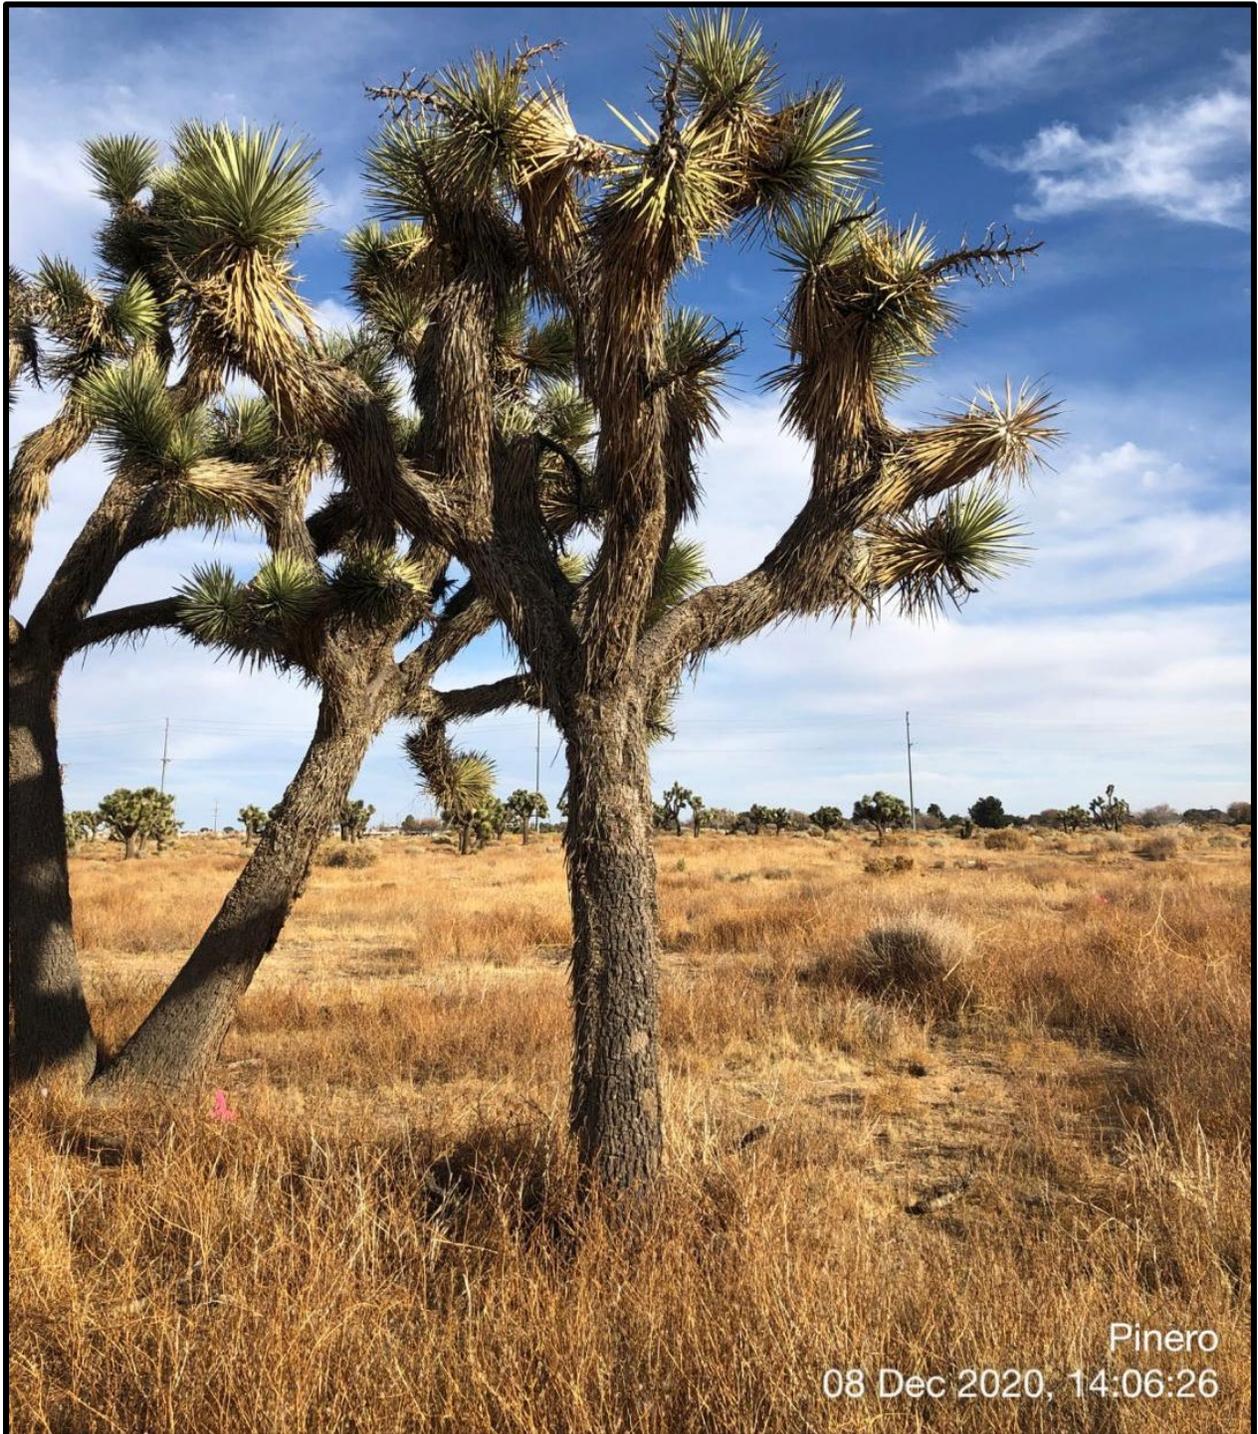
Fair: Small amount of rodent activity at base, root to crown ration questionable, minimal damage, moderate transplant survivability.

Figure 3: Example of fair condition Joshua tree. Note damage along trunk of tree.

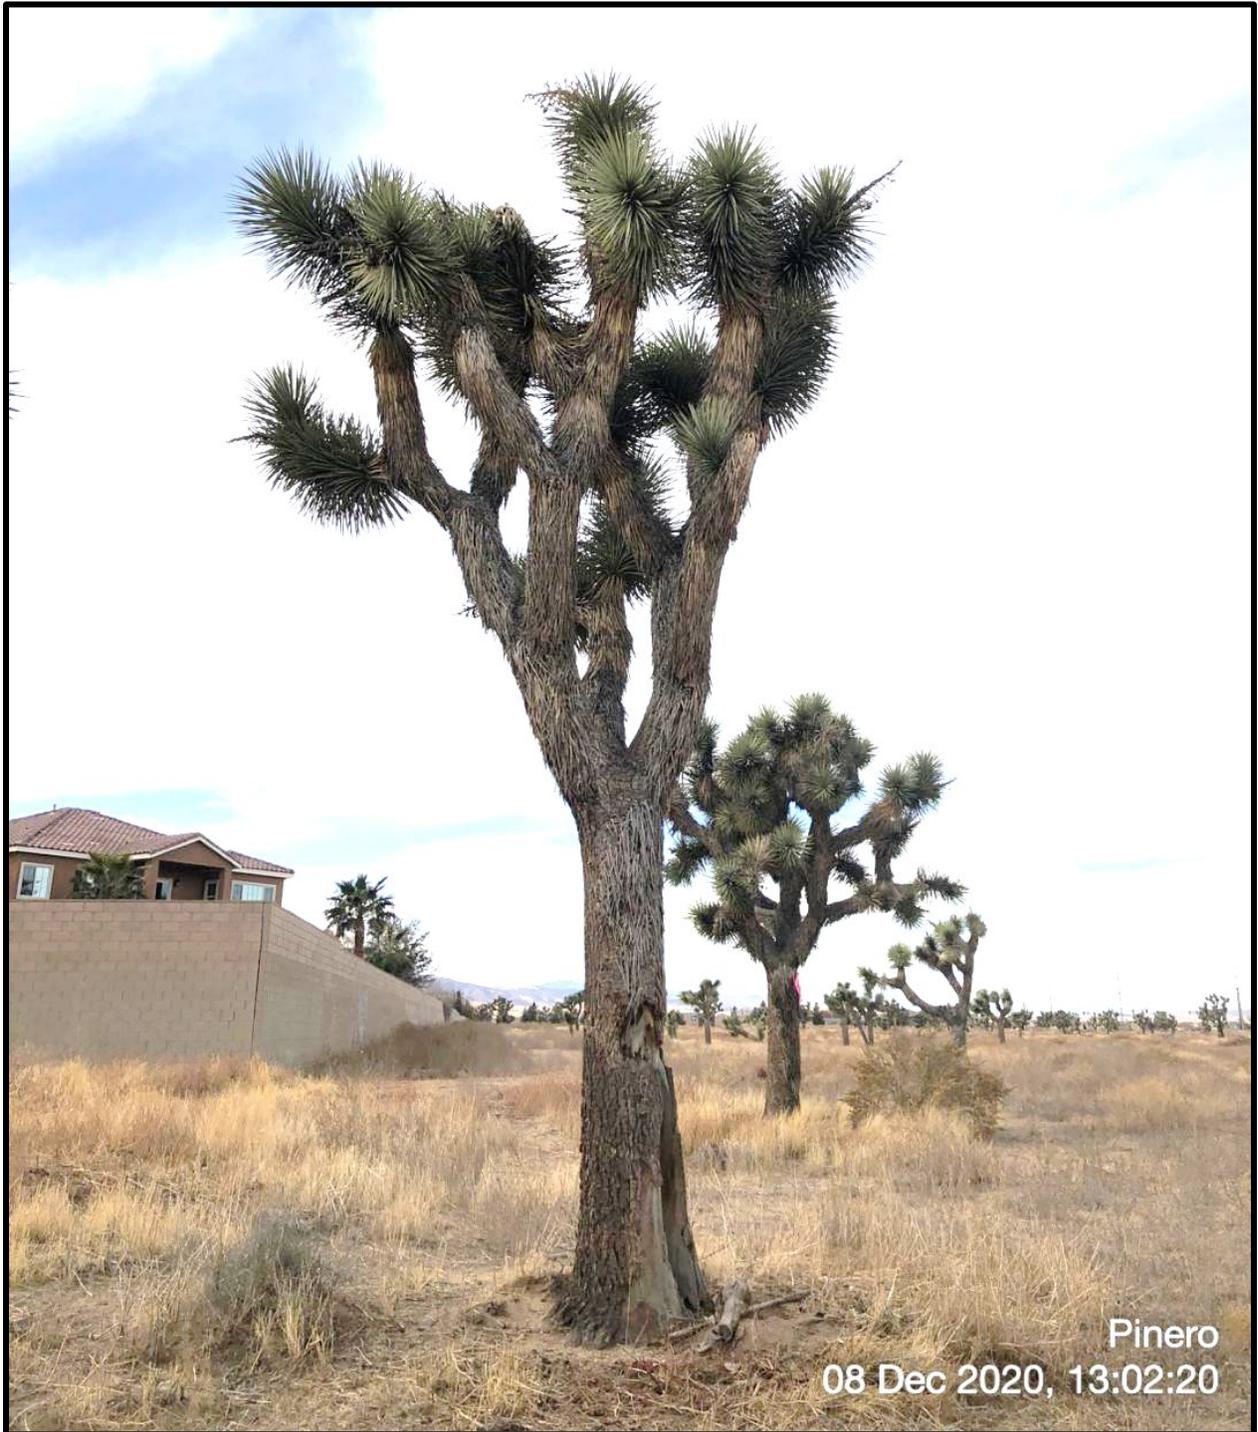
Poor: Shows sign of severe damage, insect borings, potential compromise of root system by rodents, low transplant survivability.

Figure 4: Example of poor condition Joshua tree. Note severe damage at base of tree.
