CROSSINGS CAMPUS

Addendum to Draft Environmental Impact Report State Clearinghouse No. 2021110079

ADDENDUM TO THE ENVIRONMENTAL IMPACT REPORT FOR THE CROSSINGS CAMPUS PROJECT

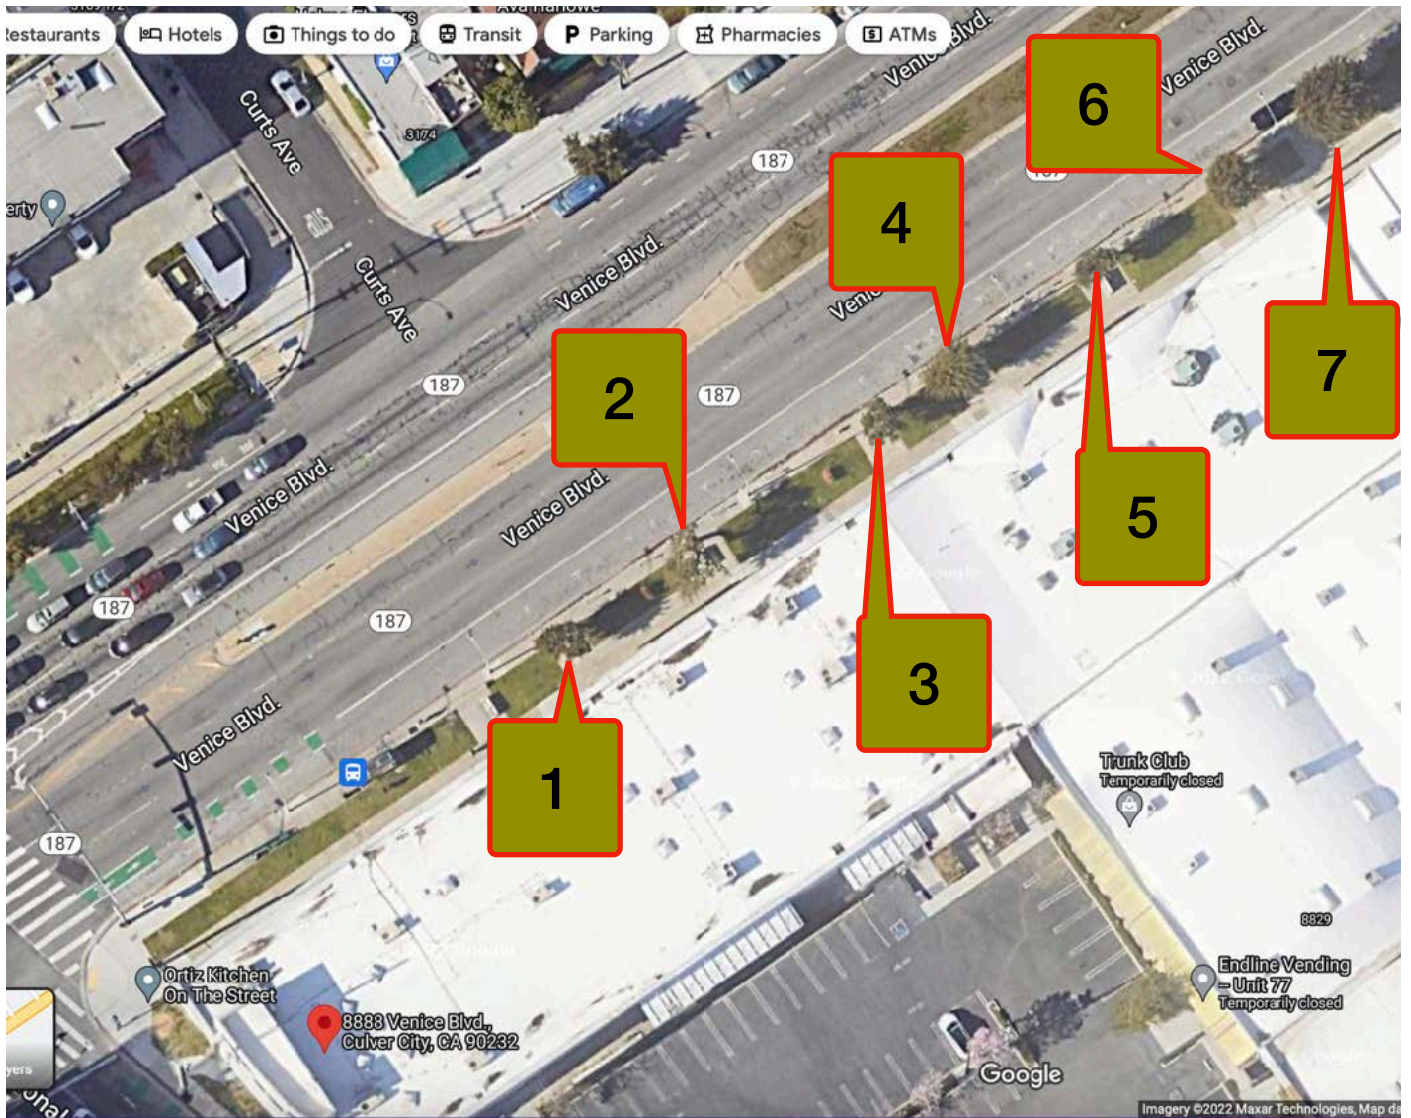
PHOTO 1 - Shows City of Los Angeles street trees #1- #7. Trees #1 - #7 are recommended for removal and replacement.

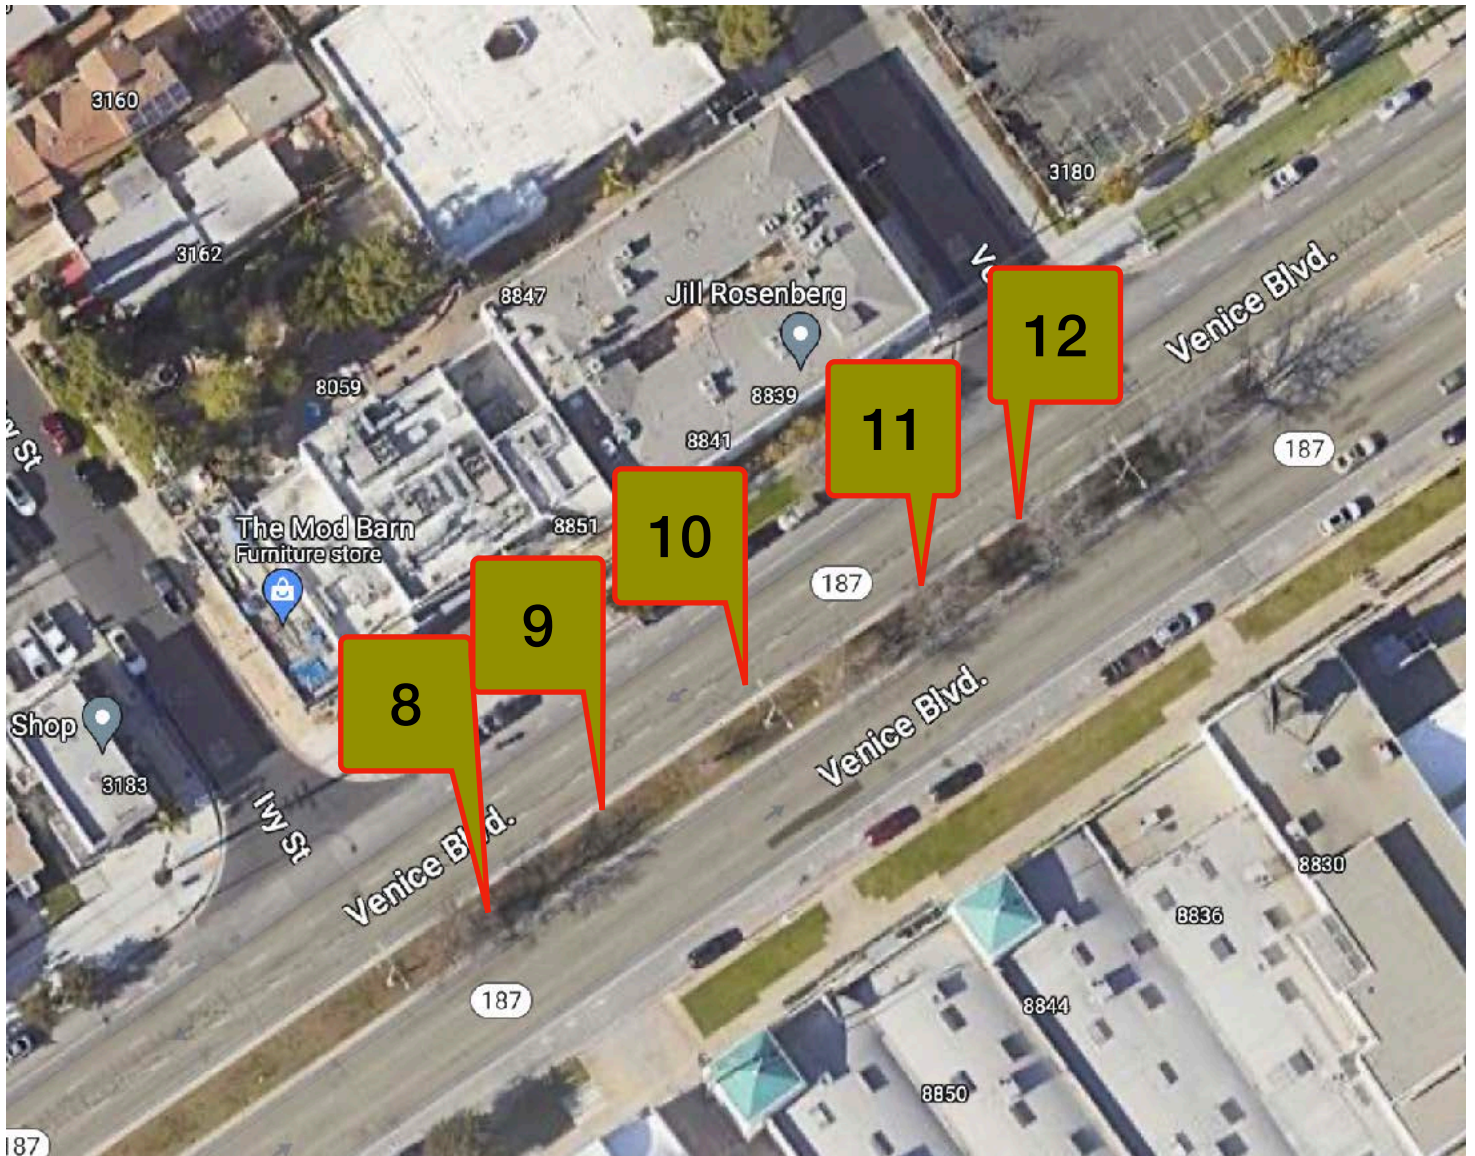
PHOTO 2 - Shows City of Los Angeles street trees #8- #12 that are recommended for removal and replacement.

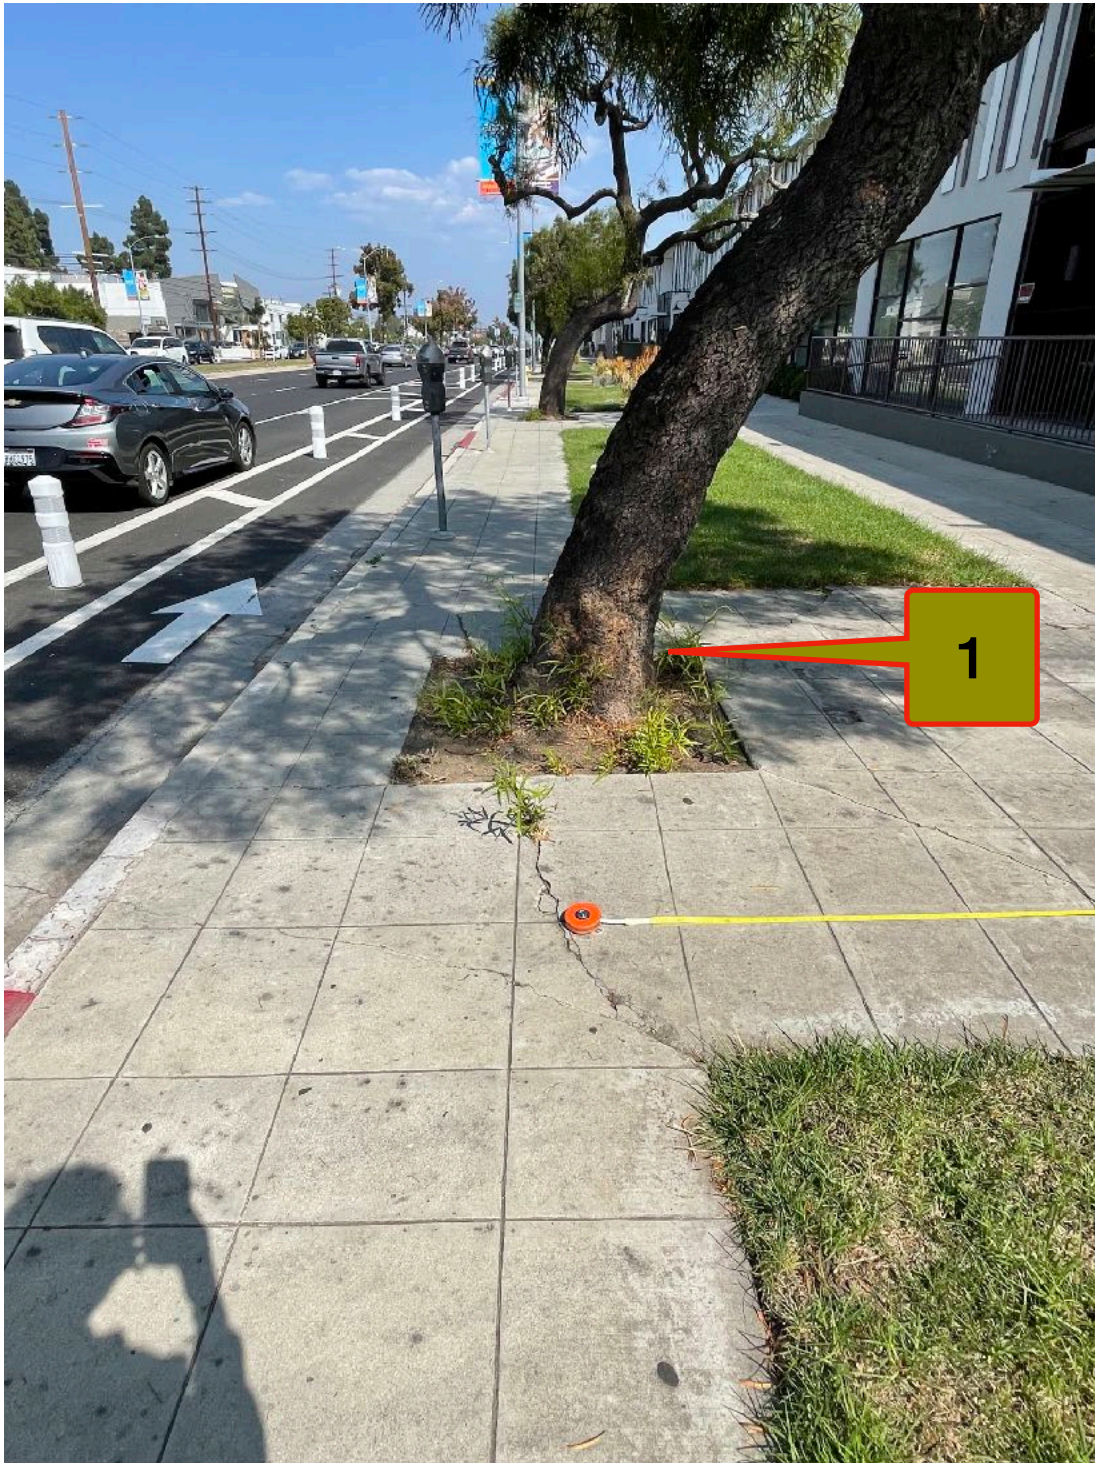
PHOTO 4 - Shows City of Los Angeles street tree #1 with prominent lean.

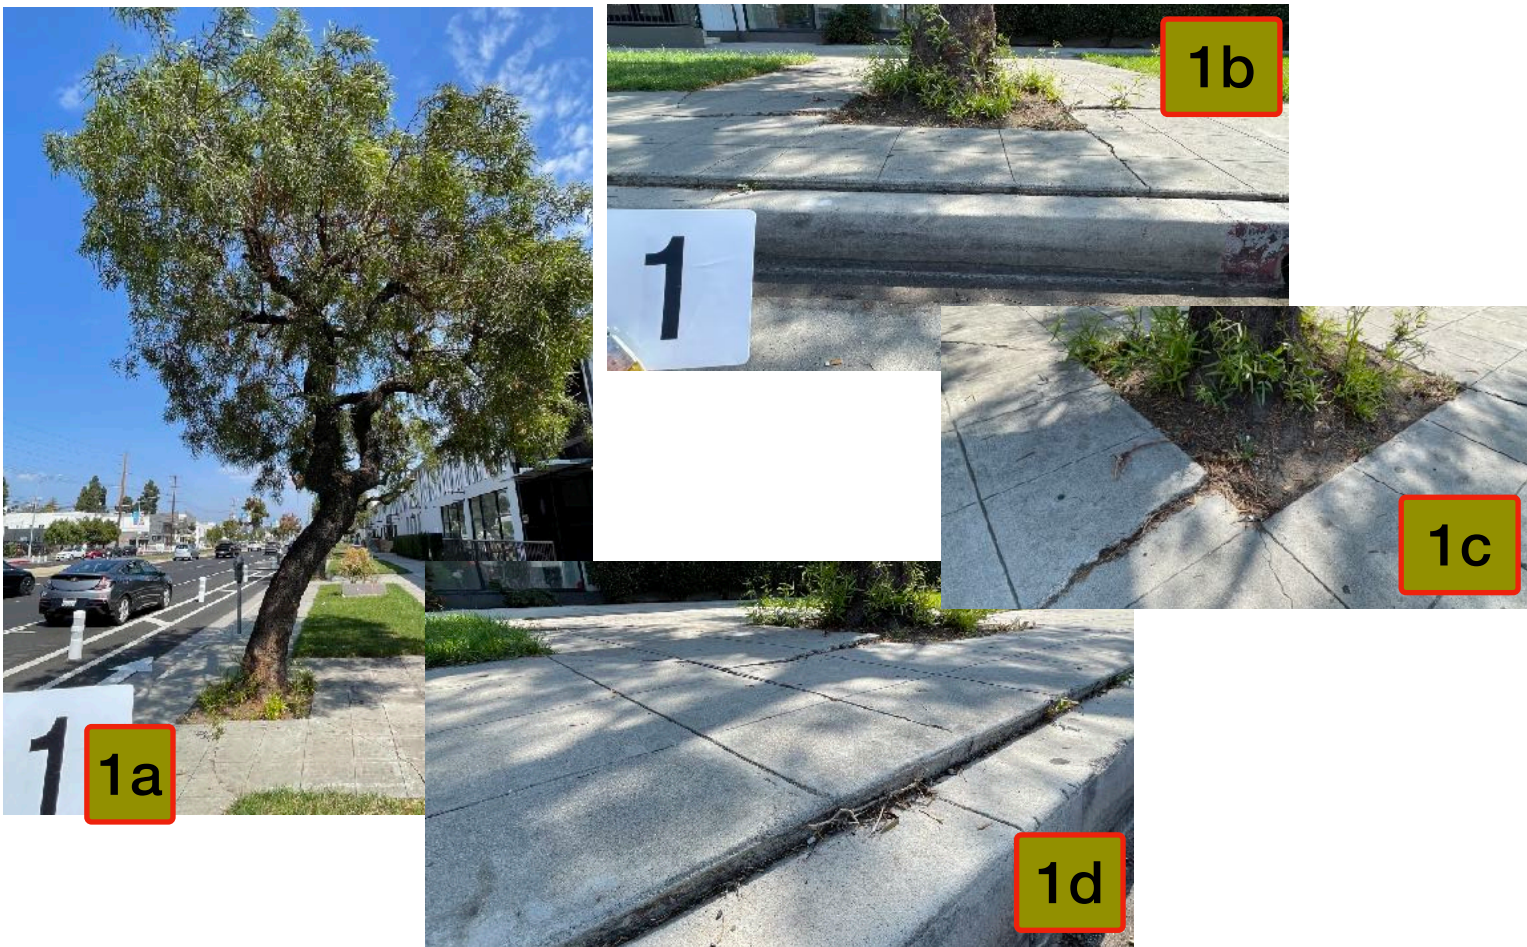
PHOTO 5 - Shows City of Los Angeles street tree #1, recommend for removal.

1a) Leaning trunk, asymmetrical canopy

1b, c, d) Cracking and lifting sidewalk

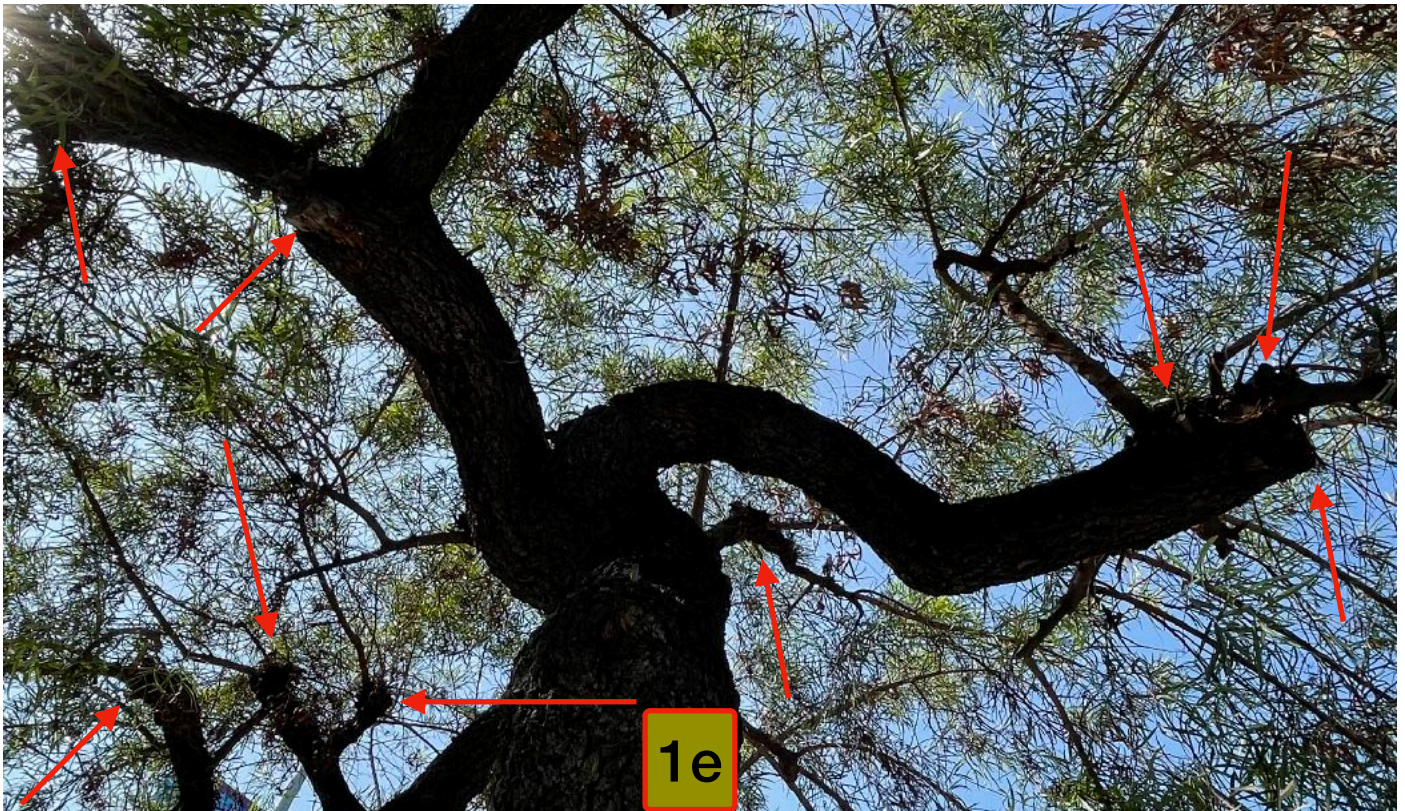
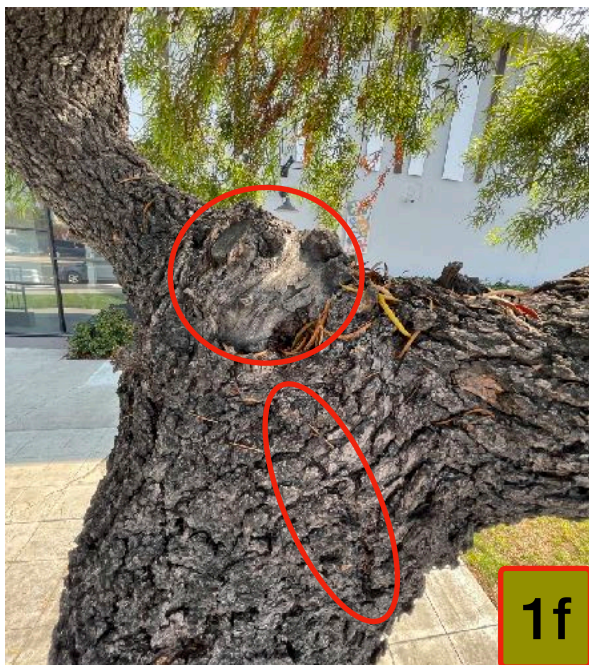
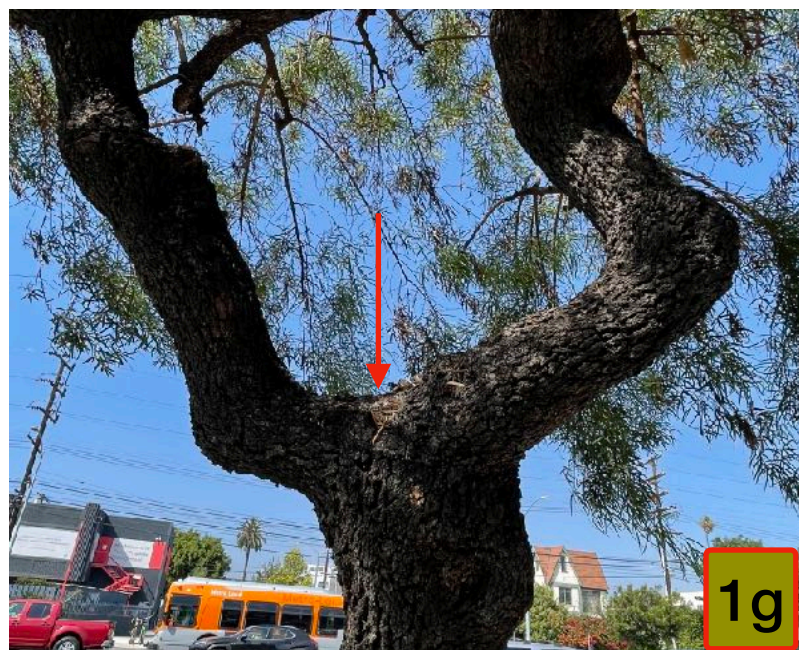
PHOTO 6 - Shows City of Los Angeles street tree #1, recommend for removal.

1e) Wound wood and regrowth from decades of topping, sparse regrowth (a tree of this species and age should have a more dense full canopy), regrowth is prone to breakage.

1f) Red circle is an old topping wound, decay column present, Red oval is a bark fissure; The red circle and oval weakened attachment at the main union between bole (main trunk) and the two primary scaffold limbs.

1g) Shows opposite side of main union as seen in 1f.

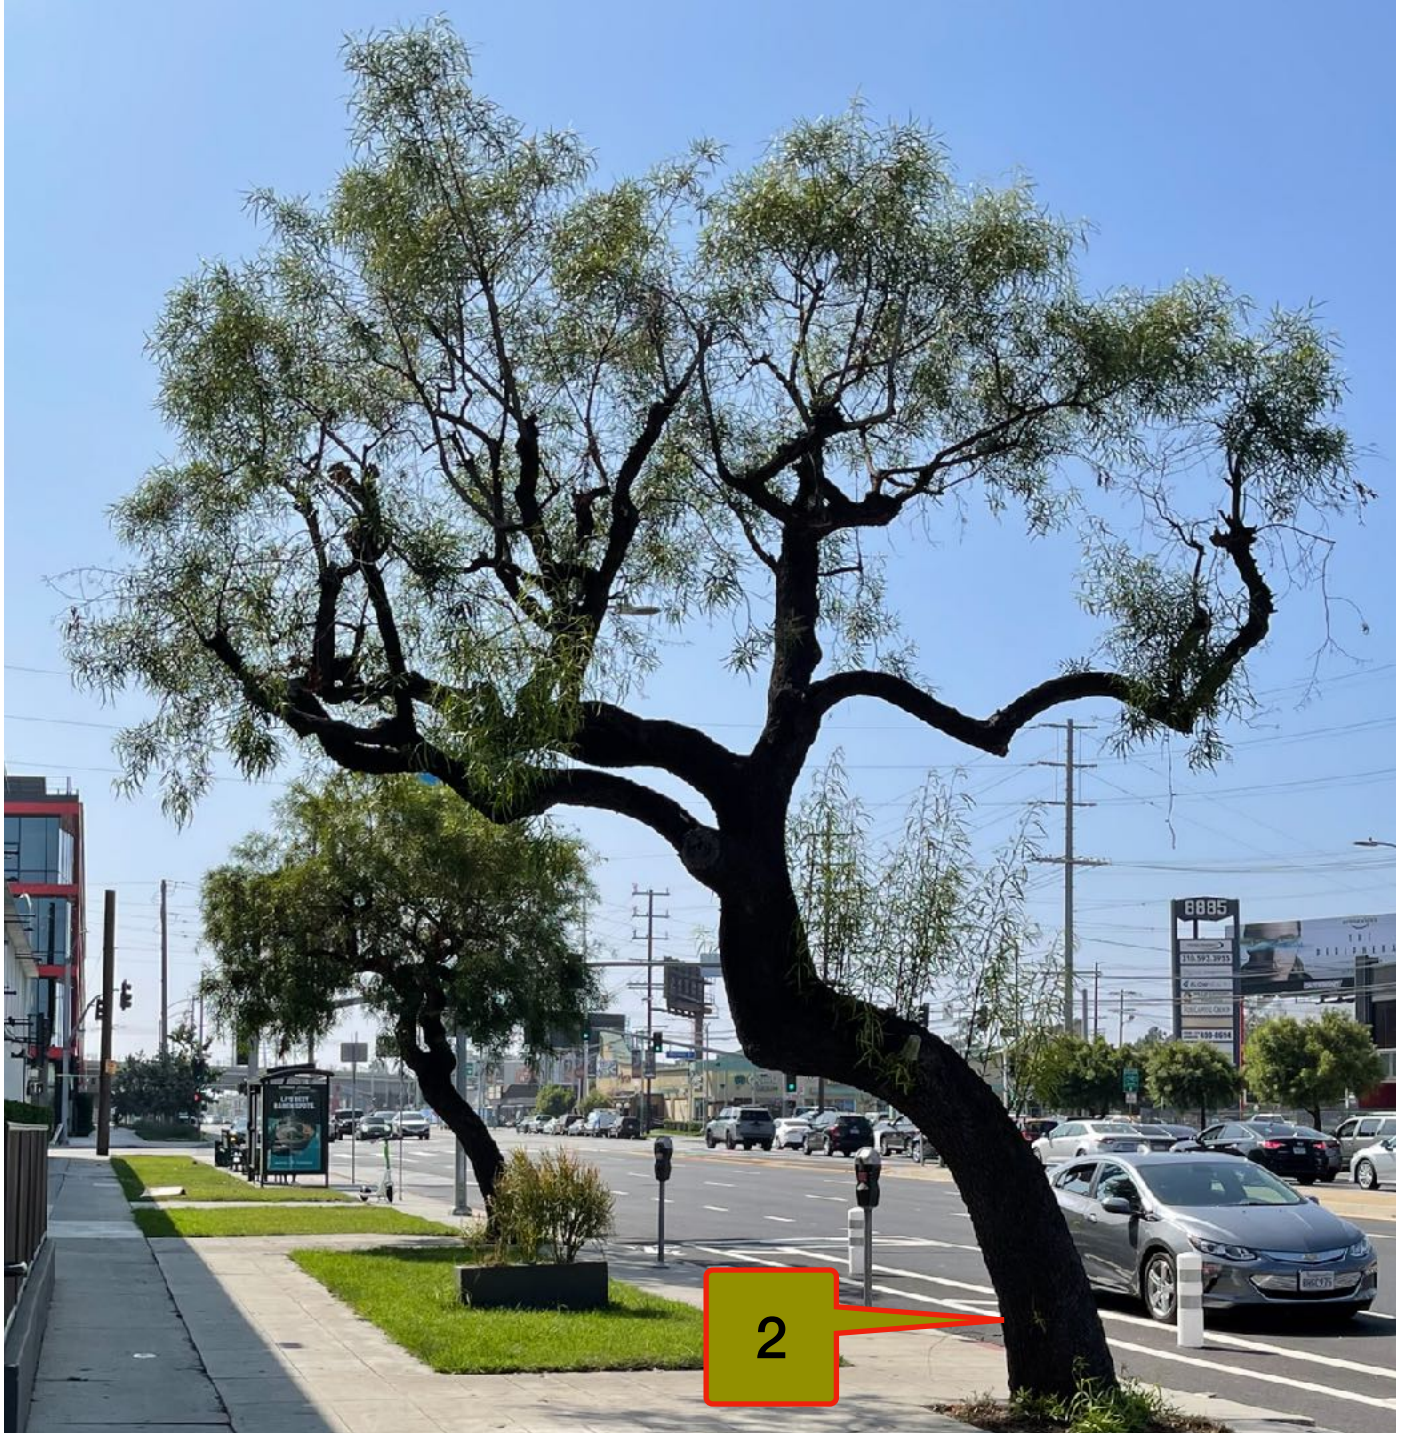
PHOTO - Shows City of Los Angeles street tree #2. This tree has a sparse canopy density and lack of leaf area to produce photosynthesis is not enough to sustain the health and vigor of a tree of this age and size. Trees #1 through #7 are recommended for removal and replacement.

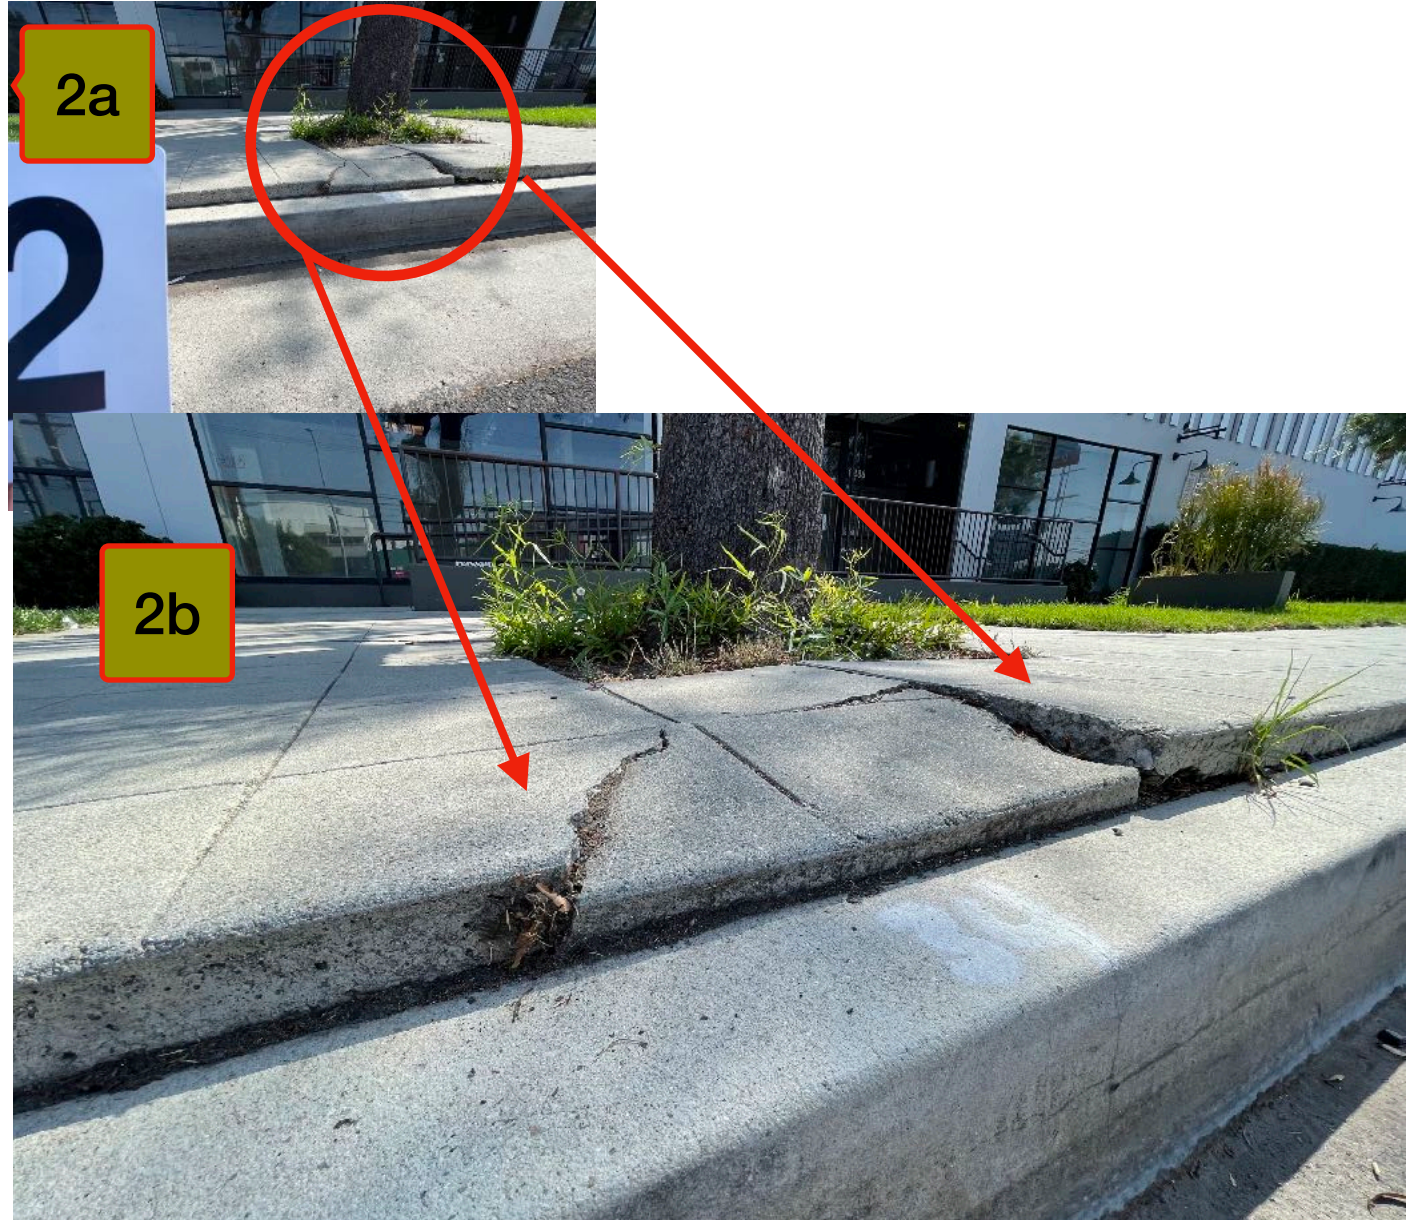
PHOTO - Shows City of Los Angeles street tree #2, recommend for removal.
2a, b) Cracking and uplifting of sidewalk in public right of way

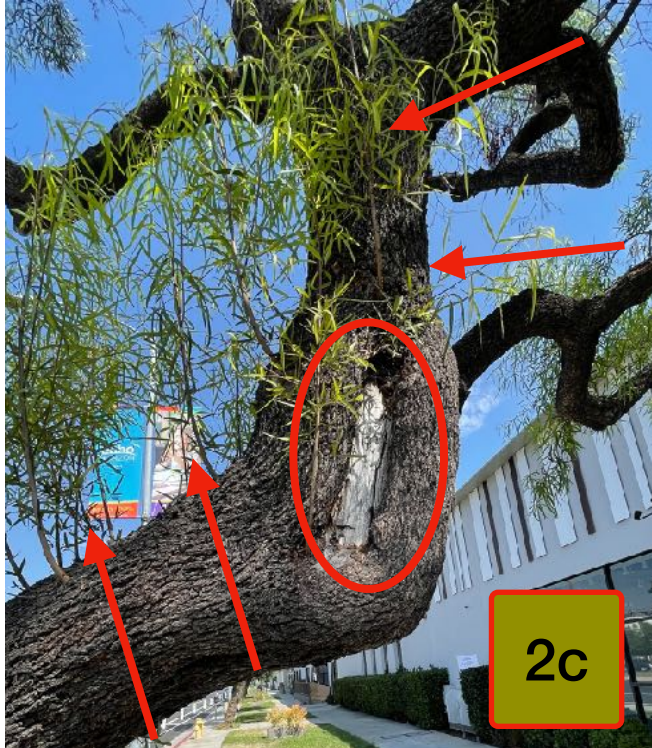
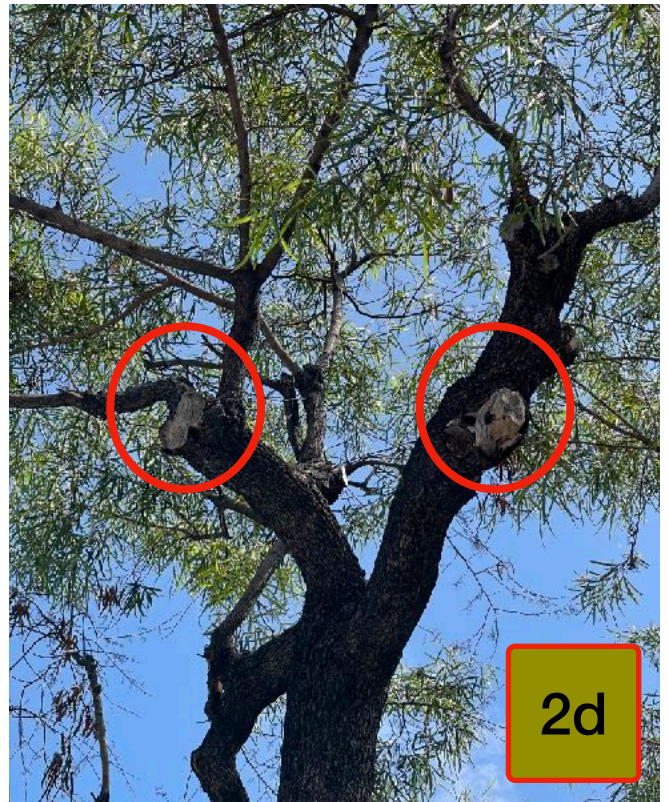
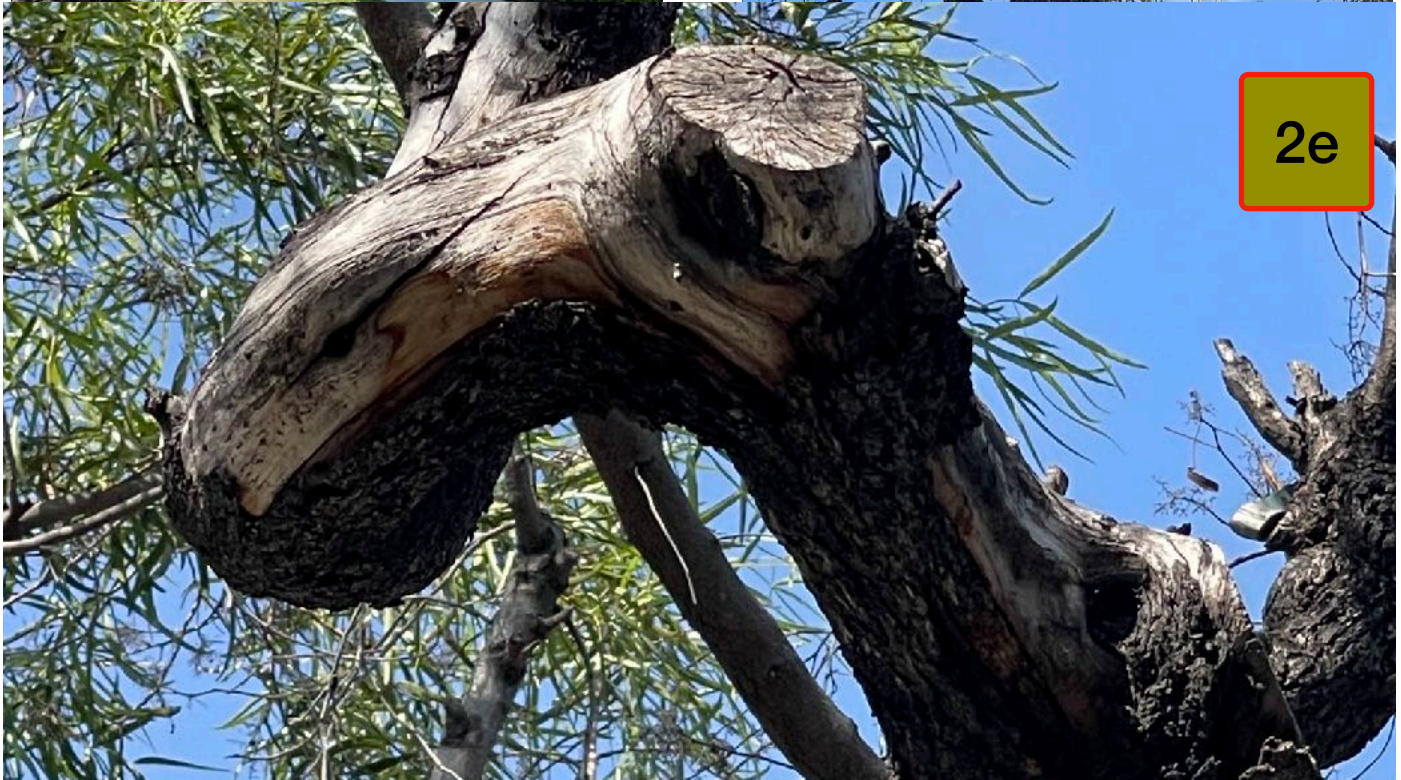
PHOTO 6 - Shows City of Los Angeles street tree #2, recommend for removal.

2c) Red oval is an old trunk segment break, decay column present, Red arrows show epicormic sprout growth in reaction to repeated topping.

2d) Red circles are old topping wounds too large for the tree to properly close off, site for breakage & decay

2e) Necrotic old topping wound stub

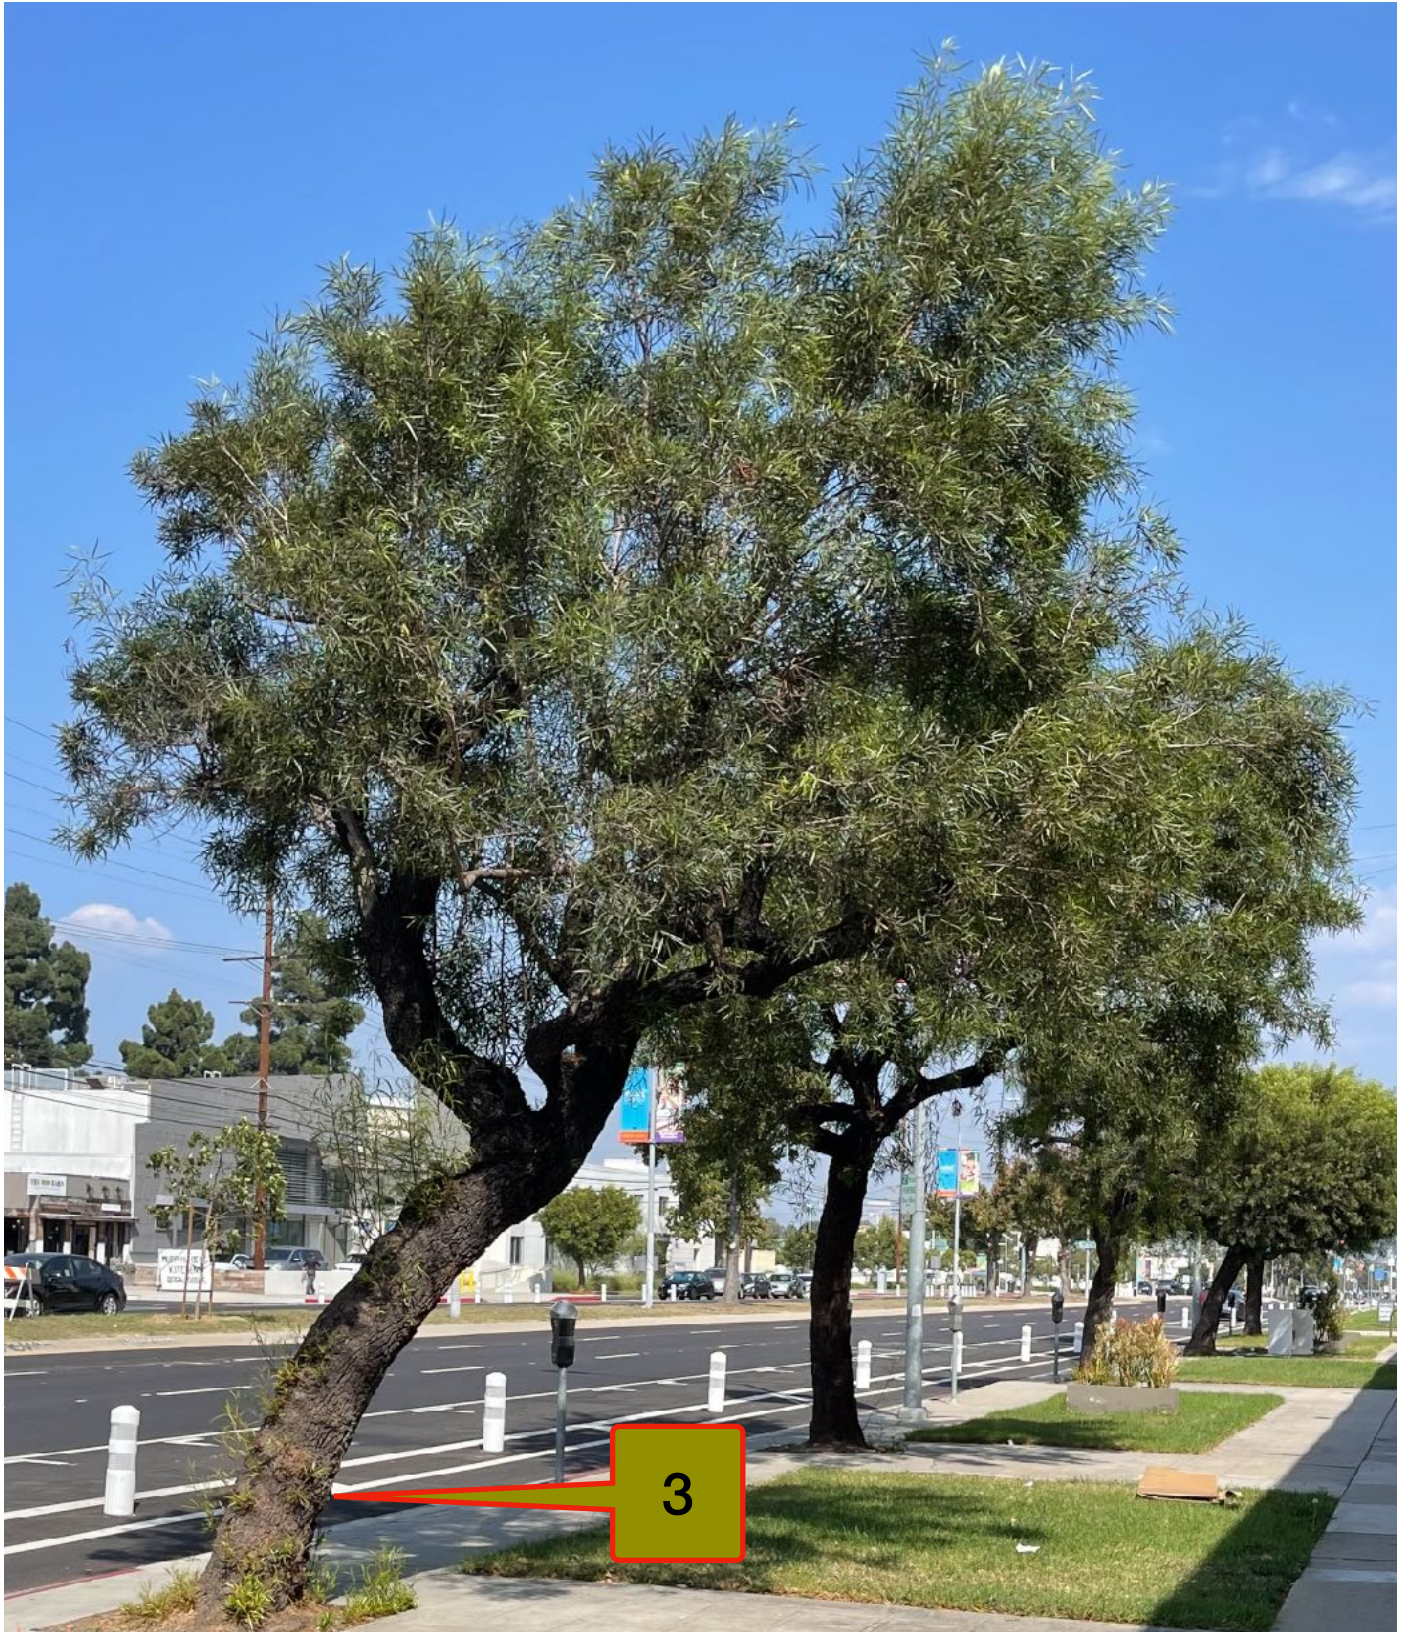
PHOTO - Shows City of Los Angeles street tree #3. Tree has a pronounced lean and an asymmetrical canopy. Trees #1 through #7 are recommended for removal and replacement.

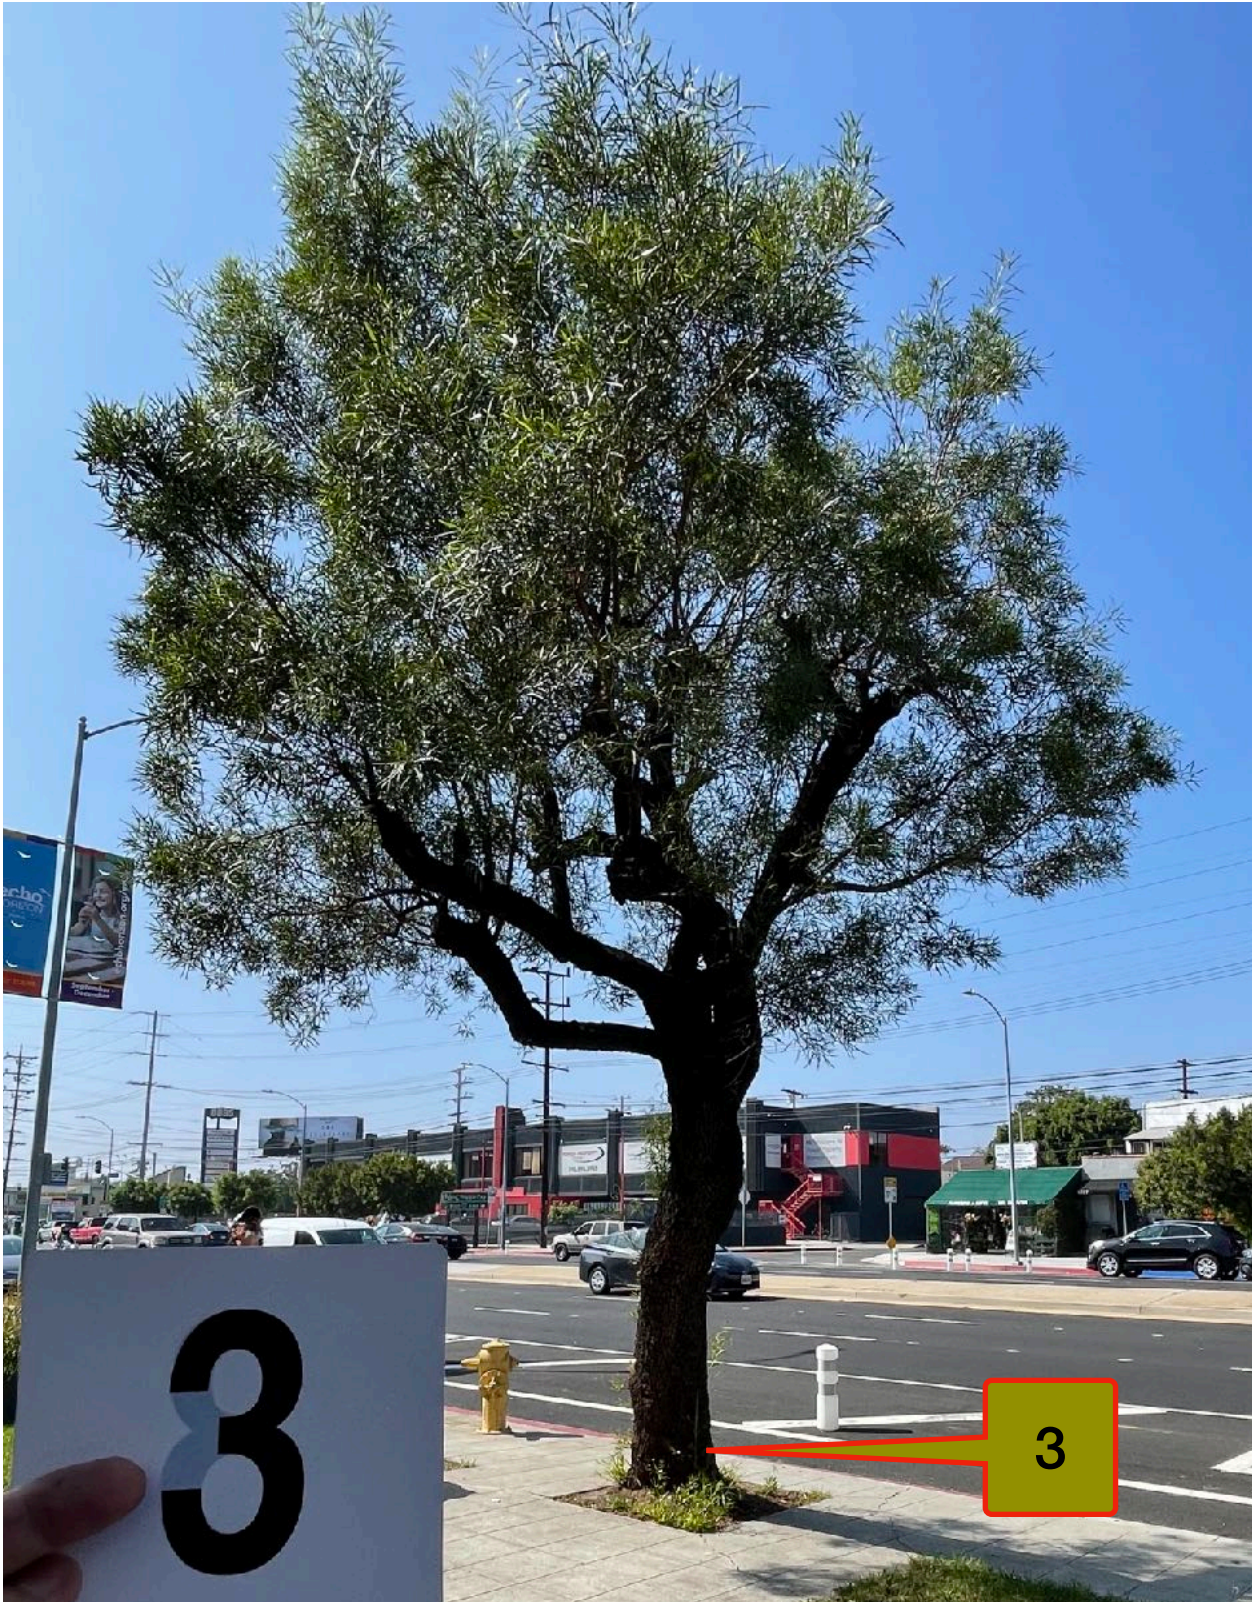
PHOTO - Shows City of Los Angeles street tree #3. Tree has an asymmetrical canopy from repeated toppings. Trees #1 through #7 are recommended for removal and replacement.

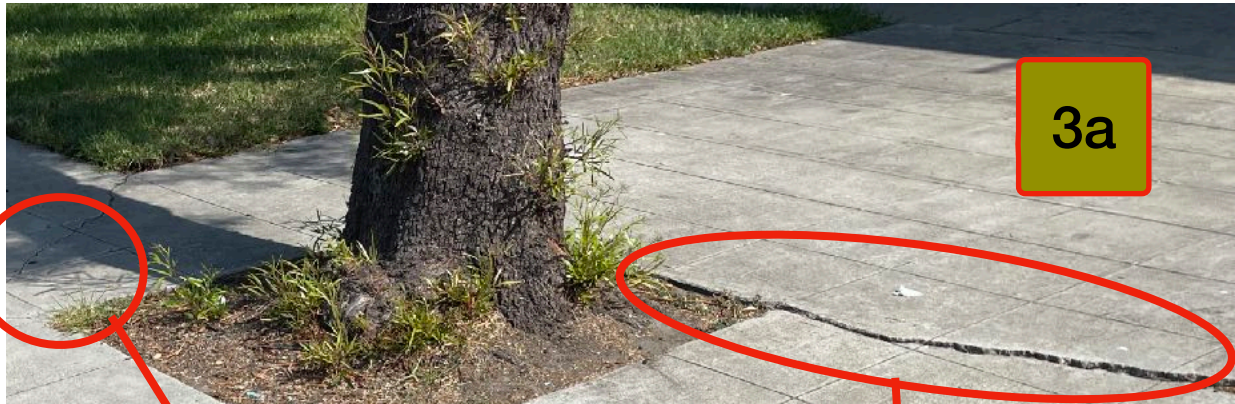
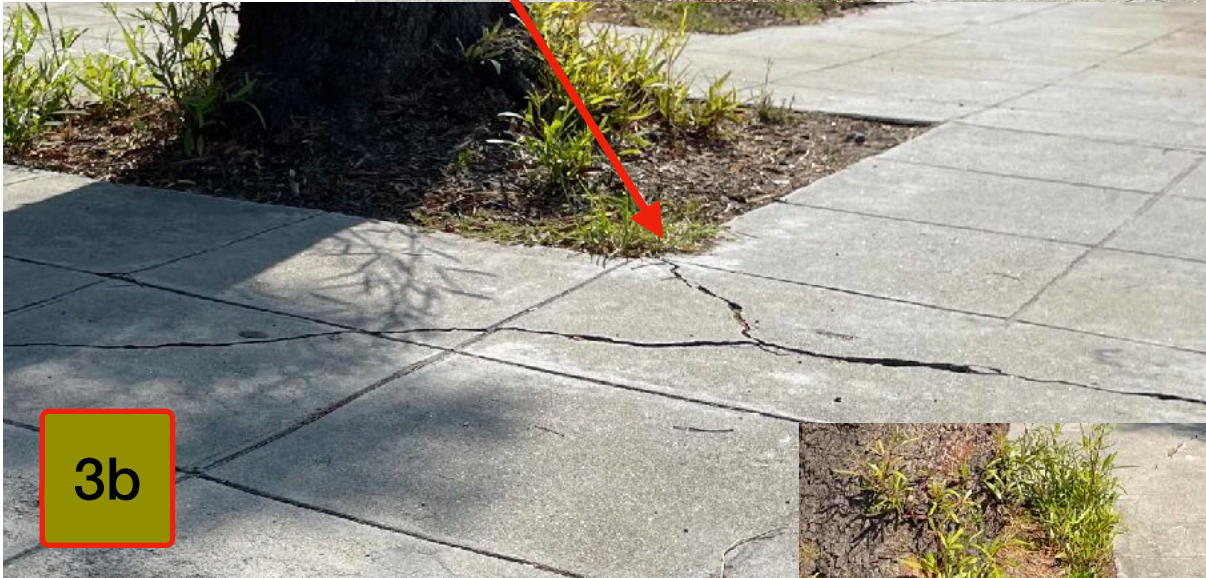
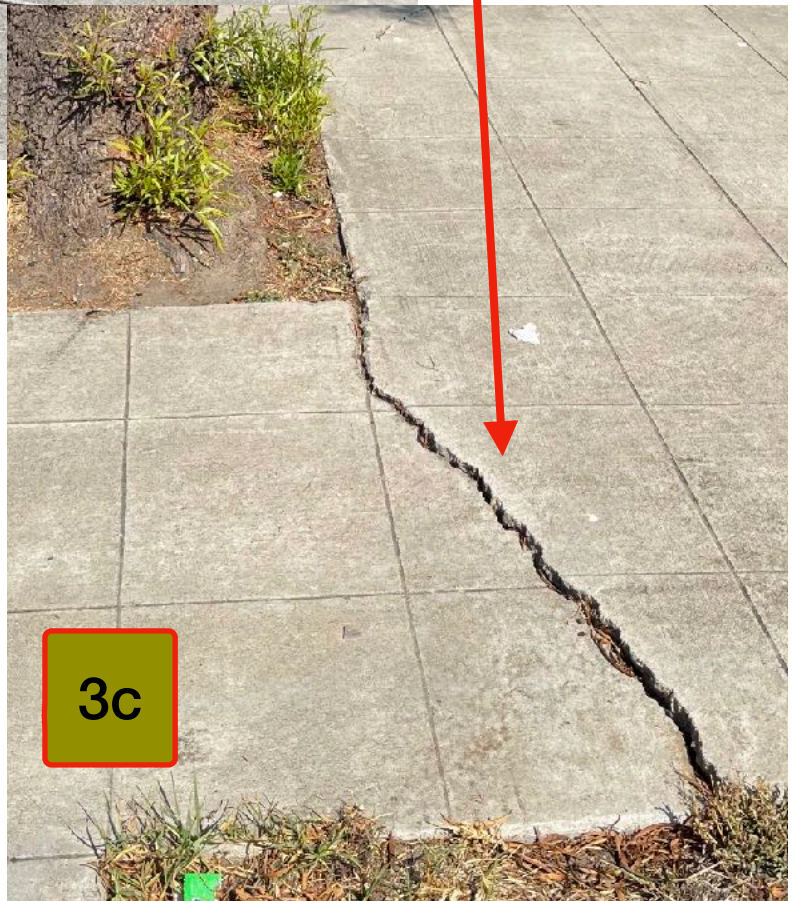
PHOTO - Shows City of Los Angeles street tree #3, recommend for removal.

3a, b, c) Cracking and uplifting of sidewalk in public right of way
