CROSSINGS CAMPUS

Addendum to Draft Environmental Impact Report State Clearinghouse No. 2021110079

ADDENDUM TO THE ENVIRONMENTAL IMPACT REPORT FOR THE CROSSINGS CAMPUS PROJECT

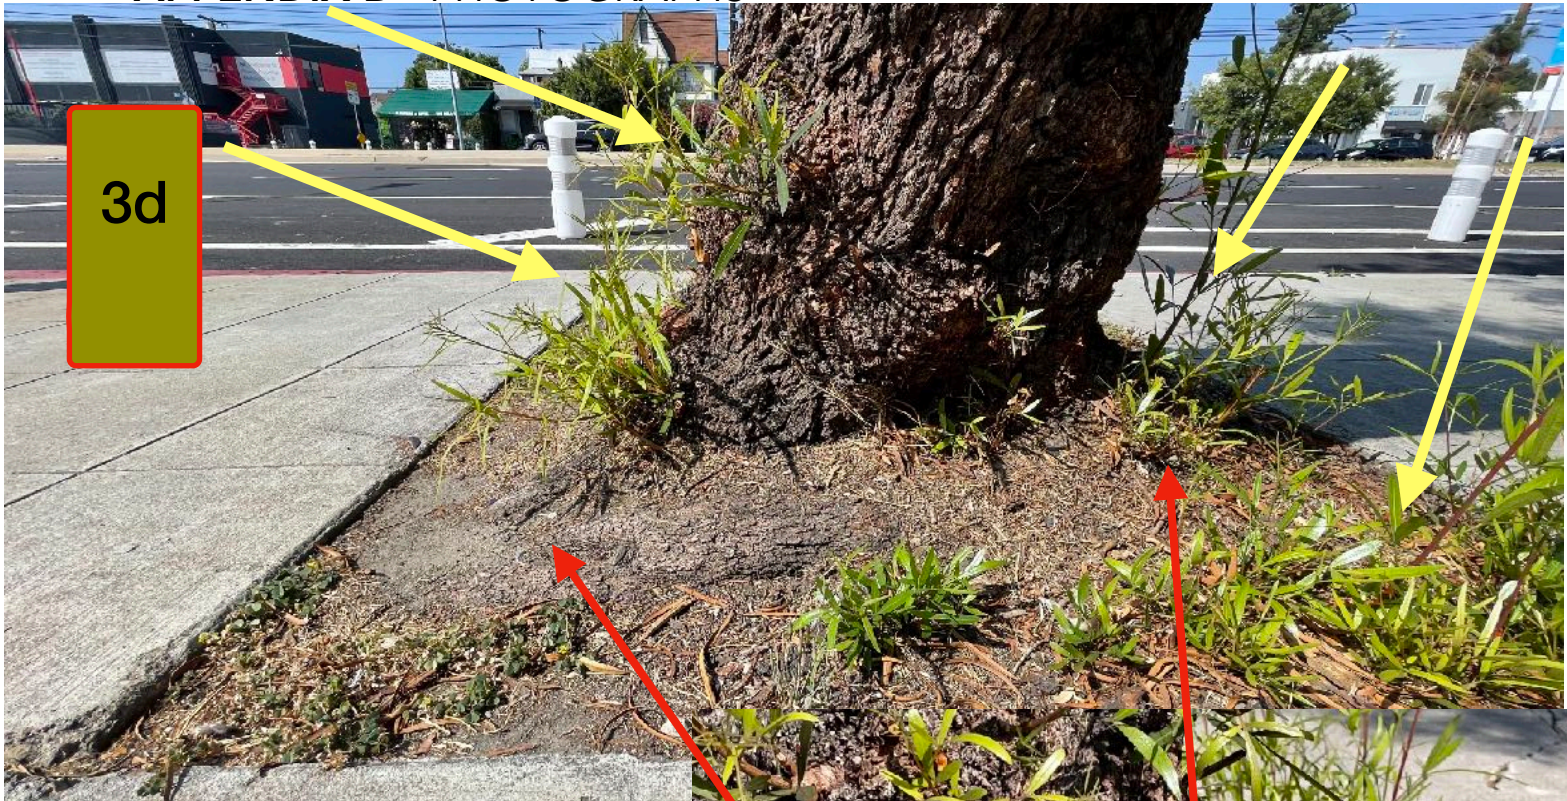
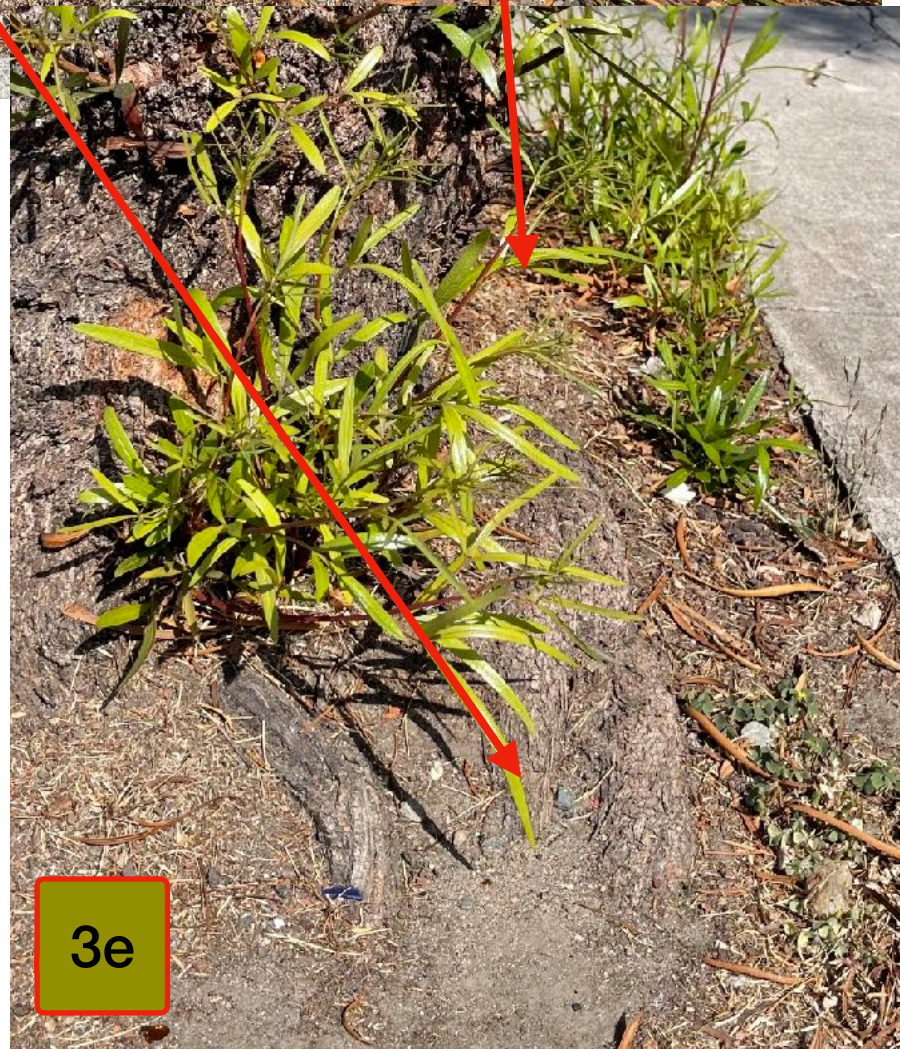
PHOTO - Shows City of Los Angeles street tree #3, recommend for removal.

3d) Yellow arrows show epicormic trunk and root sprouting, an indication the tree is stressed.

3d, e) Double red arrows show STEM GIRDLING ROOTS wrapped around trunk - from two different angles and indication how the ends correspond in each photo.

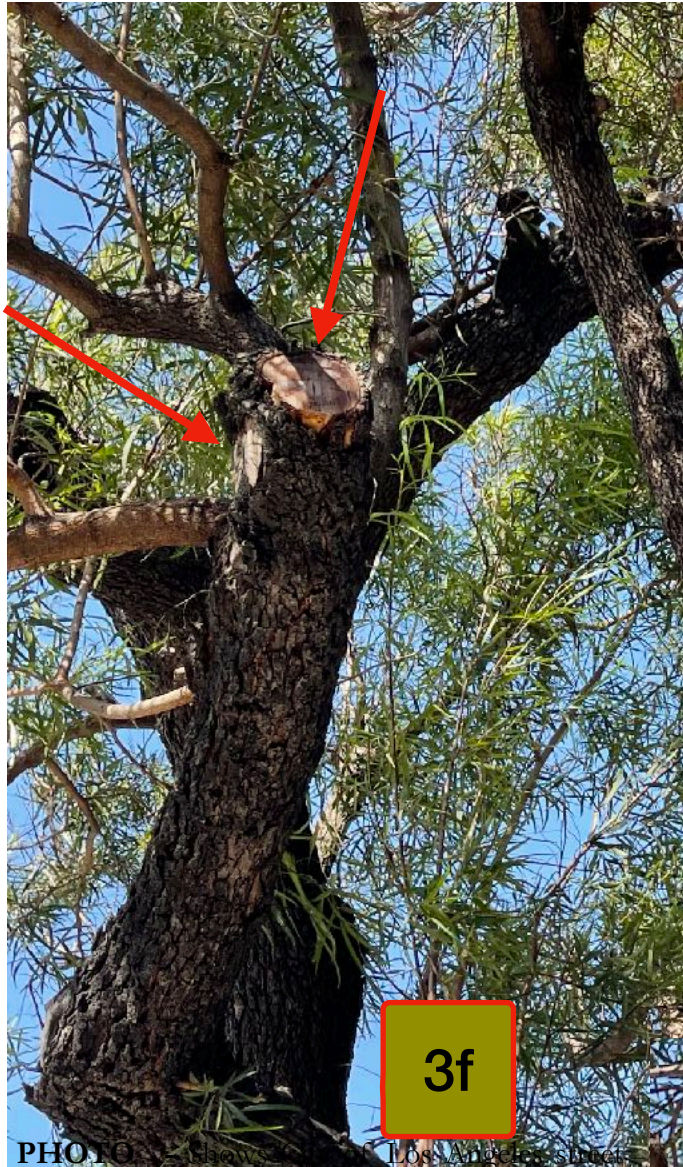
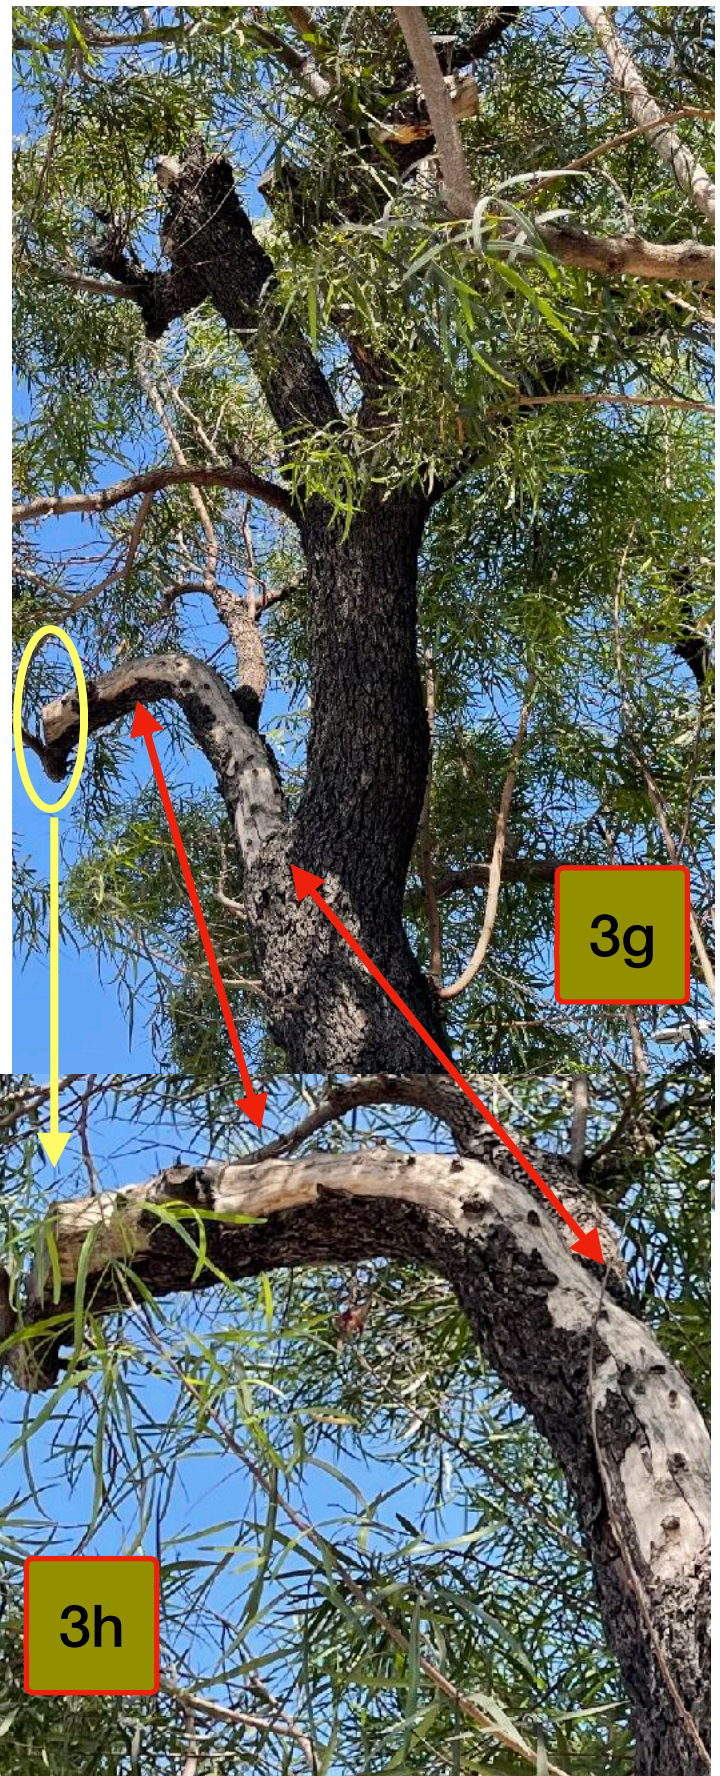
PHOTO 3f shows tree #3, recommend for removal.

3f) Old aggressive heading and topping cuts, all wood present at the time of wounding shall decay. The stems growing out of or adjacent to these topping cuts are more weakly attached to the tree and more prone to breakage.

3g, h) SUNSCALD - reduces branch strength and integrity - increases likelihood of branch failure. Topping exposes interior scaffold limbs to sun scald. Necrotic tissue on limb is a result of over exposure to direct sunlight and stub cut (yellow circle).

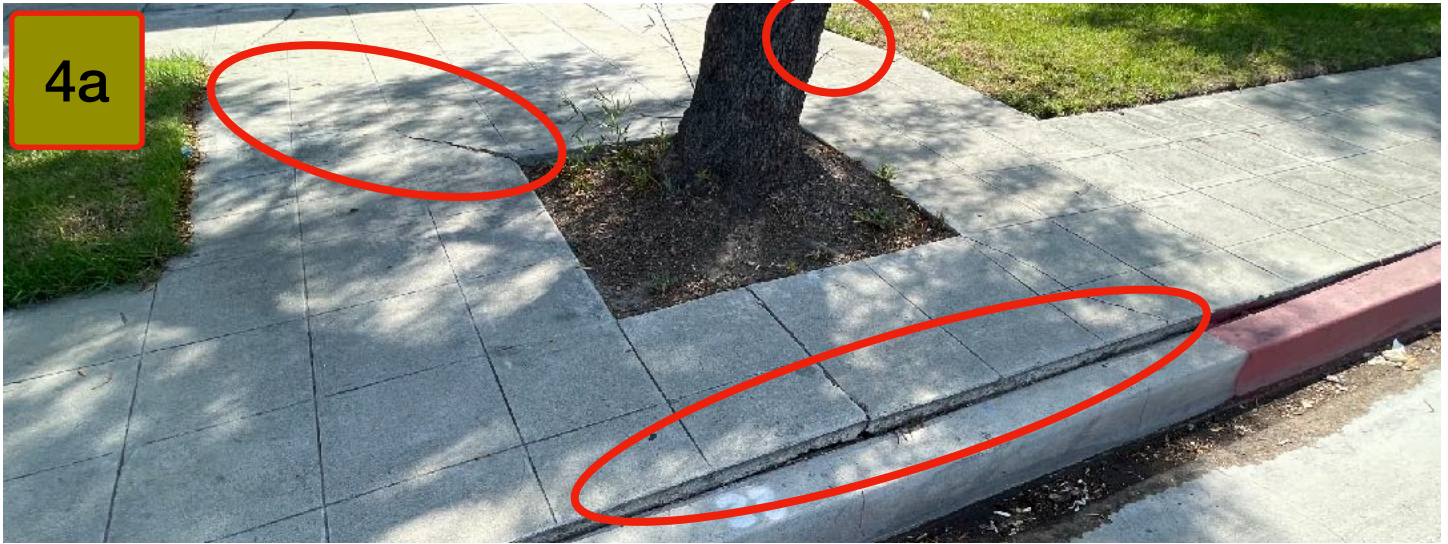
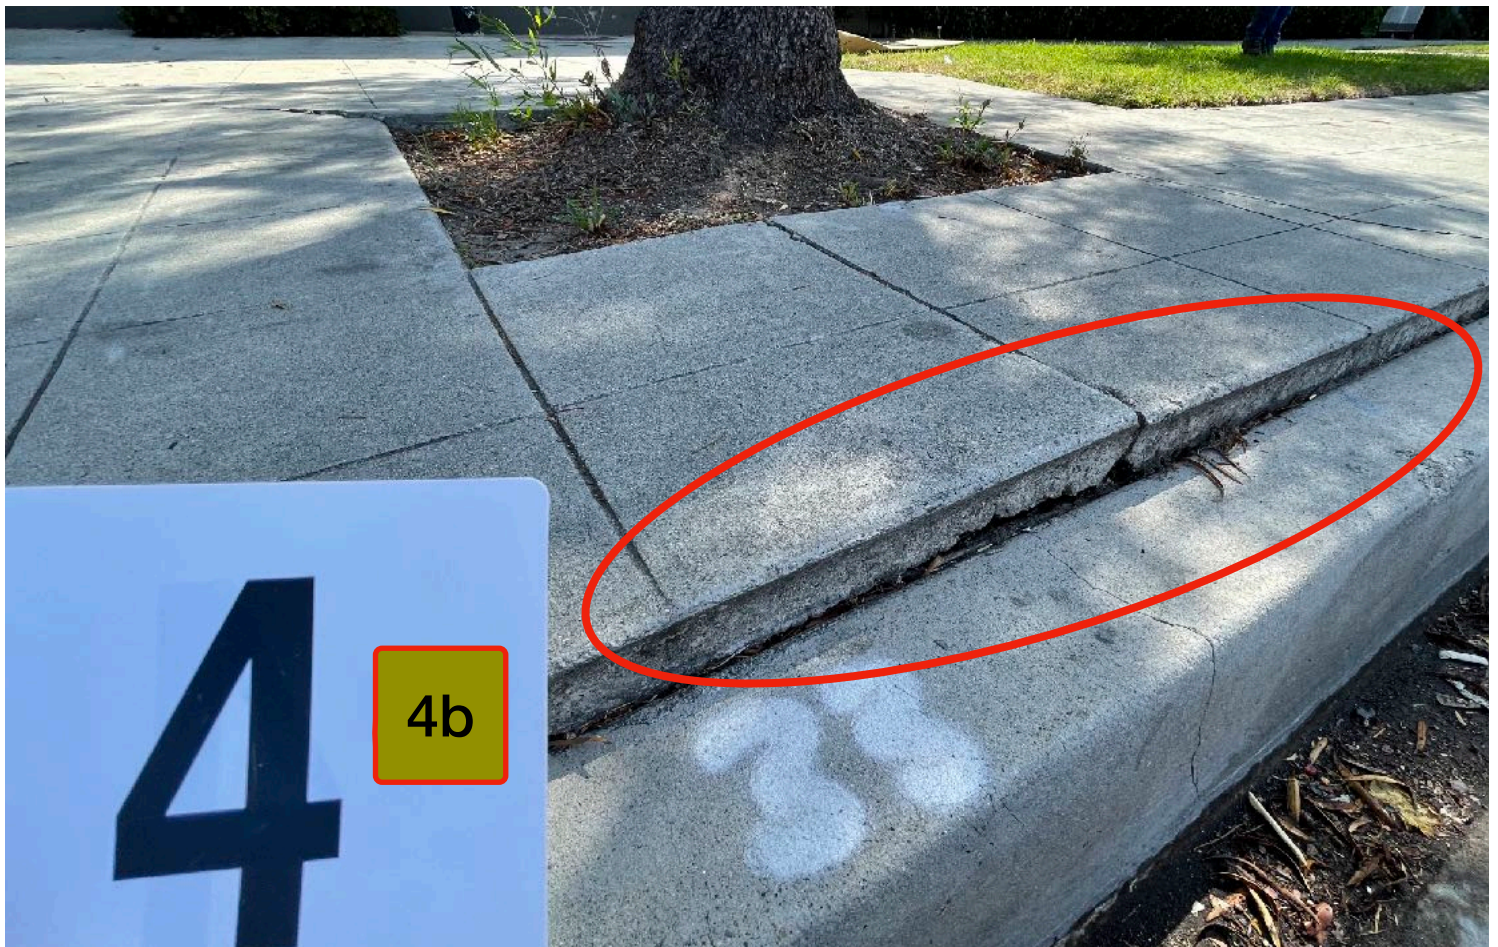
PHOTO - Shows City of Los Angeles street tree #4, recommend for removal.

3a) Cracking and uplifting of sidewalk in public right of way

3b) More prominent picture of sidewalk uplift.

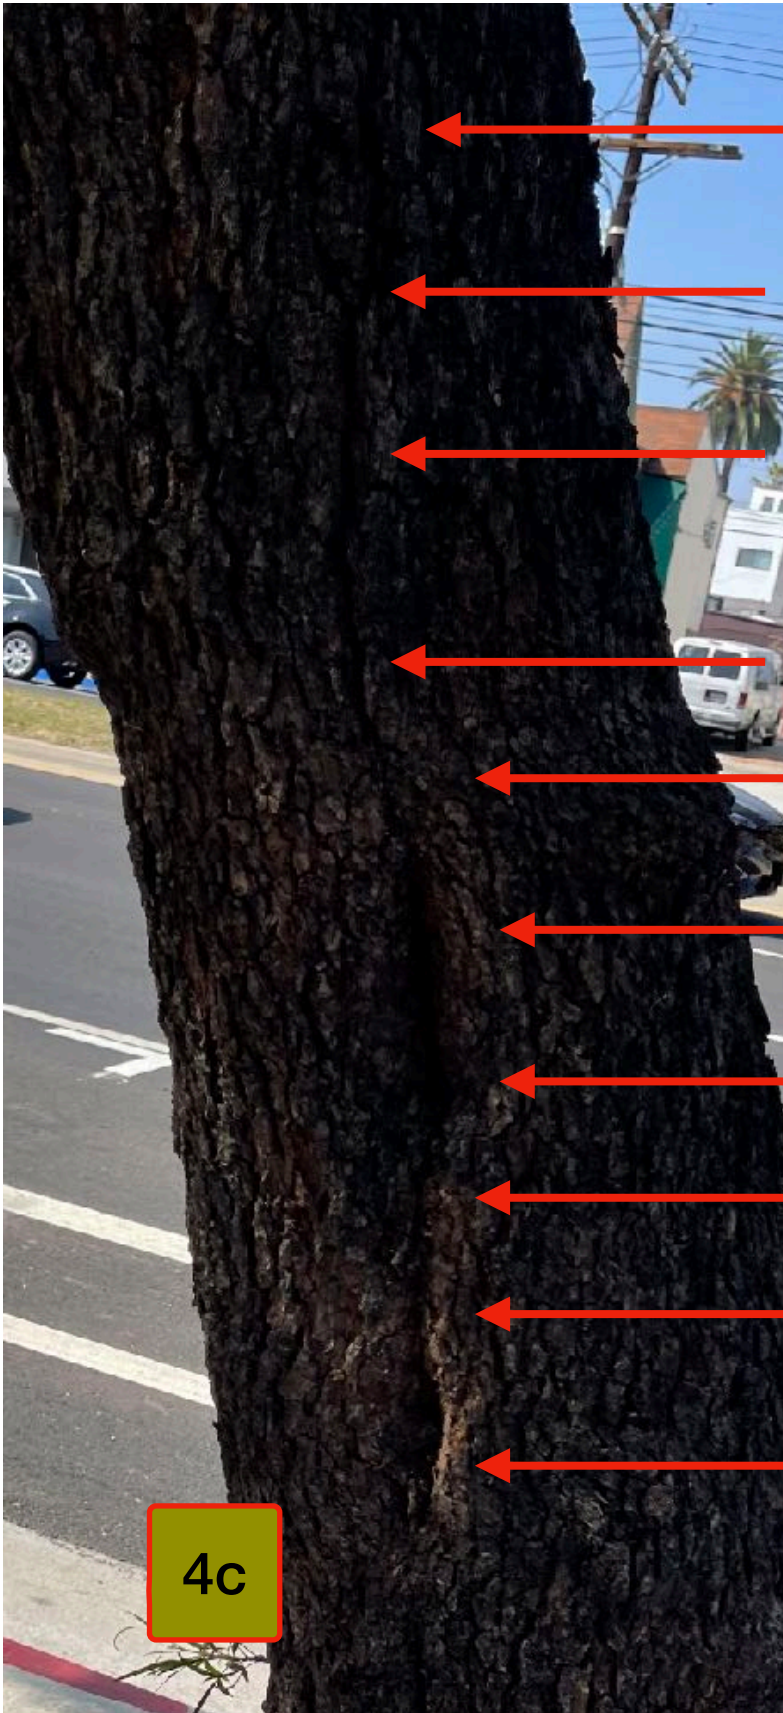
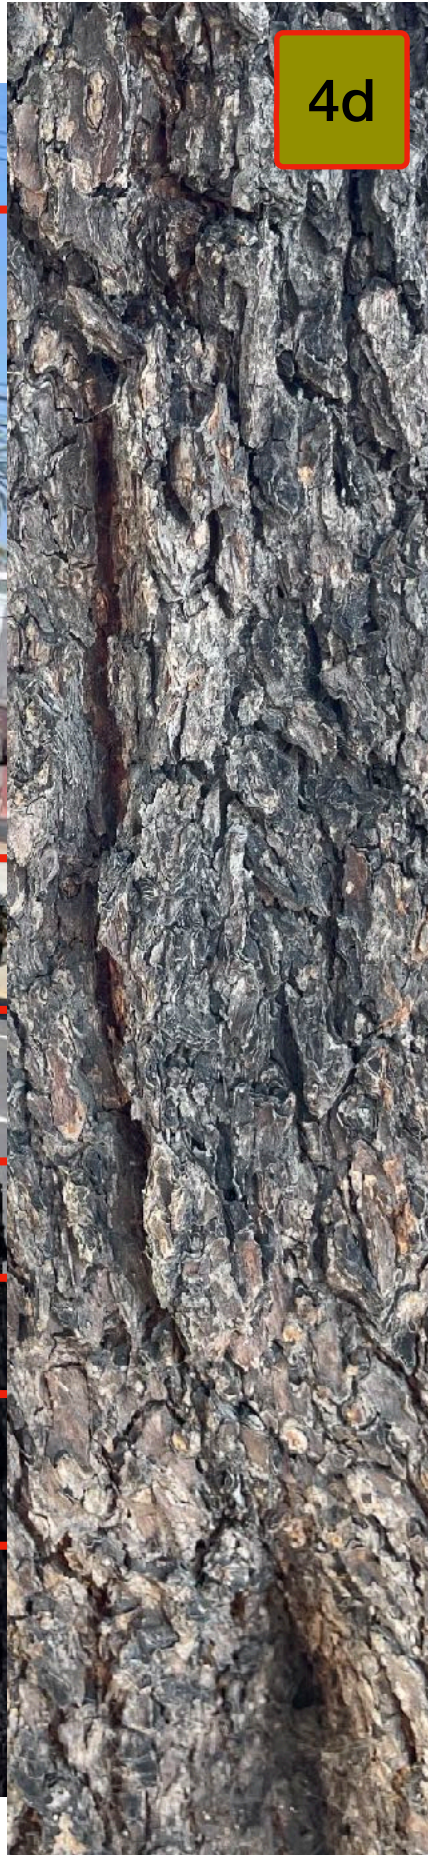
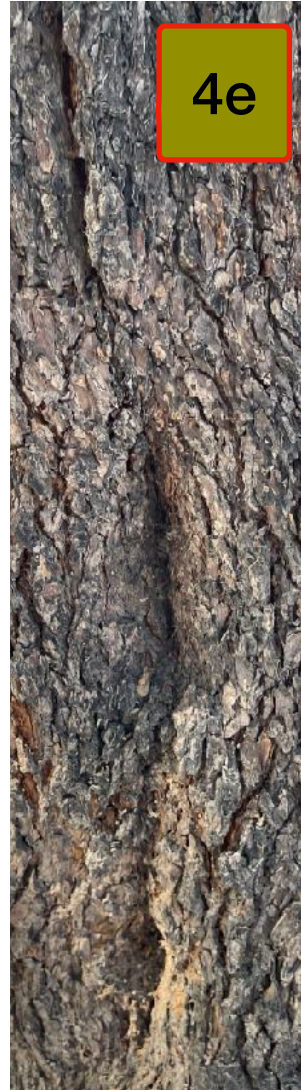
PHOTO - Shows City of Los Angeles street tree #4, recommend for removal.

4c, d, e) Bark fissure. Level 3 Tree Risk Assessment (Sonic Tomography) needed to determine extent of decay.

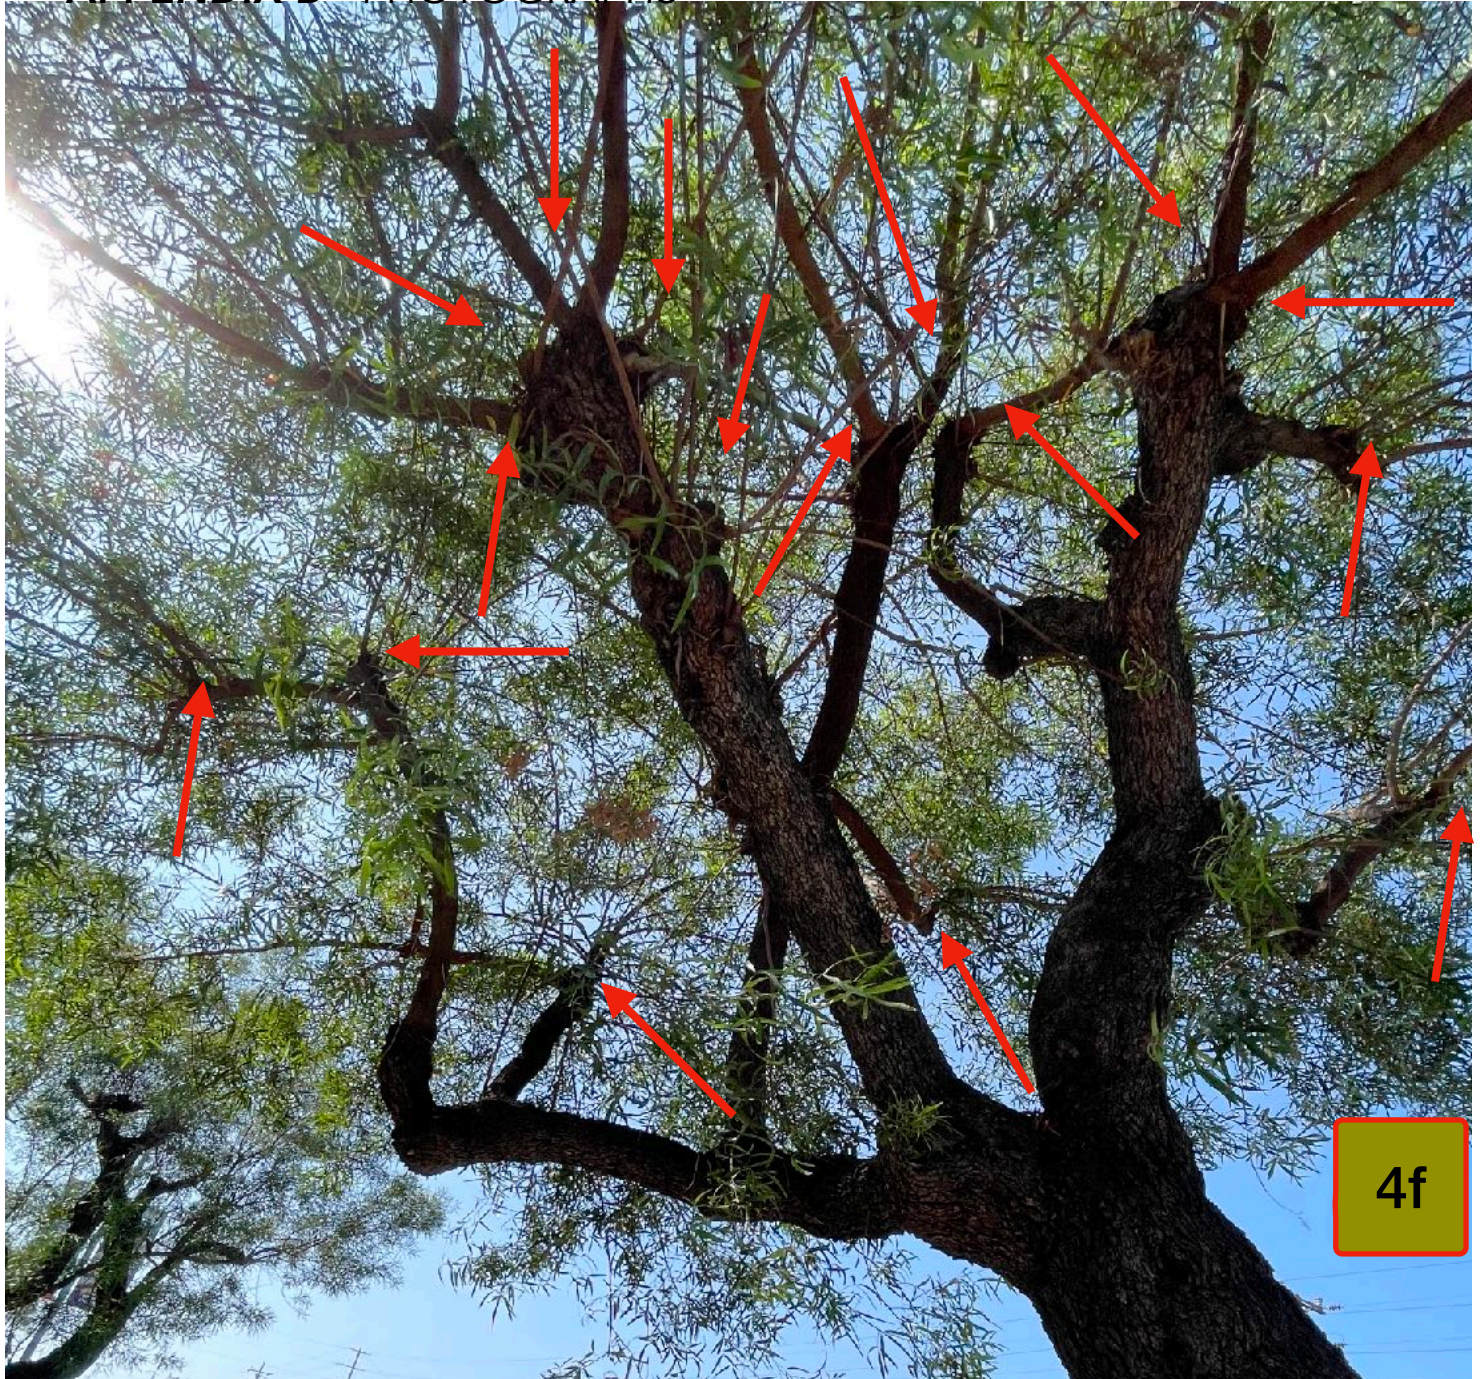
PHOTO - 4f) Shows the volume and extent of topping cuts. Sprouts emanating from these topping cuts have weaker attachment, are more prone to breakage and decay

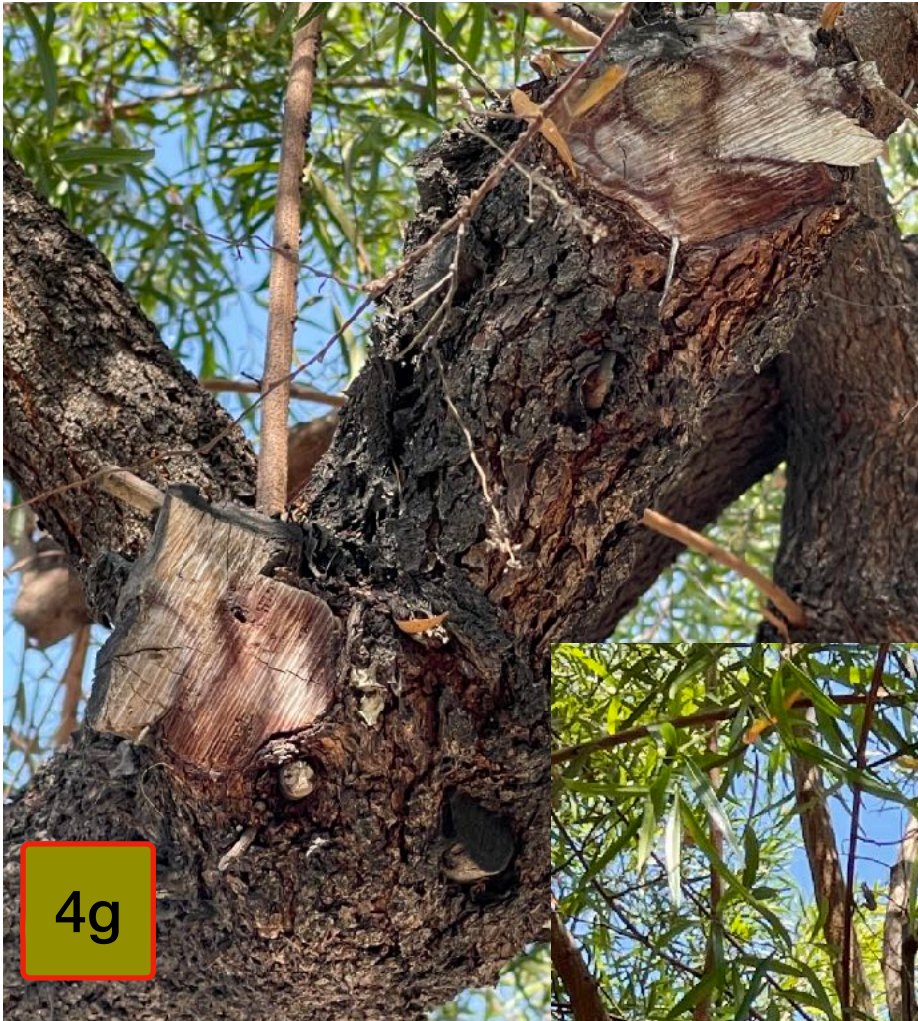
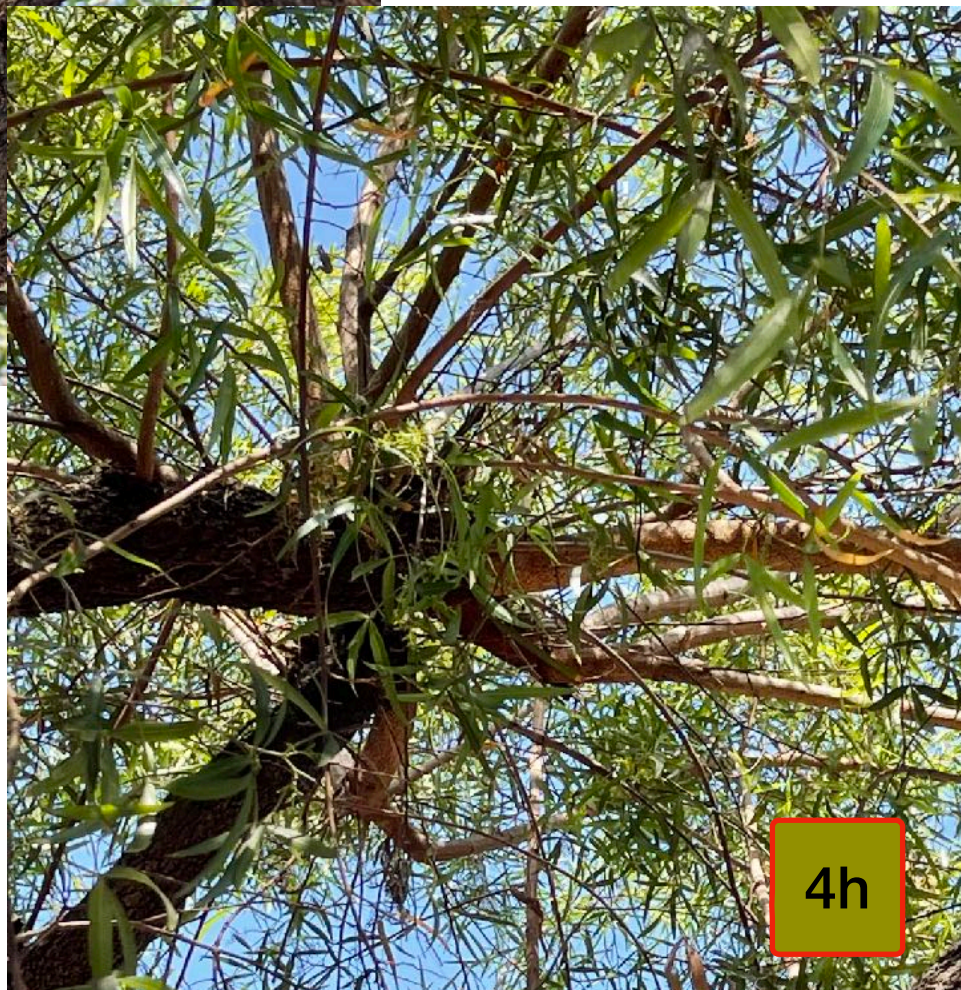
PHOTO - Shows City of Los Angeles street tree #4, recommend for removal.

4g) Old topping wounds with necrotic stubs

4h) Old topping wound with adventitious sprout growth.

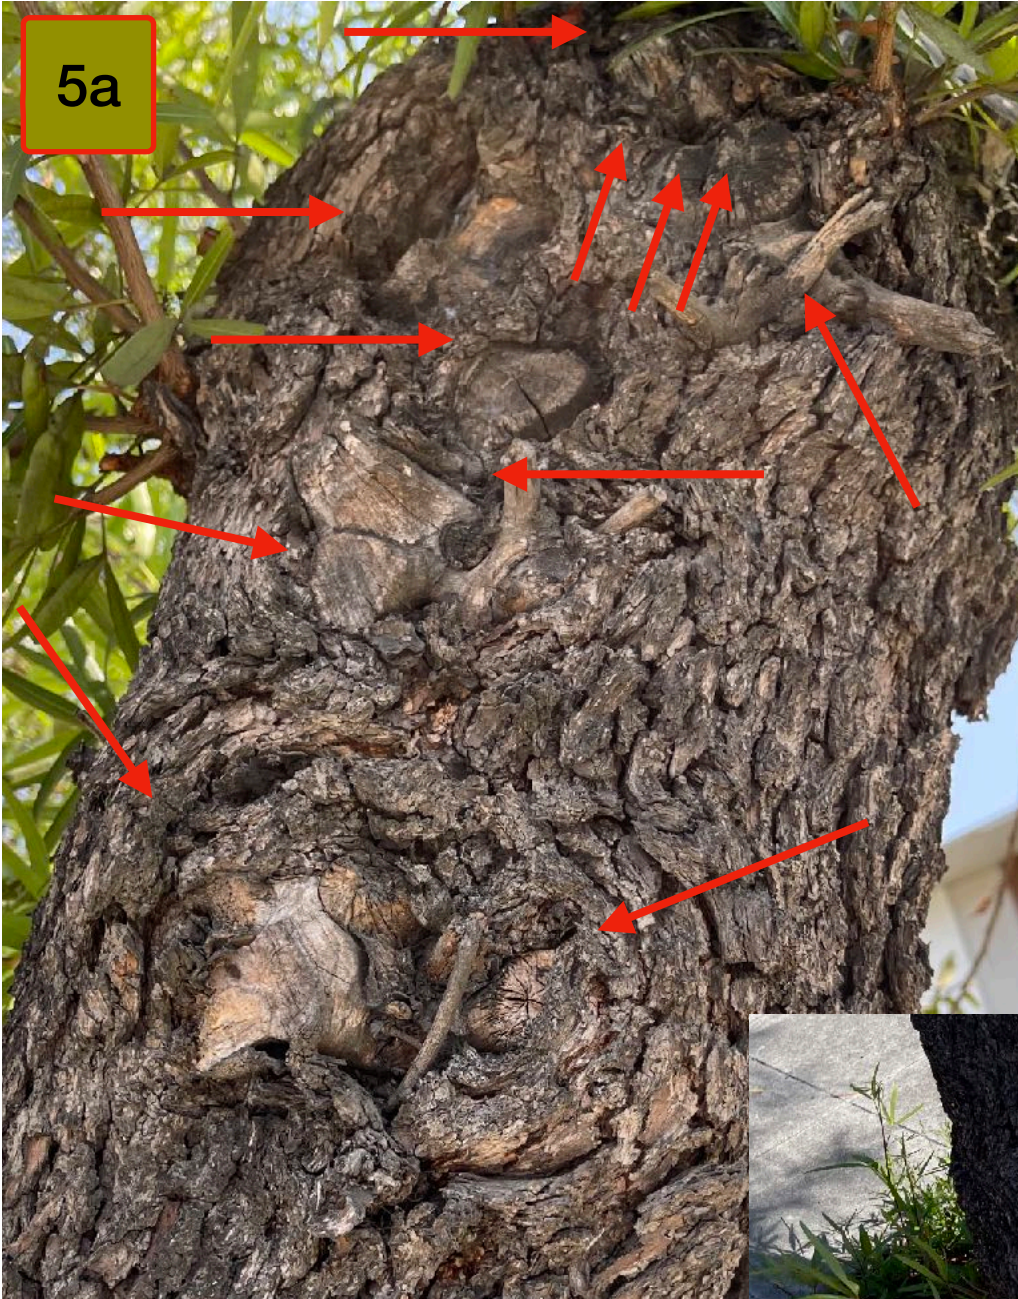
5a

PHOTO - Shows City of Los Angeles street tree #5, recommend for removal.

5a) Many years worth of old flush cuts now with necrotic stubs, decay present.

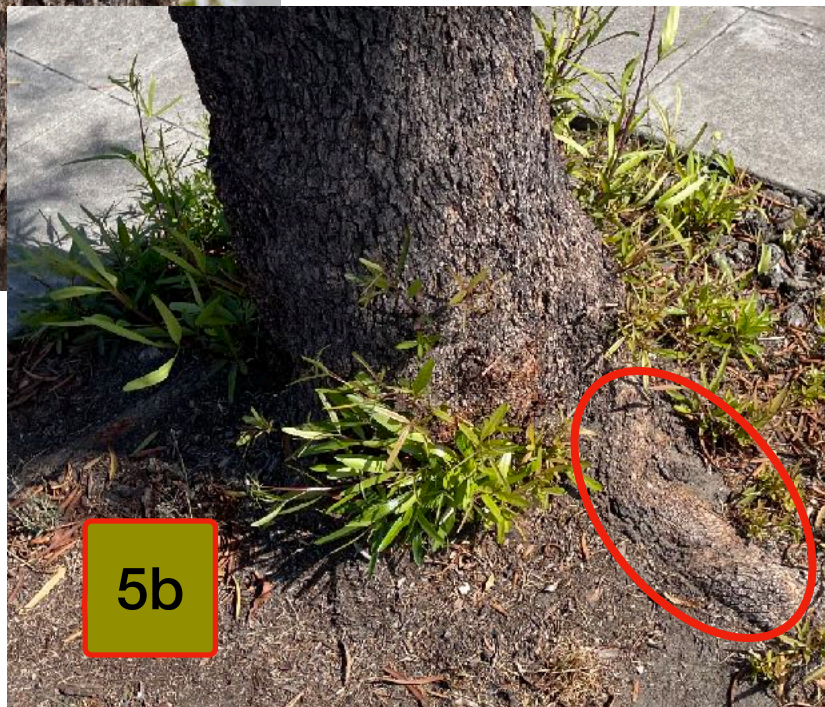
5b

5b) Girdling root

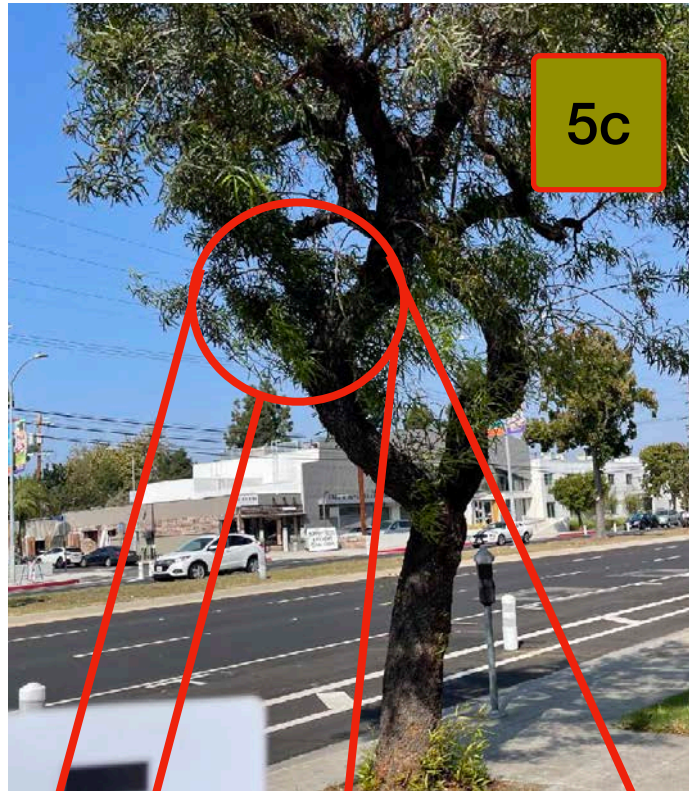
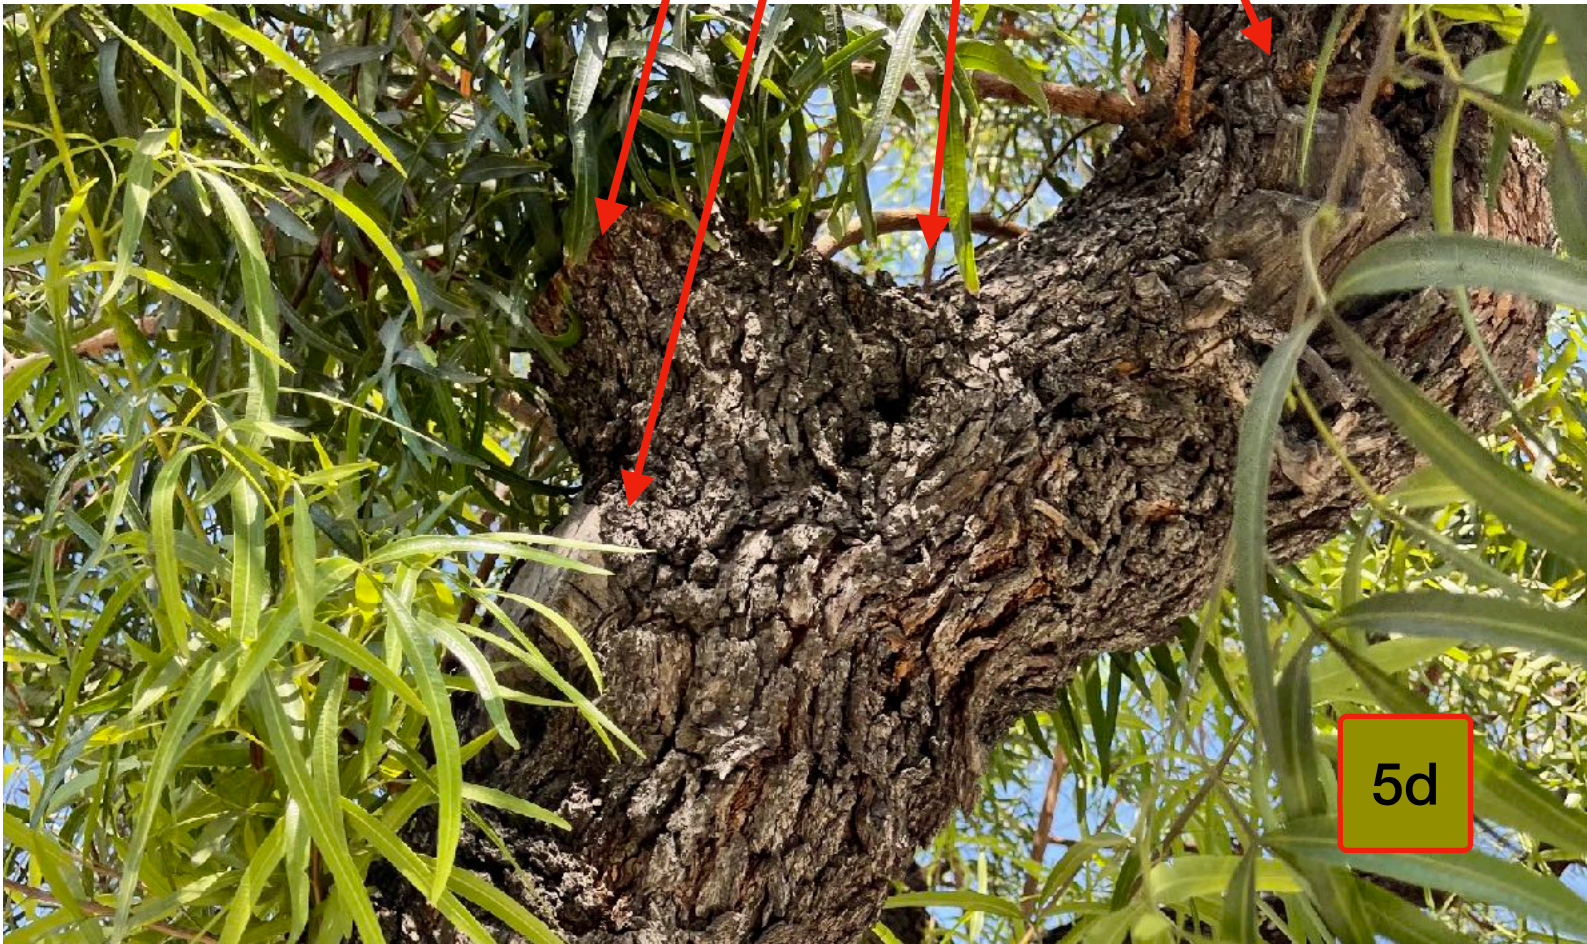
PHOTO - Shows City of Los Angeles street tree #5, recommend for removal.

5c) Macro view of area with necrosis.

5d) Expanded view of frequent flush cutting, necrotic stubs & cavity.

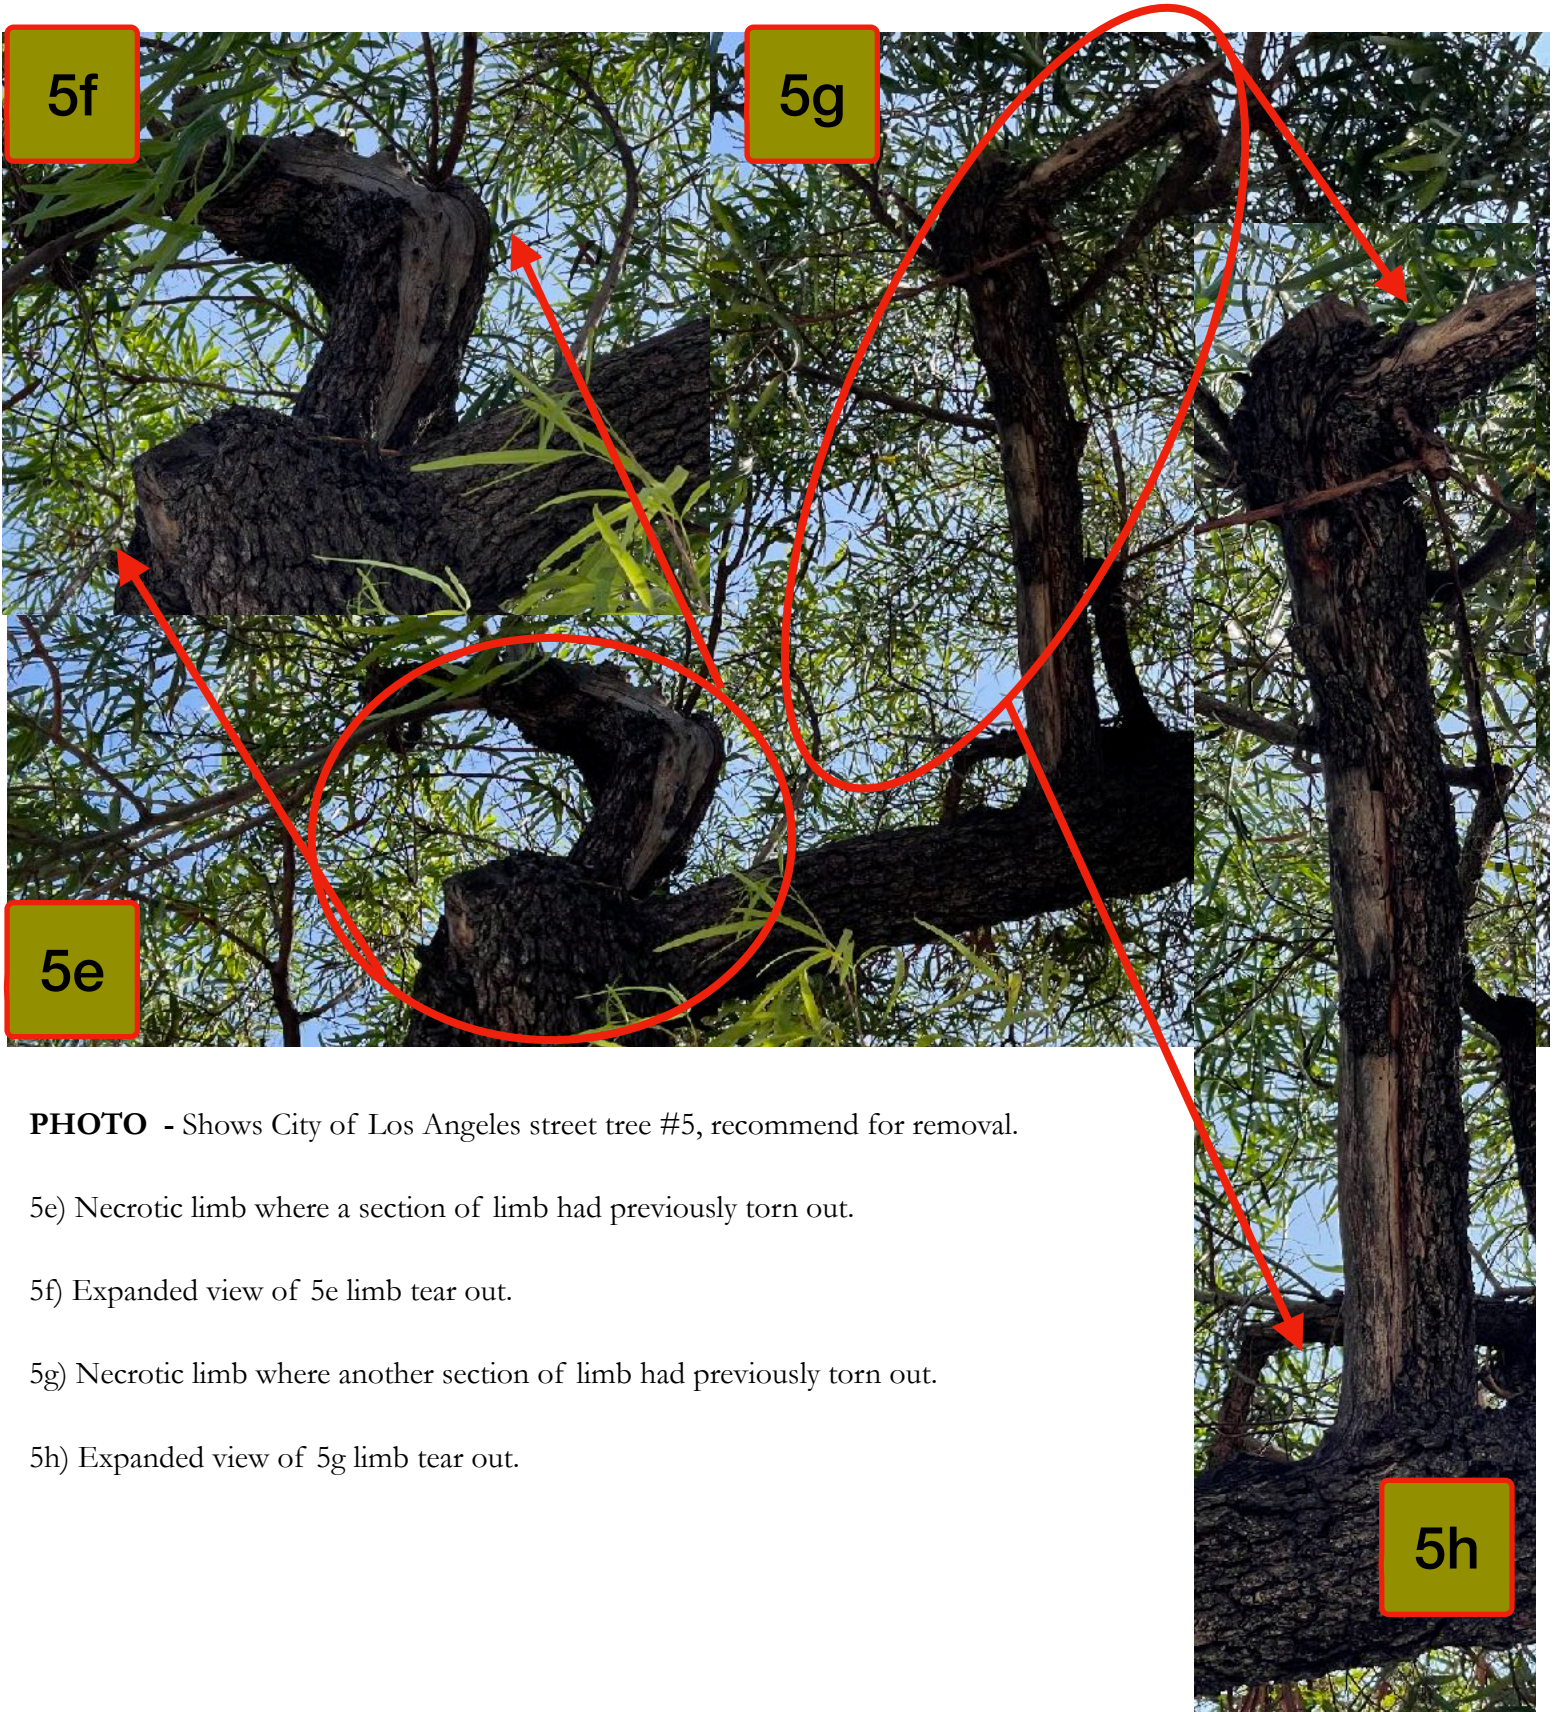
PHOTO - Shows City of Los Angeles street tree #5, recommend for removal.

5e) Necrotic limb where a section of limb had previously torn out.

5h) Expanded view of 5g limb tear out.

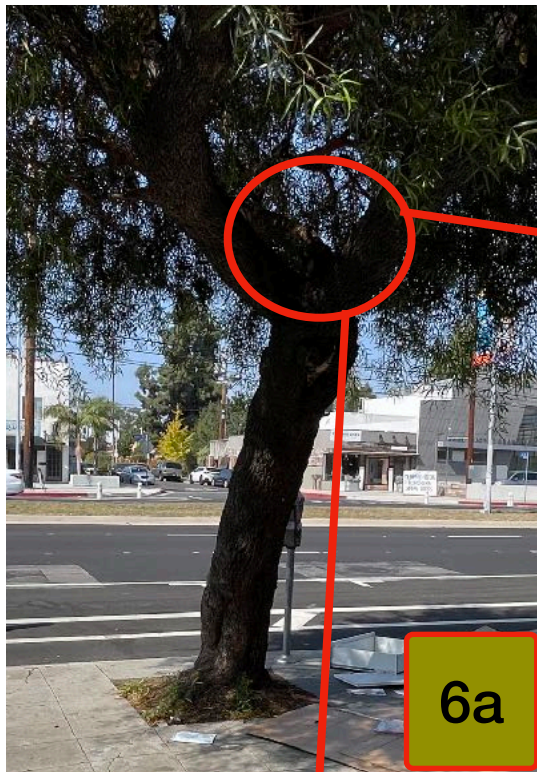
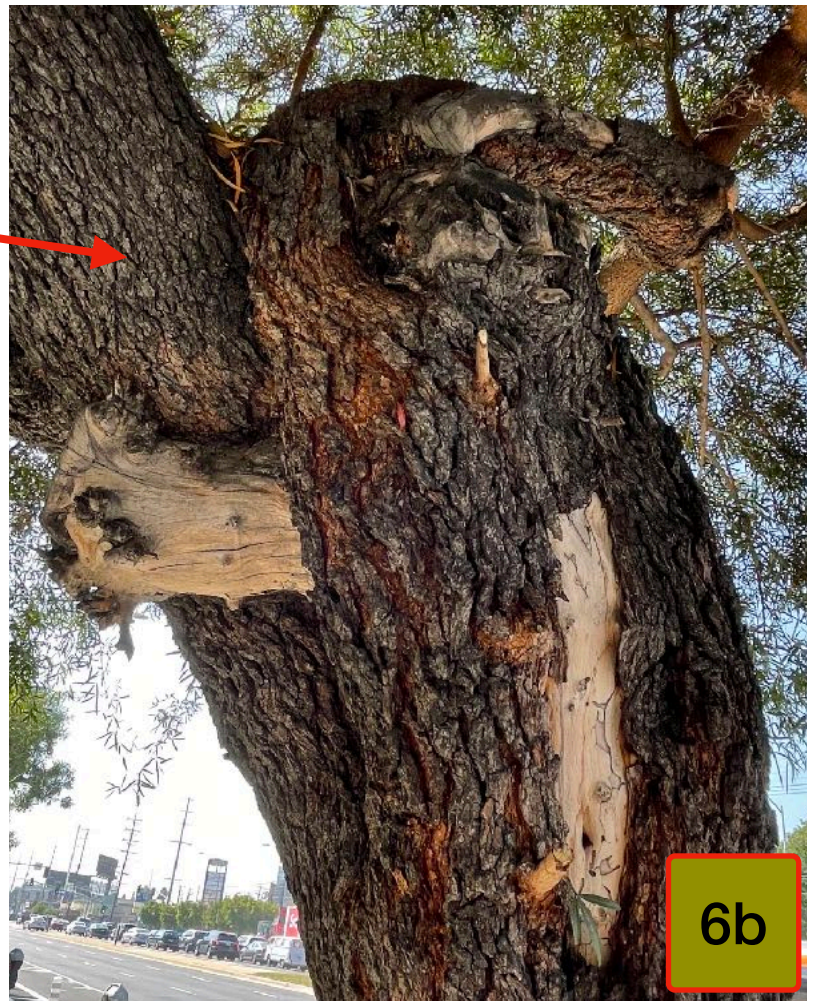
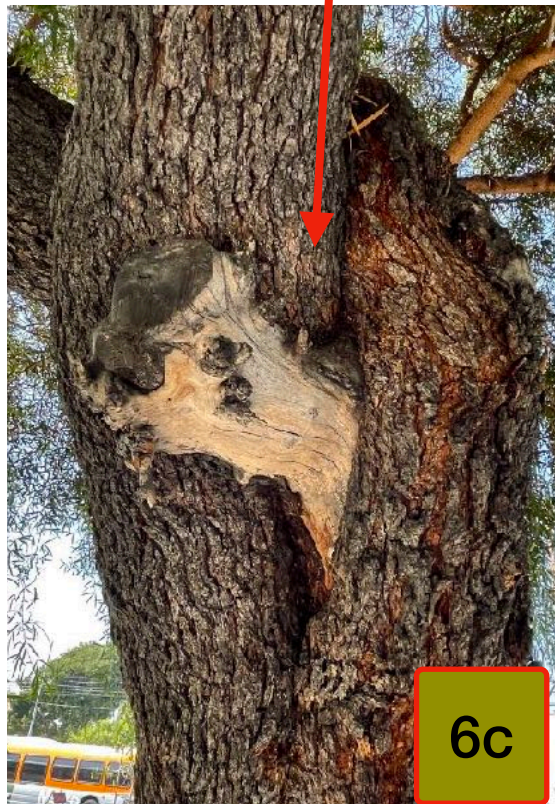
PHOTO - Shows City of Los Angeles street tree #6, recommend for removal.

6a) Where main trunk (bole) and largest scaffold limbs branch out.

6c) Scaffold limb with necrotic stub and very poor structure, expanding crossing limb and an inclusion, that has a high likelihood of being an area prone to trunk splitting.
