CROSSINGS CAMPUS

Addendum to Draft Environmental Impact Report State Clearinghouse No. 2021110079

ADDENDUM TO THE ENVIRONMENTAL IMPACT REPORT FOR THE CROSSINGS CAMPUS PROJECT

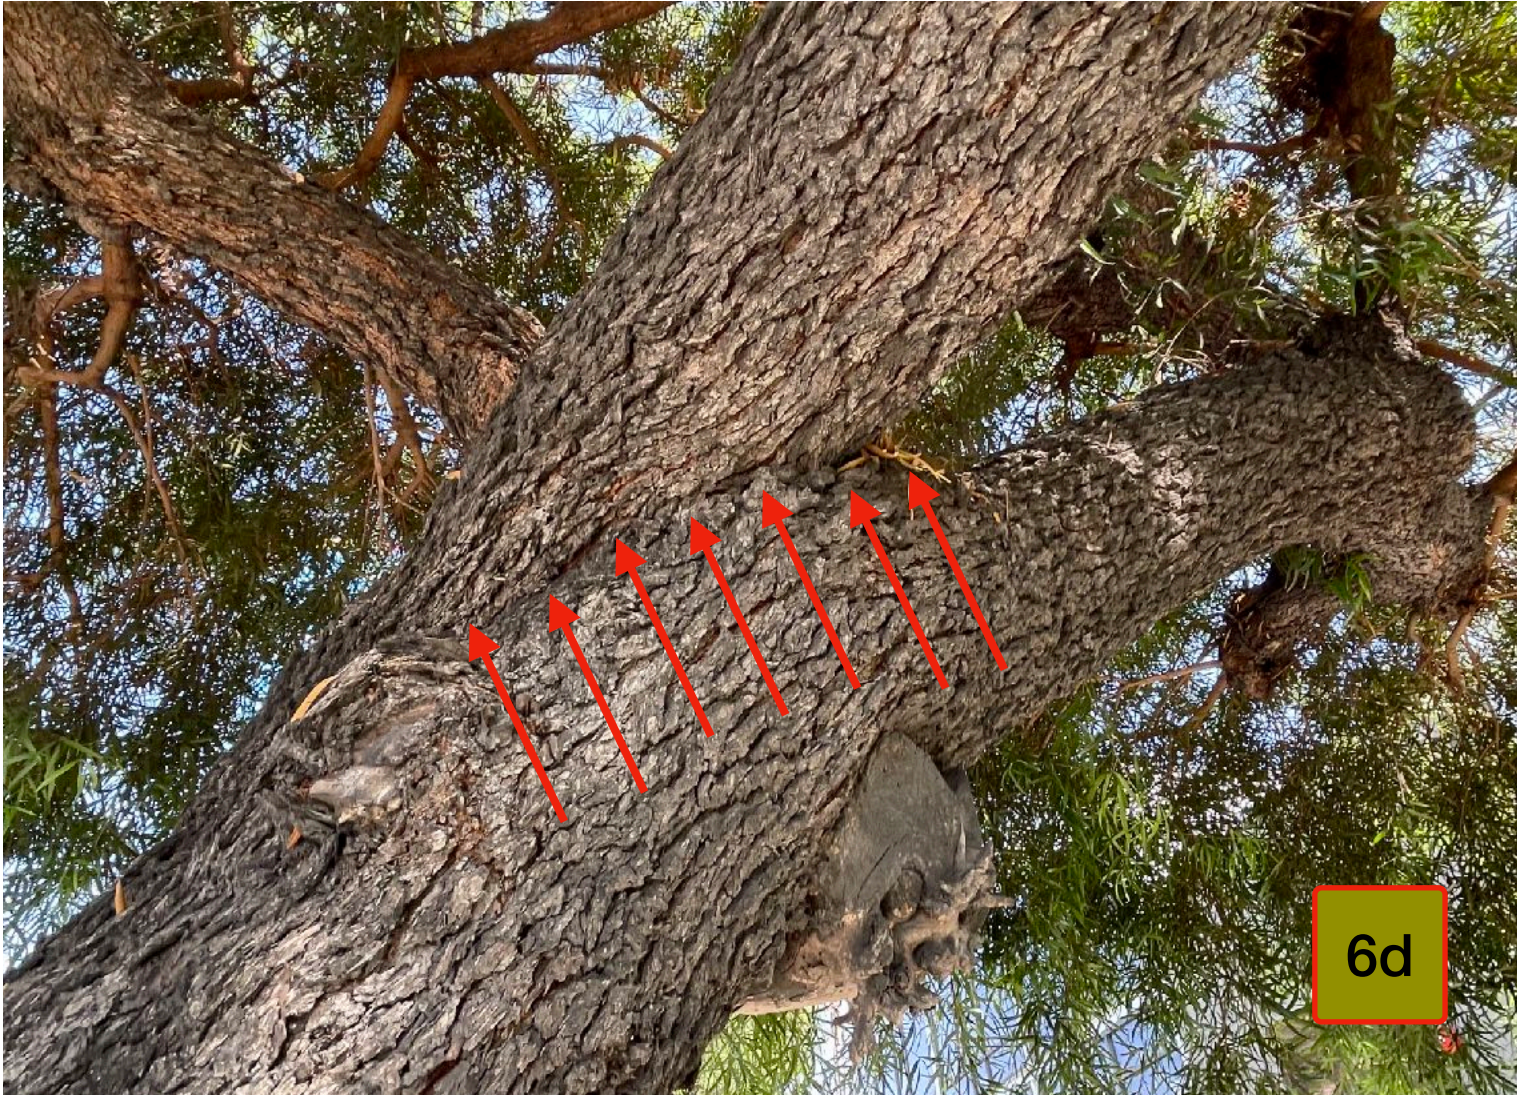
PHOTO - Shows City of Los Angeles street tree #6, recommended for removal and replacement.

6d) Shows the opposite side of the trunk from photos 6b and 6c. The inclusion from the crossing limb show the same potential or likelihood of failure is present on both sides of where the main trunk has generated primary scaffold limb structure.

All other defects or issues above this union only compound the problem. As the tree continues growing the weight this union is expected to support grows in every direction, increasing the likelihood of failure.

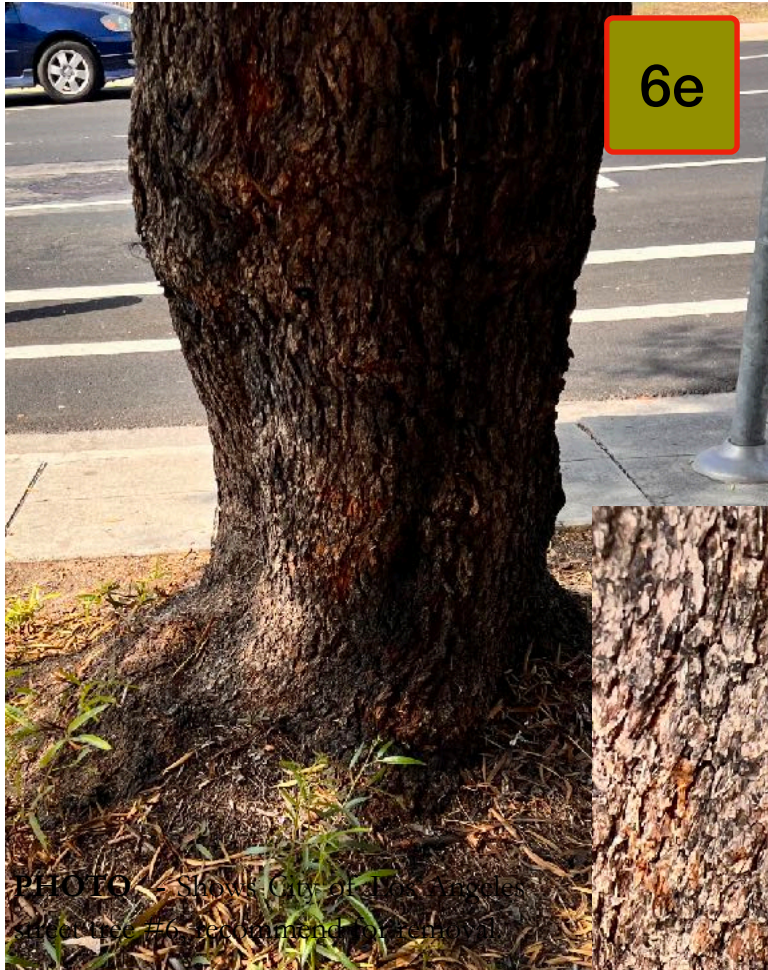
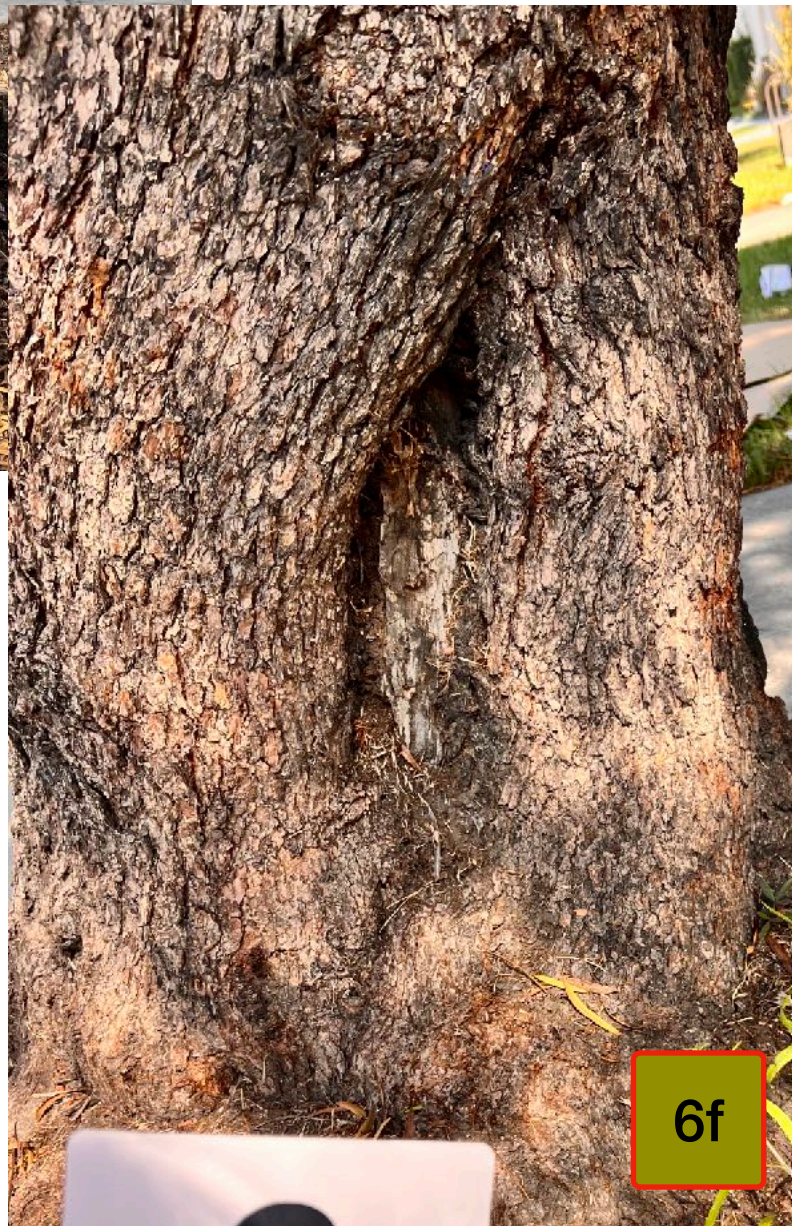
6e) A tree trunk with a vase shape is an indication that nutrient transport between the root system and the rest of the tree has been interrupted. The bottom of this “vase” is another area prone to failure.

6f) This cavity is a contributing factor in the tree trunk narrowing at the base, similar to a vase. The cavity was only noted and recorded, no probing of the cavity was performed.

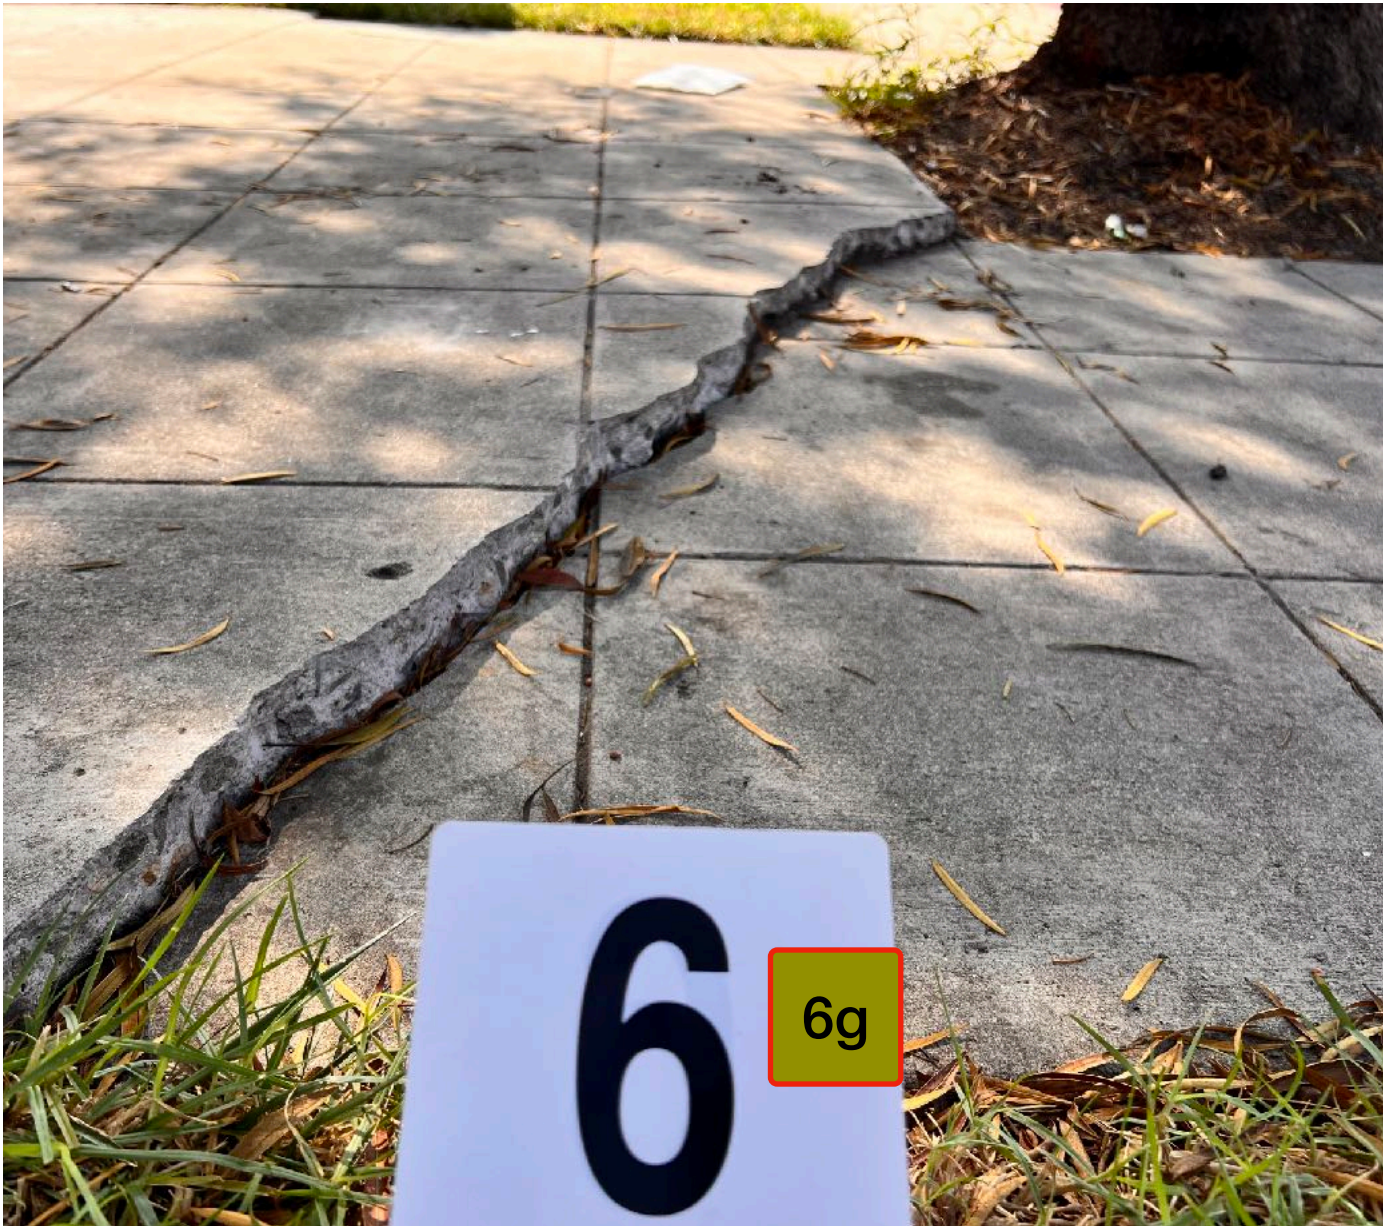
PHOTO - Shows City of Los Angeles street tree #6, recommend for removal.

6g) Cracking and uplifting of sidewalk in public right of way.

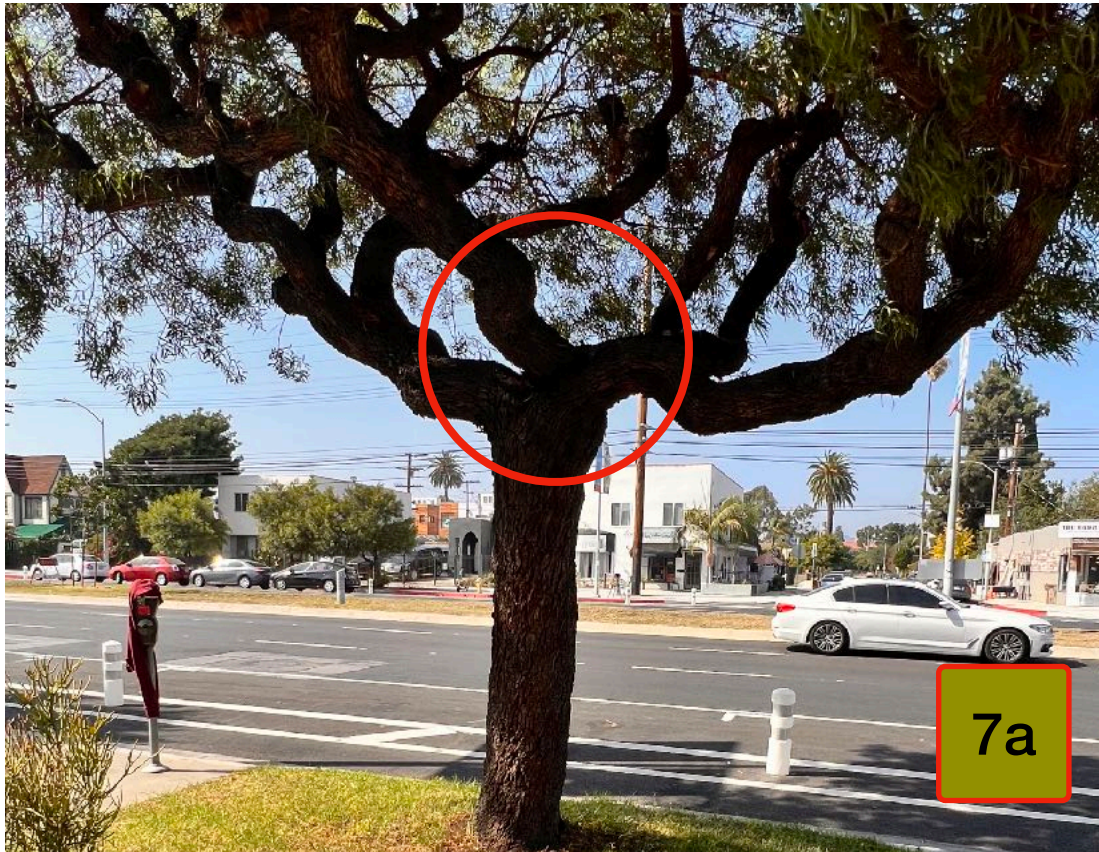
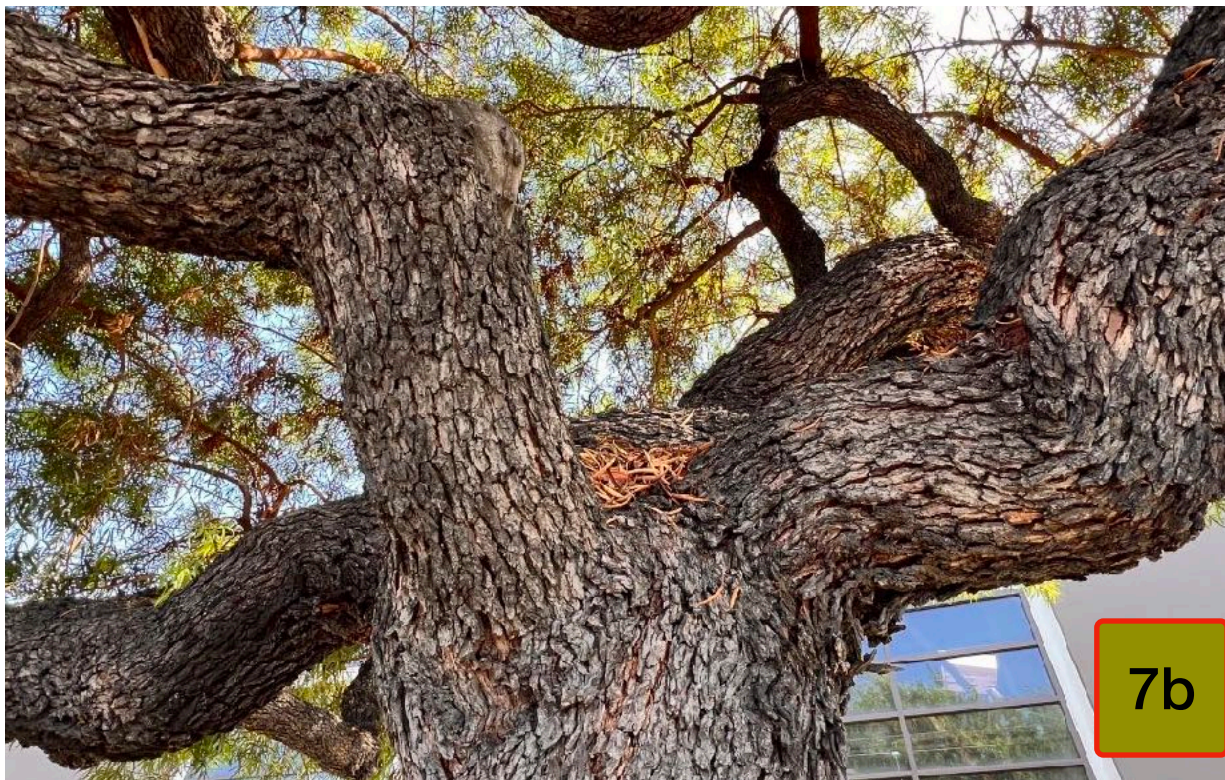
PHOTO - Shows City of Los Angeles street tree #7, recommended for removal and replacement.
7a, b) Represent poor structure and attachment for a tree of this species and size, that is prone to breakage.
8888 Venice Blvd, Los Angeles

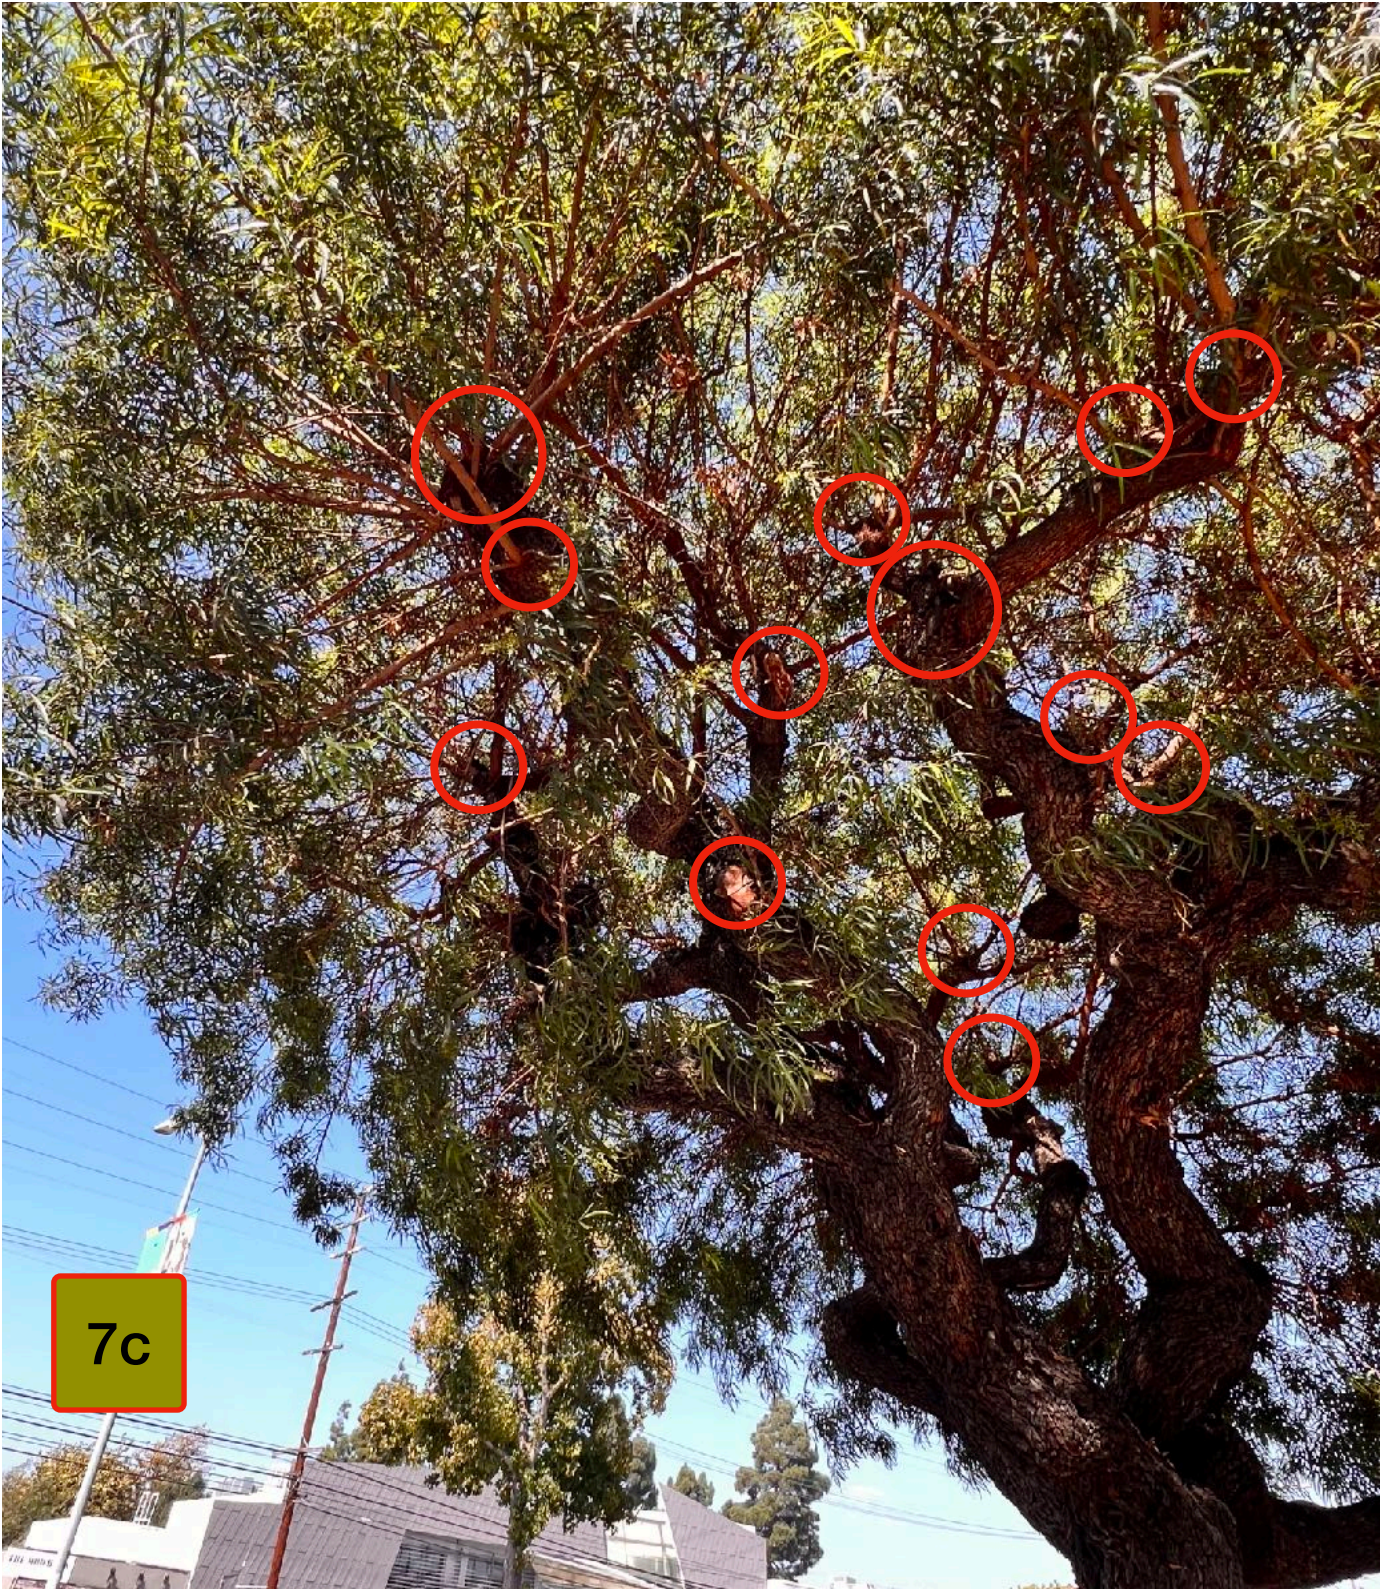
PHOTO - Shows City of Los Angeles street tree #7, recommended for removal and replacement.

7c) Red circles represent origin points for dozens of resprouting limbs from topping cuts.
8888 Venice Blvd, Los Angeles
