RE: 2535 Pulgas Street, East Palo Alto, CA

Date: 11/20/2020

ARBORIST REPORT

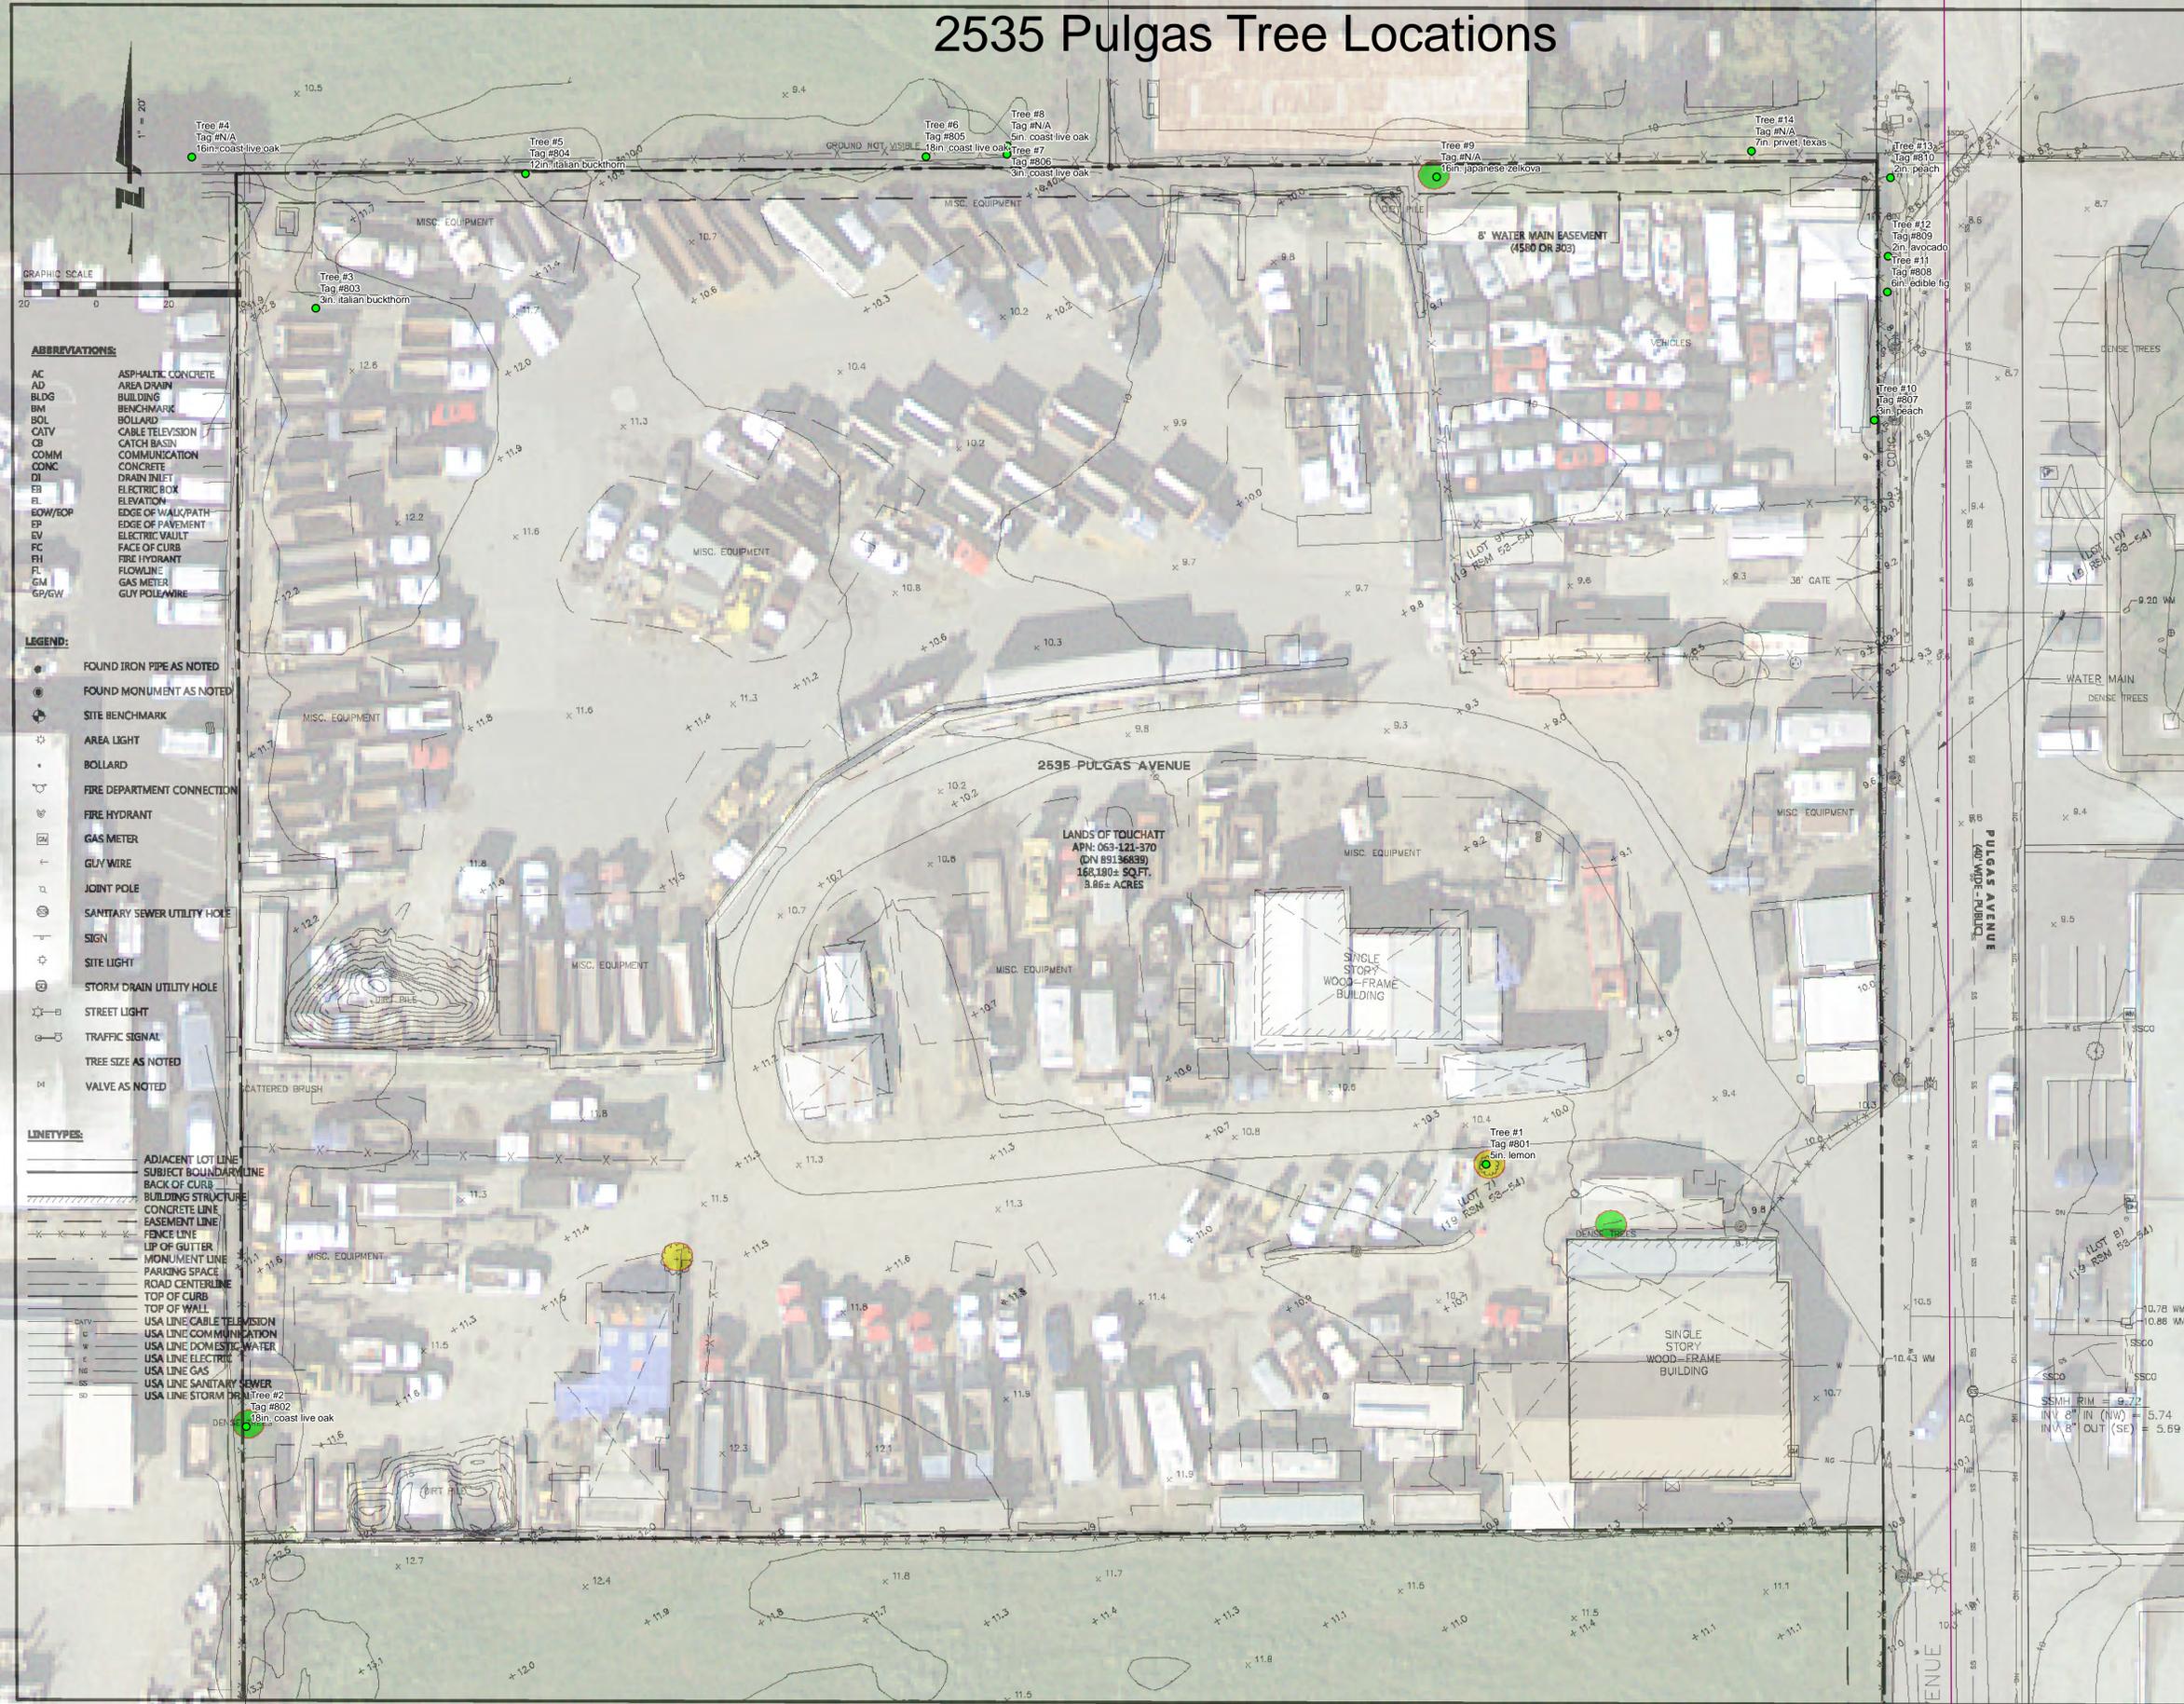
2535 Pulgas Tree Locations

We visited the site on November 17, 2020 and completed the tree survey that day. A total of (14) trees met the criteria of the scope. Eight (8) of these surveyed trees were determined to be Protected Trees. Complete data for the inventoried trees can be found in the attached data table. Along with the data available in the data table, tree locations were noted in the field using GPS coordinates and used to overlay the surveyed trees on a site survey dated 10/19/2020 prepared by BKF Engineers. Aerial imagery downloaded from the US Geological

Survey was also included in the map to provide better context for the tree locations. Some trees on private property were near the fence-line, but the fence was missing or smashed, so their ownership is uncertain.

We recommend that the existing trees on site and adjacent street trees be removed. If owners of trees on neighboring properties are amenable, the inventoried trees on those properties should also be removed. Current preliminary plans show at least 50 trees planned for planting as part of the project. These deliberate plantings that can be managed from planting to maturity will provide much greater benefits to the property than the unmanaged collection currently on site.
