# T.O. Ranch Mixed-Use and Multi-Family Residential Redevelopment Project

## Oak and Landmark Tree Report

**March 2022**

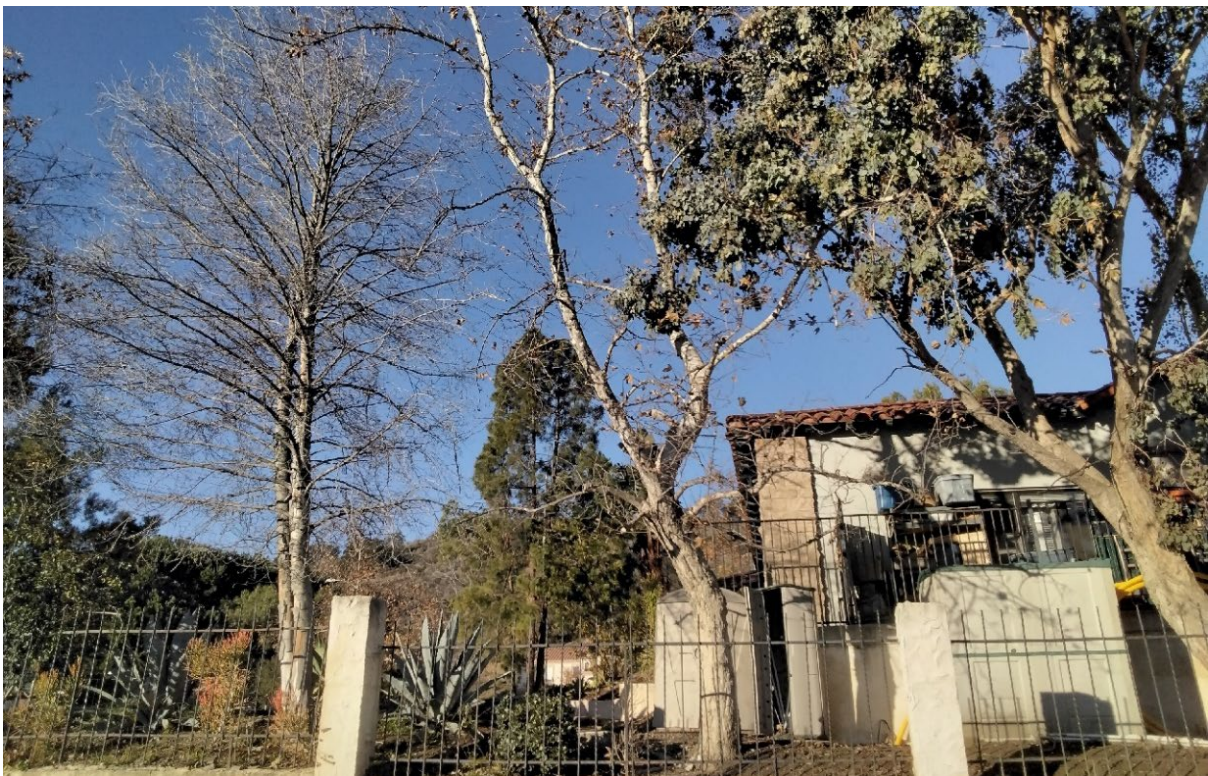
**Photograph 6.** Tree #6 California sycamore (*Platanus racemosa*)

6	California sycamore <i>Platanus racemosa</i>	1	12.5	12.5	30	20	(15,10,16,5,10,5,5,5)	D	Y	Codominant stems, weak branch attachments, sparse canopy abnormal of seasonal leaf drop, leaning caused by kink midway up trunk	Tree on elevated slope on other side of fence, not tagged	Major (Removal)	Approximately 63% of TPZ will be encroached by grading. The tree's long-term survival would be unknown.
7	California sycamore <i>Platanus racemosa</i>	3	18, 18, 9	45	35	40	(25,15,20,20,15,20,20,25)	D	Y	Included bark between codominant stems causing weak trunk attachment, vines covering trunk base making way up through branching into canopy, may contribute to restricting tree's ability to uptake nutrients/water	Tree in fence line, within project boundary	Major (Removal)	Approximately 30% of TPZ will be encroached by grading. The tree's long-term survival would be unknown
8	Coast live oak <i>Quercus agrifolia</i>	3	6, 8, 10	24	22	20	(15,10,10,5,5,8,10,10)	C	N	5% leaf chlorosis throughout canopy, codominant stems, cracked trunk	Tree on sidewalk outside of fence, immediately adjacent to project boundary, canopy and tpz within project area, tagged	Major (Removal)	Tree will be removed due to location of Building C

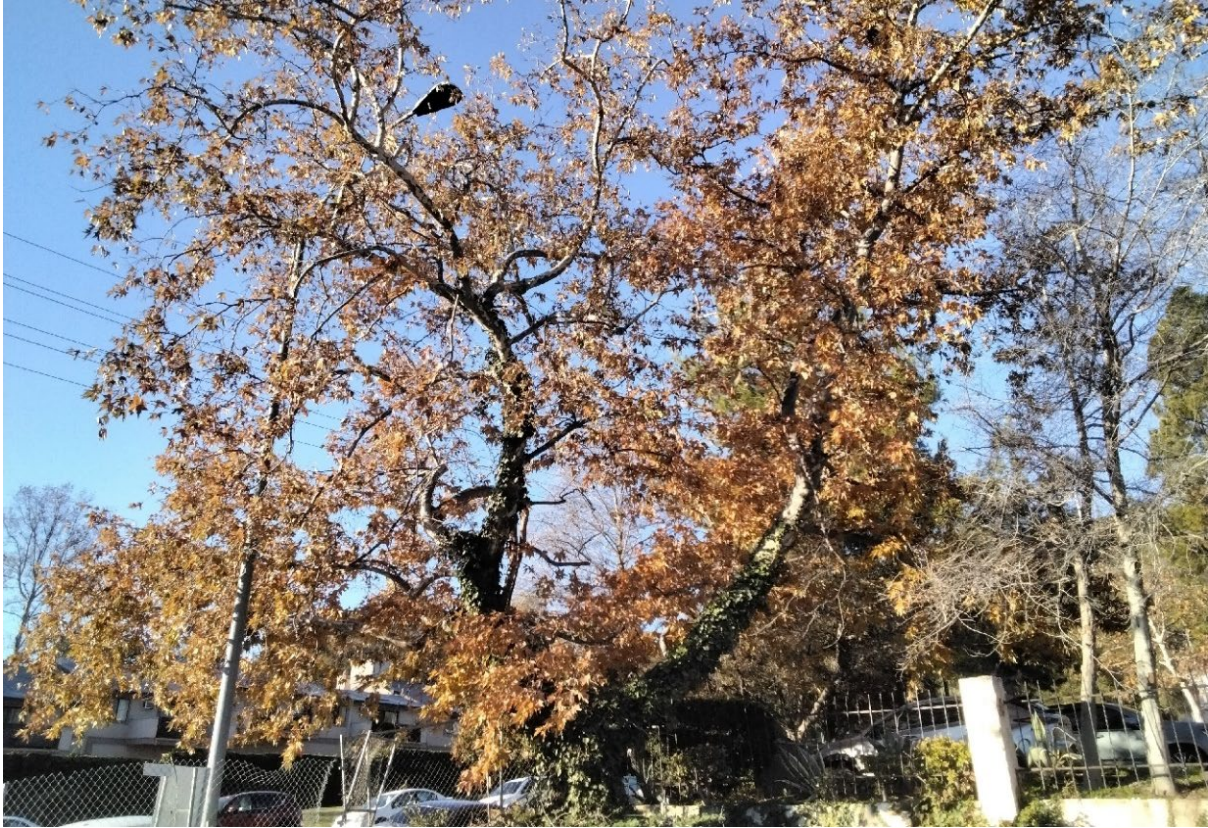
**Photograph 7.** Tree #7 California sycamore (*Platanus racemosa*)

*7	California sycamore ( <i>Platanus racemosa</i> )	45	Major (Removal)	Approximately 30% of TPZ will be encroached by grading, directly next to major roots and tree trunk. The tree’s long-term survival would be unknown; therefore, this tree shall be mitigated as a removal.
8	Coast live oak ( <i>Quercus agrifolia</i> )	24	Removal	Tree will be removed due to location of Building C
9	Coast live oak ( <i>Quercus agrifolia</i> )	17	Removal	Tree will be removed due to location of Building C; if feasible, preservation is recommended because it is in good health
10	Coast live oak ( <i>Quercus agrifolia</i> )	2.5	Removal	Tree will be removed for parking lot improvements

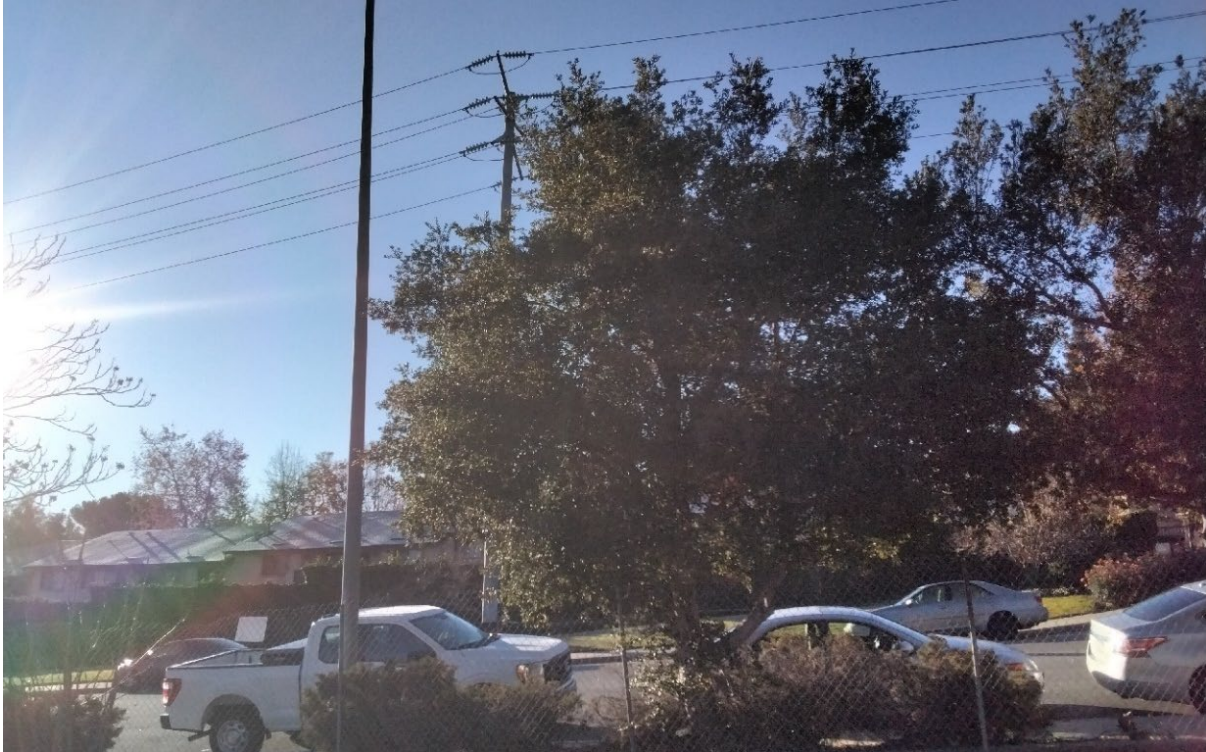
**Photograph 9.**Tree #9 Coast live oak (*Quercus agrifolia*)

9	Coast live oak <i>Quercus agrifolia</i>	2	6, 11	17	24	20	(8,8,5,8,5,8,10,8)	B	N	Codominant stems, slight lean, 5% leaf chlorosis throughout canopy, overall good vigor	tree on sidewalk outside of fence, immediately adjacent to project boundary, canopy and tpz within project area, tagged	Major (Removal)	Tree will be removed due to location of Building C; if feasible, preservation is recommended because it is in good health
10	Coast live oak <i>Quercus agrifolia</i>	1	2.5	2.5	12	6	(3,3,3,3,3,3,3,3)	D	N	15% leaf chlorosis throughout canopy, moderate lean, low vigor, epicormic shooting starting from the basal area of the trunk to the branch and canopy	Tree in planter median within project area	Major (Removal)	Tree will be removed for parking lot improvements
