**5863 RUE FERRARI DRIVE
TECHNICAL BIOLOGICAL REPORT
SAN JOSE, SANTA CLARA COUNTY, CALIFORNIA**

August 6, 2021

PN 2591-01

Updated Arborist Report

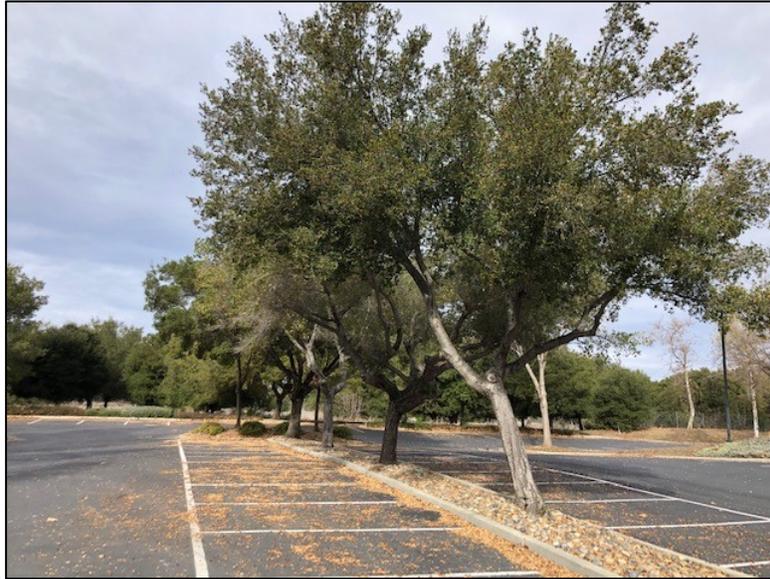
Coast live oak was the most frequently occurring species (31% of the inventory). One hundred and eight (108) coast live oaks grew, often in narrow planters, around the parking lot that surrounded the existing buildings (Photo 1). Coast live oak #318 was located offsite. Tree conditions ranged from poor (four trees) to good (59 trees) with 45 trees in fair condition. Trunk diameters ranged widely from 4 to 29" with an average of 15". When they had adequate growing space, the crowns of the coast live oaks were dense and spreading. Conversely, canopies were thinner and smaller where larger coast live oaks suppressed and shaded out smaller oaks.

Photo 1 – Many coast live oaks were growing in narrow parking lot planters.

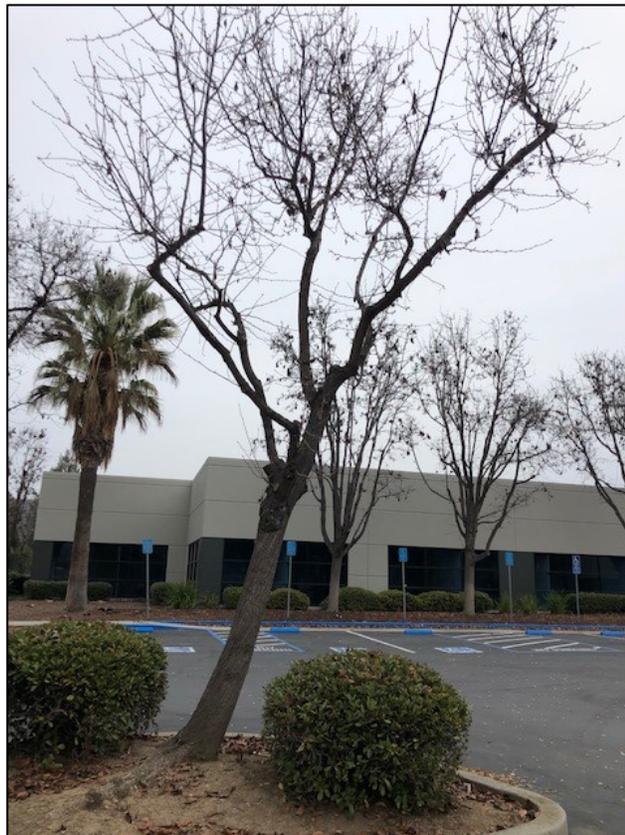
Seventy-six (76) callery pears were included in the assessment (Photo 2). Tree conditions ranged from poor (eight trees) to good (23 trees) with 45 trees in fair condition. Trunk diameters ranged widely from 5 to 20" with an average of 12". Most of the callery pears had been clearance pruned adjacent to street lights and parking lot areas- lower branches were removed and resulted in high crowns (Photo 2). The callery pears also often had multiple stems or codominant stems that arose from the same point. This type of growth can result in weakly attached stems.

Photo 2 – The callery pears were pruned for clearance. Some had poor structure from heading cuts.

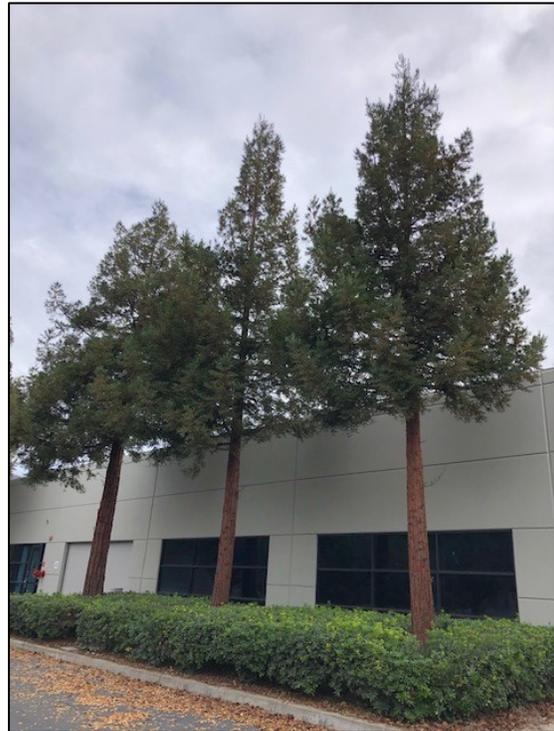
Thirty-nine (39) coast redwoods were growing along existing buildings. Coast redwood was the species with trees in the best condition with one tree in poor condition, 35 trees in good condition with vigorous, and three trees in fair condition. Trunk diameters ranged widely from 4 to 29" with an average of 15". Nearly all the coast redwoods had been clearance pruned to heights above adjacent buildings (Photo 3, next page).

Photo 3 – The coast redwoods had been clearance pruned to heights above adjacent buildings.

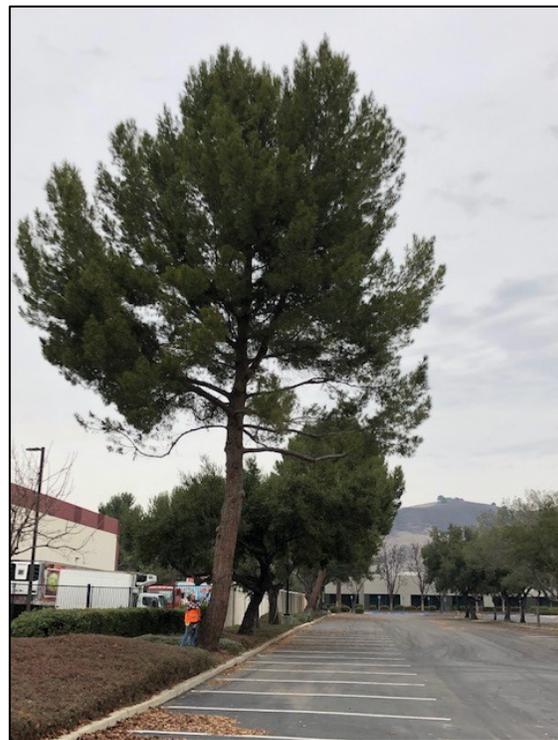
Photo 4 – Many Aleppo pines were assessed along the perimeter of the property.

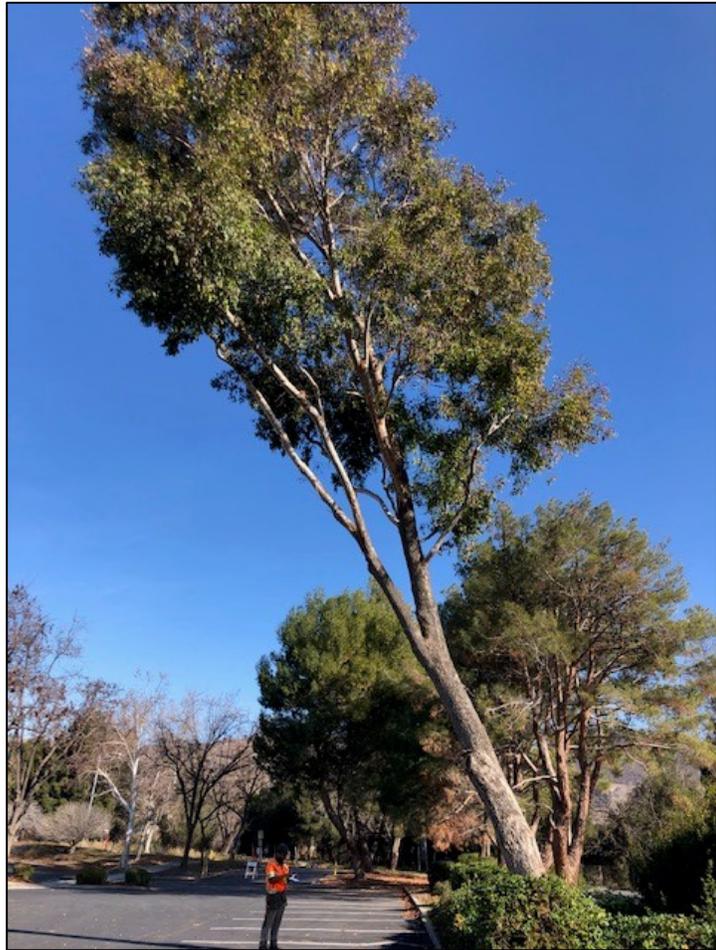
Photo 5 – Nichol's willowleafed peppermint #338 was in poor condition with a severe lean over the adjacent parking lot.
