Appendix E
Arborist Report

PRELIMINARY ARBORIST REPORT FOR SAN JOSE INDUSTRIAL PARK, 2150, 2222, 2350 Qume Drive, San Jose

September 10, 2021

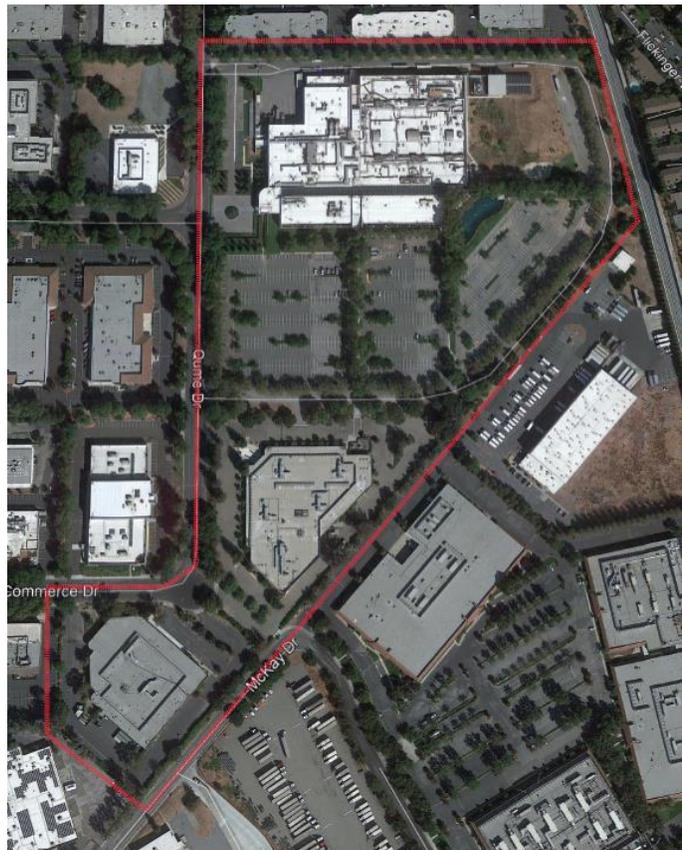
Figure 1. The subject property encompasses three parcels on Qume Drive, highlighted in red. Most landscaping & trees are limited to small planting areas.

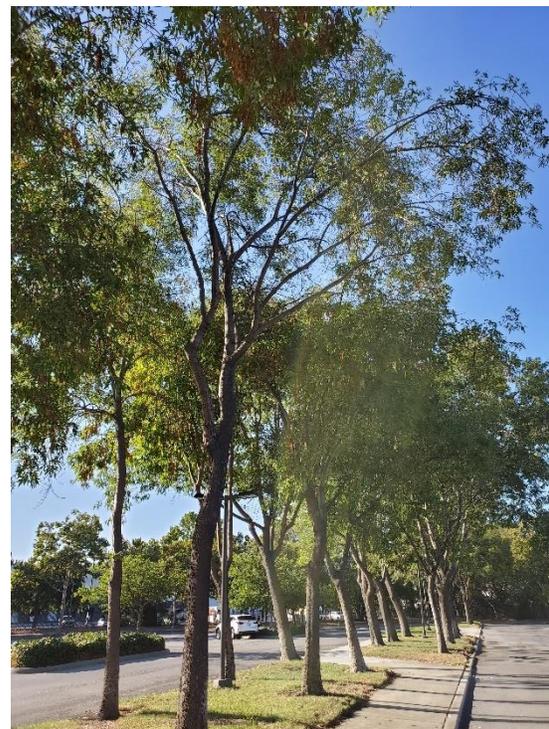
Figure 2. The ashes are packed together in landscape strips surrounded by hardscape (tree #142 in foreground). The repair of the adjacent walkway has damaged the roots of many trees, resulting in sparse canopies and declining branches.

141	Mulberry	9		F	F	12	Y	X	H	Sparse canopy. Multiple trunk cankers with largest on E side (4'). In proposed drive aisle.	Remove.
142	Mulberry	6		F-P	F	8	Y	X	H	Slightly sparse and chlorotic canopy. Curb lifted 1". Wound with decay at base. In proposed drive aisle.	Remove.

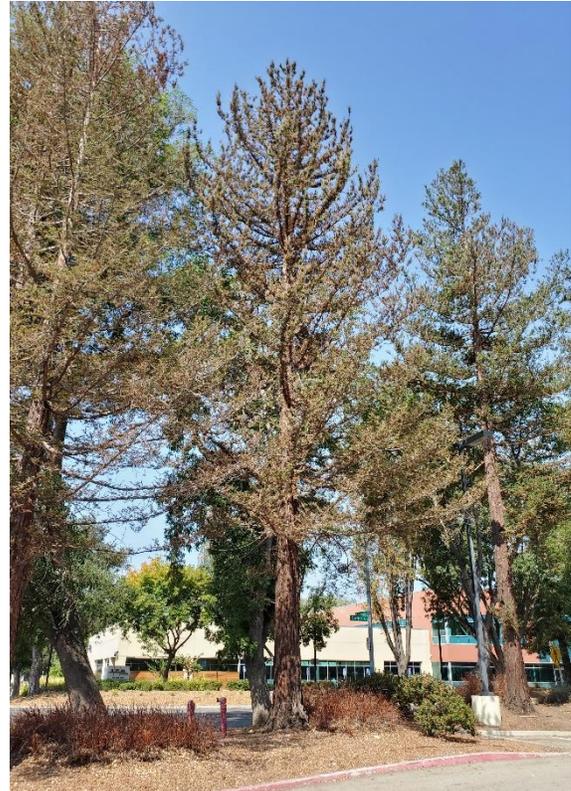
I also noticed purple pipes throughout the three parcels, indicating the use of recycled water for irrigation - an increasing trend in updated landscapes. The main problem with using recycled water in landscapes is that different species have different tolerances to salinity, which is elevated in recycled water. Standard water treatment practices are not able to remove salt from the water, and the use of recycled water for irrigation increases the salt content in the soil. If the salts are not flushed out of the soil by rainfall or irrigation with potable water, they can damage plant roots. The damage may occur directly via toxic concentrations, or it may be indirect in that it is harder to absorb water from saline soils. Coast redwoods are known to be highly sensitive to salt – all the redwoods on 2222 Qume Drive are showing symptoms of severe salt damage (Figure 3).

Figure 3. The redwoods (#648 at center) are highly sensitive to salinity and are suffering from recycled water damage. Unless there is a switch back to potable water, the trees would likely not recover.

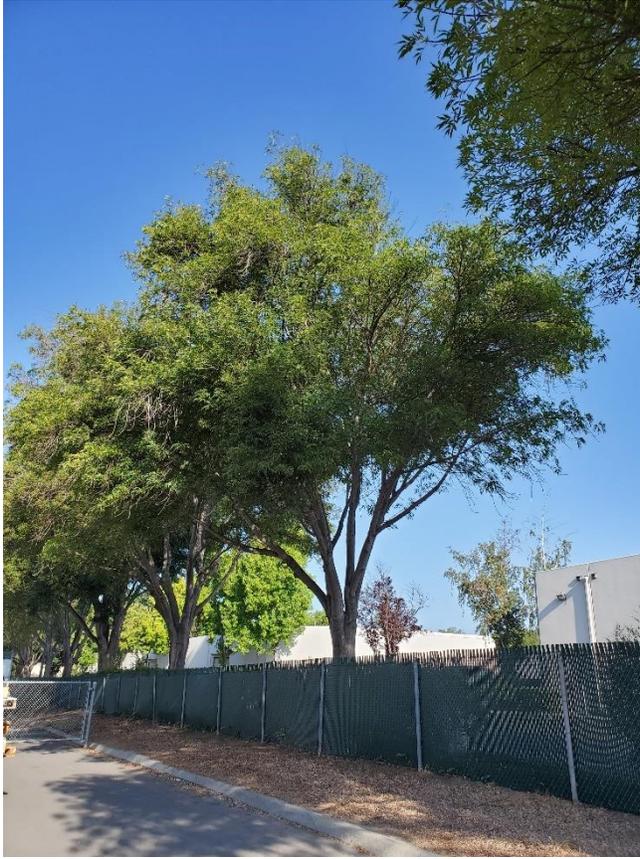
Figure 4. Proposed hardscape expansion and bio-retention improvements along the north property line will encroach upon the roots of the neighbor's trees (#12 above), potentially requiring their removal.

- If feasible, relocate proposed TSM area near off-site trees #3-28 & 30, and pull proposed hardscape further from the property line. Otherwise, the landscape specifications shall be as flexible as possible around these trees to reduce root damage during construction.

- The project arborist shall be on site during grading trees #3-28 & 30 to review root encroachment and provide recommendations as needed. If root loss is high, the trees may need to be removed.

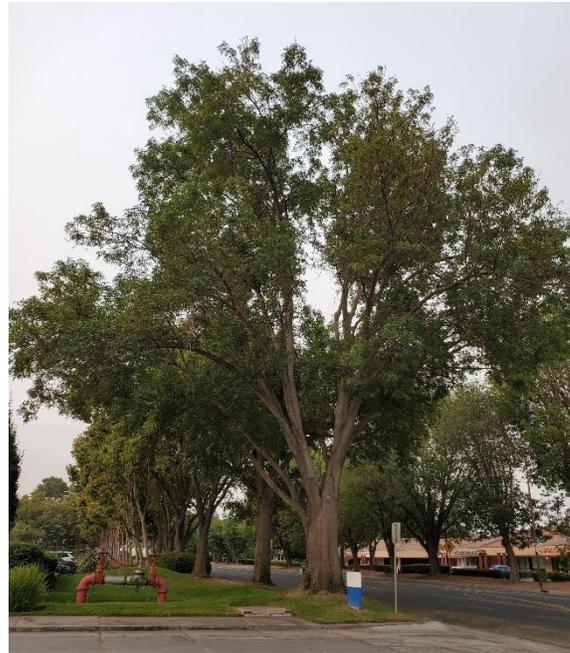
Figure 5. Several mature trees, including ash #440 above, are located in the proposed City-mandated sidewalk. Grading of the berm above the sidewalk will require removal of London planetrees to its east (lower left).

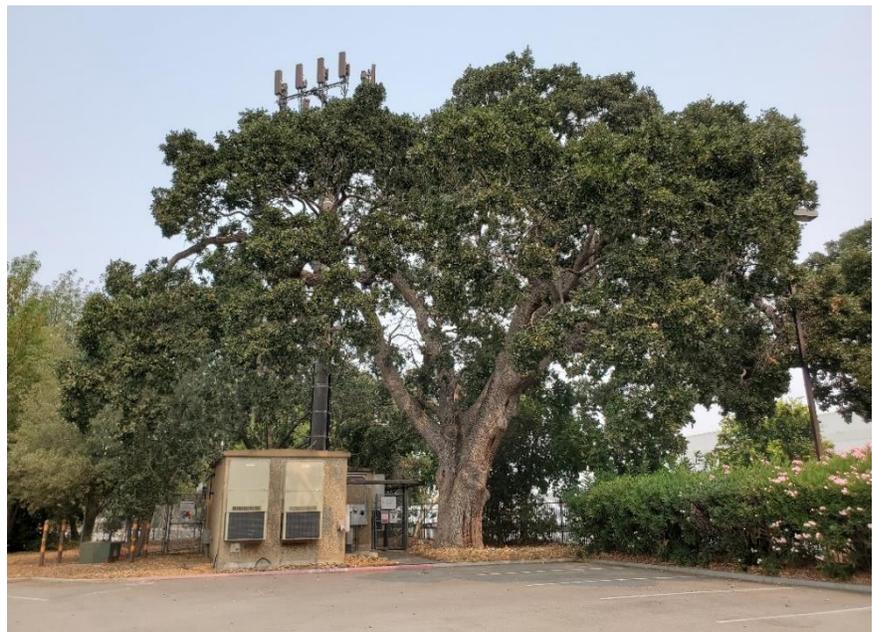
The existing telecommunications facility is located at the east side of the property between 2150 & 2222 Qume Dr. In addition to other native oaks, this space contains the largest tree on the entire property - a massive 65" diameter valley oak (tree #572, Figure 6). This oak is centuries old, existed well before the neighborhood was developed, and is doing well in spite of the structures and hardscape that have been built all around it. **This oak is**

irreplaceable. Because of its veteran status, every effort must be made to respect its surroundings and reduce impact. Accidentally damaging a tree of this age can trigger a slow descent into death, since it may not be growing actively enough to repair damage or replace lost foliage. As a blanket recommendation, every detail and change shall be passed through a consulting arborist, and a consulting arborist must be on-site for any ground-disturbing activities that occur around it. The design shows minor changes around the tree, except for the conversion of the parking lot to landscaping. Even demolition of the existing hardscape can be detrimental if roots have grown underneath the parking lot. Chain-link fencing shall be installed around the planter area at the limit of grading, and additional fencing should be left on-site to expand the protected area after demolition. Pruning of the tree should not be done unless absolutely necessary for hazard reduction.

Figure 6. Valley oak #572 is a magnificent specimen located in the telecommunications area. Every effort shall be made to reduce encroachment on this tree, even in demolishing the existing parking lot. Changes must be reviewed by the project arborist, who will also monitor construction activities.
