REPORT
FAULT RUPTURE HAZARD EVALUTION
PROPOSED MINOR SUBDIVISION
1276 JENSEN LANE
WINDSOR, CALIFORNIA

JOB NO. 7845.02

Subject: Alquist-Priolo Earthquake Fault Study
Proposed Minor Subdivision
1276 Jensen Lane
Windsor, California

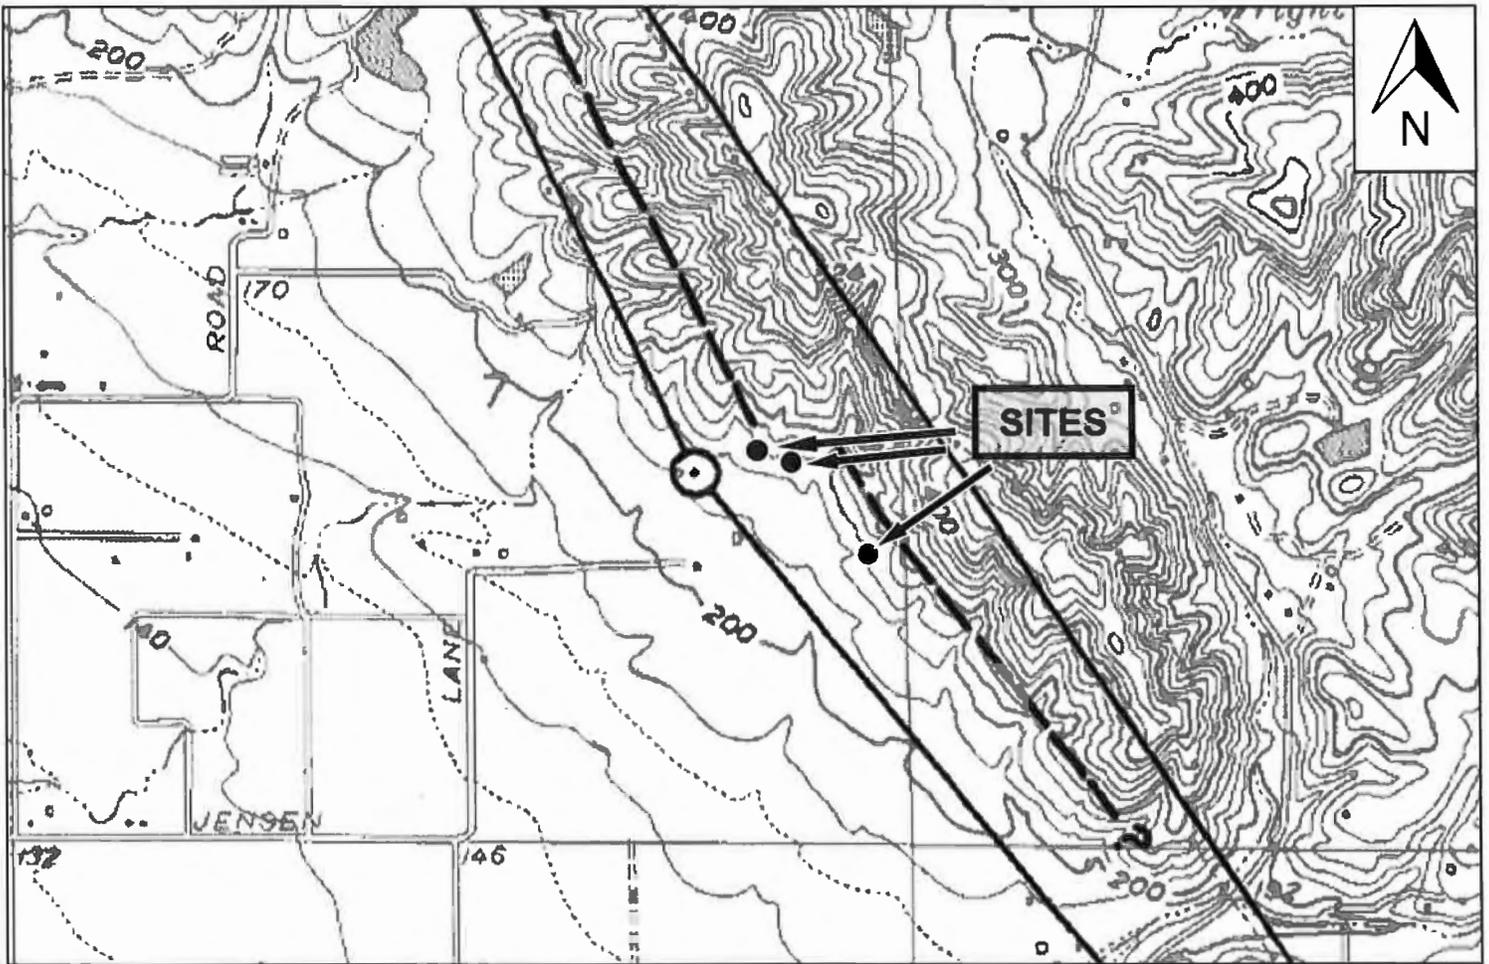
ALQUIST PRIOLO LOCATION MAP
PROPOSED MINOR SUBDIVISION
1276 JENSEN LANE
WINDSOR, CALIFORNIA

- a. General. The site is located in a highly active seismic zone associated with the Rodgers Creek fault. It is our understanding that the Rodgers Creek fault is essentially considered the northern continuation of the Hayward fault. Some geologic literature also labels the northern lineament of this fault trace as the Healdsburg Fault. The active faults which bisect the Bay Area region and the Coast Ranges are considered part of the San Andreas Fault system. The San Andreas Fault system has long been recognized as the major active fault system along the Pacific Coast of the United States. The Rodgers Creek fault and generally all of the faults associated with San Andreas Fault system exhibit right-lateral strike-slip relative movement. The Rodgers Creek fault, in the vicinity of the project site, generally trends at approximately north 26° to 32° west. The Rodgers Creek fault trace is often marked by sag ponds, offset stream channels, pressure ridges, shattered rock, fault gouge, etc. Contrary to popular belief, the boundaries of most faults typically do not consist of a single linear, straight line. Numerous jogs and step-overs are present throughout the entire length of the Rodgers Creek fault, as shown on Plate 2A.

- b. Fault Location. According to the APEFZ map, approximately located active fault traces bisect the northern and eastern margins of the subject property. Based on our review of the APEFZ map, it appears that the mapped northern fault trace enters the property approximately 100 feet to the north of Lot 1. The southern terminus of this fault trace is approximately 225 feet to the northwest of Lot 2. The mapped active fault trace on the eastern margin appears to exit the property near the center of the eastern margin of the property, and at its closest point is approximately 145 feet to the northeast of Lot 3. The CGS geologic map of the Healdsburg 7.5

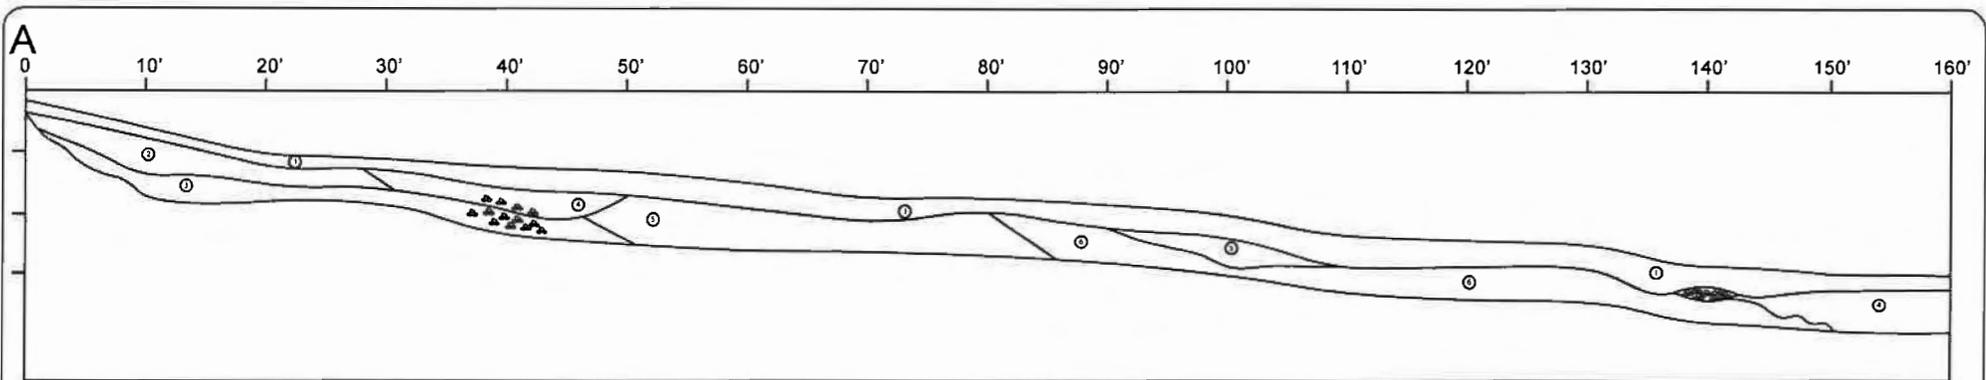
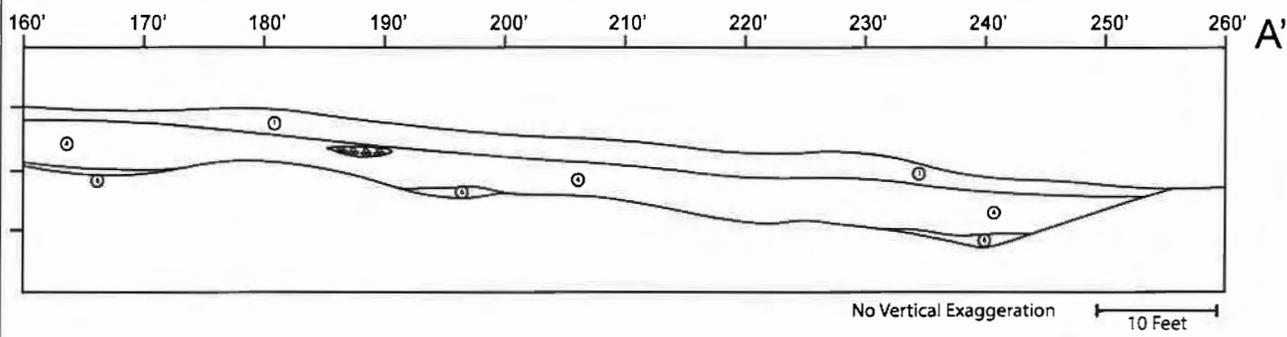
Trench Cross Section A-A' Proposed Minor Subdivision 1276 Jensen Lane Windsor, California	Proj. No: 7845.02 Date: 8/17 App'd By: PJC
PJC & Associates, Inc. Consulting Engineers & Geologists	PLATE 3

Orangish yellow brown
Silty Sand
Dry
Medium Stiff
Fine to Coarse
(SM) (Topsoil)
- 2

Yellow with Black Tamish
Sandy Gravels with Clay
Moist
Dense
Well graded
(GW) (QTg)
- 3

Olive Brown
Silty Sandstone
Slightly Hard
Moderately Strong
Moderately Weathered
(QTg) (Bedrock)
- 4

Moderate Brown
Sandy Clay
Slightly Moist
Very Stiff to Hard
High Plasticity
(CH) (Residual Soil)
- 5

Moderate Brown
Clayey Gravel
Moist
Dense
Well Graded
(GC) (Residual Soil)
Exhibits Normal Grading
- 6

Olive Brown With Trace Oxidation
Mudstone
Slightly Hard
Moderately Strong
Moderately Weathered
(QTg) (Bedrock)

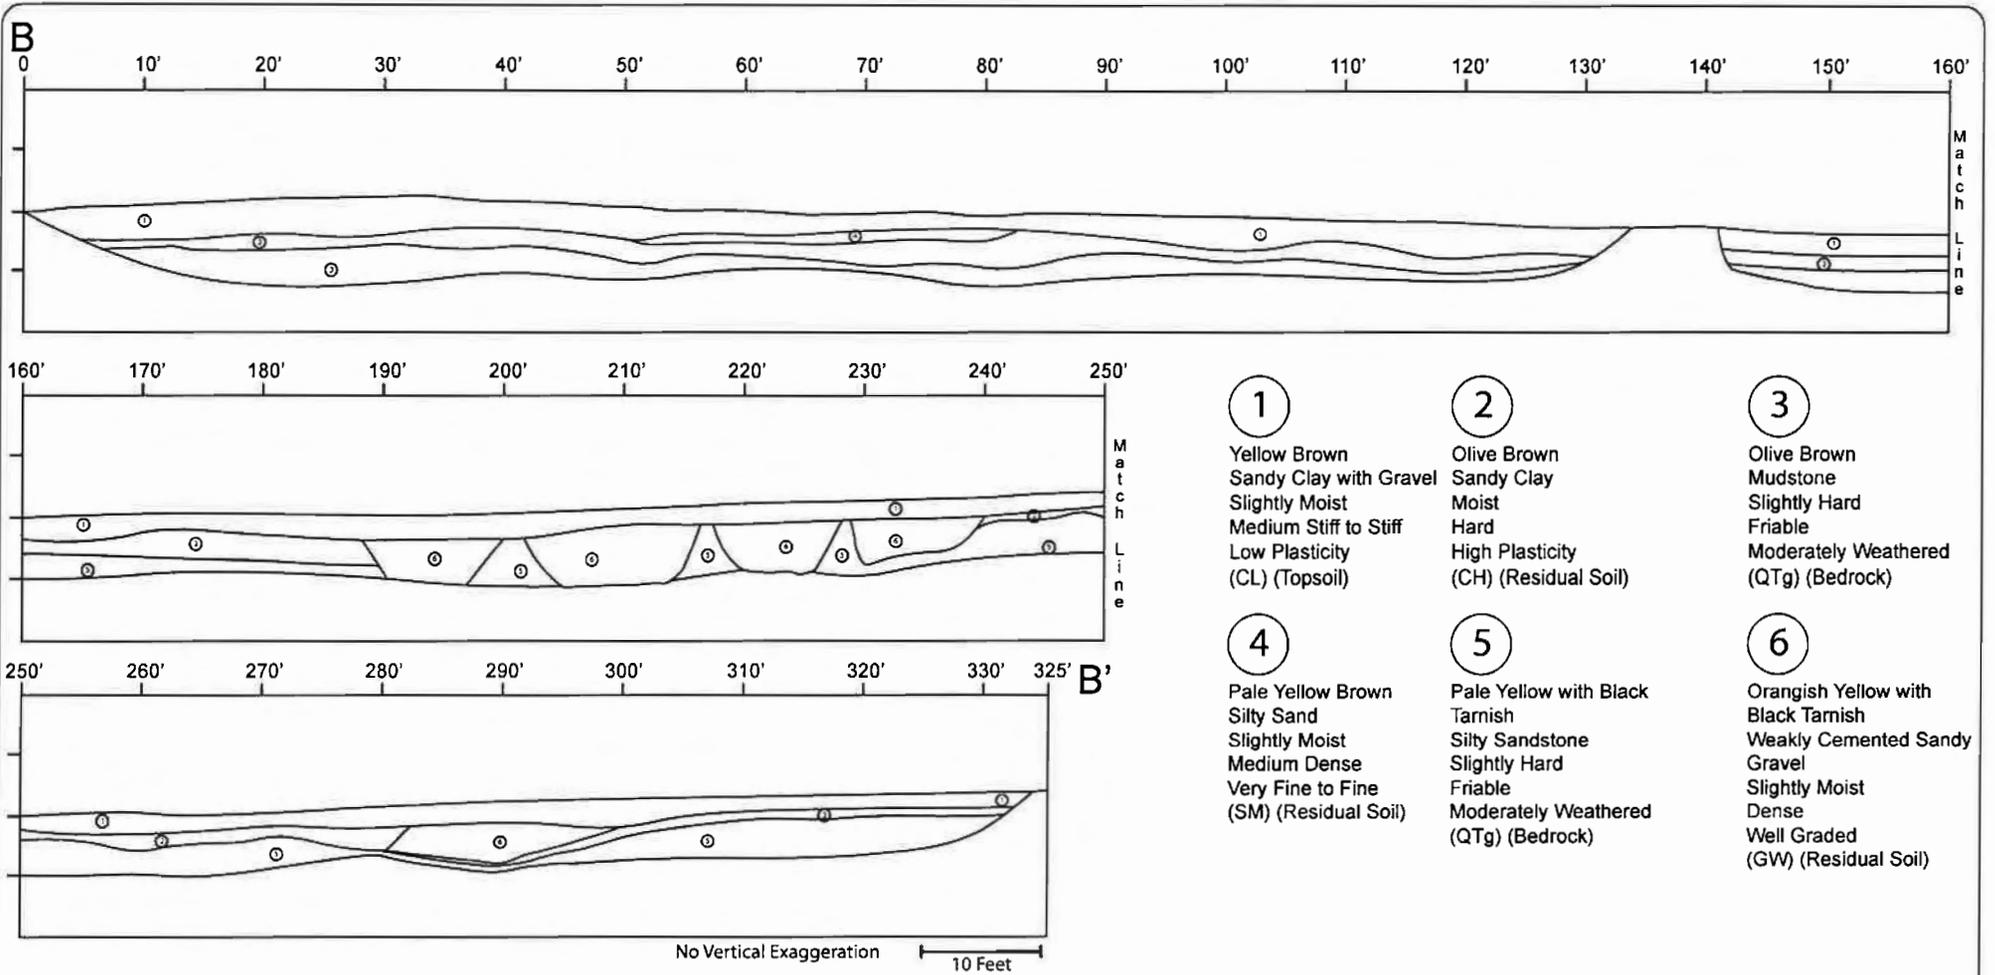
<p>Trench Cross Section B-B' Proposed Minor Subdivision 1276 Jensen Lane Windsor, California</p>	Proj. No: 7845.02
	Date: 8/17
	App'd By: PJC
PJC & Associates, Inc. Consulting Engineers & Geologists	PLATE 4

- 1**
 Yellow Brown
 Sandy Clay with Gravel
 Slightly Moist
 Medium Stiff to Stiff
 Low Plasticity
 (CL) (Topsoil)
- 2**
 Olive Brown
 Sandy Clay
 Moist
 Hard
 High Plasticity
 (CH) (Residual Soil)
- 3**
 Olive Brown
 Mudstone
 Slightly Hard
 Friable
 Moderately Weathered
 (QTg) (Bedrock)
- 4**
 Pale Yellow Brown
 Silty Sand
 Slightly Moist
 Medium Dense
 Very Fine to Fine
 (SM) (Residual Soil)
- 5**
 Pale Yellow with Black
 Tarnish
 Silty Sandstone
 Slightly Hard
 Friable
 Moderately Weathered
 (QTg) (Bedrock)
- 6**
 Orangish Yellow with
 Black Tarnish
 Weakly Cemented Sandy
 Gravel
 Slightly Moist
 Dense
 Well Graded
 (GW) (Residual Soil)

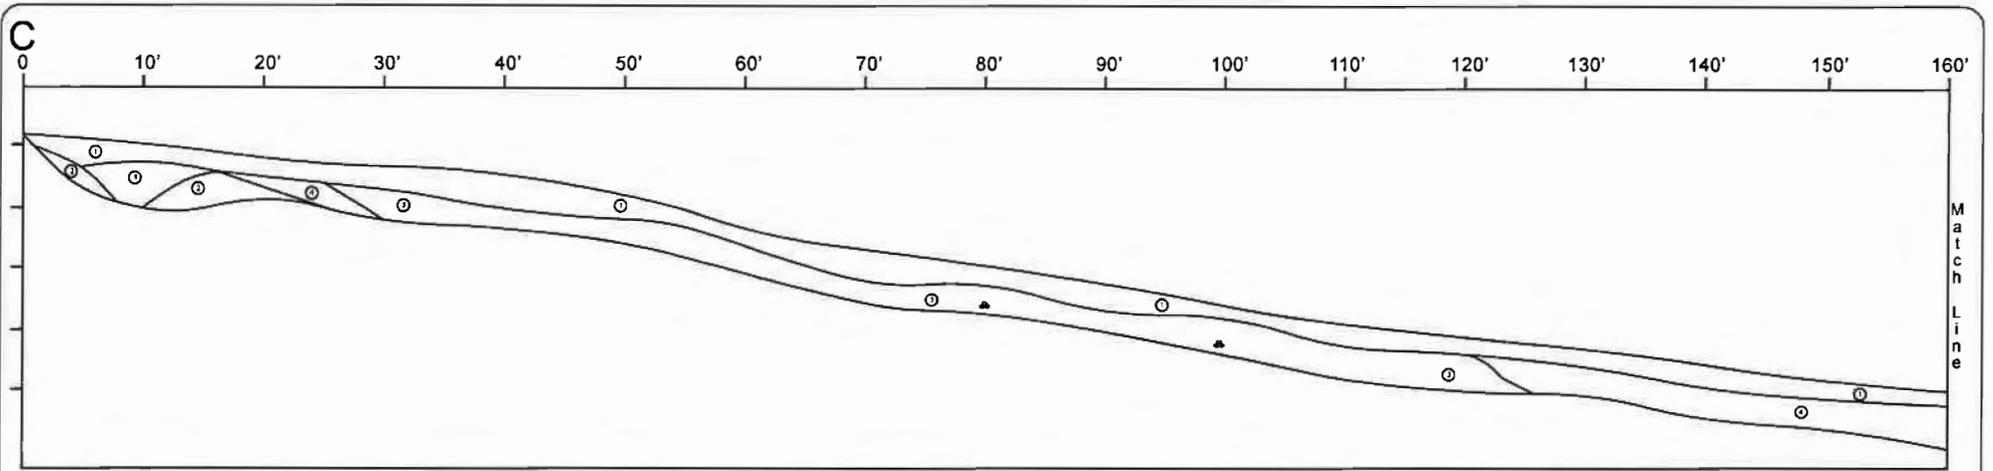
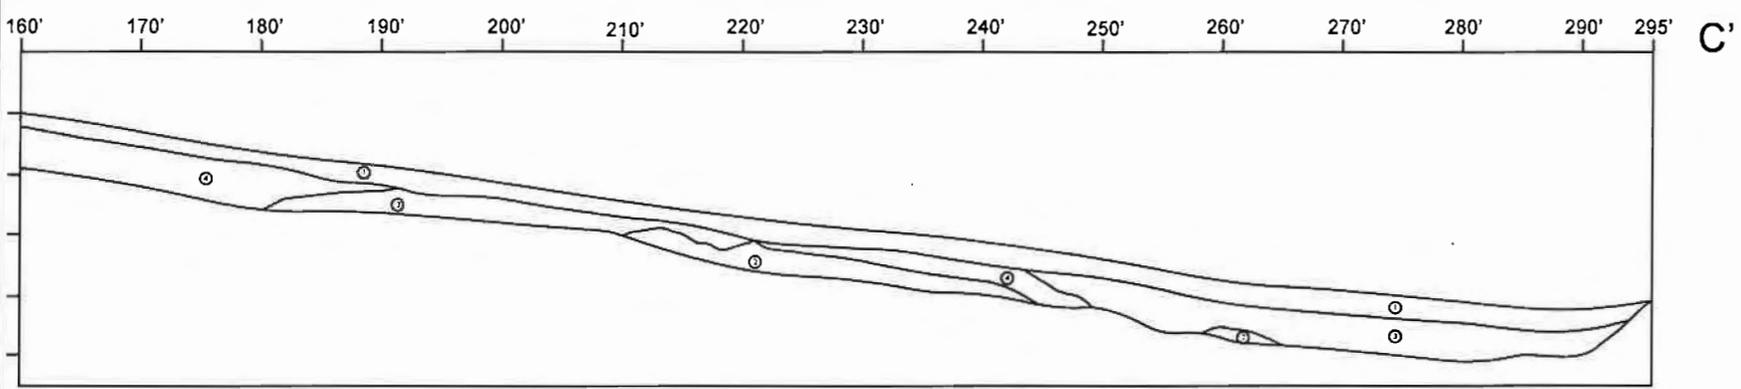
Trench Cross Section C-C'
 Proposed Minor Subdivision
 1276 Jensen Lane
 Windsor, California

1
 Grayish Brown
 Sandy Clay
 Slightly Moist
 Stiff
 Low Plasticity
 (CL) (Topsoil)
 Porous and Weak

2
 Pale Yellow
 Silty Sandstone
 Slightly hard
 Friable to Weak
 Moderately Weathered
 (QTg) (Bedrock)

3
 Pale Brown with Orange
 Oxidation
 Sandy Gravel with Clay
 Moist
 Dense
 Well Graded
 (GW) (Residual Soil)
 With Cobbles and Boulders

4
 Pale to Moderate Brown
 Sandy Clay with Gravel
 Moist
 Hard
 High Plasticity
 (CH) (Residual Soil)
