PRELIMINARY GEOTECHNICAL STUDY REPORT

CHALK VISTA SUBDIVISION 1276 JENSEN LANE WINDSOR, CALIFORNIA

3909.01.01.1

May 7, 2018

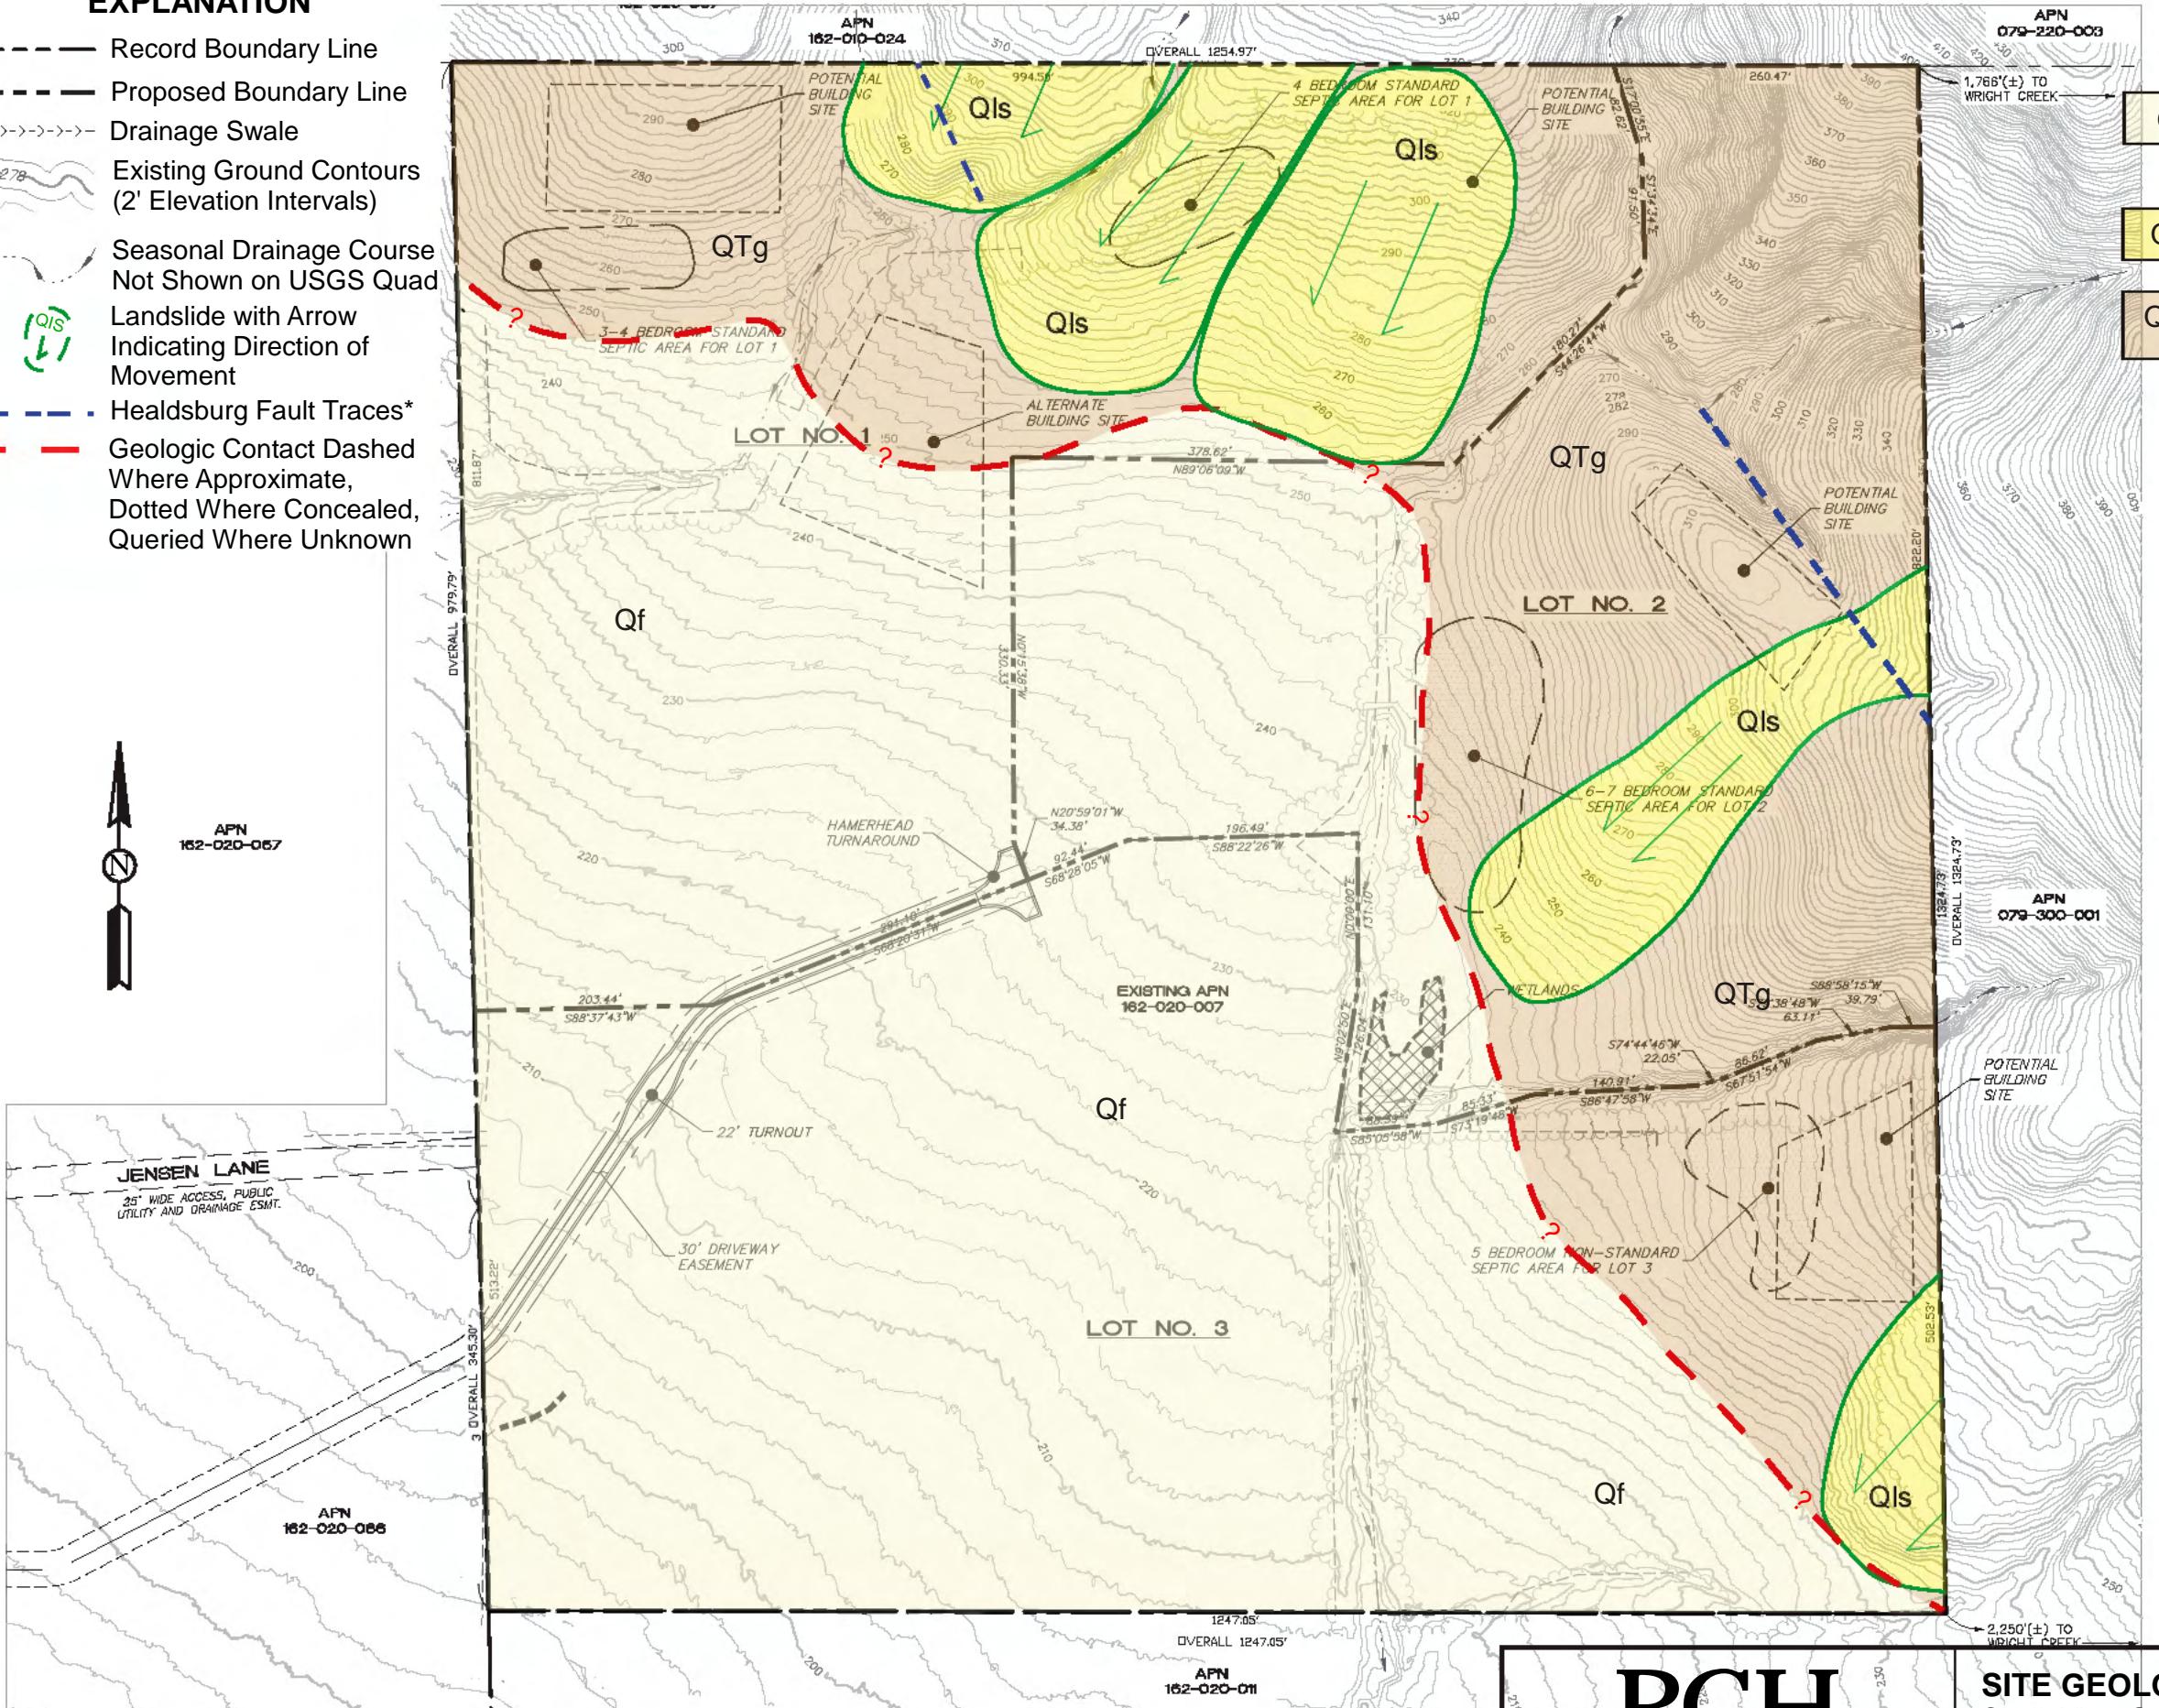
PLATE
2

Published landslide maps (Delattre, 2011; and Huffman, 1980) indicate large-scale slope instability at the site. A review of LiDAR for the property and the surrounding area found indications of landslides at the property. During our reconnaissance of the property, we observed the landslides indicated on the LiDAR and additional features. The observed landslides are mapped on Plate 2.

As discussed previously, landslide features were mapped and observed at the project site. The observed landslide features are mapped on Plate 2. Development including roadway and utilities should avoid these areas unless remedial work is performed to stabilize the slopes. Remedial work could include removing the landslide debris and constructing a buttress. In addition, landslide features can have adverse impact on improvements constructed downslope if the feature were to reactivate. The design level geotechnical study should address these issues in detail.

The proposed building envelopes appear to be located outside of the traces of the Healdsburg fault and are outside of unstable areas in order to reduce the risks associated with slope instability. The locations of the building envelopes in relation to such areas are shown on Plate 2. The locations of the identified active fault traces and unstable areas are shown on Plate 2. Initially, a structural setback of approximately 50-feet from unstable areas and breaks in slope of 2:1 or steeper should be established. A site-specific study should finalize recommended structural set backs.
