APPENDIX 9.0
OAK TREE SURVEY REPORT

Arborist Report

THE COMMONS AT HIDDEN SPRINGS PROJECT

November 12, 2019

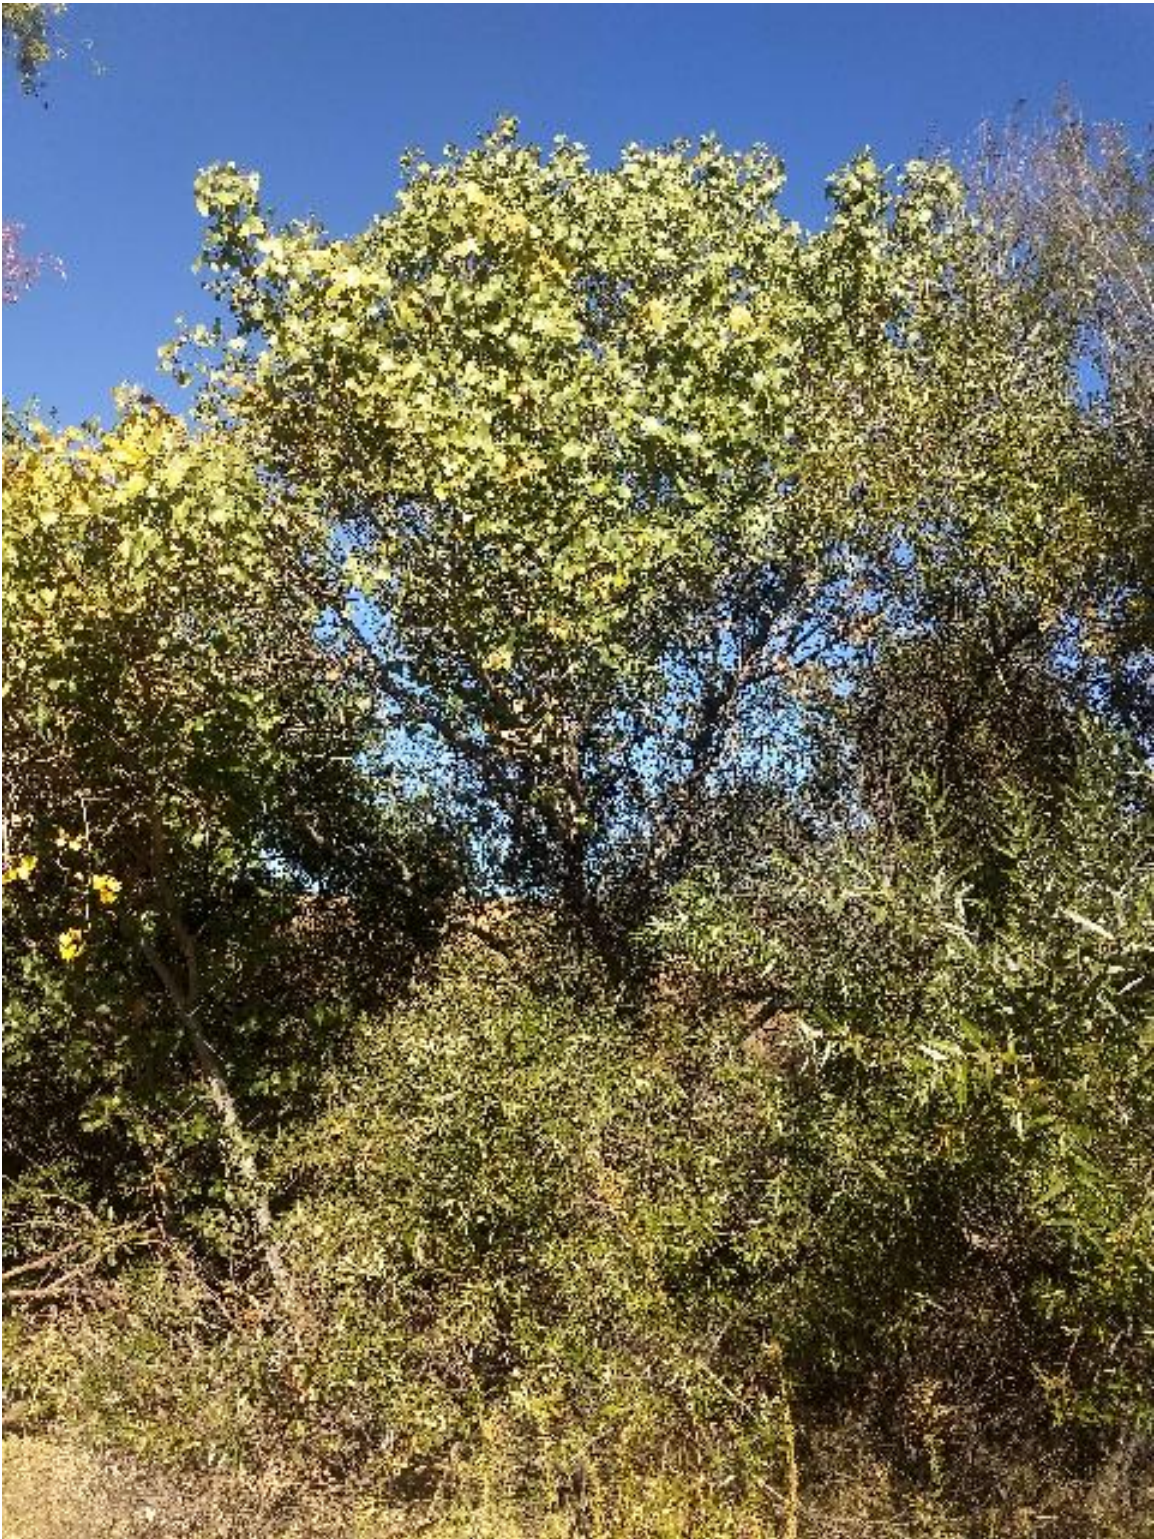
Tree #	Species	Common name	DBH (in)	Height (ft)	Width (ft)	Health (A-F)	Issues Observed
Cottonwood #1	<i>Populus fremontii</i>	Freemont's cottonwood	10	30	20	A	
Cottonwood #2	<i>Populus fremontii</i>	Freemont's cottonwood	6	20	15	B	
Cottonwood #3	<i>Populus fremontii</i>	Freemont's cottonwood	4	15	40	D	multi-trunk, many stems, underneath much larger sugar gum, suppressed, asymmetrical, damage to twig, branch and trunk
Oak #1	<i>Quercus agrifolia</i>	coast live oak	10	25	15	A	angled trunk
Oak #2	<i>Quercus agrifolia</i>	coast live oak	8	25	20	B	angled trunk
Oak #3	<i>Quercus agrifolia</i>	coast live oak	10	25	20	A	lean to the N, wasps
Oak #4	<i>Quercus agrifolia</i>	coast live oak	6	20	15	B	suppressed by nearby oak
Oak #5	<i>Quercus agrifolia</i>	coast live oak	14	15		A	excessive clearance, co-dominant trunks, lean to N
Oak #6	<i>Quercus agrifolia</i>	coast live oak	18, 6	35	25	B	wasps, multi-trunk

Based on the Site Plan in Appendix A, the entire project area will be developed, and as a result, all the trees will be removed. Trees that would be removed include Cottonwood #'s 1-3, Oaks #'s 1-18, all 86 willows, and 113 sugar gum trees identified during the survey on the project site. Only the smallest oaks would be candidates for relocation. The position of the trees on slopes and proximity to other trees may

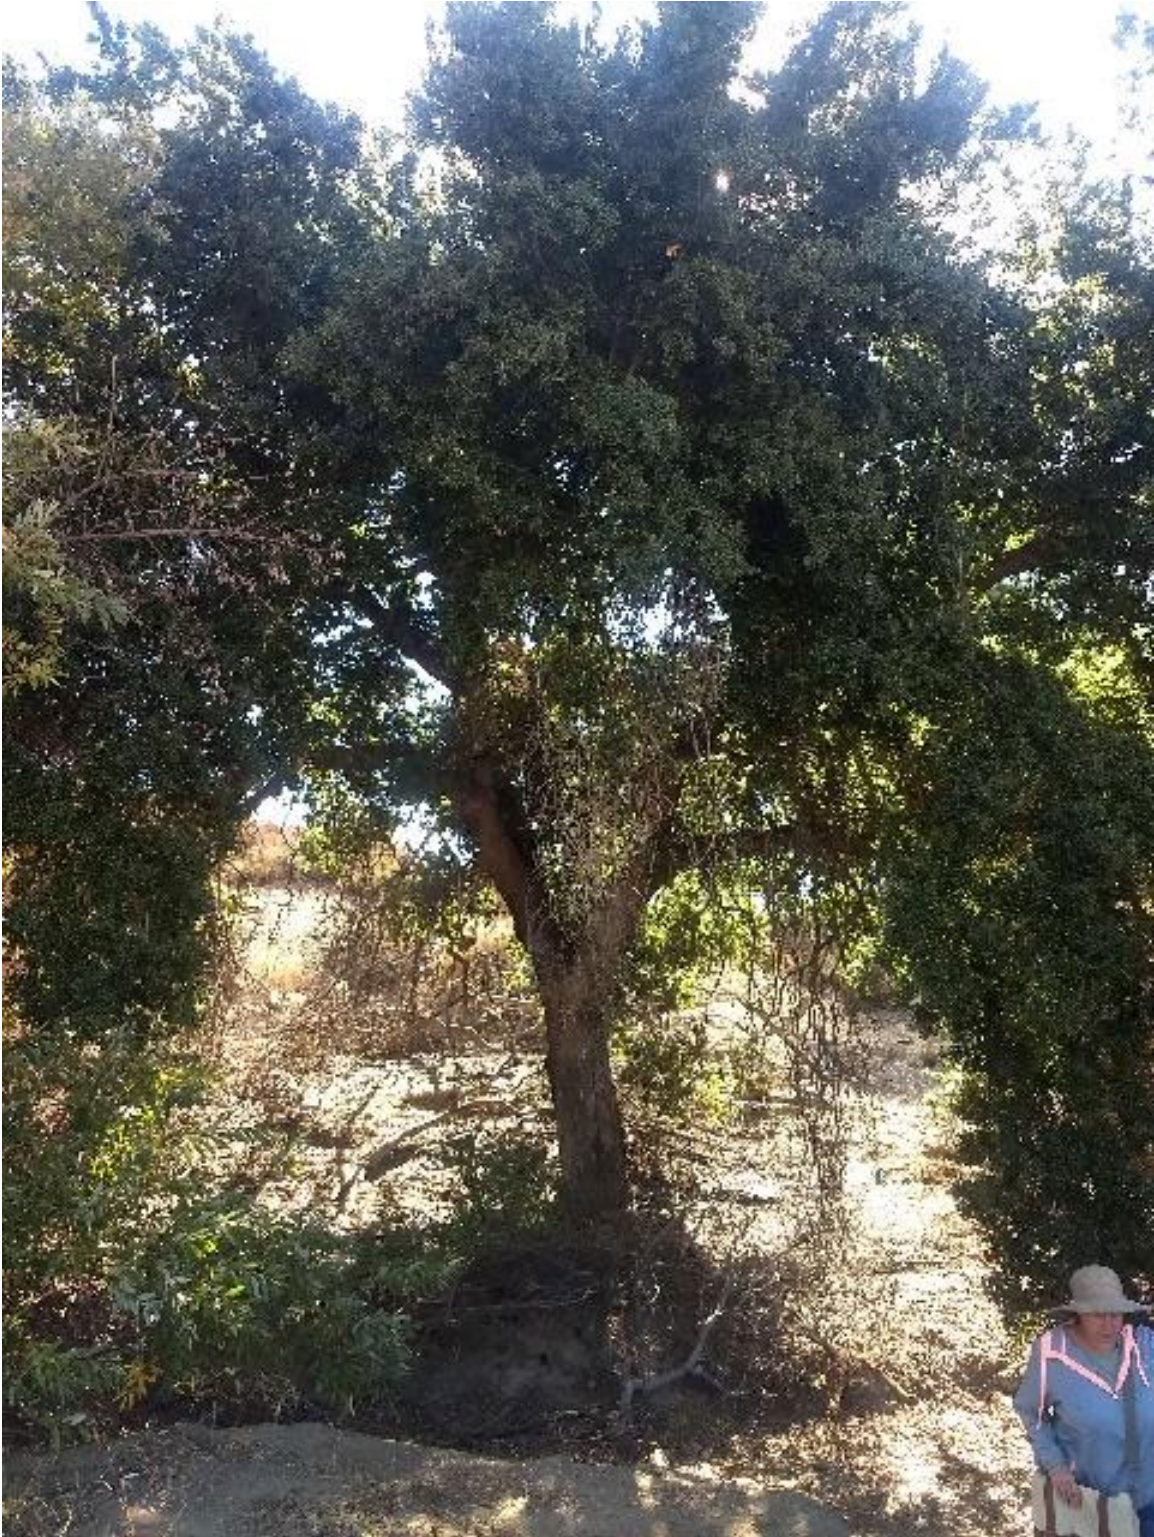
Oak #7	<i>Quercus agrifolia</i>	coast live oak	30	50	60	B	trunk burned on one side, soil on trunk, signs of new growth, 25% dead, history of failures, squirrel nest

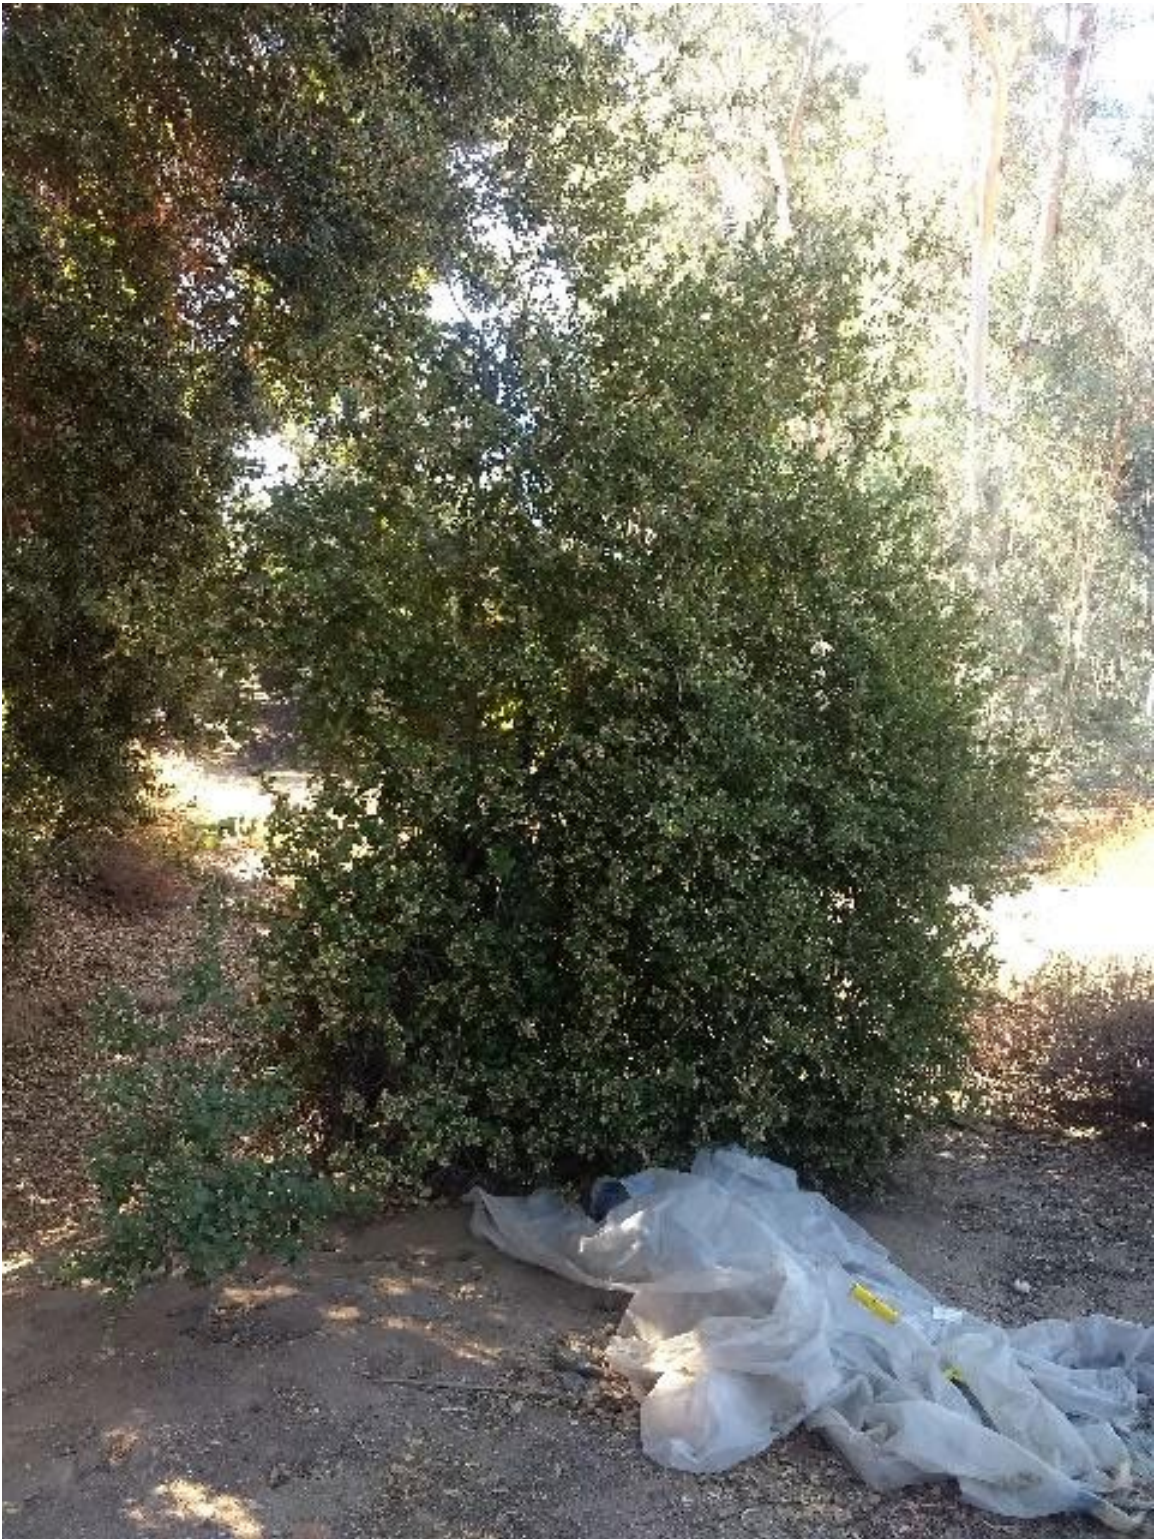
Tree #	Species	Common name	DBH (in)	Height (ft)	Width (ft)	Health (A-F)	Issues Observed
Oak #8	<i>Quercus agrifolia</i>	coast live oak	5	15	10	D	topped, dead wood caught in canopy, leaf and twig damage, wasps
Oak #9	<i>Quercus agrifolia</i>	coast live oak	24	20	20	B-	lopsided to S and E, history of failures, top is broken, lateral branching is largest
Oak #10	<i>Quercus agrifolia</i>	coast live oak	10	25	25	C	dead branches 25%, fungus, lean to N, suppressed
Oak #11	<i>Quercus agrifolia</i>	coast live oak	11	25	20	B	suppressed, lean to E
Oak #12	<i>Quercus agrifolia</i>	coast live oak	4	20	8	A	multi-trunk
Oak #13	<i>Quercus agrifolia</i>	coast live oak	3	17	10	A	Young tree
Oak #14	<i>Quercus agrifolia</i>	coast live oak	11	30	35	A	co-dominant trunks
Oak #15	<i>Quercus agrifolia x wislizeni</i>	coast live oak	7	25	40	A	dead wood 5%
Oak #16	<i>Quercus agrifolia</i>	coast live oak	7, 14	15	20	B	dieback 10%, low N growth

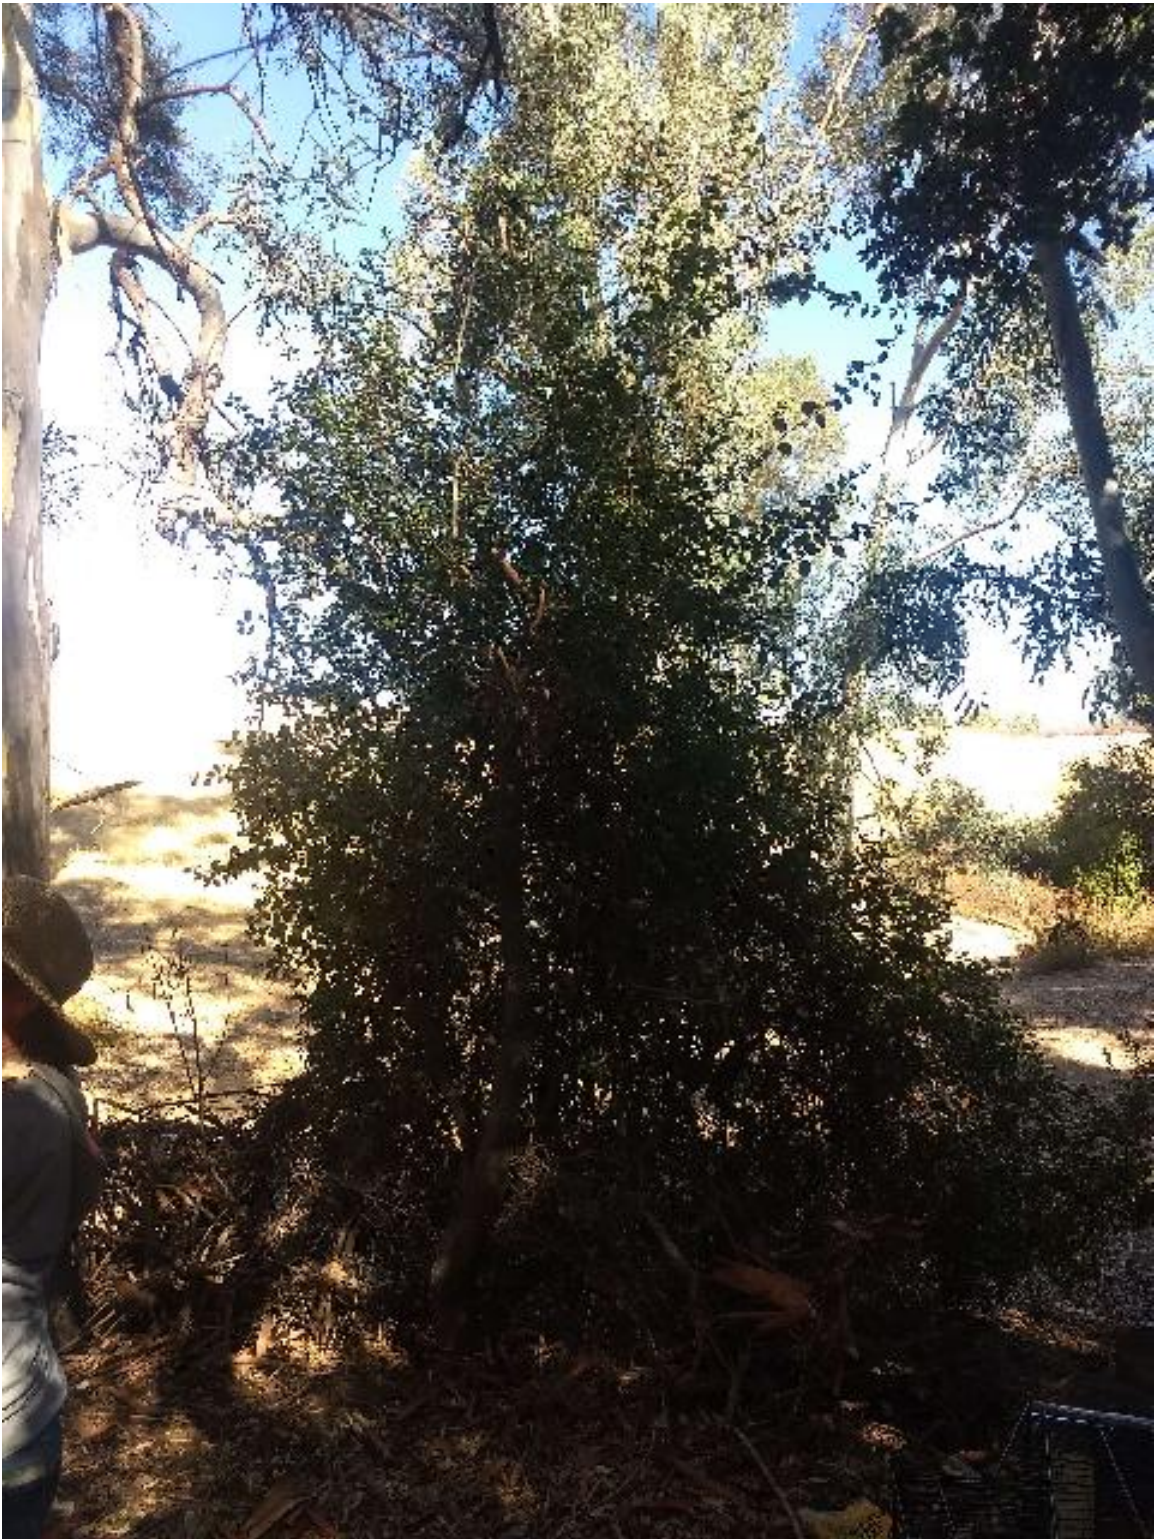
Oak #17	<i>Quercus agrifolia</i>	coast live oak	4	15	8	B	topped
Oak #18	<i>Quercus agrifolia</i>	coast live oak	10	18	25	C	suppressed
Oak #19	<i>Quercus agrifolia</i>	coast live oak	8	20	20		5 stems, wasps, bacterial canker
Oak #20	<i>Quercus agrifolia x wislizeni</i>	coast live oak	4	12	15	B-	dieback 20%, wasps
Oak #21	<i>Quercus agrifolia</i>	coast live oak	13	25	30	A	co-dominant, low-branching trunks, asymmetrical
Oak #22	<i>Quercus agrifolia</i>	coast live oak	18	40	45	A	deadwood 15%, canopy hitting ground, wasps, co-dominant trunks
Oak #23	<i>Quercus agrifolia</i>	coast live oak	10	30	25		suppressed, wood rat midden at base, 3 trunks
Oak #24	<i>Quercus agrifolia</i>	coast live oak	17	35	35	B	dieback 15%, soil on trunk, co-dominant leaders
Oak #25	<i>Quercus agrifolia</i>	coast live oak	17	35	35	B-	suppressed, deadwood 20%, good new growth

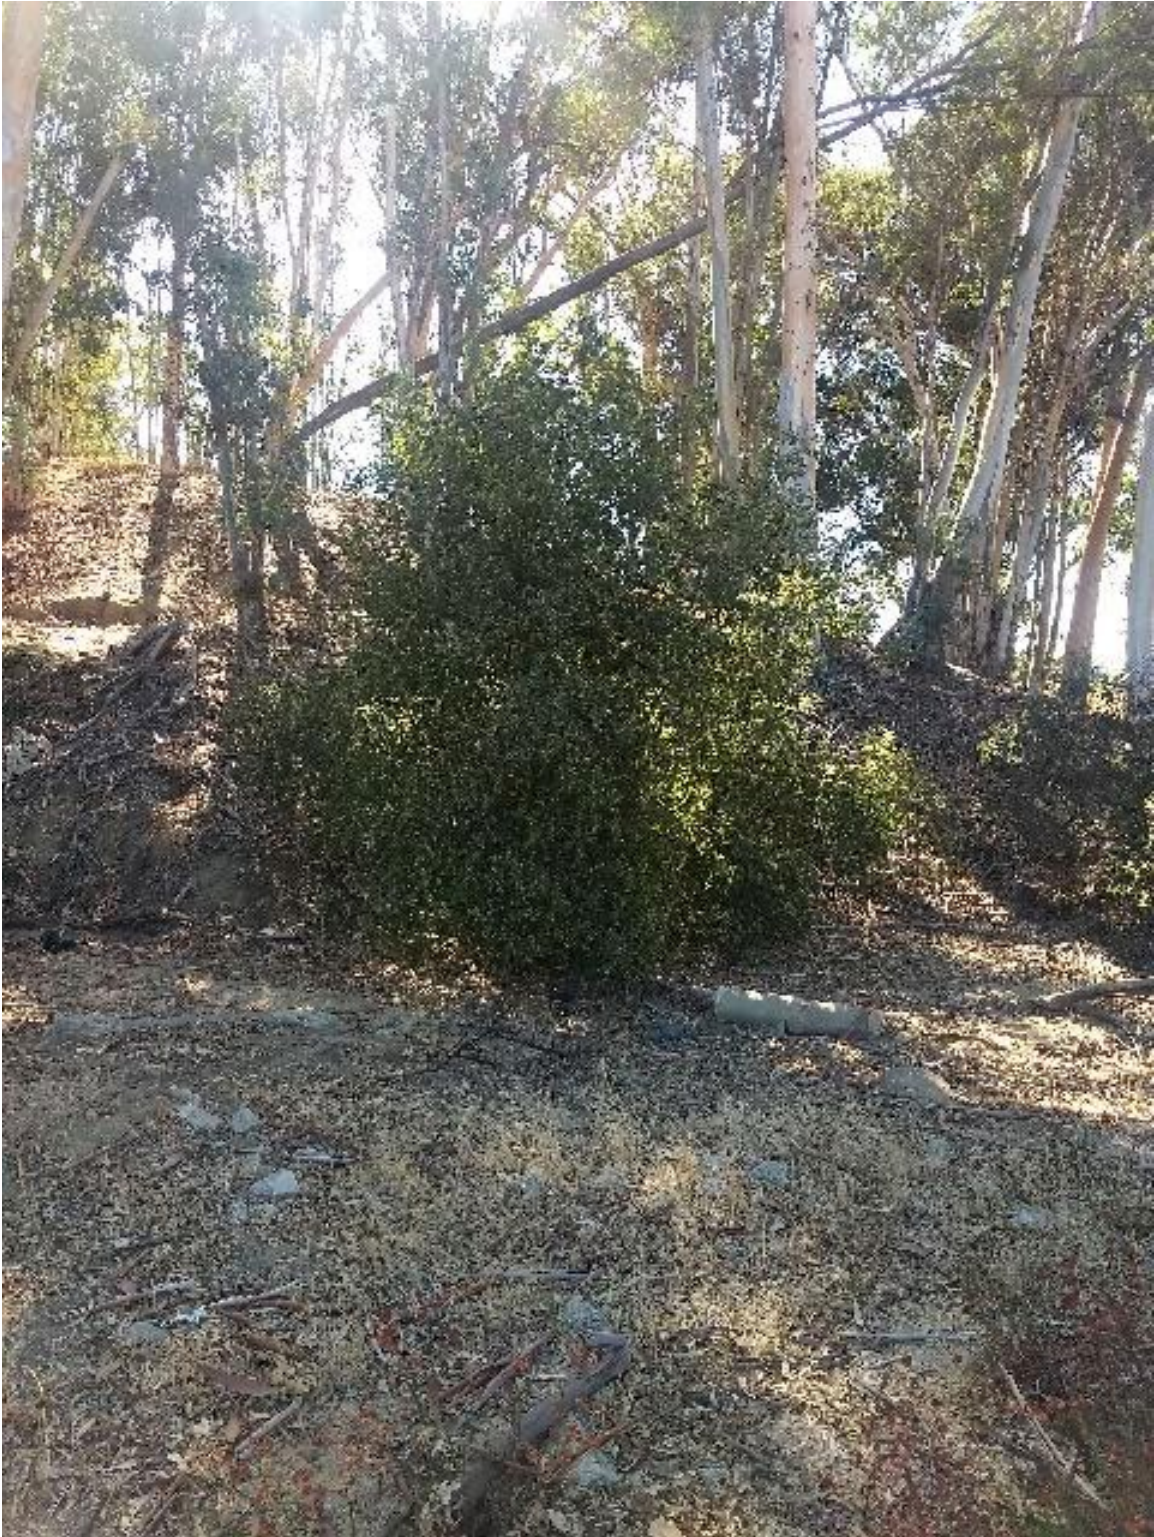
Oak #19

Oak #'s 19-25 are outside of the proposed development area and based on the distance from proposed development, it is likely that these trees would avoid impacts during construction and operation of the project.

Oaks that are on the two parcels adjacent to proposed construction should remain in place. The Tree Protected Zone (TPZ) of these oaks (defined as the area under the canopy and 5 feet beyond the canopy edge), should be protected during construction using protected fencing as described below.
