# Biological Resource Analysis 0 Seely Avenue Mixed-Use Project

San Jose, Santa Clara County, California

December 2022

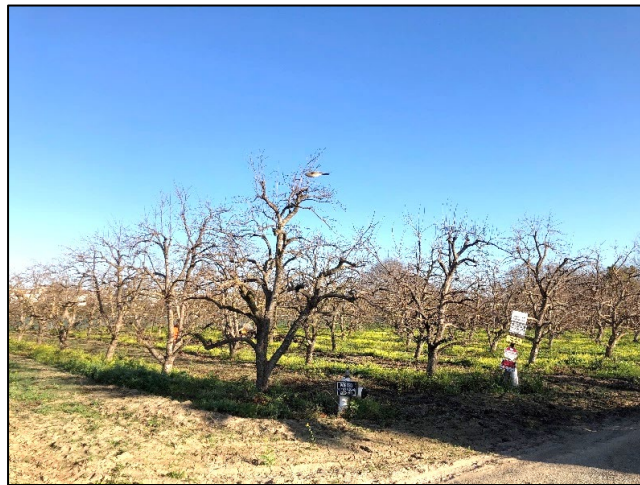
Persimmon was the most commonly occurring species on-site. One hundred and seven (107) persimmons were growing in an orchard on the southern half of the property (Photo 1). Tree conditions ranged from poor (32 trees) to fair (75 trees). The trees had been pruned for fruit production, resulting in vase shaped crowns, re-sprouting from heading cuts, and multiple stems or codominant stems arising from the same points along each tree's trunk. Many of the trees also had mechanically damaged trunks and lower branches, likely from farm equipment.

**Photo 1** – One hundred and seven (107) persimmon orchards trees were growing onsite.

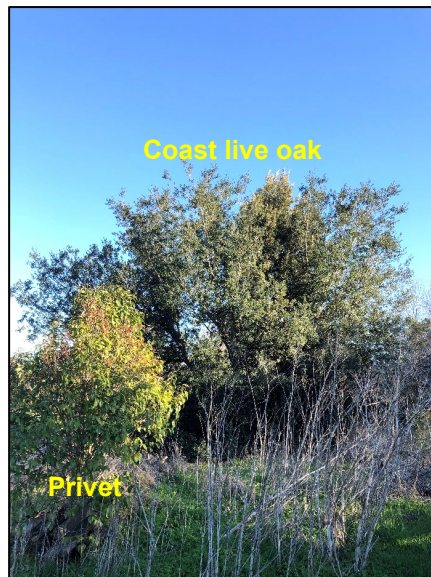
Forty (40) glossy privets were also assessed. Tree conditions ranged from poor (13 trees) to good (two trees), with 25 trees in fair condition. The privets were unmaintained and appeared to be volunteers. Many had shrubby, overgrown forms and multiple stems that arose from the ground (Photo 2).

**Photo 2** – Background: The larger coast live oaks had vigorous, spreading crowns.  
 Foreground: Many privets had shrubby, overgrown forms.

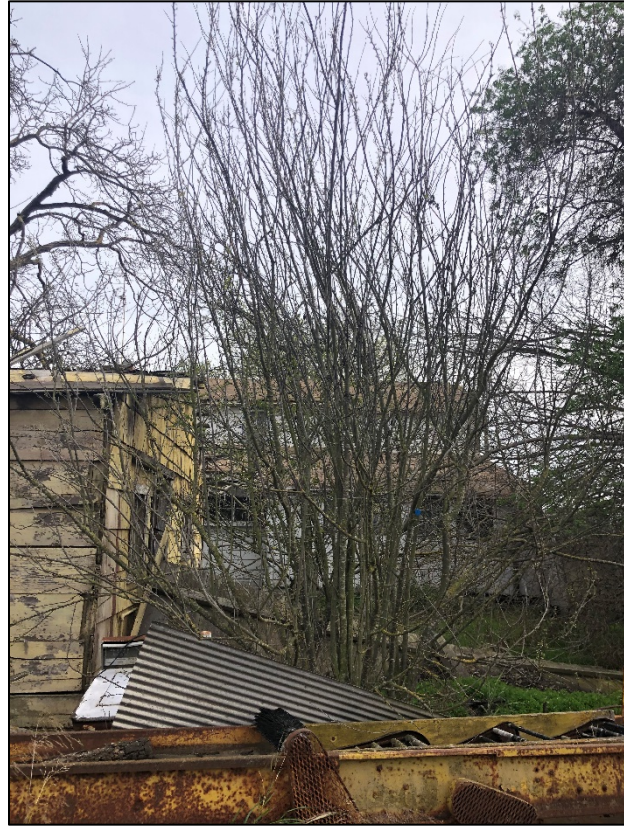
Twenty-three (23) trees of heaven were growing throughout the site. Tree conditions ranged from poor (one tree) to good (one tree) with 21 trees in fair condition. Most appeared to be volunteers with shrubby, vigorous, and unmaintained growth (Photo 4).

**Photo 4** – Most of the trees of heaven appeared to be volunteers with shrubby, vigorous, and unmaintained growth.
