# WILEY CANYON (SMISER RANCH) MIXED USE DEVELOPMENT

## Oak Tree Report

April 2020; Revised February 2024

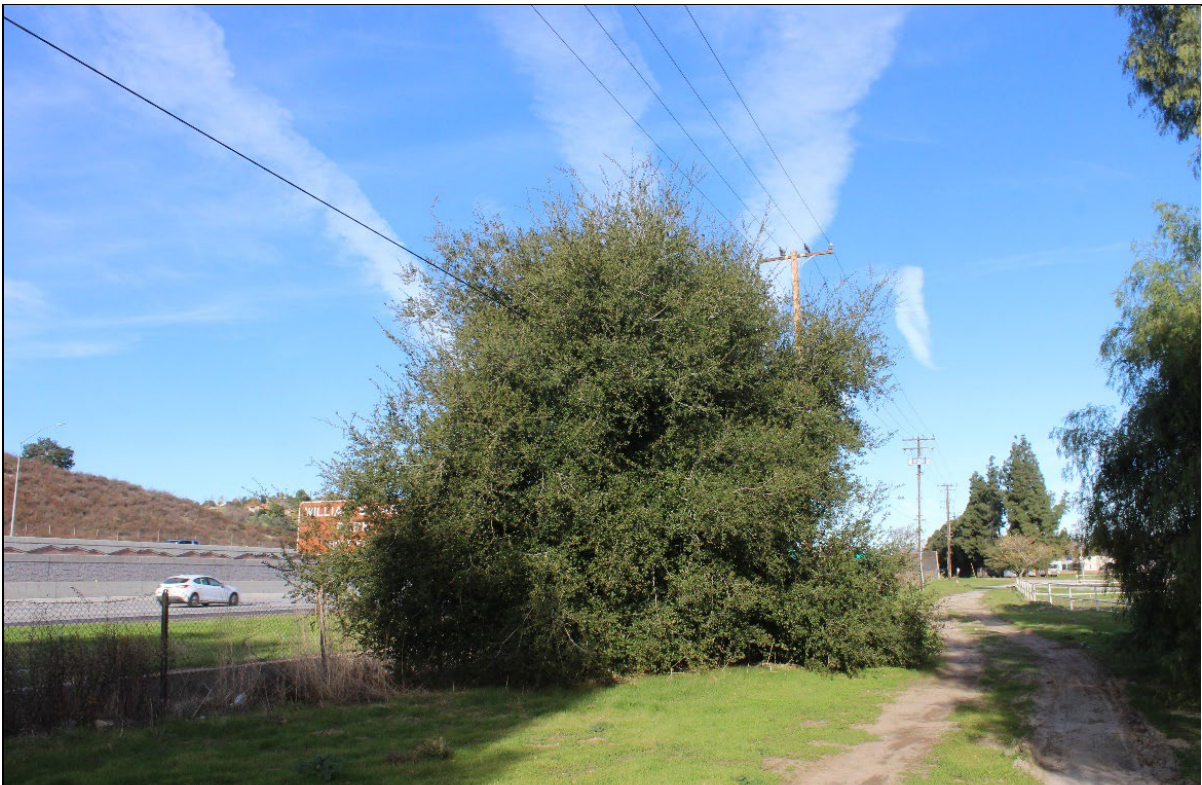
**Photograph 1:** Coast live oak 450, facing north.

Trees 450, 451, 452, 453, 454, 455, and 456 were recorded within the proposed project design area and trees 450, 452, 455, and 456 will be removed because of proposed project grading. The project design will result in minor encroachment of canopy dripline of trees 451 (heritage), 453, 454 (heritage), 457 and 459. No impacts are anticipated for trees 458, 460, and 466.

The ISA dollar value for Trees 450, 452, 455, and 456 is based upon the required tree replacement cost for construction of a new commercial development which requires mitigation based upon the ISA (International Society of Arboriculture) dollar value of each oak tree proposed and approved for removal. Currently the mitigation is estimated at approximately \$303,400 for the removal of four (4) oak trees: 450 (\$26,000), 452 (\$15,600), 455 (\$170,200), and 456 (\$91,600).

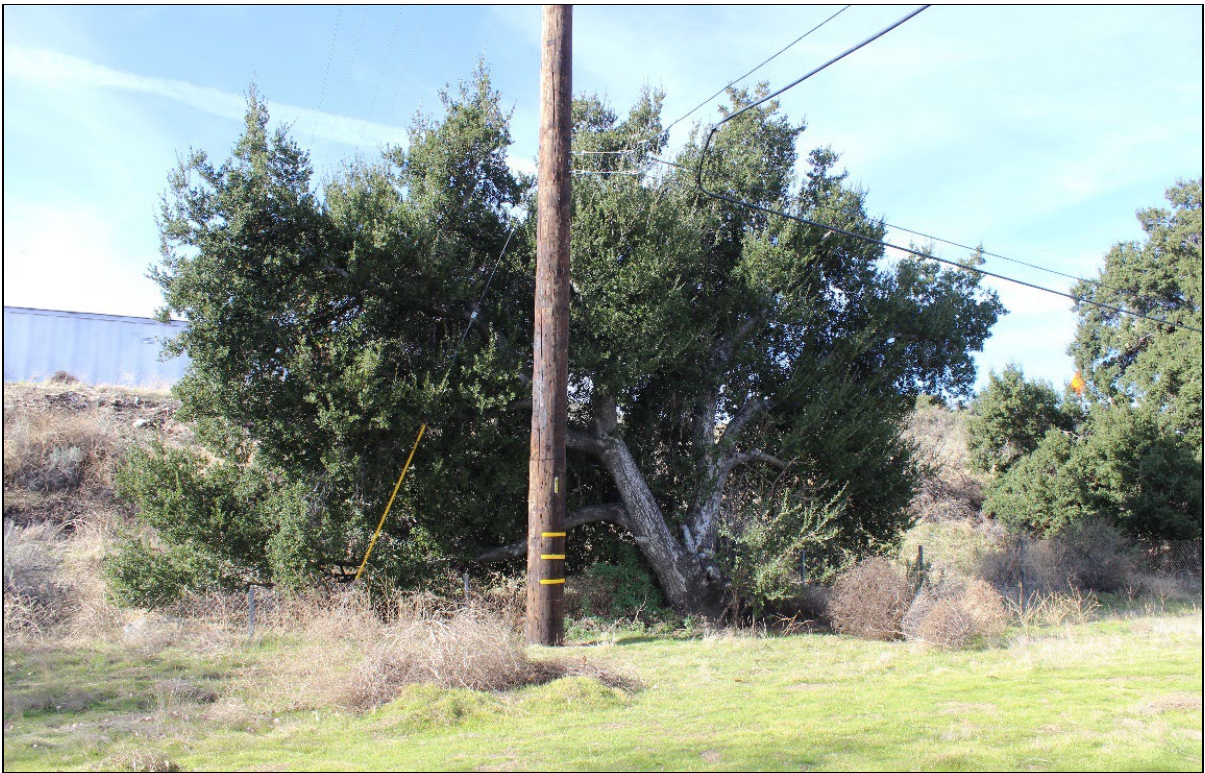
In general, the overall physical condition of the oak trees was consistent with that of trees found within urban areas. Trees 458 and 459 have been improperly pruned for utility or property clearance, reducing the overall balance or health ratings. Tree 459 is not located within the project site and has been subject to minor pruning. Barrels of potentially hazardous hydraulic oil previously observed in the vicinity of two oak trees (Trees 453 and 454) have subsequently been removed since the initial site visit. Tree 453 also has a pronounced lean, but this is not out of the ordinary for coast live oak trees.

**Photograph 9:** Coast live oak tree 458, facing west. Note lopsided canopy due to utility line clearance.

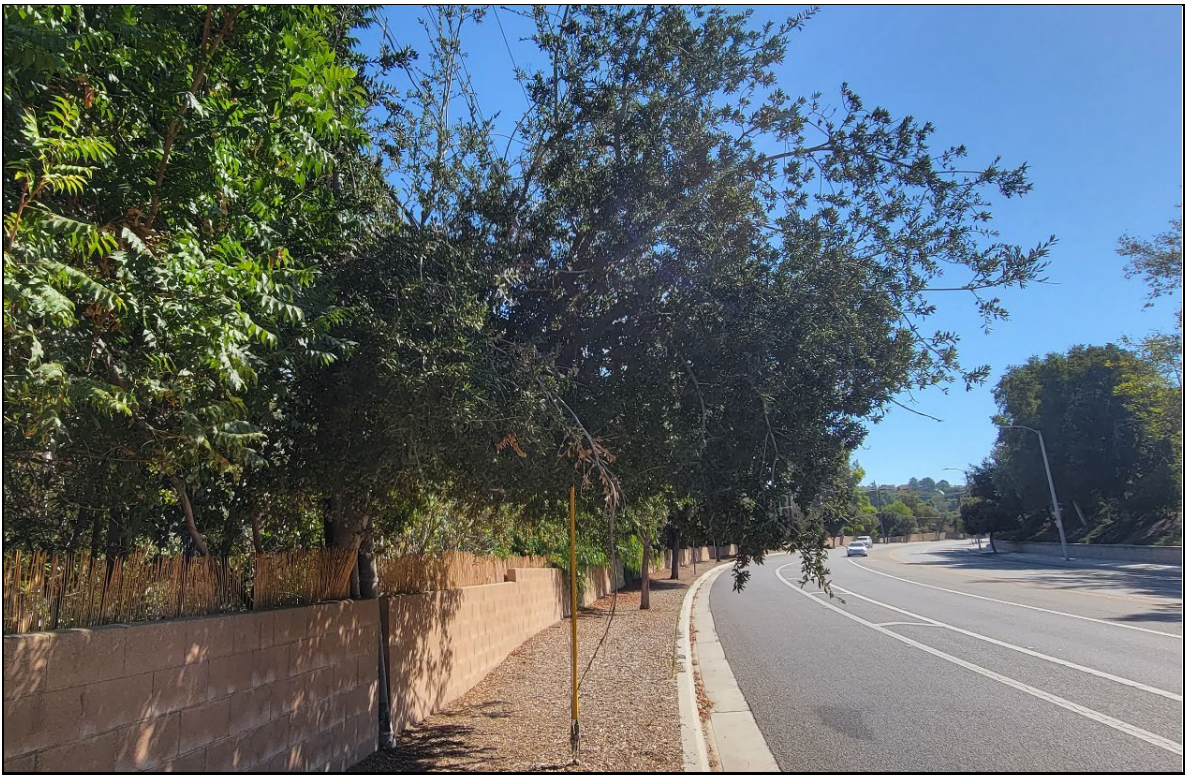
**Photograph 31:** coast live oak QA20, facing north. Note tree extending from brick wall, not located within parkway.
