# **Updated Arborist Report**

1265 Montecito Ave. Mountain View, CA

July 19, 2022

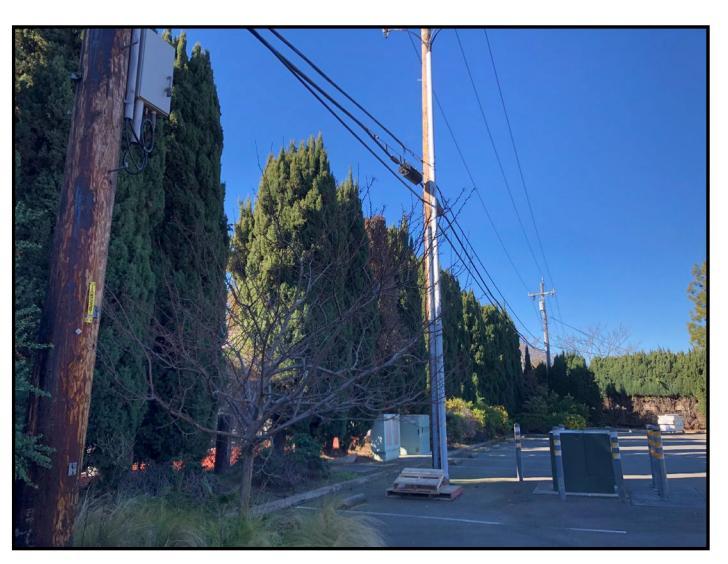
Photo 1: Italian cypress were growing in rows along the perimeter of the property. The row between the Shorebreeze Apartments and the building (#73-107) were space far enough apart to develop well and were in good condition.
