Valor Elementary School Project

Arborist Report

August 11, 2022

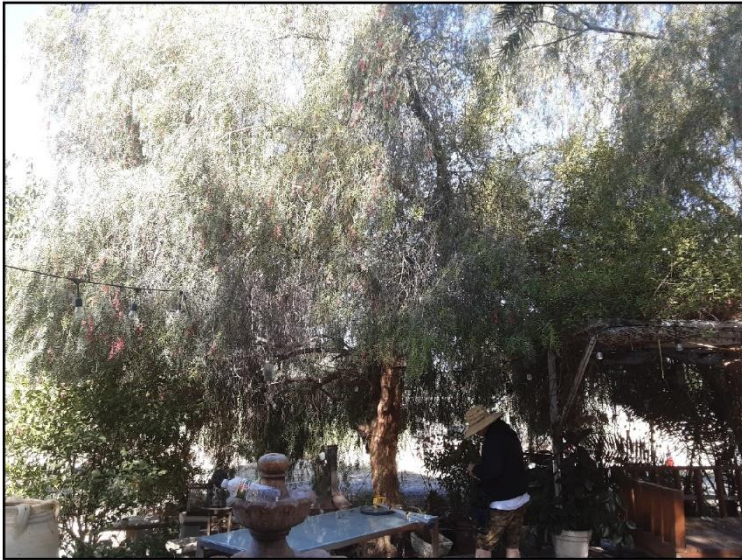
Tree #10 Peruvian pepper (*Schinus molle*)

10	<i>Schinus molle</i>	Peruvian pepper	28	10, 10, 12, 15, 18, 15, 14, 10	12	12	Fair	No	branch dieback in 20% understory, previously pruned	Grading and repurposing of existing single-family residence
11	<i>Morus alba</i>	Mulberry	15	10, 10, 10, 10, 10, 10, 10, 10	9	9	Good	No		Grading and installation of synthetic turf field
12	<i>Cupressus sempervirens</i>	Italian cypress	40	3, 3, 3, 3, 3, 3, 3, 3	8	8	Fair	No	mechanical damage to trunk	Grading and installation of synthetic turf field
13	<i>Cupressus sempervirens</i>	Italian cypress	30	3, 3, 3, 3, 3, 3, 3, 3	4, 4	8	Fair	No	codominant stems	Grading and installation of synthetic turf field
14	<i>Cupressus sempervirens</i>	Italian cypress	40	3, 3, 3, 3, 3, 3, 3, 3	8	8	Fair	No		Grading and installation of synthetic turf field
15	<i>Cupressus sempervirens</i>	Italian cypress	40	3, 3, 3, 3, 3, 3, 3, 3	12	12	Good	No		Grading and installation of synthetic turf field

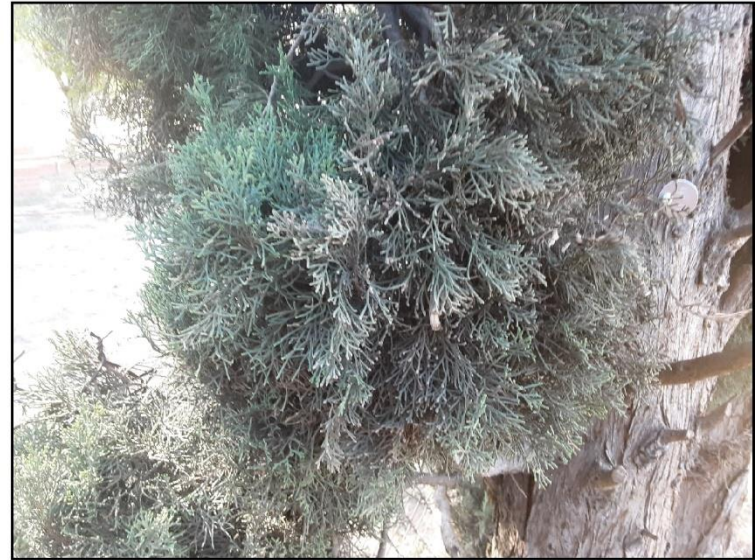
Tree #16 Italian cypress (*Cupressus sempervirens*)

16	<i>Cupressus sempervirens</i>	Italian cypress	40	3, 3, 3, 3, 3, 3, 3, 3	8	8	Fair	No	20% canopy dieback	Grading and installation of synthetic turf field
17	<i>Cupressus sempervirens</i>	Italian cypress	40	3, 3, 3, 3, 3, 3, 3, 3	8	8	Fair	No	mechanical damage to trunk	Grading and installation of synthetic turf field
18	<i>Washingtonia filifera</i>	California fan palm	20	5, 5, 5, 5, 5, 5, 5, 5	16	16	Good	No		Grading and construction of multipurpose room
19	<i>Syagrus romanzoffiana</i>	Queen palm	10	6, 6, 6, 6, 6, 6, 6, 6	8	8	Fair	No		Grading and construction of multipurpose room
20	<i>Syagrus romanzoffiana</i>	Queen palm	20	8, 8, 8, 8, 8, 8, 8, 8	9	9	Fair	No		Grading and construction of multipurpose room
21	<i>Syagrus romanzoffiana</i>	Queen palm	20	6, 6, 6, 6, 6, 6, 6, 6	8	8	Fair	No		Grading and construction of multipurpose room
22	<i>Juglans californica</i>	Southern California black walnut	15	10, 10, 10, 10, 10, 10, 10, 10	3, 3, 3	9	Poor	Yes	main leaders are dead, sprouts alive, graft of old walnut stock	Grading and construction of kindergarten classrooms
