SUBJECT: Coastside Design Review Continuance
Cedar Street, Montara
APN 036-132-210; County File No. PLN 2019-00362

NEW CONSTRUCTION SINGLE FAMILY RESIDENCE TIM PATTERSON CEDAR STREET MONTARA, CA 036-132-210

PATTERSON SFD Montara, California San Mateo County

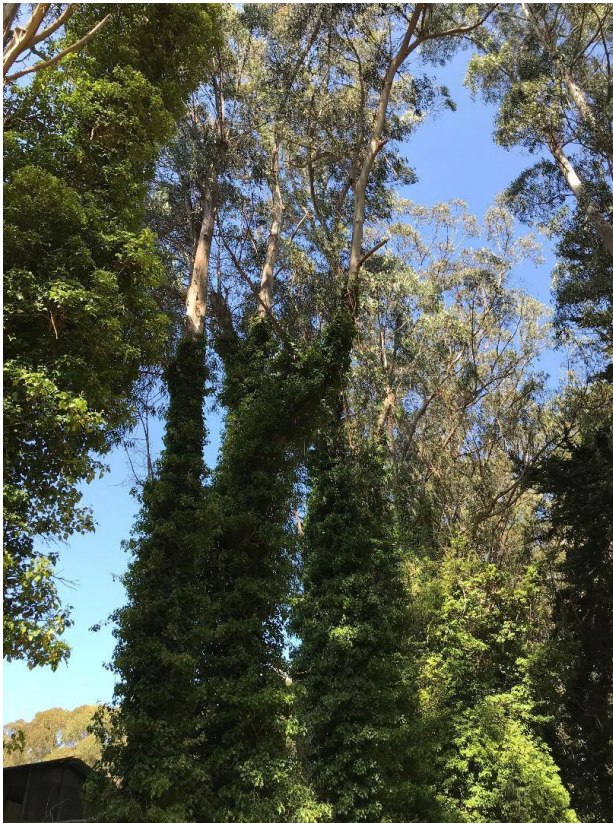
On the west side of the property, at the property line, is a large stand of mature blue gum eucalyptus trees. Ivy growth has taken over a majority of the trees, as ivy can be seen at heights of 40 feet up the tree trunks. The majority of these trees are on the neighboring property or on the property line and can be considered shared trees. All of these trees are recommended to be heavily pruned using acceptable reduction cuts out on the ends of the limbs, to reduce the risk of a large branch failure. Both sides of the tree, on the property side and neighboring side, should be pruned so that the tree canopies do not become unbalanced. All ivy growth is also recommended to be removed. Root crown inspection are recommended for all of the eucalyptus trees at the property line. Any signs of root rot may raise the need for tree removal. If the adjacent neighbor agrees, the trees should be removed and replaced with a different species acceptable in the climate as they can all be considered hazardous by nature.

Showing ivy growth on eucalyptus trees

Removing the eucalyptus trees and replanting with a native species or a species that does good in a coastal setting would help return the site to a more native setting and alleviate the liabilities associated with the grove of eucalyptus.
