ARBORIST REPORT

February 26, 2021
Rev. September 22, 2022
Rev. 2 September 27, 2022
5899.00

1040 Terra Bella Ave.
Mountain View, CA

Public Storage

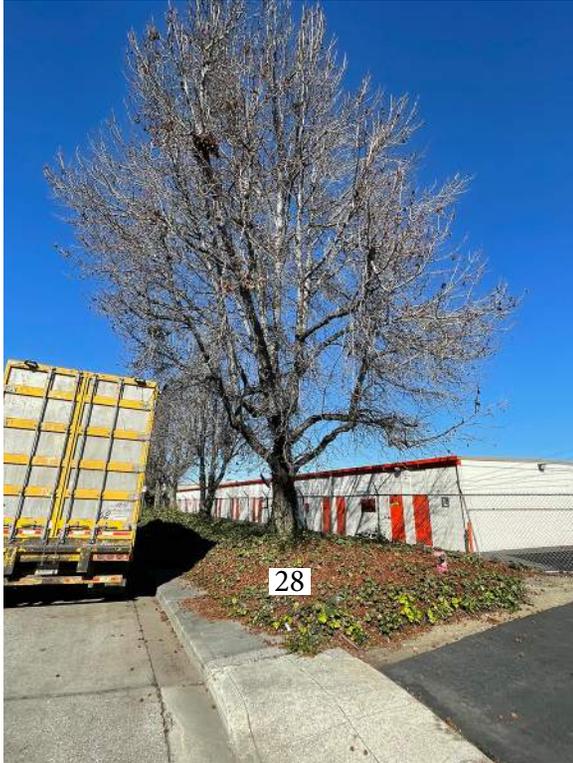
The Sweetgum trees are mature specimens and are in good shape. They are located on the west site of the Public Storage site on Linda Vista Avenue. The internal branching structure of these trees could benefit from a structural pruning effort. Additionally, clearing out some of the ivy and leaf and seed debris from around the trunk of the tree would also benefit the trees. As Liquidambar trees are a moderate water use tree ensuring that adequate irrigation is being applied would help the vigor of these trees. Upon reviewing the landscape plans, these trees must be removed due to a new sidewalk being constructed in their current location. These trees are not good candidates for relocation.

| TREE # | BOTANICAL NAME | COMMON NAME | DBH (INCHES) | CIRCUMFERENCE (INCHES) | HERITAGE TREE | HEALTH | PRESERVATION SUITABILITY | ONSITE OR ROW | RETAIN/ REMOVE/ RELOCATE | NOTES |
|---|---|---|---|---|---|---|---|---|---|---|
| 28 | <i>Liquidambar styraciflua</i> | Sweetgum | 28.0 | 88 | YES | 4 | Moderate | ROW | REMOVE | |

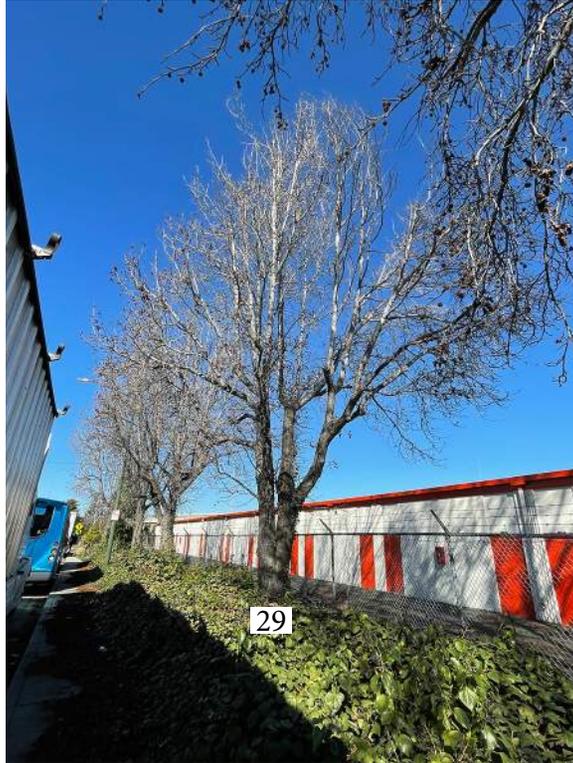
| TREE # | BOTANICAL NAME | COMMON NAME | DBH (INCHES) | CIRCUMFERENCE (INCHES) | HERITAGE TREE | HEALTH | PRESERVATION SUITABILITY | ONSITE OR ROW | RETAIN/ REMOVE/ RELOCATE | NOTES |
|---|---|---|---|---|---|---|---|---|---|---|
| 29 | <i>Liquidambar styraciflua</i> | Sweetgum | 26.0 | 82 | YES | 4 | Moderate | ROW | REMOVE | MULTI-TRUNK |

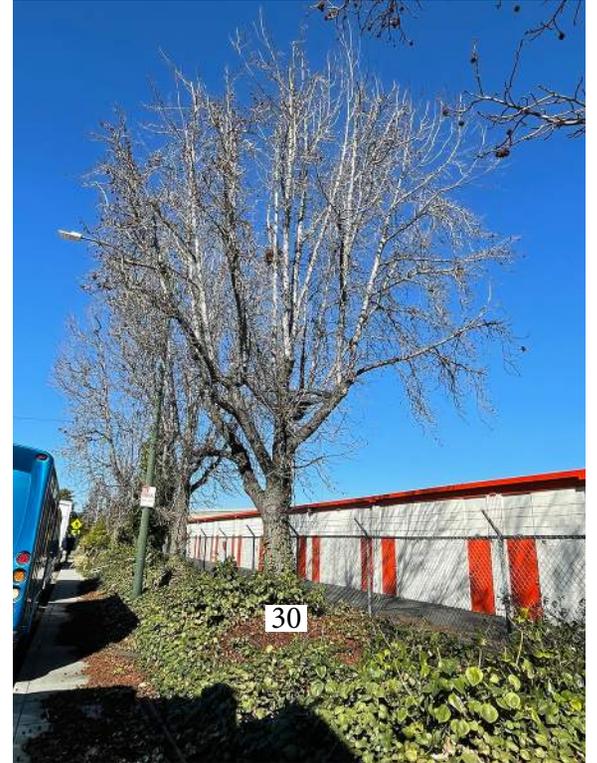
| TREE # | BOTANICAL NAME | COMMON NAME | DBH (INCHES) | CIRCUMFERENCE (INCHES) | HERITAGE TREE | HEALTH | PRESERVATION SUITABILITY | ONSITE OR ROW | RETAIN/ REMOVE/ RELOCATE | NOTES |
|---|---|---|---|---|---|---|---|---|---|---|
| 30 | <i>Liquidambar styraciflua</i> | Sweetgum | 21.0 | 66 | YES | 4 | Moderate | ROW | REMOVE | |
