SUPPLEMENTAL GEOLOGIC FAULT HAZARD STUDY OF THE RIVERSIDE COUNTY EARTHQUAKE ZONE, FOR THE PROPOSED RESIDENTIAL DEVELOPMENT, LOCATED AT 800 N. GIRARD STREET, CITY OF HEMET, RIVERSIDE COUNTY, CALIFORNIA.

***Dated: September 10, 2018
Project No. G18-1647-10***

Subject: Supplemental Geologic Fault Hazard Study of the Riverside County Earthquake Fault Zone, For the Proposed Residential Development, Located at 800 N. Girard Street, City of Hemet, Riverside County, California

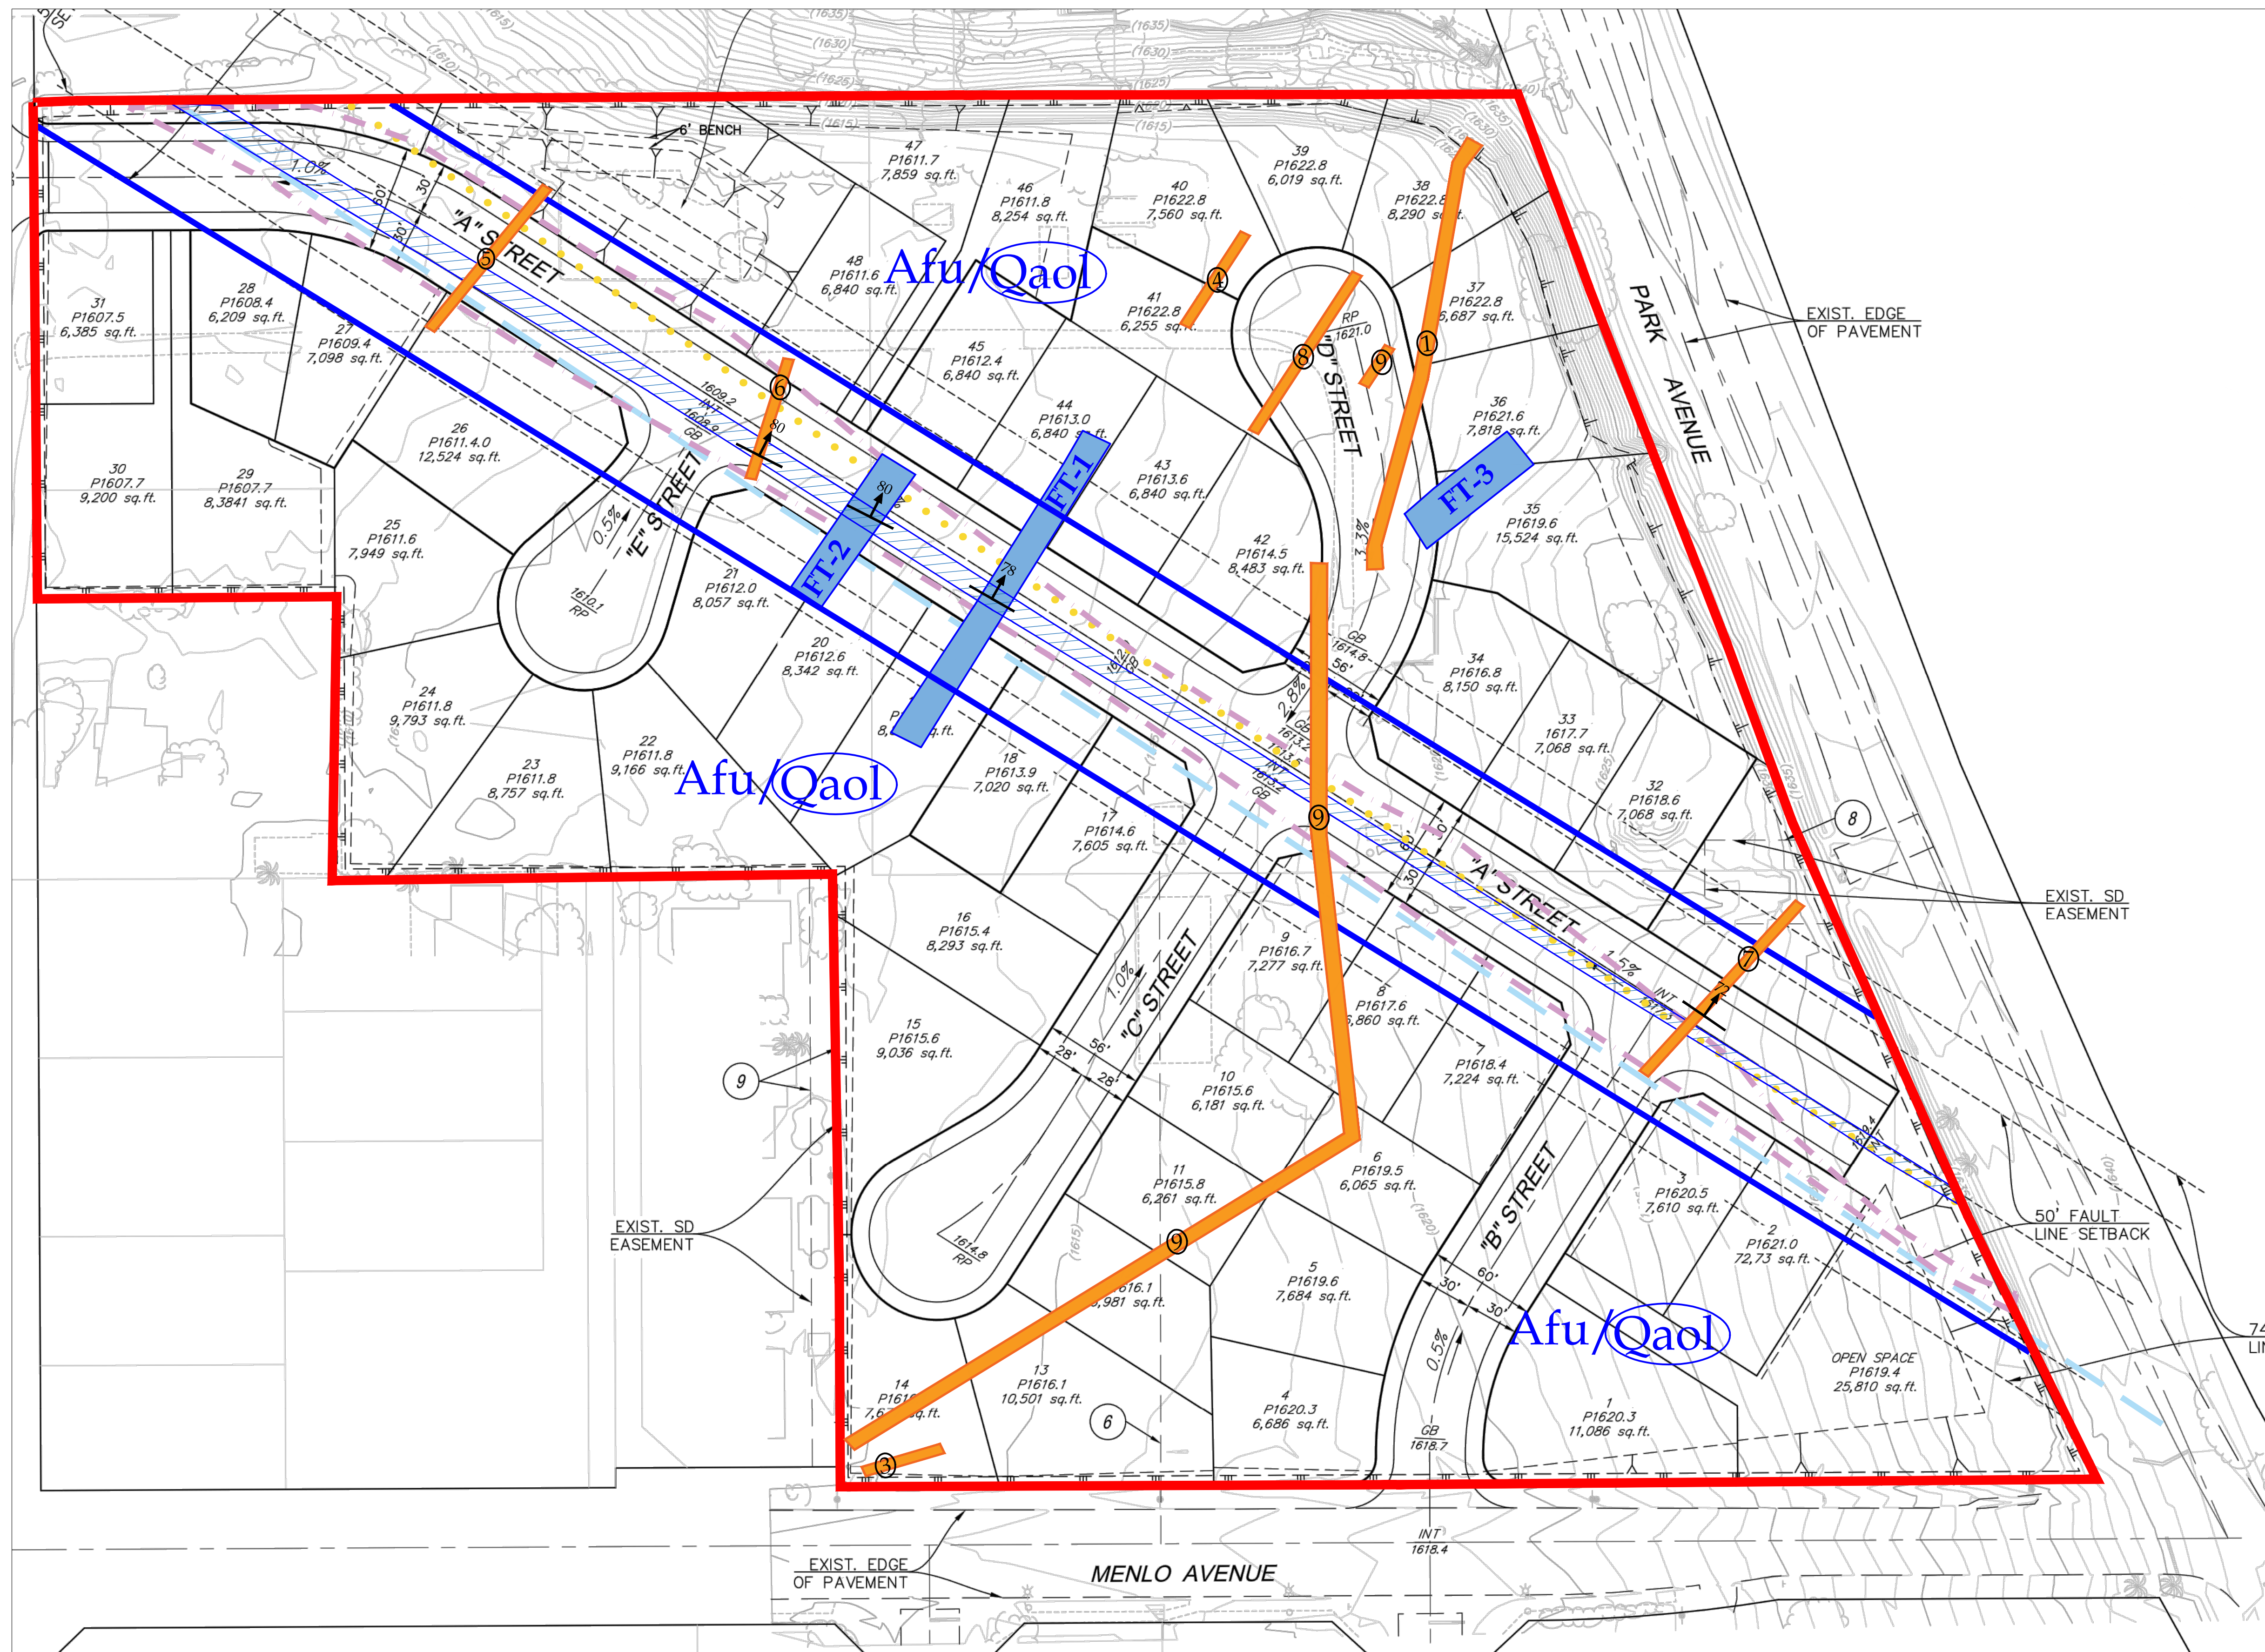
Faults (active, potentially active, or inactive) *are* known to project through the site. The subject site is located within a Riverside County Earthquake Fault Zone. During our investigation faulting associated with the Casa Loma were located trending northwest/southeast through the site in FT-1 and FT-2 (See Plate 1). In addition, Rasmussen concluded there is active faulting onsite and identified what they believe to be the major active trace along the Casa Loma fault (Rasmussen, 2018).

Based on the findings of this investigation and review of previous fault hazard reporting active faulting does exist on site and a fault hazard setback zone is recommended, as indicated on the geologic/fault Location Map (Plate 1).

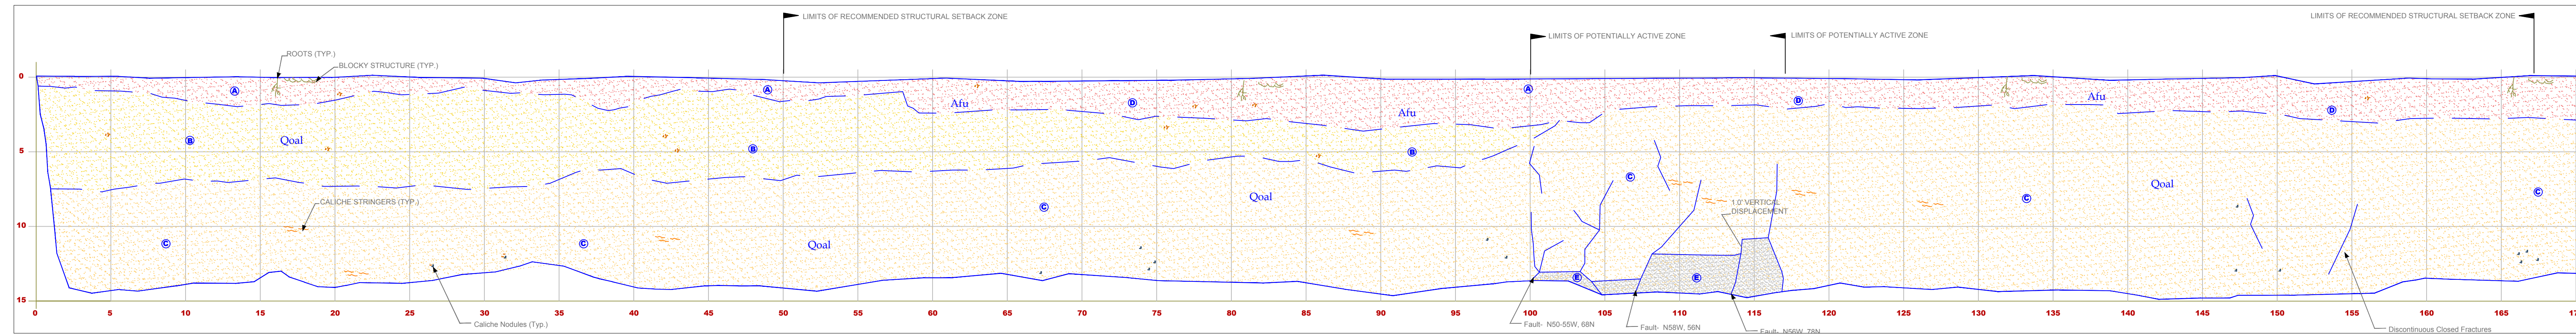
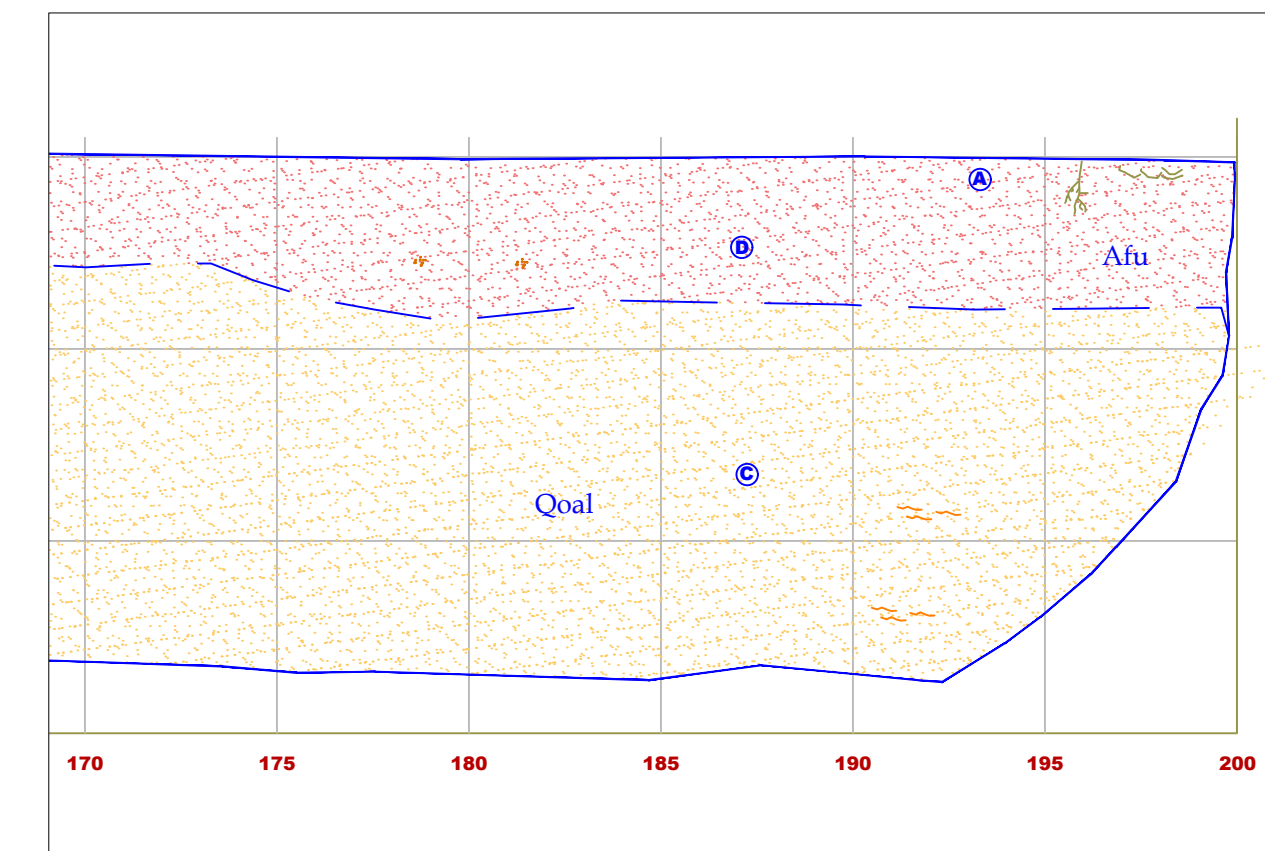
FT-1, TREND: N33E, PART 1 OF 2

Fault Trench FT-1 was excavated roughly perpendicular to the mapped trend of the Casa Loma Fault as indicated by previous reporting by Rasmussen (1988) and lineaments observed during aerial photo analysis. This trench was approximately 200 feet in length and to a maximum depth of approximately 15 feet below existing ground surface (see Plate 2). The majority of the trench generally exposed artificial fill and topsoil directly overlying older alluvium juxtaposed against Bautista Formation bedrock. Multiple fault breaks were mapped within the Bautista Formation and older alluvium (see Plate 2). Faulting showed evidence of slickensides and vertical displacement. The observed faulting coincided with both the aerial photo lineaments and the previous geotechnical reports by Rasmussen (1988). Lack of Holocene aged overlying soils was not observed within this trench do discern if this faulting is inactive or active. However Rasmussen concluded there is active faulting onsite and identified what they believe to be the major active trace along the Casa Loma fault. The mapped location of our observed faulting is similar with Rasmussen's in both general trend and location. Therefore, LGC conservatively concurs with Rasmussen that this is the major trace of the Casa Loma fault and is indeed active.

LGC recommends a restricted use for human occupancy structures setback zone for the major active trace of the Casa Loma Fault (See Plate 1). Rasmussen stated, "surface ground rupture due to active faulting along Fault Zone 3 (See Plate 1) may occur during the lifetime of the proposed structures (Rasmussen, 1988)." A previous setback zone was provided by Rasmussen however we believe the most recent setback zone represents the most current evidence of faulting and should be incorporated into the proposed development.

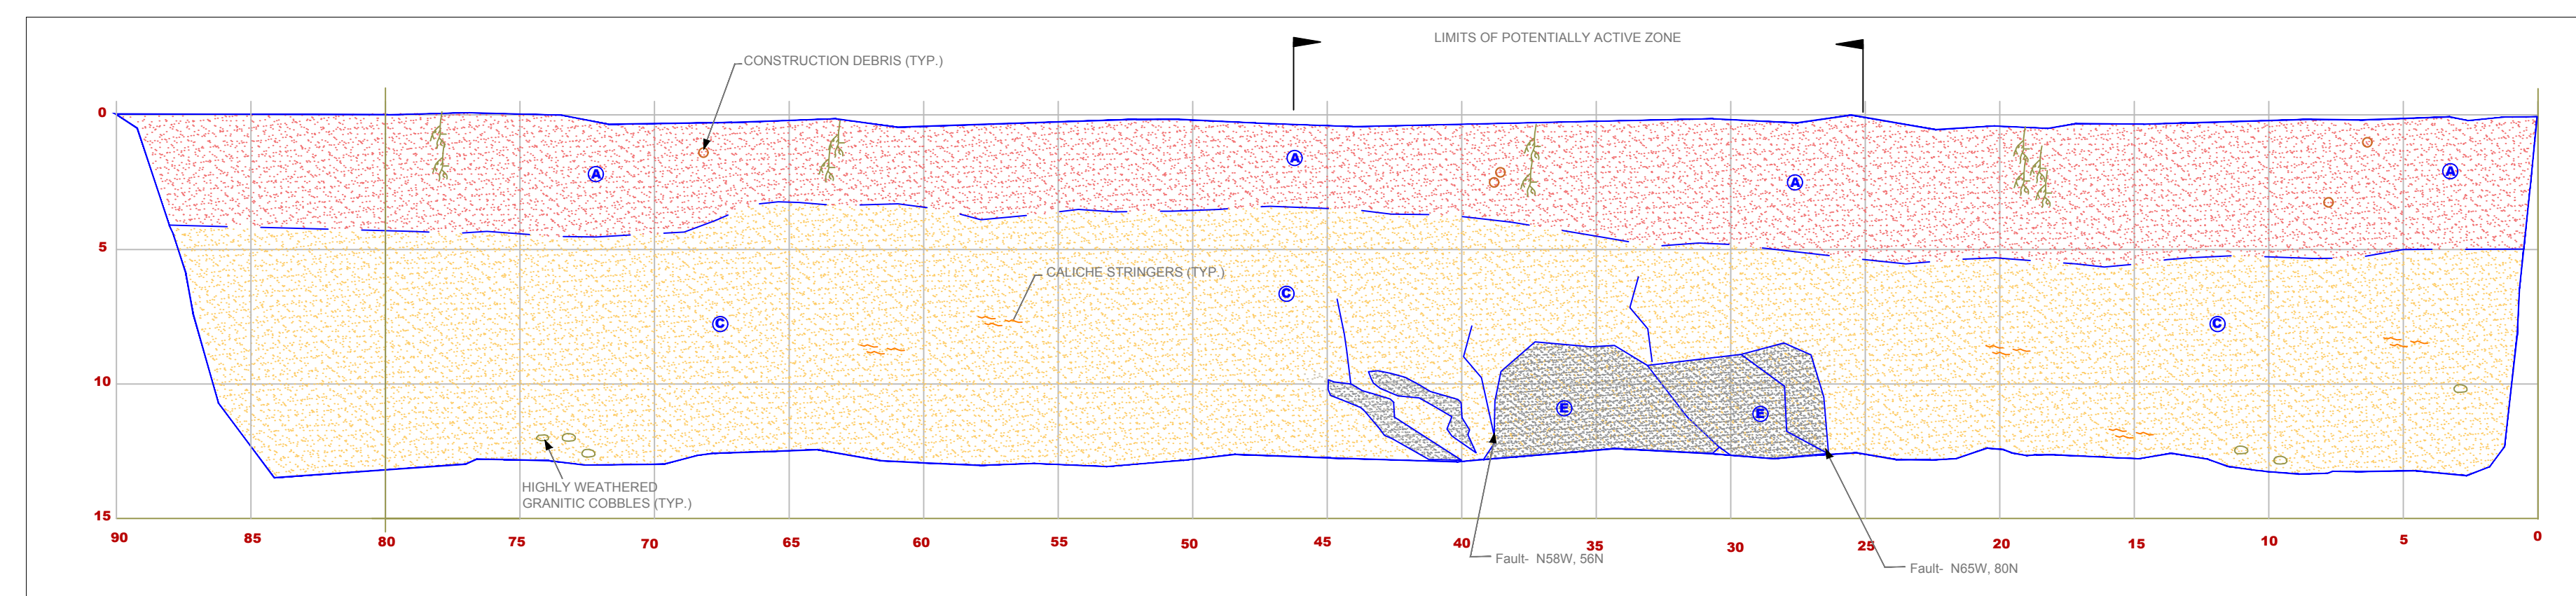
FT-2, TREND: N35E, PART 1 OF 1

Fault Trench FT-2 was excavated northwest of FT-1 to relocate the active fault encountered in FT-1 transecting the site. This trench was approximately 80 feet in length, a maximum of approximately 14 feet deep, and exposed artificial fill over older alluvium and Bautista Formation Bedrock. The trench generally exposed artificial fill directly overlying older alluvium juxtaposed against Bautista Formation bedrock. Multiple fault breaks were mapped within the Bautista Formation and older alluvium (see Plate 2). Faulting showed evidence of slickensides, indiscernible displacement, dragged and brecciated fragments of Bautista Formation Bedrock. Additionally, the general location and orientation of the exposed faulting was identified in previous reporting by Rasmussen (1988).

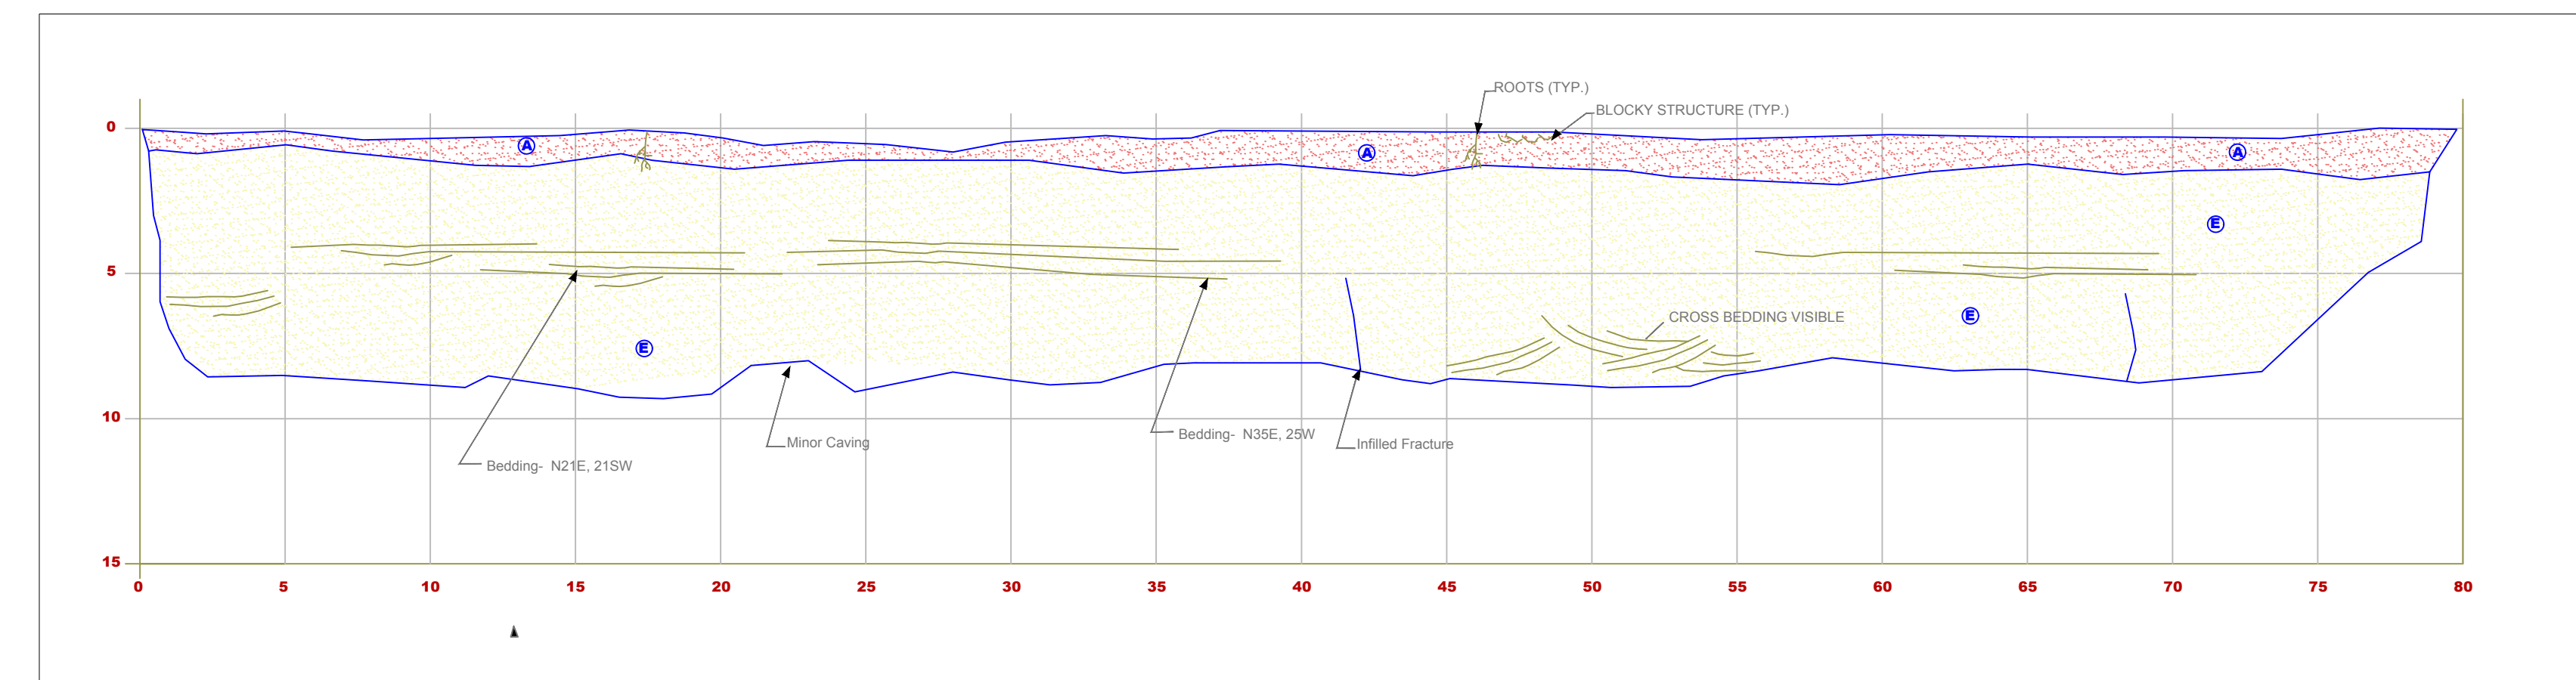
FT-3, TREND: N55E, PART 1 OF 1

Fault Trench FT-3 was excavated approximately 80 feet in length and 9 feet in depth below ground surface (See Plate 2). This trench exposed artificial fill overlying Bautista Formation Bedrock. Although some minor fractures were mapped during our investigation no conclusive evidence of faulting was identified within the Bautista Formation Bedrock or artificial fill in FT-3 (see Plate 2).
