# BROOKSIDE GOLF COURSE IMPROVEMENTS PROJECT

## Tree Report

November 2020

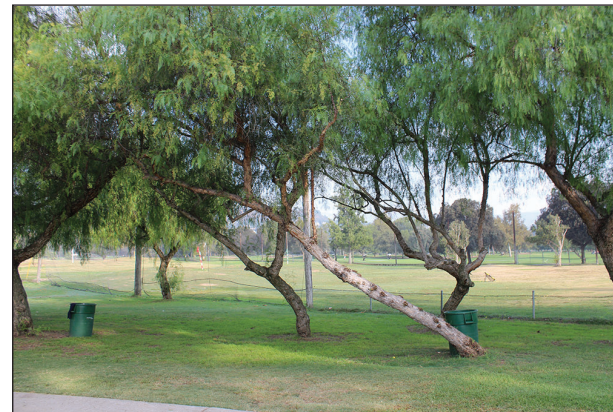
Tree 59 - Peruvian pepper

59	Peruvian pepper	<i>Schinus molle</i>	34.16462272	-118.1683236	P	10.5	20	8	13	15	15	13	10	4	4	B	C	C	C	self corrected lean, root damage, exposed roots, basal sprouting	normal
60	Peruvian pepper	<i>Schinus molle</i>	34.1646015	-118.1682719	P	8.0	13	1	1	18	16	5	1	1	1	C	C	D	C	strong lean to w-sw, basal sprouting, lion tailed, exposed damaged roots, decay at base	normal
61	Peruvian pepper	<i>Schinus molle</i>	34.164594	-118.1683748	P	15.6	30	11	12	10	14	18	15	12	8	B	B	C	C	root damage, self corrected lean, basal sprouting,	normal
62	Peruvian pepper	<i>Schinus molle</i>	34.16460405	-118.1684377	P	13.1	26	10	12	13	16	15	14	12	13	C	B	B	C	damaged roots with decay, crown raised, recommend decay assessment	normal
63	Peruvian pepper	<i>Schinus molle</i>	34.1647125	-118.1684683	P	14.5	25	5	11	15	17	17	11	14	6	C	C	C	B	basal sprouting, lopsided due to presence of driving range fence, built up soil over roots, burls on trunk	normal

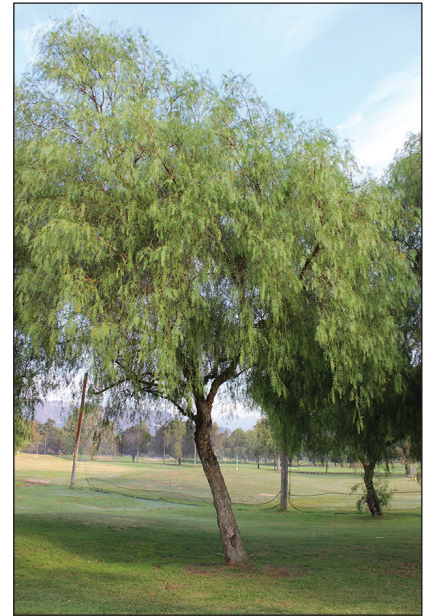
Tree 64 - Peruvian pepper

64	Peruvian pepper	<i>Schinus molle</i>	34.16456372	-118.1684914	P	12.7	19	10	11	12	16	13	12	6	4	C	B	B	C	exposed roots, mechanical damage at base, slight lean	normal
65	holly oak	<i>Quercus ilex</i>	34.16534225	-118.1684775	P, M	19.0, 15.0 (24.2) <sup>4</sup>	30	7	6	7	9	6	6	5	6	C	C	C	C	golfball damage, topped, dead hangers in canopy, measurements estimated due to location on active driving range	normal
66	Peruvian pepper	<i>Schinus molle</i>	34.16455606	-118.1685528	P	14.1	25	10	17	15	10	11	14	10	6	C	C	B	C	root decay present, exposed damaged roots, fungus at base, basal sprouting, recommend decay assessment	normal
67	Peruvian pepper	<i>Schinus molle</i>	34.16455511	-118.1686195	P	12.5	23	13	12	14	14	15	9	5	8	B	B	B	B	crown raised, built up soil over roots	normal
68	Peruvian pepper	<i>Schinus molle</i>	34.16452709	-118.1687499	P	15.0	23	10	14	17	15	14	15	14	12	B	C	B	B	basal sprouting, minor bark beetle	pavement over roots

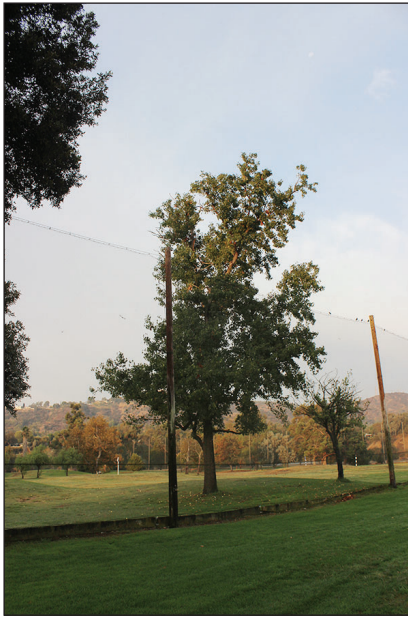
Tree 69 - American sweetgum

69	American sweetgum	<i>Liquidambar styraciflua</i>	34.16549444	-118.1687804	P, S	23	50	16	20	18	14	15	18	15	16	C	C	B	C	dieback in canopy with multiple dead hangers, leaf scorch, golfball damage, exposed damaged roots, remove dead hangers	normal
70	Peruvian pepper	<i>Schinus molle</i>	34.16476468	-118.1688068	P	14.5	19	11	13	15	15	13	12	10	6	C	C	C	C	golfball damage, slight lean, large limb removal, bark beetle, basal sprouting	normal
71	Japanese yew	<i>Podocarpus macrophyllus</i>	34.16553927	-118.1688504	P	11.0	20	6	8	6	6	4	6	7	6	D	D	C	C	golfball damage, dieback in crown, multiple dead hangers, mold/mildew on trunk due to sprinkler overspray, measurements estimated due to location on active driving range	normal
72	Peruvian pepper	<i>Schinus molle</i>	34.16476679	-118.1688848	P	13.3	26	14	16	15	18	16	20	15	13	C	C	B	C	golfball damage, basal sprouting, bark beetle	saturated
73	Peruvian pepper	<i>Schinus molle</i>	34.1646987	-118.1689294	P	15.5	29	12	15	12	11	11	14	12	10	C	C	B	C	built up turf over crown, basal sprouting, possible decay at base	normal

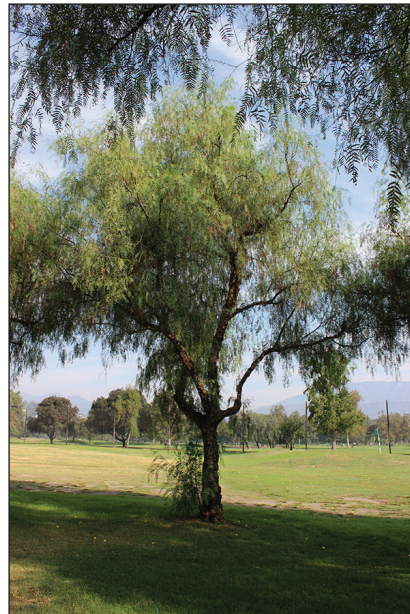
Tree 74 - Peruvian pepper

74	Peruvian pepper	<i>Schinus molle</i>	34.16479735	-118.1689614	P	13.3	25	12	13	9	13	10	7	8	9	B	C	C	B	golfball damage, basal sprouting	normal
75	Peruvian pepper	<i>Schinus molle</i>	34.1647948	-118.1690292	P	18.3	18	10	11	19	11	12	12	13	11	C	C	C	C	golfball damage, exposed damaged roots	normal
76	Peruvian pepper	<i>Schinus molle</i>	34.1648121	-118.1690845	P	8.3	14	10	12	11	10	12	7	5	5	C	C	B	C	golfball damage, basal sprouting, crown raised	normal
77	Peruvian pepper	<i>Schinus molle</i>	34.16481319	-118.1691521	P	13.3	28	9	13	14	15	13	12	12	8	C	B	C	C	golfball damage, crown raised	normal
78	Peruvian pepper	<i>Schinus molle</i>	34.1648411	-118.1692159	P	8.3	18	6	8	10	9	10	6	7	7	C	C	C	C	golfball damage, basal sprouting, crown raised	normal
79	Peruvian pepper	<i>Schinus molle</i>	34.16483821	-118.1692768	P	12.3	25	13	14	13	19	12	11	13	12	B	B	B	C	golfball damage, crown raised, basal sprouting	normal

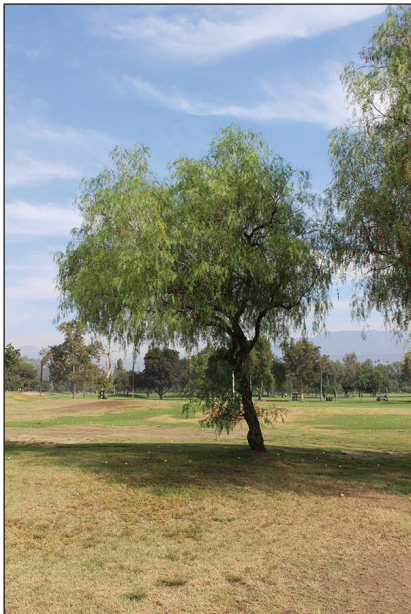
Tree 80 - Peruvian pepper

80	Peruvian pepper	<i>Schinus molle</i>	34.16486196	-118.1693348	P	8.0	16	6	8	9	7	8	6	4	3	D	C	C	C	slight lean, decay at base, basal sprouting, flush cuts along trunk	compacted
81	Peruvian pepper	<i>Schinus molle</i>	34.16485852	-118.1694193	P	8.4	16	2	5	8	11	12	9	6	6	C	C	B	C	basal sprouting, golfball damage, exudate in upper canopy	normal
82	Peruvian pepper	<i>Schinus molle</i>	34.16488537	-118.1694786	P	7.0	11	5	6	6	6	7	5	4	4	C	B	B	C	golfball damage, lean,	compacted
83	Peruvian pepper	<i>Schinus molle</i>	34.16488429	-118.1695386	P	9.1	18	8	7	7	6	5	6	9	8	B	B	B	C	golfball damage, crown raised, basal sprouting	normal
84	red ironbark	<i>Eucalyptus sideroxylon</i>	34.16439789	-118.1695949	P, S	26.6	30	14	17	11	10	11	13	12	9	C	C	B	C	epicormic and basal sprouting, included bark, built up turf/soil on crown	normal
85	western sycamore	<i>Platanus racemosa</i>	34.16583031	-118.1696162	P, N, M	29	19	5	5	5	5	5	5	5	5	D	F	D	D	tree mostly dead, basal resprouts present, upper 20 feet of canopy all dead decaying wood, measurements estimated due to location on driving range, recommend removal	normal

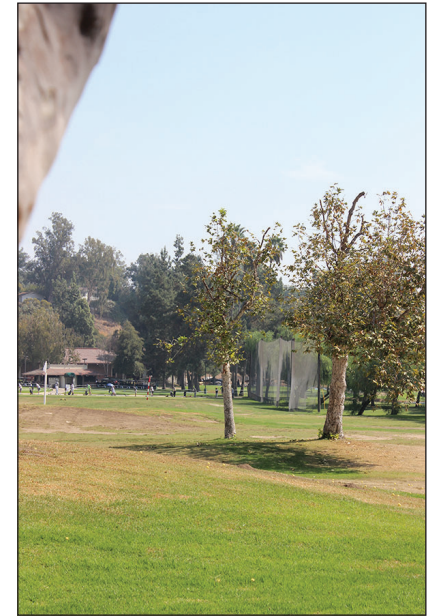
Tree 87 - western sycamore

86	Peruvian pepper	<i>Schinus molle</i>	34.16490345	-118.1696161	P	10.4	20	6	8	7	8	10	6	6	7	B	C	B	B	golfball damage, slight lean, crown raised	compacted
87	western sycamore	<i>Platanus racemosa</i>	34.16514762	-118.1696988	P, N	12	28	10	10	10	10	10	10	10	10	C	D	C	C	golfball damage, dieback in crown, ISHB-FD <sup>7</sup> likely, measurements estimated due to location on active driving range	normal
88	western sycamore	<i>Platanus racemosa</i>	34.16515487	-118.1697231	P, N, M	23	30	10	8	12	15	18	10	10	10	C	D	C	C	ISHB-FD likely, dieback in crown, large dead hangers in canopy, golfball damage, measurements estimated due to location on active driving range	normal
89	western sycamore	<i>Platanus racemosa</i>	34.16420445	-118.1699793	P, N, M	27.5	50	17	19	21	15	17	19	19	14	D	C	C	C	ISHB-FD likely, basal resprout, decay in trunk, termites, frass	pavement over roots
90	western sycamore	<i>Platanus racemosa</i>	34.16586899	-118.1700128	P, N, M	23.4	37	20	23	19	19	24	16	20	19	C	C	C	C	multiple cavities and woodpecker holes, ISHB-FD likely, golfball damage, lean	normal

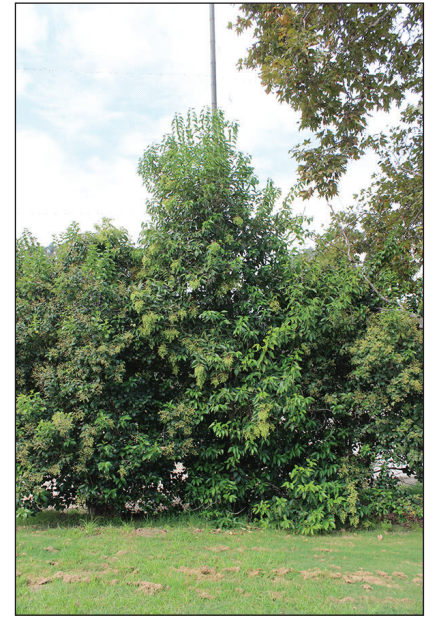
Tree 104 - Chinese privet

104	Chinese privet	<i>Ligustrum lucidum</i>	34.16458844	-118.1702719	P	10.1	19	6	4	3	3	5	5	5	5	A	A	A	A	Grouping of 3 hedges with one trunk of appropriate size	normal
105	Sydney red gum	<i>Angophora costata</i>	34.16534667	-118.170263	P, S, M	34.5	50	18	6	4	6	27	25	20	23	C	C	B	C	multiple dead hangers in upper canopy, golfball damage, dieback in crown	normal
106	shamel ash	<i>Fraxinus uhdei</i>	34.16507957	-118.1702809	P, M	10.0, 10.2, 14.0 (20.0)	35	16	18	20	22	24	10	11	16	B	C	C	B	large exposed buttress roots with mechanical damage, multiple trunks, fence girdling trunk and base, growing over concrete	compacted
107	shamel ash	<i>Fraxinus uhdei</i>	34.16475871	-118.1702734	P	8.1, 2.0, 1.0 (8.4)	21	10	8	9	10	10	8	8	11	B	B	B	A	multiple trunks, growing in fence	normal
108	shamel ash	<i>Fraxinus uhdei</i>	34.16491561	-118.1702779	P	10.0	20	11	10	12	9	8	1	1	1	B	C	D	B	growing in fence, half of tree pruned at fence, basal sprouting	normal

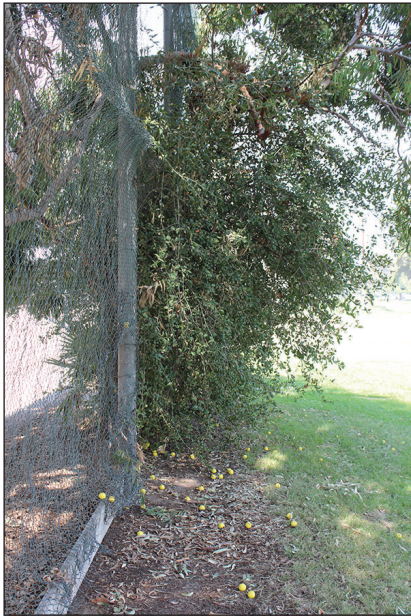
Tree 109 - coast live oak

109	coast live oak	<i>Quercus agrifolia</i>	34.16540595	-118.1702754	P, N	4.0	10	5	6	4	4	6	7	6	5	B	B	C	B	growing in fence, poor pruning,	pavement over roots
110	Sydney red gum	<i>Angophora costata</i>	34.16538686	-118.1702957	P, S, M	28.0	45	20	23	20	23	25	12	6	10	B	B	B	B	roots covered by concrete, fence pruning made tree lopsided	pavement over roots
111	white alder	<i>Alnus rhombifolia</i>	34.16540811	-118.167398	P, N	9.7	35	12	11	10	10	10	9	12	13	B	B	A	B	slight lean, golfball damage and mechanical damage at base	normal
112	American sweetgum	<i>Liquidambar styraciflua</i>	34.16526892	-118.1675728	P	8.5	33	8	7	8	6	5	6	8	9	A	A	B	A	mechanical damage at base	normal
113	swamp mahogany	<i>Eucalyptus robusta</i>	34.16534997	-118.1675964	P, M	19.9	35	11	7	6	12	17	18	11	10	B	B	B	B	slight lean, large cavity on main trunk, golfball damage, wetwood on east side,	pavement over roots
114	swamp mahogany	<i>Eucalyptus robusta</i>	34.16539175	-118.167642	P, M	31.2	50	11	16	17	21	13	16	12	13	B	B	B	B	cart path cut part of buttress roots, small cavities thought mid trunk, golfball damage	pavement over roots

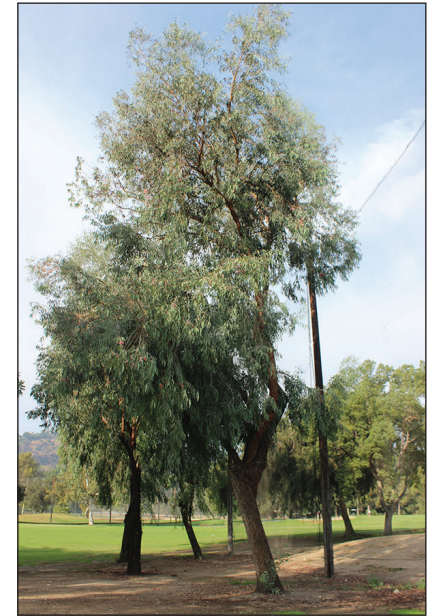
Tree 150 - red ironbark

150	red ironbark	<i>Eucalyptus sideroxylon</i>	34.16646765	-118.1687582	P	17.3	35	7	5	10	12	13	16	12	13	B	B	C	B	poor structure, basal sprouting	normal
152	carob	<i>Ceratonia siliqua</i>	34.16627251	-118.1687672	P	16.0	25	10	11	12	12	12	11	8	5	C	B	B	B	basal sprouting, exposed damaged roots, poor structure, sapsucker damage	normal
156	red ironbark	<i>Eucalyptus sideroxylon</i>	34.16640767	-118.1688308	P	16.0	35	3	4	4	18	23	17	12	6	C	C	C	C	large amounts of exudate, fissures in bark, poor structure, lean, dead hangers on south side of canopy	normal
157	red ironbark	<i>Eucalyptus sideroxylon</i>	34.1663857	-118.1688827	P	18.3	37	8	7	12	15	19	15	12	6	B	B	C	B	large amounts of exudate, lean, basal sprouting, large exposed damaged roots	normal
158	red ironbark	<i>Eucalyptus sideroxylon</i>	34.16640099	-118.1689186	P	16.2	35	3	6	6	12	14	16	6	4	B	C	D	B	large exposed damaged roots, basal sprouting, poor structure, large limbs removed, lean	normal

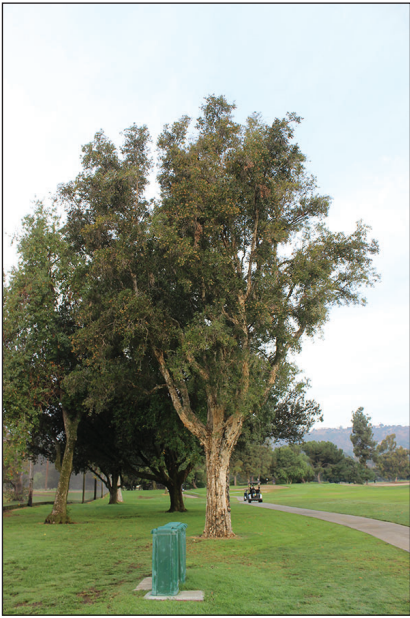
Tree 159 - white paperbark tree

159	white paperbark tree	<i>Melaleuca quinquinervia</i>	34.16579962	-118.1691422	P, M	24.9	38	15	17	15	13	14	15	16	15	B	B	B	C	golfball damage, damaged buttress roots, included bark	normal
160	California bay laurel	<i>Umbellularia californica</i>	34.16578085	-118.1692414	P, N, M	19.8	35	22	15	10	15	14	16	12	10	C	B		B	large burl at base with root decay present, exposed damaged roots, golfball damage, basal sprouting	saturated
161	holly oak	<i>Quercus ilex</i>	34.16584171	-118.1692638	P, M	27.6	40	21	22	19	25	24	19	16	15	B	B	A	B	golfball damage, basal sprouting, exfoliating bark on large limbs	saturated
162	holly oak	<i>Quercus ilex</i>	34.16588395	-118.1694883	P, M	22.2	45	17	16	21	16	12	15	19	17	A	B	A	B	epicormic sprouting in mid canopy, golfball damage, damaged exposed roots	saturated
163	western sycamore	<i>Platanus racemosa</i>	34.16598456	-118.1697542	P, N, M	28.9	49	23	26	22	20	19	17	19	22	C	C	C	C	ISHB-FD likely, Arborjet tag suggests insecticide/fungicide injections and/or soil drench, golfball damage, woodpecker holes, poor structure (topped, poor attachment)	normal

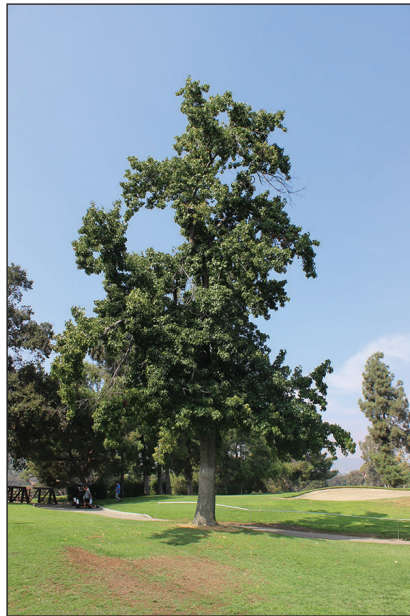
Tree 164 - American sweetgum

164	American sweetgum	<i>Liquidambar styraciflua</i>	34.16618527	-118.1700547	P, M	21.1	40	12	11	10	8	13	15	10	11	C	B	B	B	minor dieback in crown, leaf scorch, golfball damage	pavement over roots
167	Italian stone pine	<i>Pinus pinea</i>	34.16674606	-118.1702519	P, S, M	30.1	40	25	40	32	12	10	7	18	15	A	B	C	A	strong lean, exposed damaged roots	normal
168	Canary Island pine	<i>Pinus canariensis</i>	34.16649608	-118.1702985	P, M	23.2	45	17	24	20	17	12	14	18	15	A	A	A	A		normal

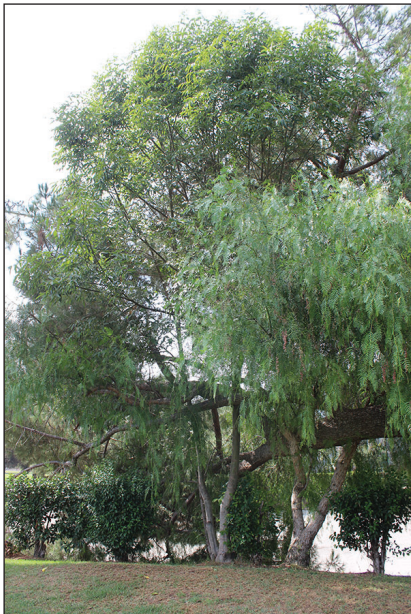
Tree 173 - shamel ash

173	shamel ash	<i>Fraxinus uhdei</i>	34.1666734	-118.170298	P	6.3, 5.2 (8.2)	35	8	9	11	12	12	13	15	15	A	B	B	A	multiple trunks, rubbing against pine	normal
174	Peruvian pepper	<i>Schinus molle</i>	34.16668904	-118.1702951	P	9.3, 8.2 (12.4)	30	15	18	13	12	13	14	15	19	B	B	C	B	multiple trunks with included bark	normal
175	Canary Island pine	<i>Pinus canariensis</i>	34.16647073	-118.1702944	P	17.2	40	18	20	19	15	17	13	18	15	A	B	A	A	minor dieback in canopy	normal
177	Italian stone pine	<i>Pinus pinea</i>	34.16671919	-118.1702833	P, S, M	36.2	38	5	10	38	35	33	3	1	1	C	C	D	C	lean, exposed, damaged roots, damp pocket in trunk growing grass, column of decay possibly present	normal
178	Canary Island pine	<i>Pinus canariensis</i>	34.16641794	-118.1702989	P	14.2	38	10	12	13	15	12	8	8	12	A	B	B	B	exposed, damaged roots	normal
179	coast live oak	<i>Quercus agrifolia</i>	34.166267	-118.1703074	P, N, M	38.8	40	25	35	33	37	33	21	19	25	B	A	B	B	Arroyo Seco concrete banks burying roots, minor dieback in crown, self corrected lean	pavement over roots

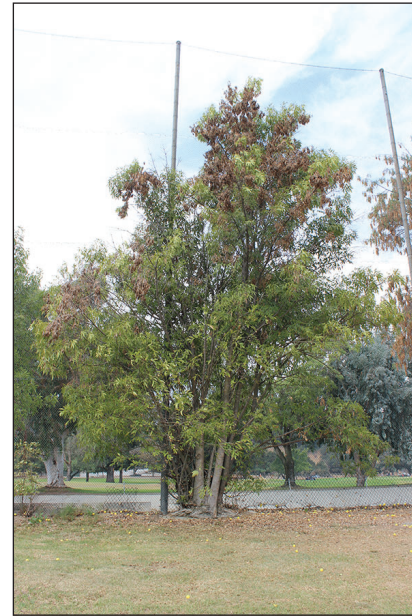
Tree 1051 - shamel ash

1051	shamel ash	<i>Fraxinus uhdei</i>	34.16498135	-118.1702949	P	6.3, 5.4, 3.8 (9.1)	25	12	6	5	7	11	10	11	14	C	C	B	C	Roots growing over concrete, girdling roots, multiple trunks, golfball damage, fence girdling stem	normal
1064	western sycamore	<i>Platanus racemosa</i>	34.16491637	-118.1697157	P, N, M	10.1, 22.5, 17.0 (29.9)	50	18	19	16	20	18	21	20	18	D	C	C	D	large dead hangers in upper canopy, woodpecker holes, ISHB-FD likely, golfball damage, large cavities in trunk with decay, basal sprouting, investigate decay in trunk, extent of fusarium dieback	normal
1556	Chinese elm	<i>Ulmus parvifolia</i>	34.16646706	-118.16913	P, M	20.6	30	11	10	12	14	16	23	20	18	C	C	B	C	large damaged buttress roots with decay present, compaction in root zone, large cavity in trunk with decay, golfball damage	compacted
