Appendix N Archaeological Survey and Evaluation Report - Redacted Version

- APE
- Eligible/Contributing ●
- Ineligible/Non-Contributing

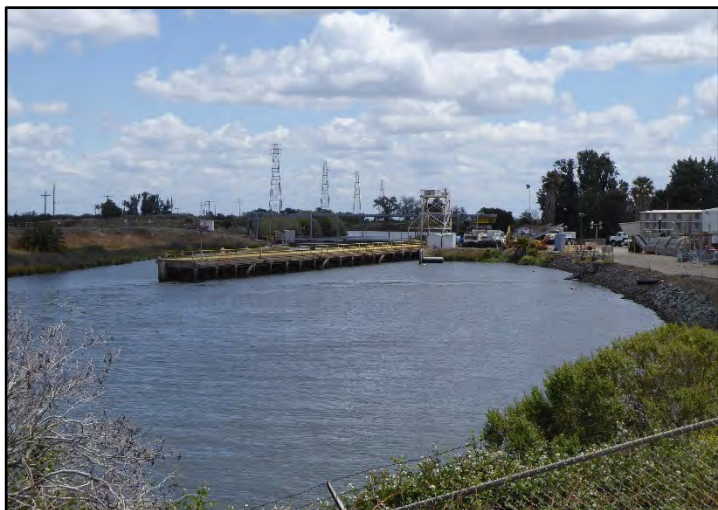
Photograph 2: View of riprap (right) and earth lining (left) at the beginning of Earth Section No. 1 of the Delta Mendota Intake Canal at the Tracy Fish Collection Facility, M.P. 0.09; camera facing upstream from left bank, May 9, 2022 (A00165).

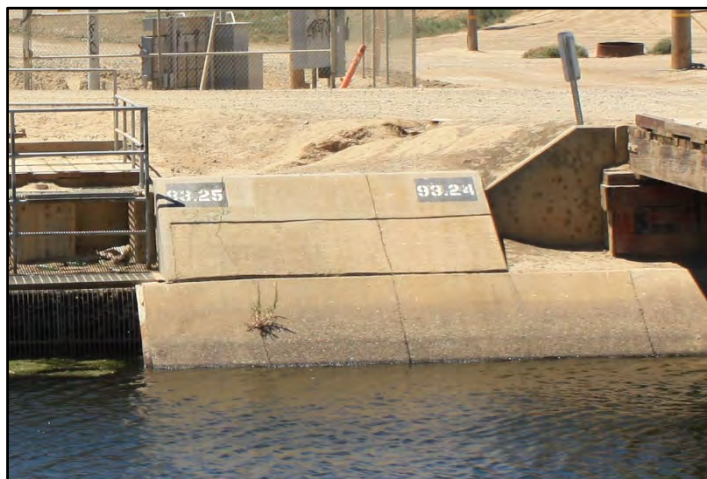
Photograph 14: View of canal lining on right bank at M.P. 93.24-93.25, where lining appears to have been raised around a modern turnout and original farm bridge; camera facing right bank from left bank, June 14, 2022 (C0385).

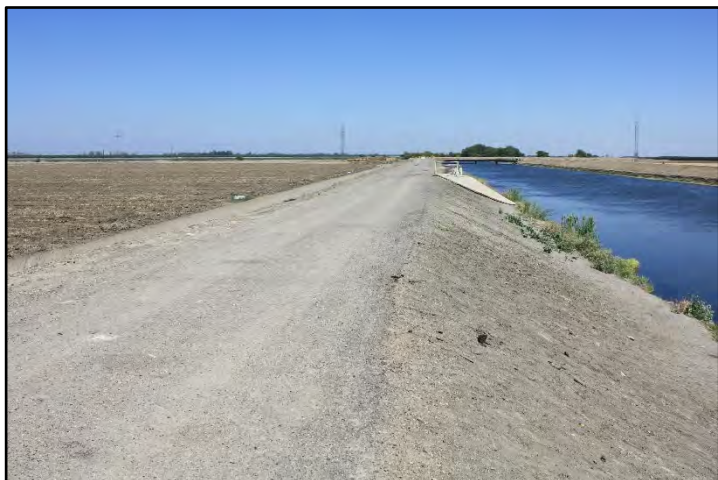
Photograph 15: View of embankment and maintenance road from approximately M.P. 111.28; camera facing downstream from left bank, June 14, 2022 (C0489).

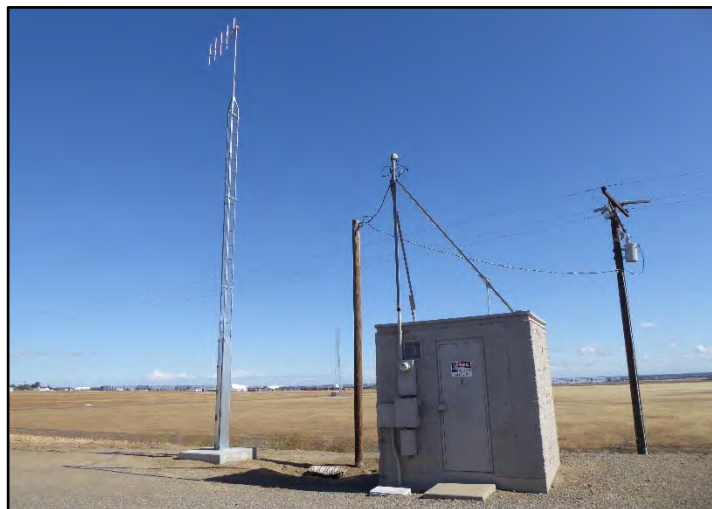
Photograph 26: Check building at Check No. 1; camera facing northwest, May 10, 2022 (A00343).

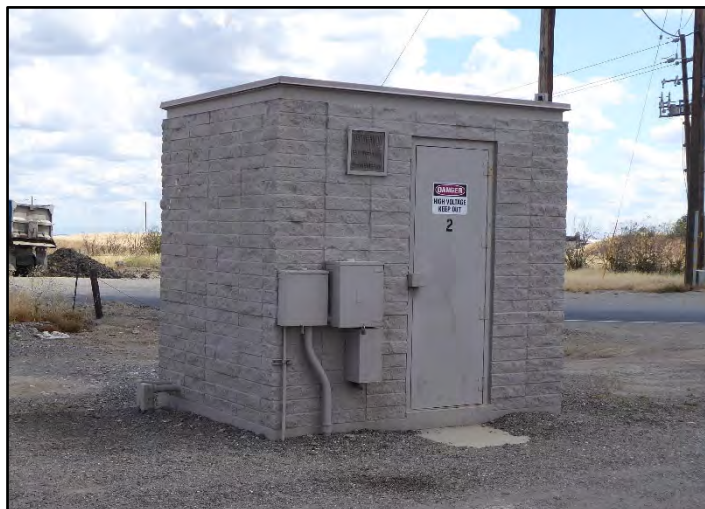
Photograph 27: View of rusticated concrete block construction of check building at Check No. 2; camera facing northeast, May 10, 2022 (A00451).

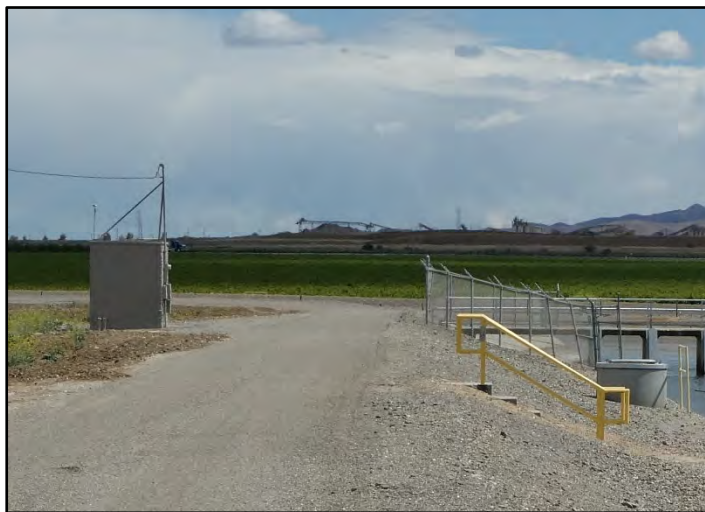
Photograph 28: View of check building (left) in relation to associated check structure (Check No. 3, right) with a stilling well in the foreground (bottom right), May 10, 2022 (B00084).

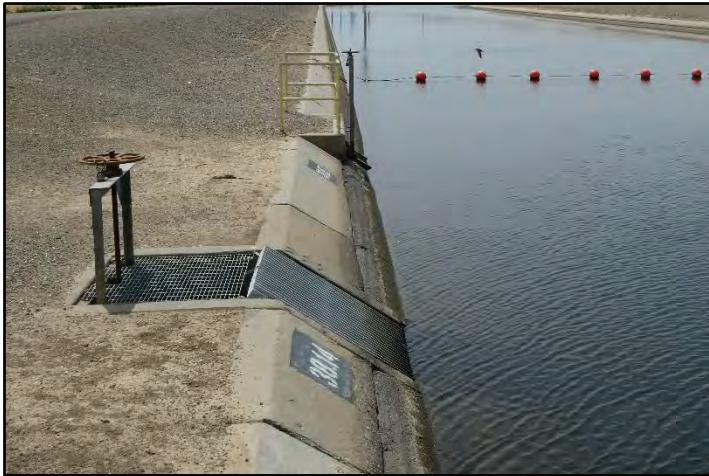
Photograph 35: An original turnout that has been altered by a replacement screen at M.P. 38.14 (foreground) and an original concrete pipe turnout along the left bank at M.P. 38.15 (background) along left bank; camera facing downstream from the left bank, May 12, 2022 (B00289).

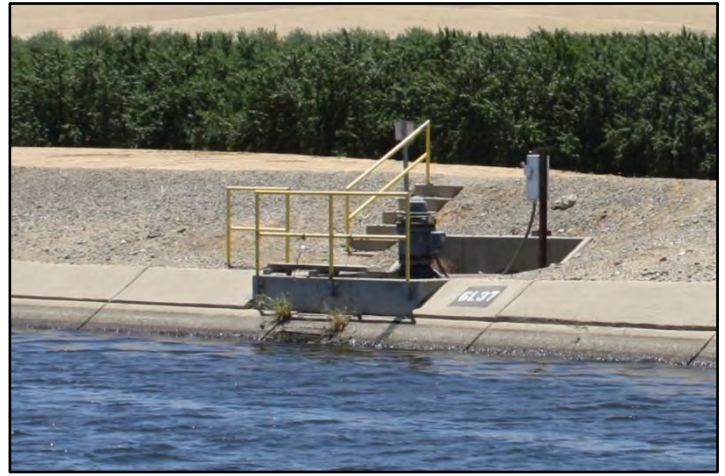
Photograph 36: Concrete pipe turnout altered by the addition of an automatic, electronic gate-operating system along the right bank at M.P. 61.37; camera facing from left bank, June 13, 2022 (C0118).

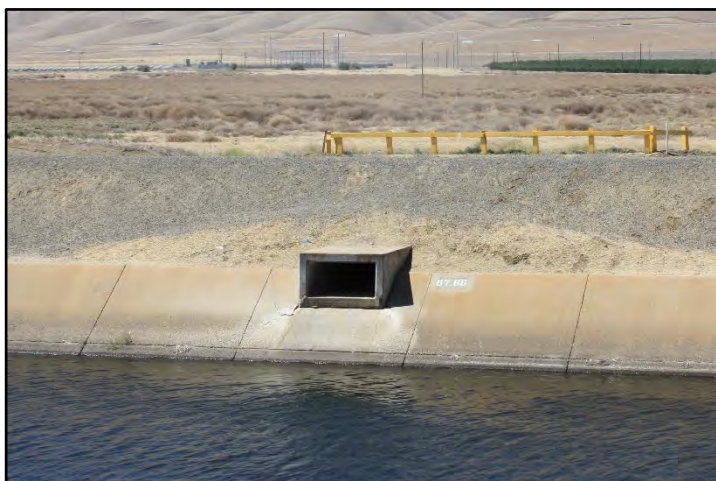
Photograph 45: Free-flowing inlet drain along the right bank at M.P. 67.66; camera facing from left bank, June 14, 2022 (C0349).

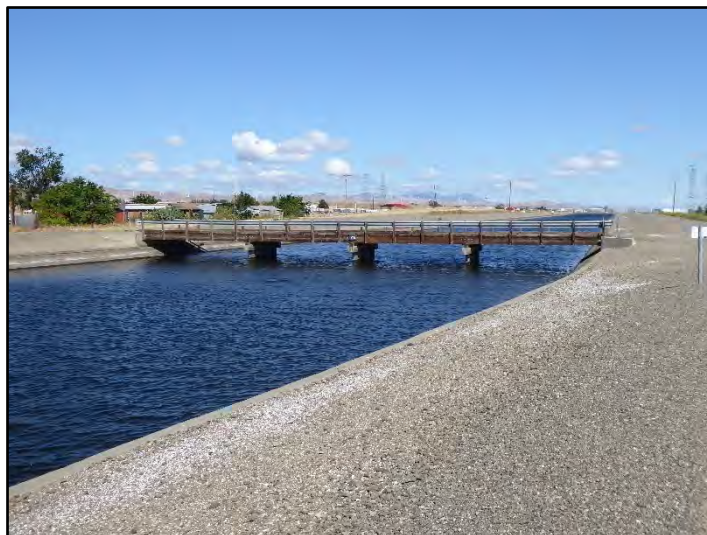
Photograph 65: View of Farm Bridge at M.P. 12.31 with 16-foot-wide timber-deck, replacement concrete piers, and modern steel guard-rails; camera facing upstream from left bank, May 10, 2022 (A00365).

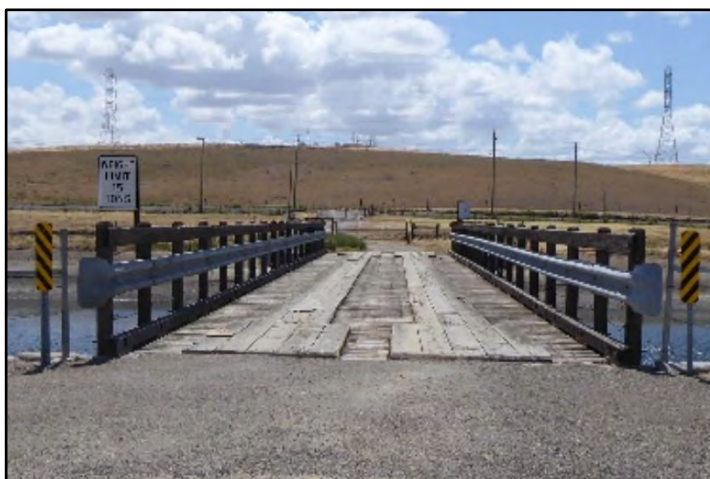
Photograph 66: Detail view Farm bridge with timber deck at M.P. 5.67, with its original timber handrails reinforced by the addition of modern steel guard-rails; camera facing west from the left bank, May 9, 2022 (A00232).

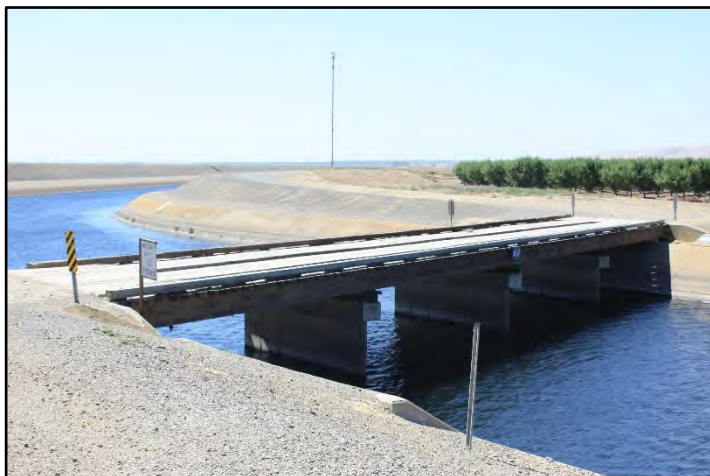
Photograph 68: View of Farm Bridge with timber deck at M.P. 85.47, where original timber handrails have been removed and not replaced; camera facing downstream from left bank, June 14, 2022 (C0338).

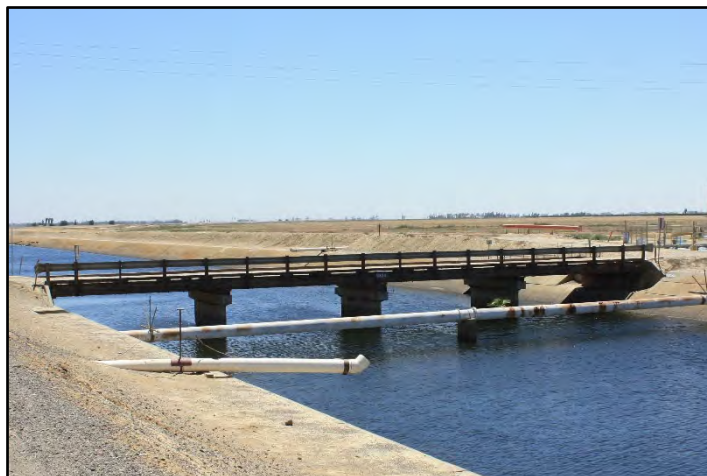
Photograph 69: View of Farm Bridge with timber deck at M.P. 93.24 which has only one modern steel guard-rail on the upstream side, but no handrail on the downstream side; camera facing downstream from left bank, June 14, 2022 (C0384).

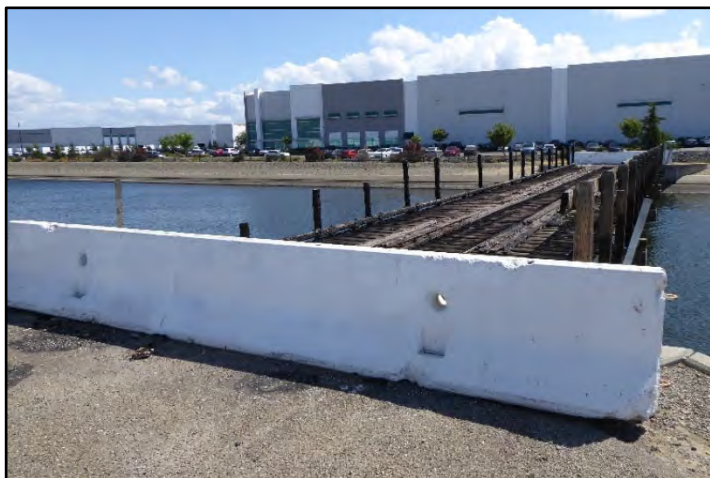
Photograph 70: View of fire-damaged Farm Bridge at M.P. 9.87, with timber deck and timber railing on upstream side; camera facing southwest from left bank, May 9, 2022 (A00297).

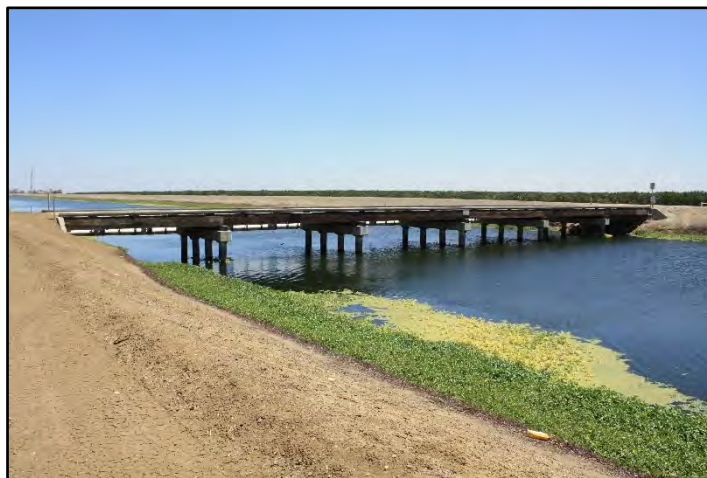
Photograph 71: View of 20-foot-wide Farm Bridge at M.P. 99.82, with original timber deck supported by five replacement concrete bents, with no handrails; camera facing downstream from left bank, June 14, 2022 (C0428).

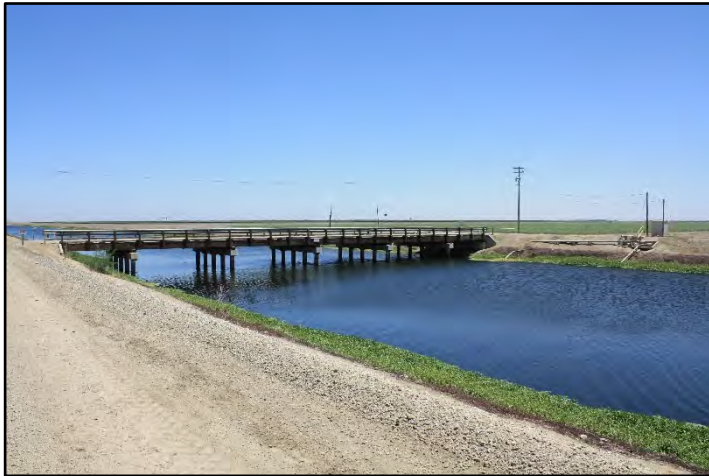
Photograph 72: View of 30-foot-wide Farm Bridge at M.P. 100.85, with original timber deck supported by five replacement concrete bents, with modern steel guard-rails; camera facing downstream from left bank, June 14, 2022 (C0436).

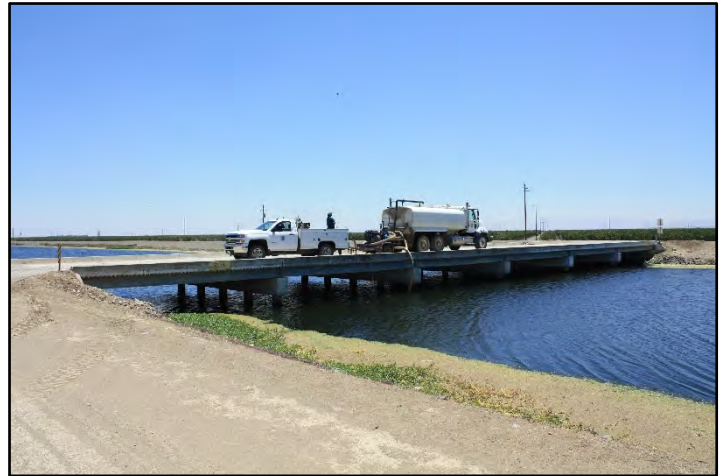
Photograph 73: View of 30-foot-wide Farm Bridge at M.P. 98.74, with replacement concrete deck supported by five replacement concrete bents, with no handrails; camera facing downstream from left bank, June 14, 2022 (C0422).

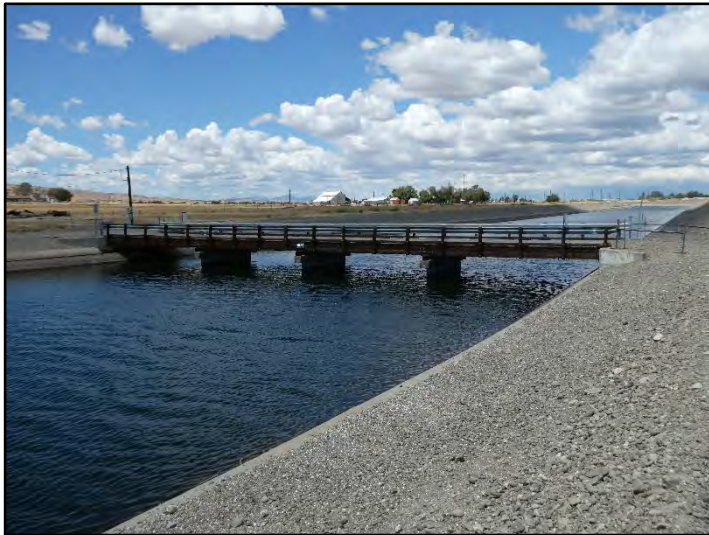
Photograph 74: View of 16-foot wide Timber Operating Bridge at M.P. 16.65 along with replacement concrete piers and modern steel guard-rails; camera facing upstream from left bank, May 10, 2022 (B00007).

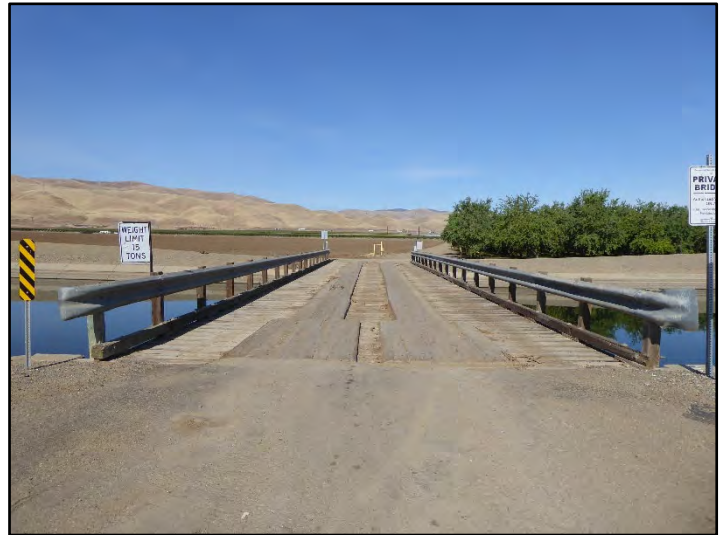
Photograph 75: Detail view of Timber Operating Bridge with 20-foot-wide deck at M.P. 34.89, with modern steel guard-rails; camera facing west from left bank, May 12, 2022 (A00807)

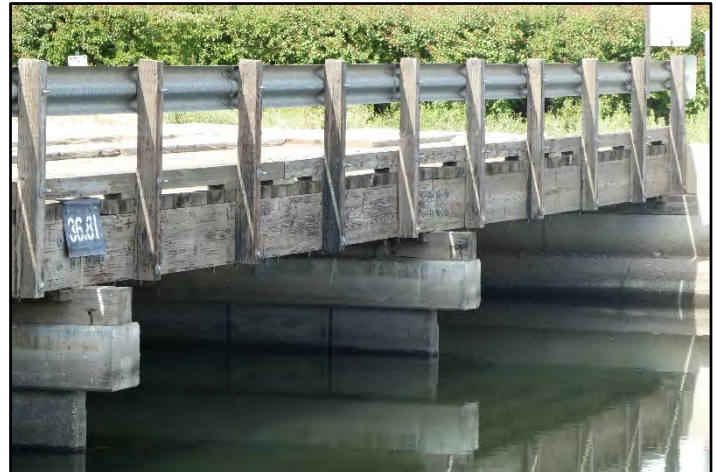
Photograph 77: Detail view of replacement concrete piers on Timber Operating Bridge at M.P. 36.81; camera facing southwest from left bank, January 16, 1948 (B00225).

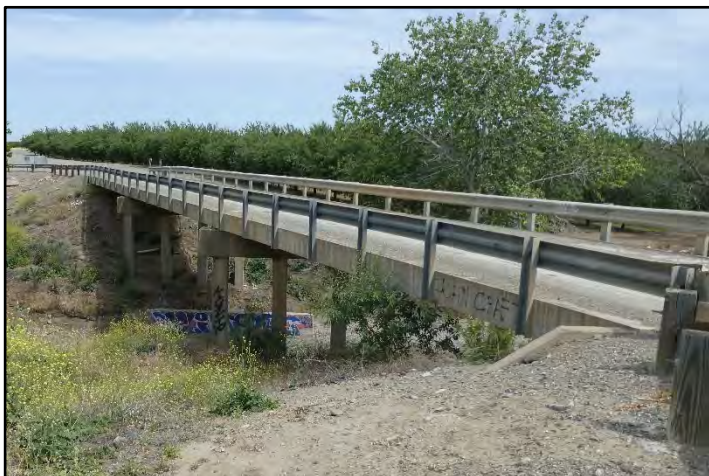
Photograph 78: View of Concrete Operating Bridge at M.P. 37.28 crossing over the Del Puerto Creek culvert; camera facing south from left bank, May 12, 2022 (B00257).

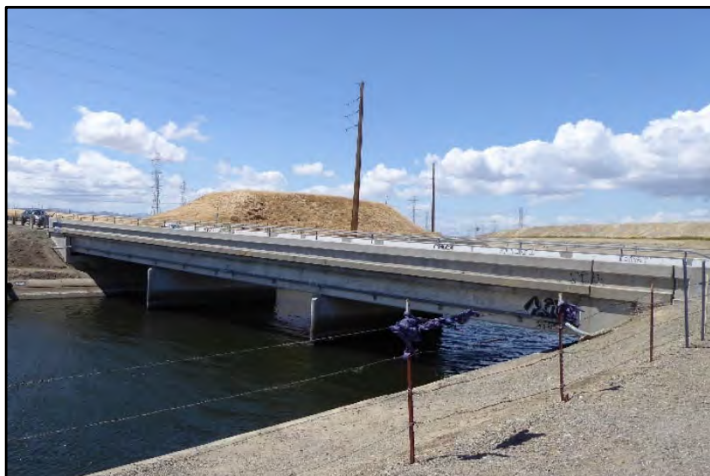
Photograph 82: View of 26-foot-wide State Highway Bridge at M.P. 6.6 along Old Highway 50, with replacement parapet walls with additional metal-pipe railing on top; camera facing upstream from left bank, May 9, 2022 (A00245).

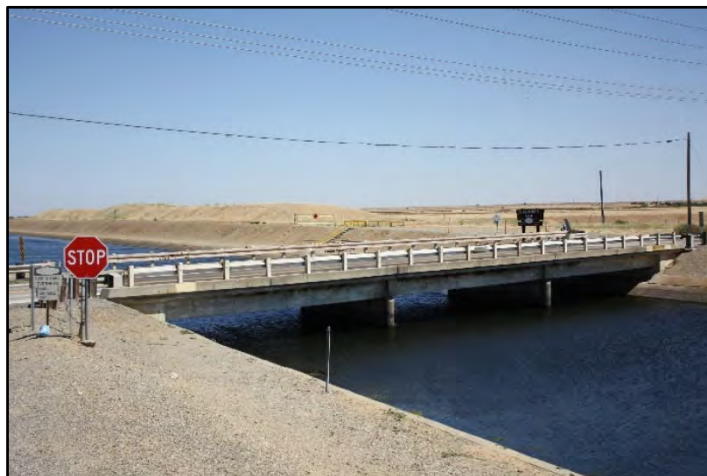
Photograph 83: View of State Highway Bridge at M.P. 71.31 along Jensen Road / State Route 207, with original steel guard-railing; camera facing downstream from left bank, June 13, 2022 (C0210).

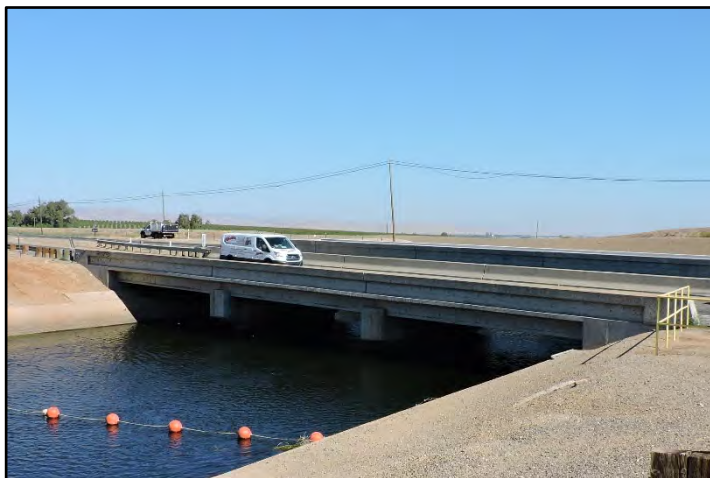
Photograph 84: View of State Highway Bridge at M.P. 75.84 along State Highway 152, with replacement concrete parapet walls; camera facing upstream from left bank, June 13, 2022 (D2237).

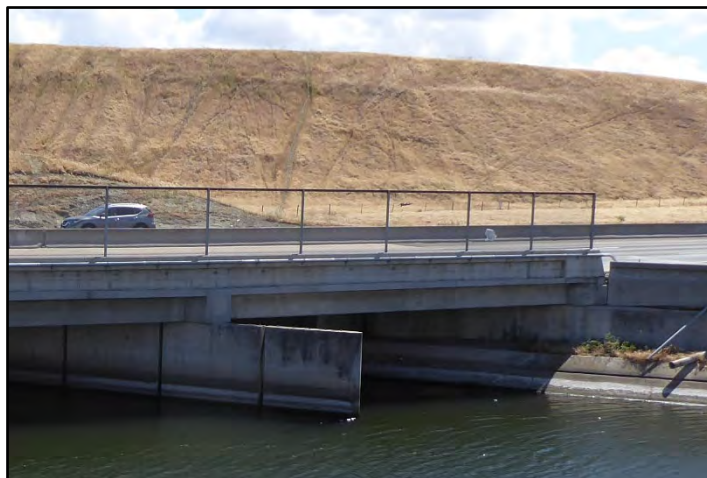
Photograph 85: Detail view of State Highway Bridge at M.P. 7.67 along Interstate 205, with replacement concrete parapet walls with additional metal fencing on top; camera facing downstream from left bank, May 9, 2022 (A00261).

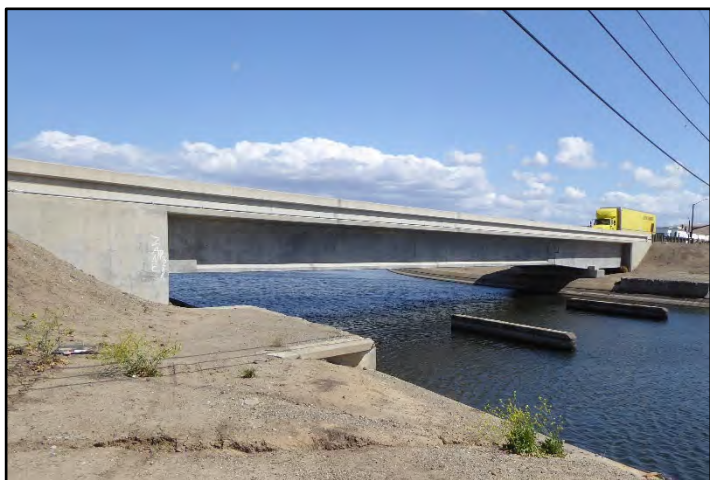
Photograph 86: View of replacement County Highway Bridge at M.P. 9.29, along International Parkway, with 30-foot-wide concrete deck, original piers and abutments visible just upstream of current bridge; camera facing downstream from left bank, May 9, 2022 (A00287).

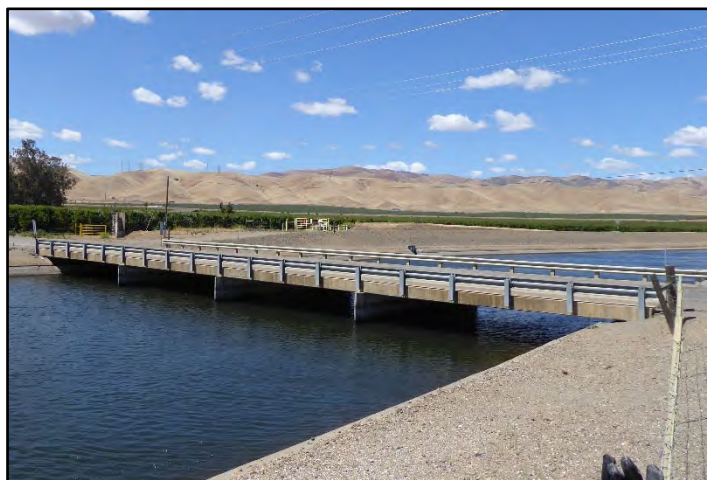
Photograph 87: View of replacement County Road Bridge at M.P. 29.93, along McCracken Road, with 24-foot-wide concrete deck, supported by three concrete solid-type piers, and steel guard-railing; camera facing upstream from left bank, May 11, 2022 (A00612).

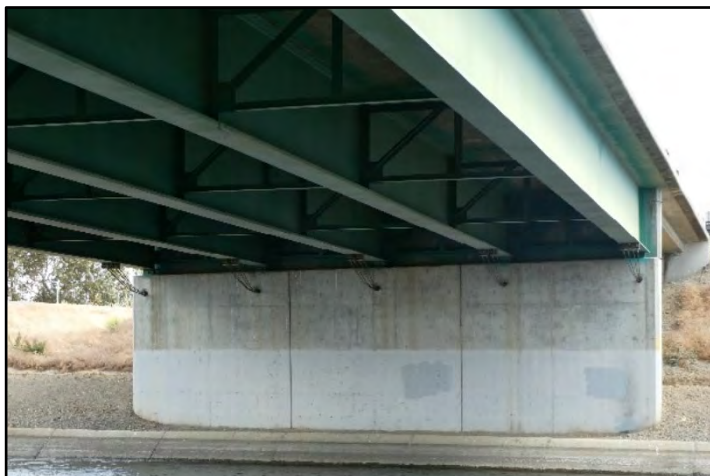
Photograph 88: Detail view of steel stringers and interior trusses on non-original (post-1958) State Highway Bridge at M.P. 22.73, along State Highway 5 Northbound; camera facing south from left bank, May 10, 2022 (B00165).

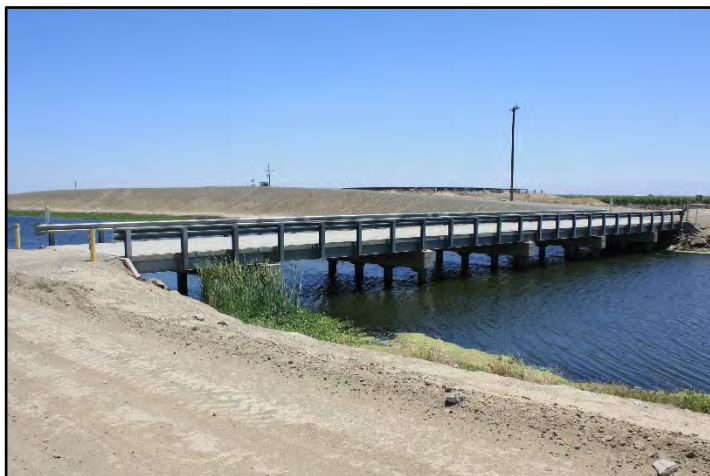
Photograph 92: View of replacement Farm Bridge built in 2004 at M.P. 106.58, with 20-foot-wide concrete deck, supported by five concrete bents; camera facing downstream from left bank, June 14, 2022 (C0460).

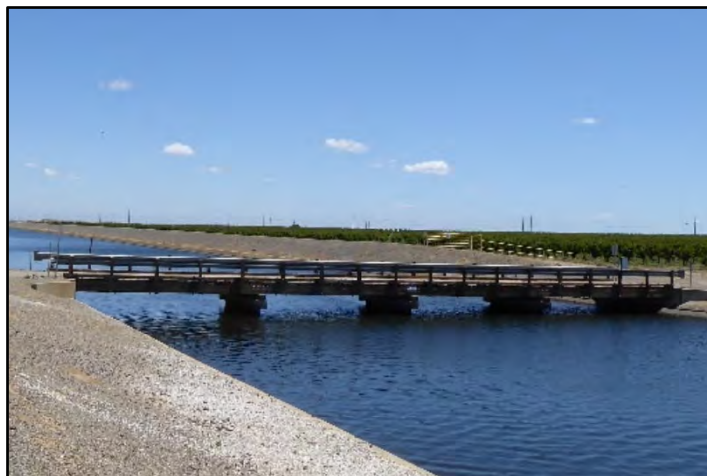
Photograph 93: View of replacement Timber Operating Bridge, constructed in 1998, at M.P. 33.29, with a 16-foot-wide timber deck supported by three concrete piers, with steel guard-rails; camera facing downstream from left bank, May 11, 2022 (A00684).

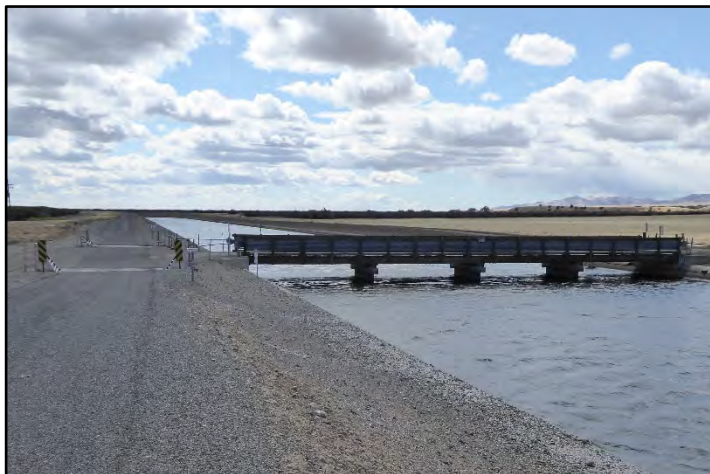
Photograph 94: View of cattle guards (left) adjacent to Farm Bridge (right) at M.P. 13.96; camera facing downstream on left bank, May 10, 2022 (A00396).

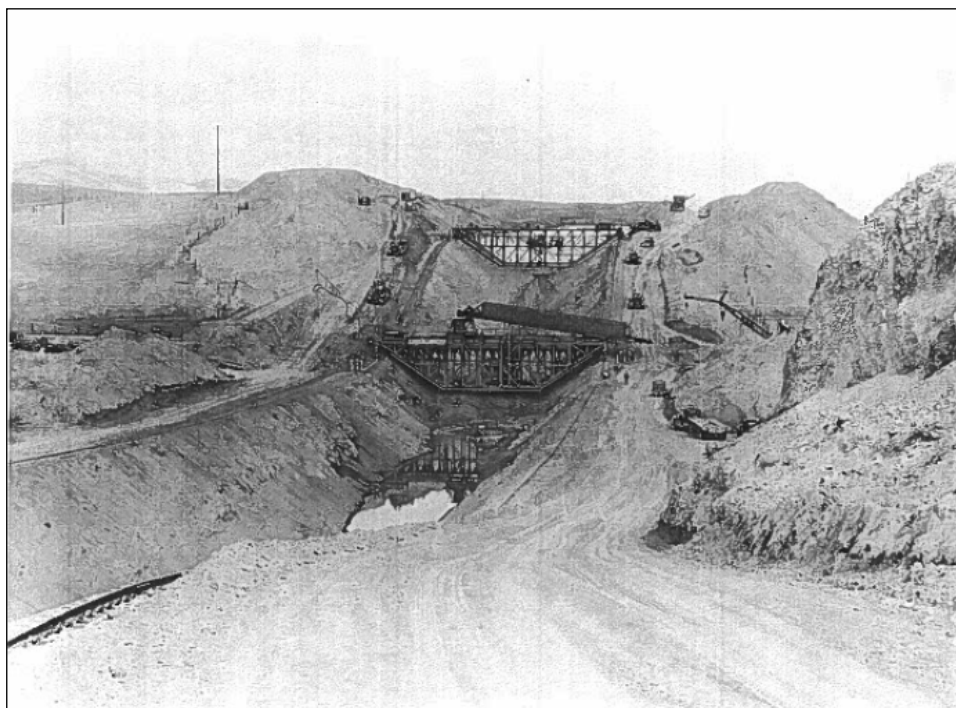
Figure 3: Morrison-Knudsen Company, Inc. and the M. H. Hasler Construction Company operating canal trimmer and slip form at Mountain House Road Siphon excavation, June 10, 1948.⁶⁴

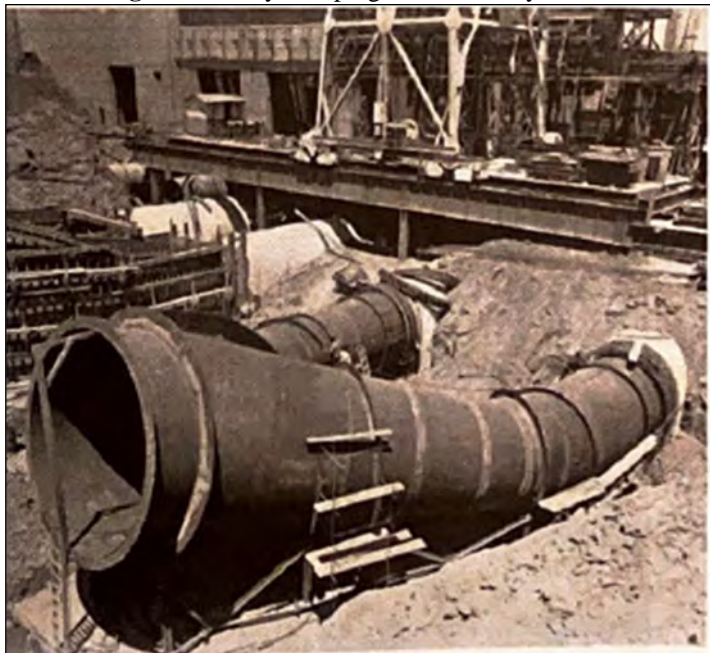
Figure 7: One of six 84-in. vertical shaft bottom suction twin volute centrifugal pumps.⁷⁰

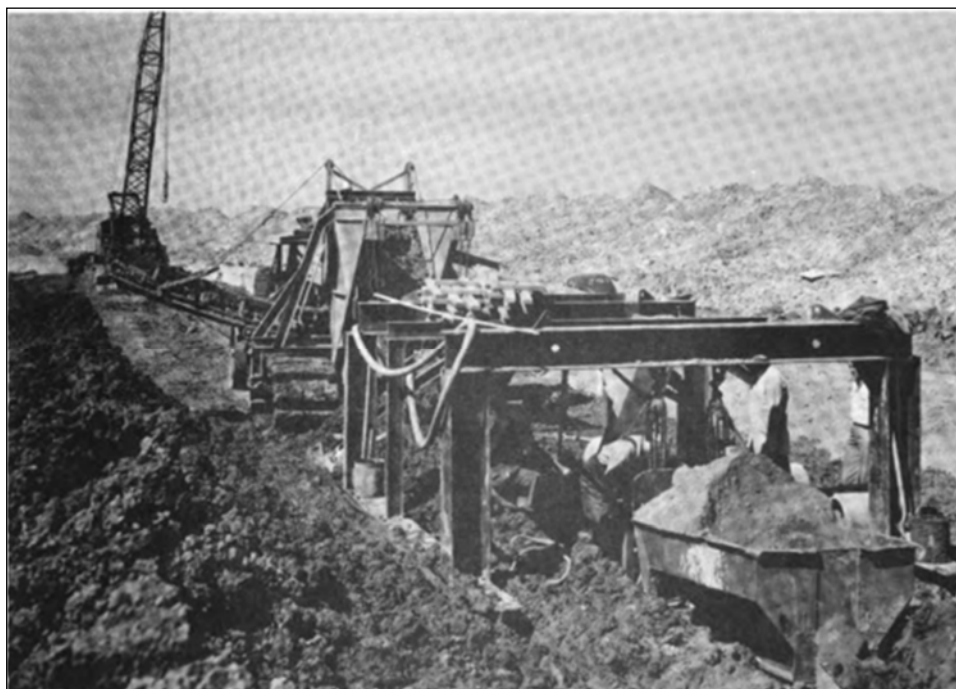
Figure 9: Converted ditcher and pipe laying machine used by United-Vinnell Co., March 1951.⁷³

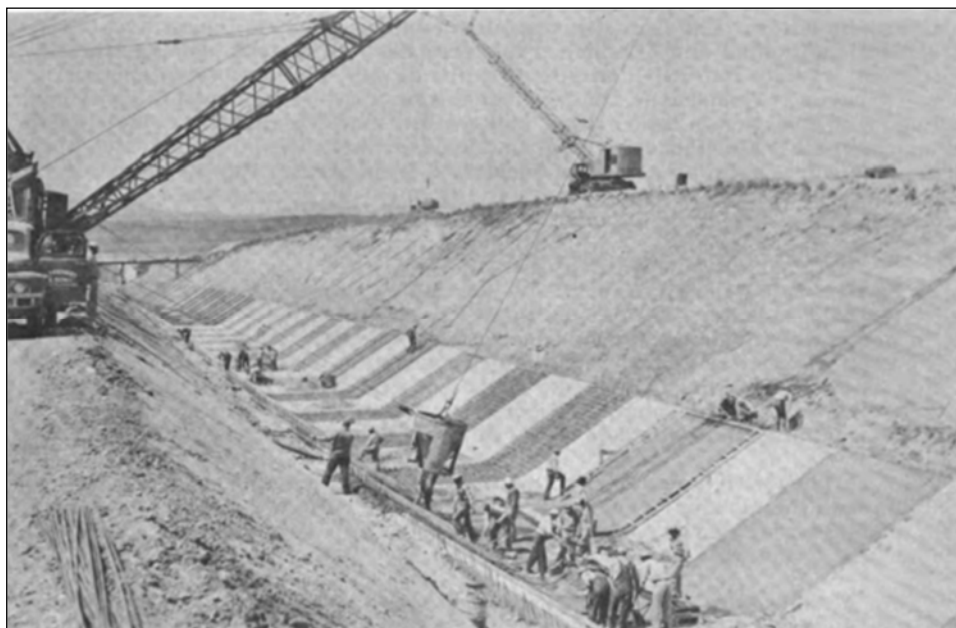
Figure 10: Placing alternate panels of reinforced concrete in Newman wasteway, April 1951.⁷⁵

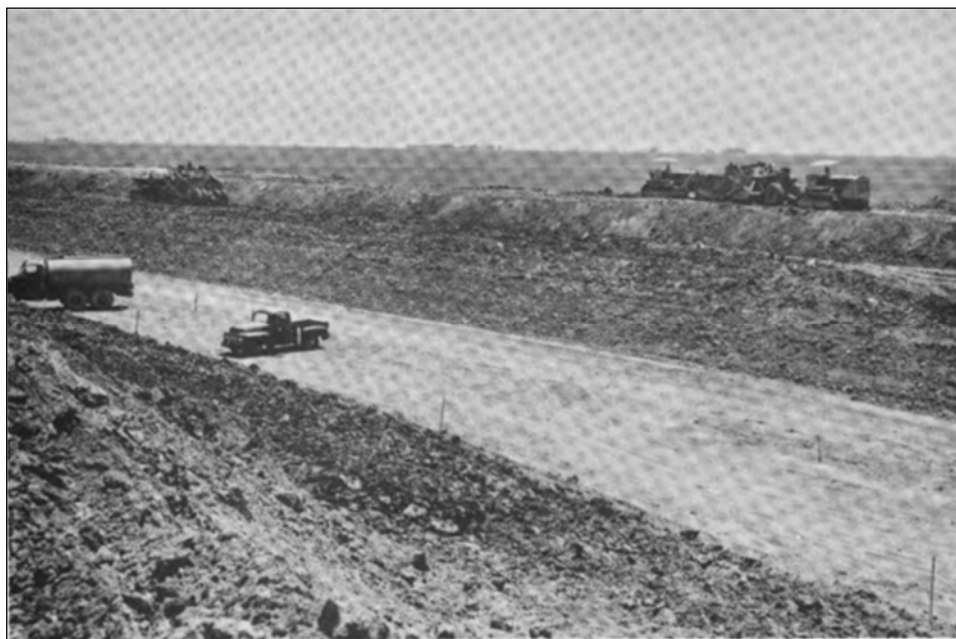
Figure 11: Placing and compacting lining material on side slope of canal, July 26, 1950.⁸³

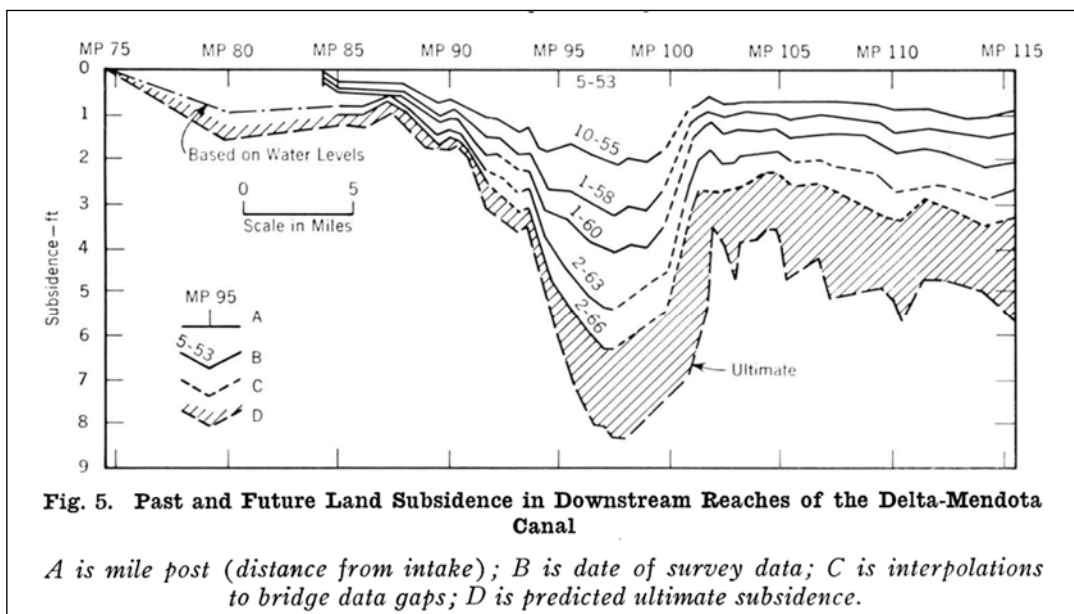
Figure 12: From Prokopovich and Hebert, graph showing past and future subsidence, 1968.⁹¹

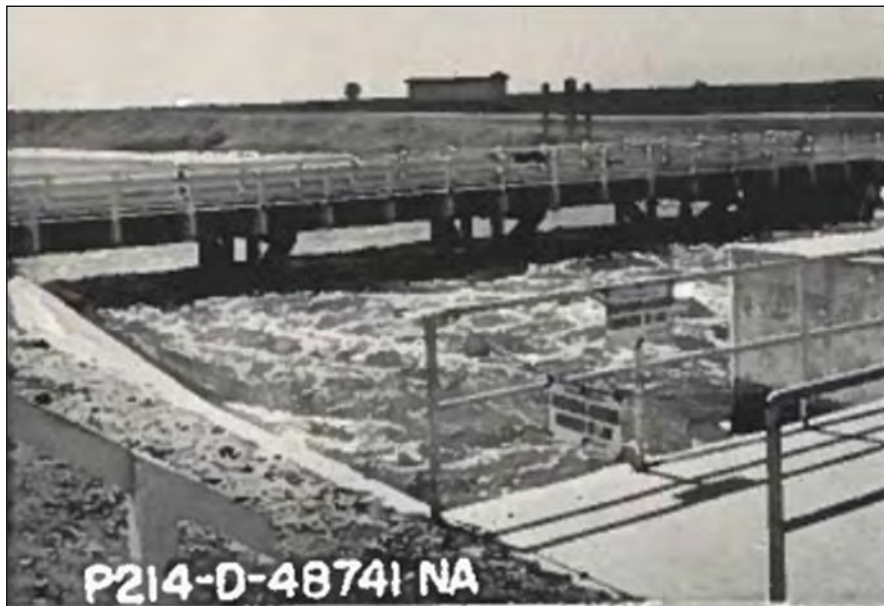
Figure 15: Bridge, Mile 90.56, scheduled for replacement. May 14, 1965.⁹⁶

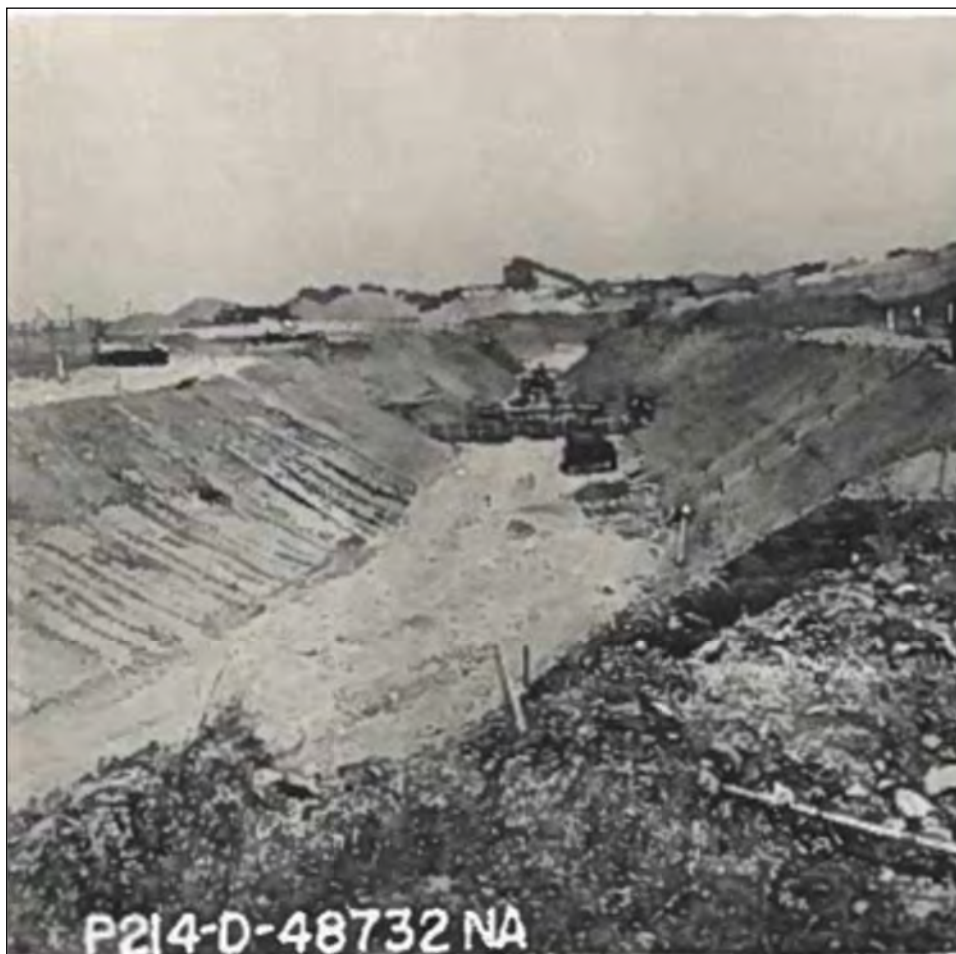
Figure 16: Baffled apron drop under construction, May 12, 1965.⁹⁷

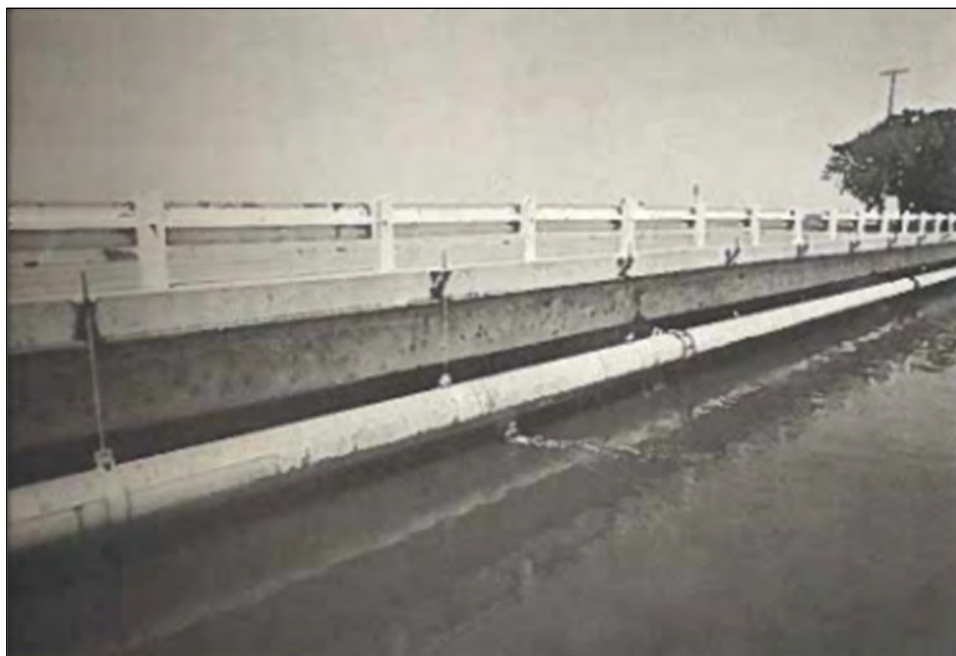
Figure 17: Discharge of barnyard manure into the canal, May 16, 1970.⁹⁹

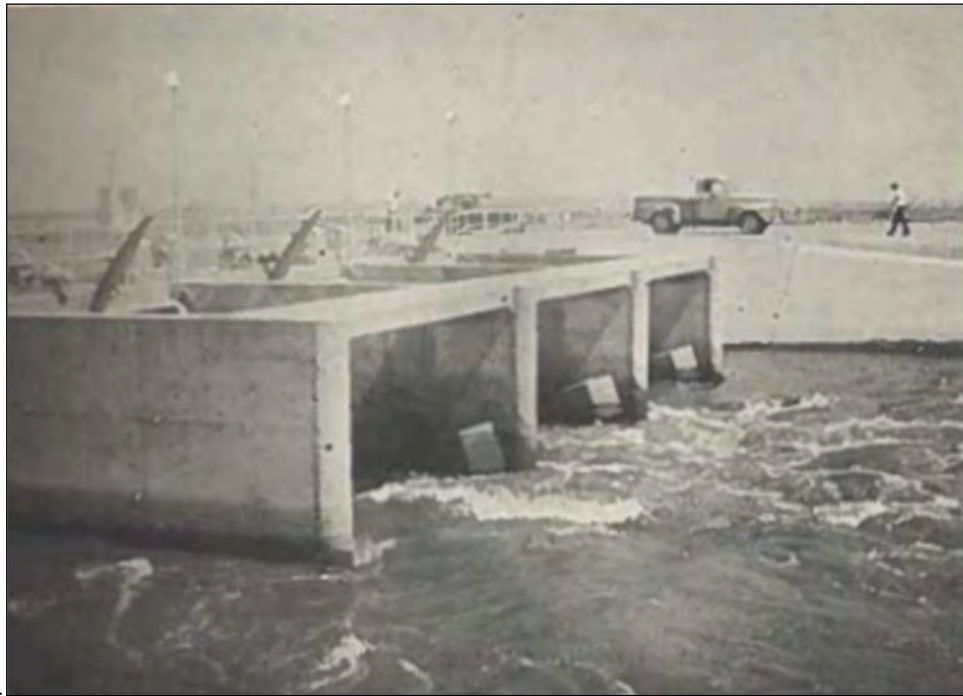
Figure 18: Note rough silty water below gates at Check No. 19, May 16, 1970.¹⁰⁰

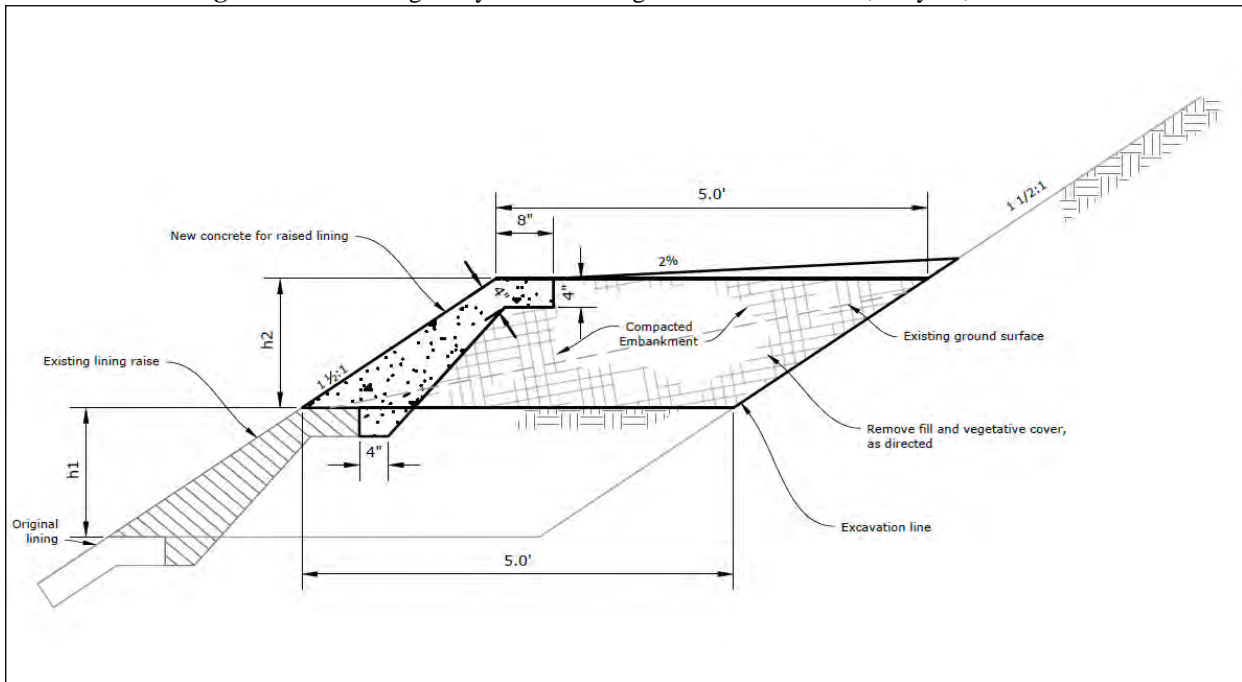
Figure 19: DMC typical cross section showing placement of original concrete lining, previous lining raise, and proposed lining raise.

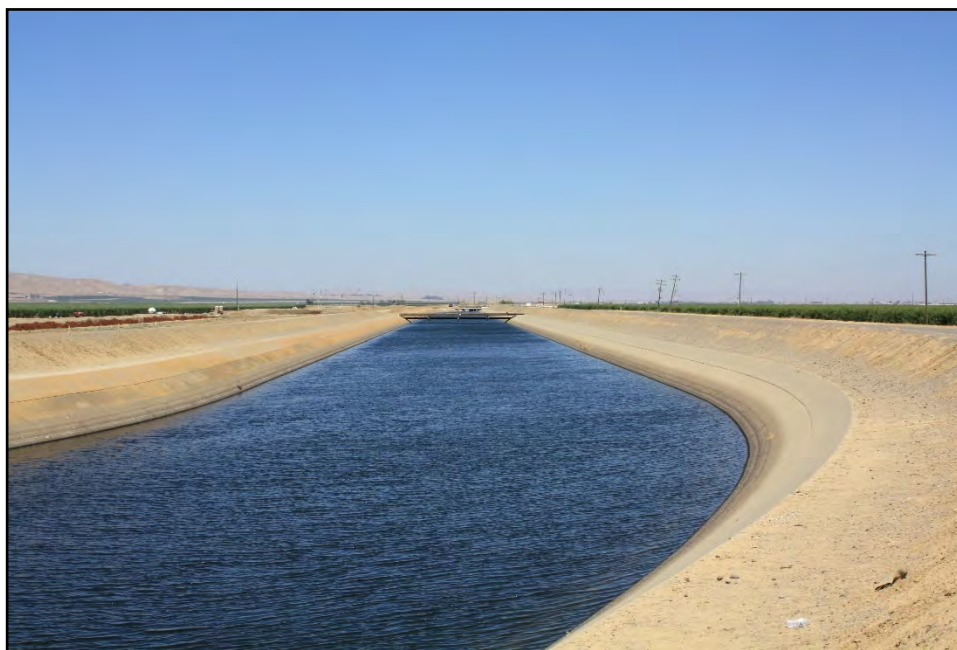
Figure 20: View of concrete-lined section of canal from approximately M.P. 91.36; camera facing upstream from left bank, June 14, 2022.

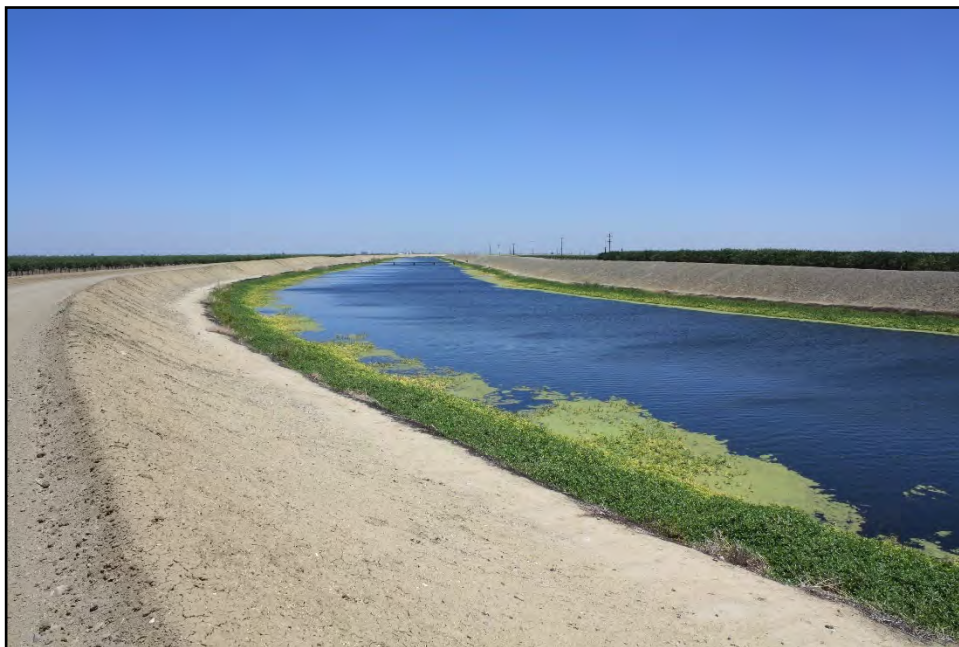
Figure 21: View of earth-lined section of canal from approximately M.P. 104.22; camera facing downstream from left bank, June 14, 2022.

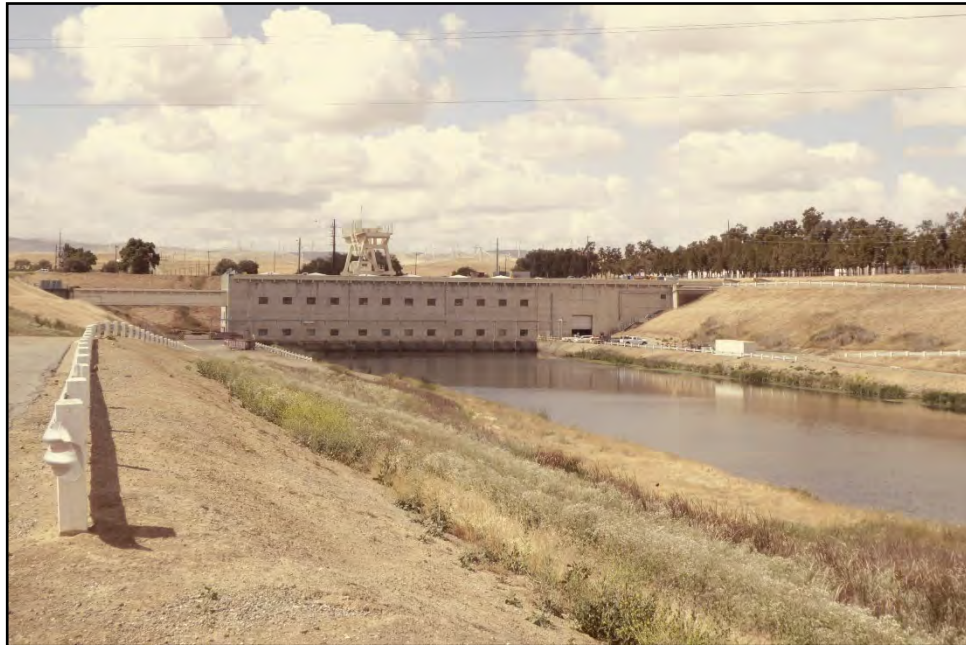
Figure 24: Tracy Pumping Plant; camera facing southwest, May 9, 2022.

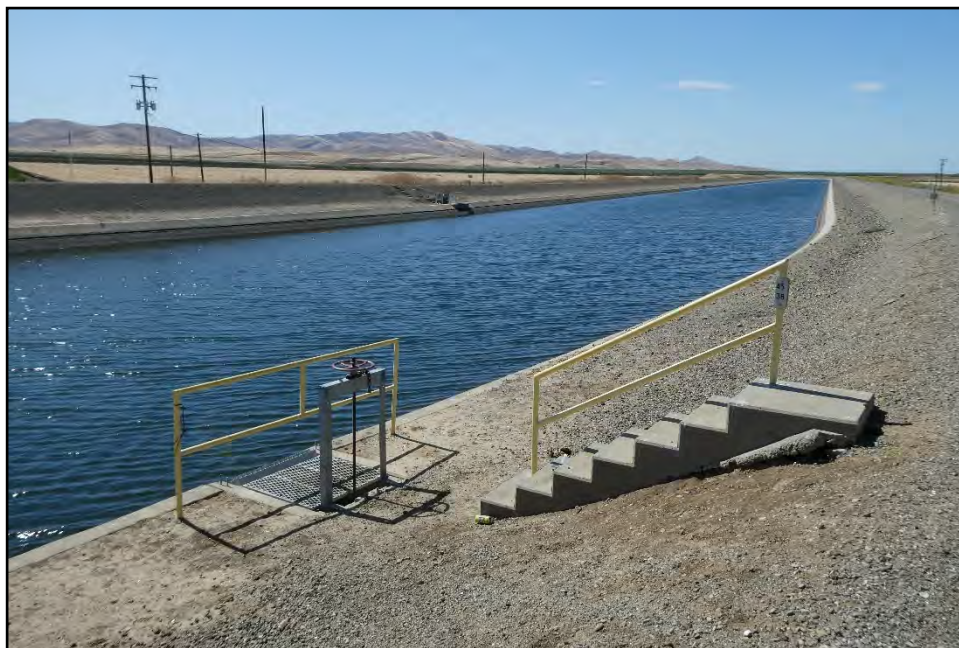
Figure 32: Turnout at M.P. 45.35; camera facing downstream from left bank, May 12, 2022.

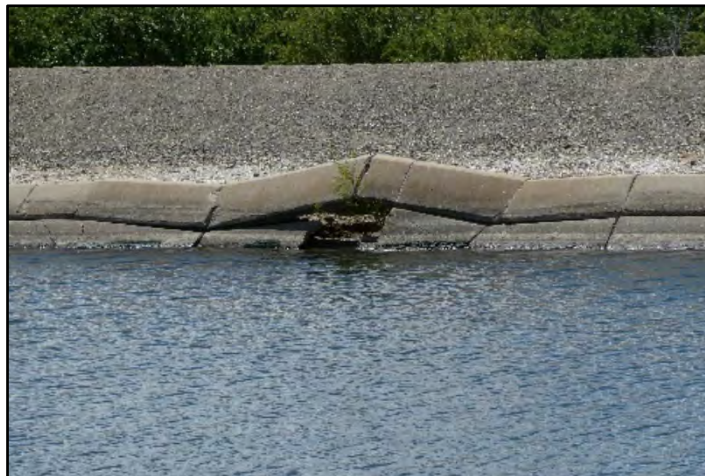
Photograph 156: New cracking at a repair to the canal lining at M.P.; camera facing right bank from left bank, May 10, 2022. (B00029)
