Appendix N Archaeological Survey and Evaluation Report - Redacted Version

- APE
- Eligible/Contributing ●
- Ineligible/Non-Contributing

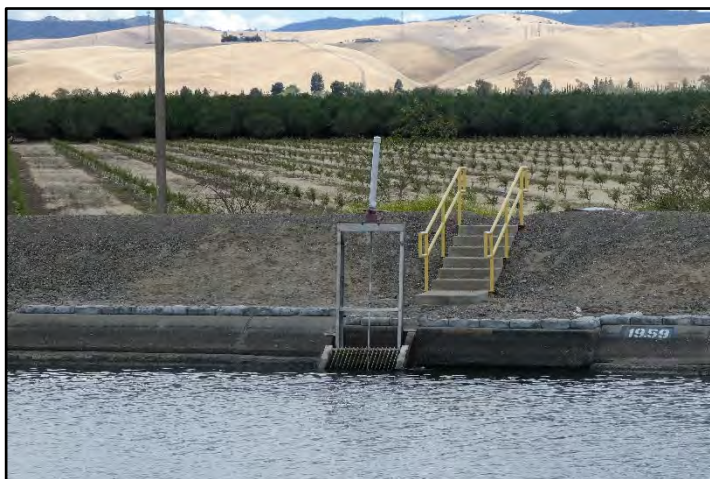
Photograph 157: View of sandbags lining the top of the canal wall at a turnout at M.P. 19.59; camera facing right bank from left bank, May 10, 2022. (B00069)

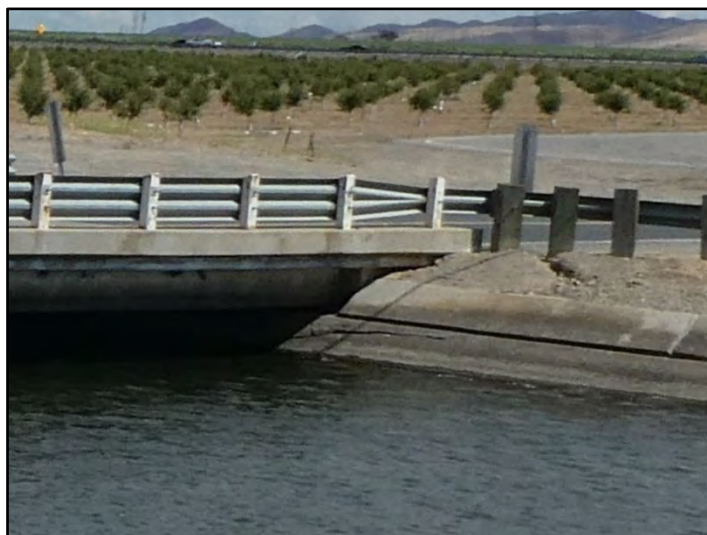
Photograph 171: Cracking in canal lining at right abutment of BRIDGE at M.P.; camera facing downstream from left bank, May 10, 2022 (B00116).

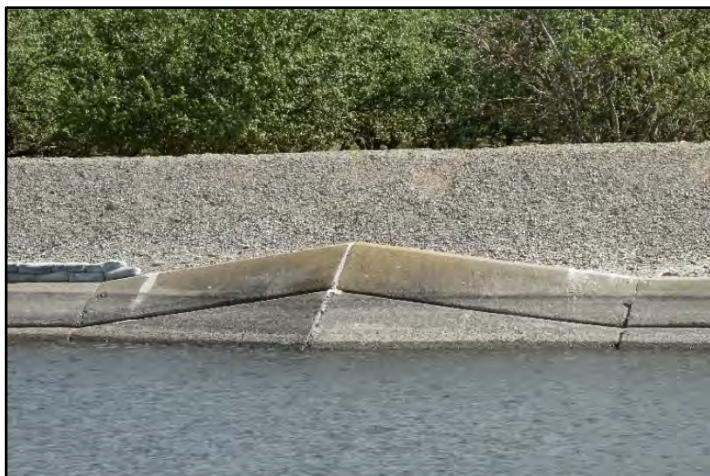
Photograph 172: View of repair to concrete lining around M.P. 22.90., with sandbags on top of wall downstream; camera facing right bank from left bank, May 10, 2022 (B00180).

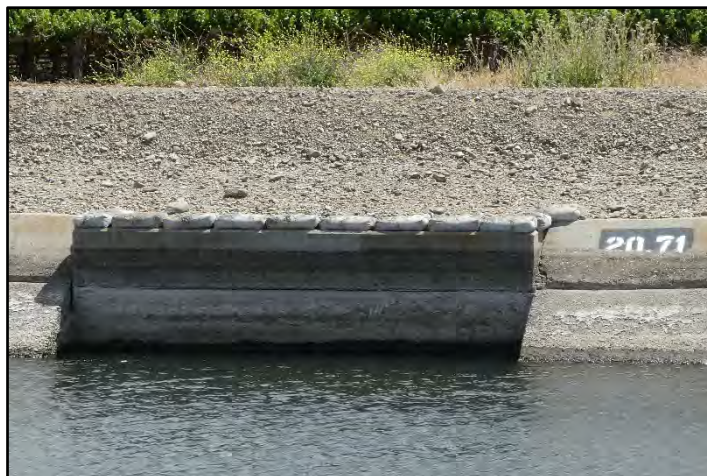
Photograph 173: Sandbags lining the concrete wall above the turnout at M.P.; camera facing right bank from left bank, May 10, 2022 (B00097)

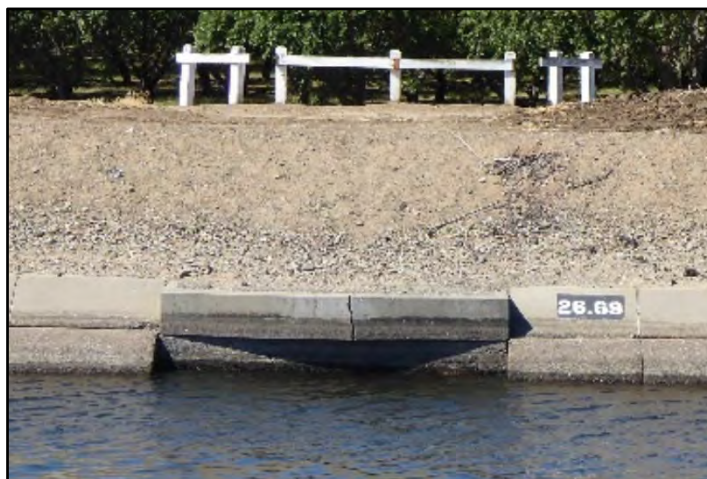
Photograph 180: Cracking on concrete lining around turnout at M.P. 26.69; camera facing right bank from left bank, May 11, 2022 (A00535).

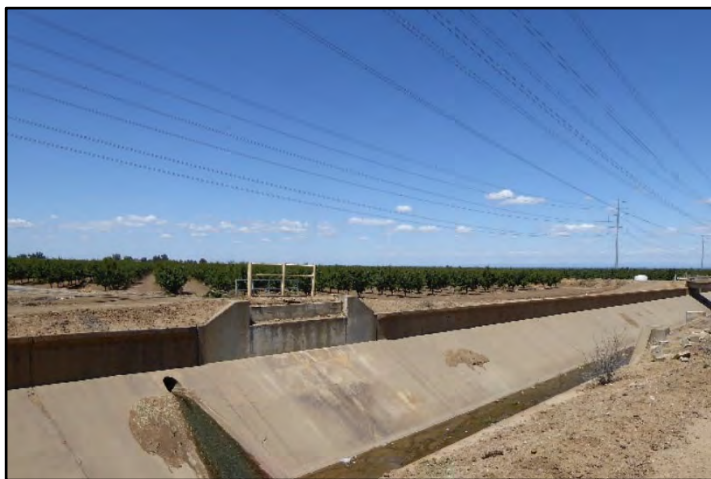
Photograph 192: View of wasteway concrete chute and missing bridge around M.P. 0.35 on the Westley Wasteway; camera facing downstream from right bank, May 11, 2022 (A00730).

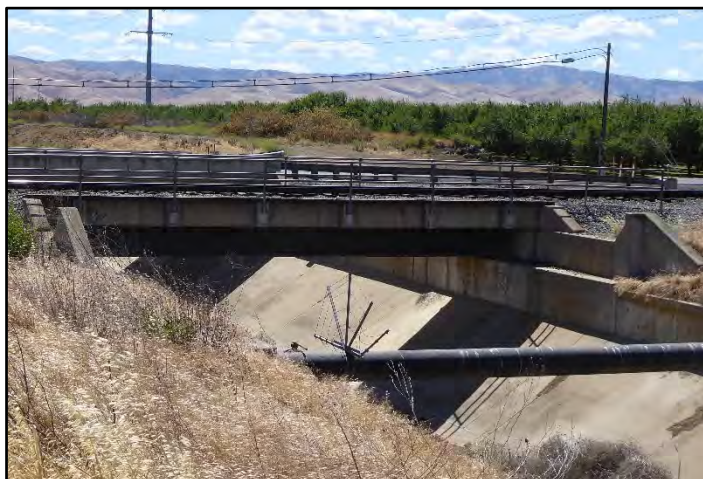
Photograph 193: View of Railroad Bridge at M.P. 2.06 on the Westley Wasteway; camera facing upstream from right bank, May 11, 2022 (A00756).

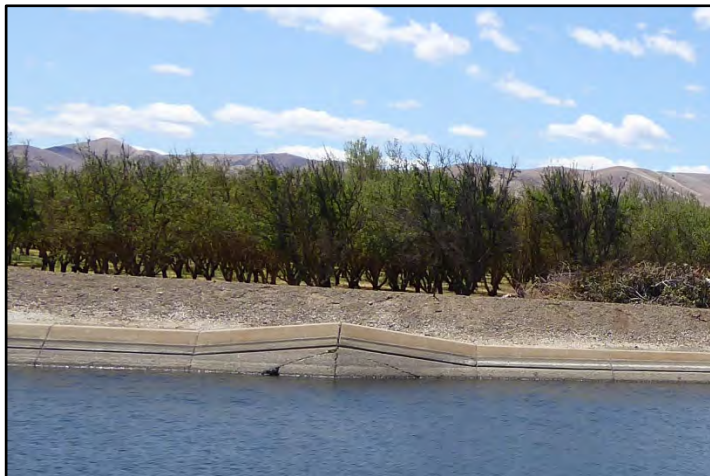
Photograph 198: View of a new crack on a repair to the canal wall near M.P. 30.63; camera facing right bank from left bank, May 11, 2022 (A00634).

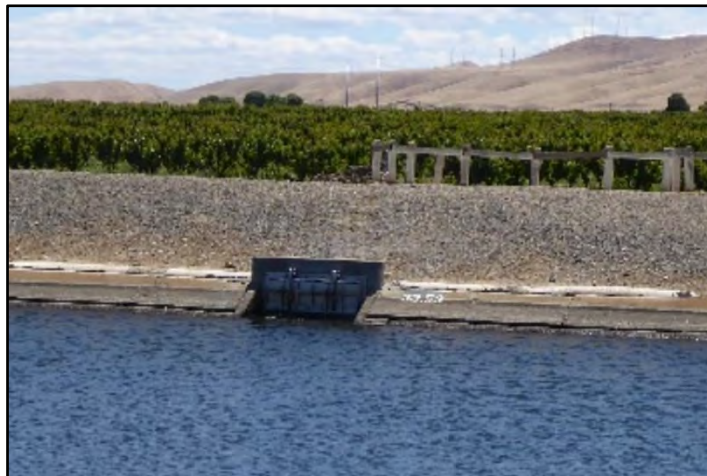
Photograph 199: View of sandbags lining the top of the concrete wall around turnout at M.P. 33.53; camera facing right bank from left bank, May 11, 2022 (A00690).

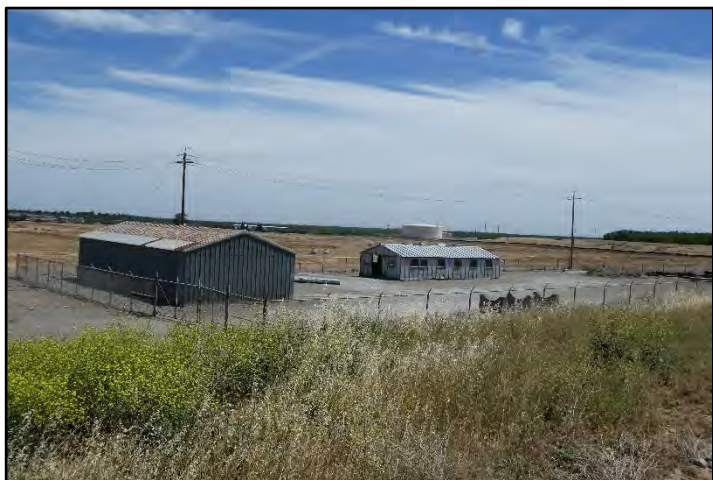
Photograph 224: Patterson O&M storage yard on the east side of the O&M road, at M.P. 40.00 containing two deteriorated and unused buildings; camera facing southeast, May 12, 2022 (B00364).

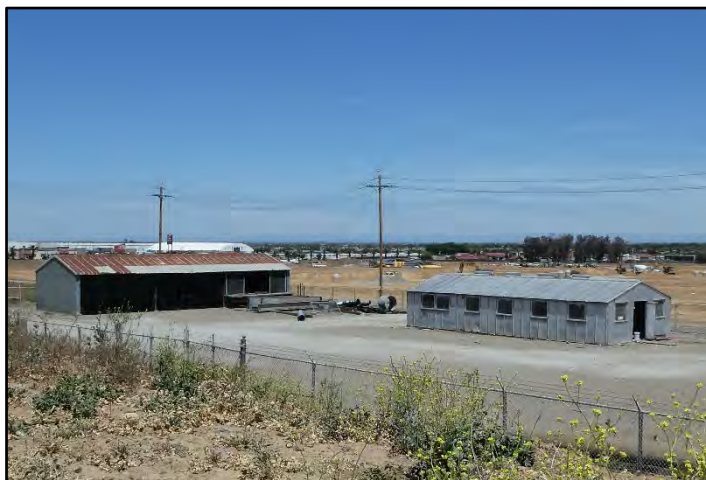
Photograph 225: Patterson O&M storage yard at M.P. 40.00 where buildings are no longer in use and have suffered heavy deterioration; camera facing southwest, May 12, 2022 (B00368).

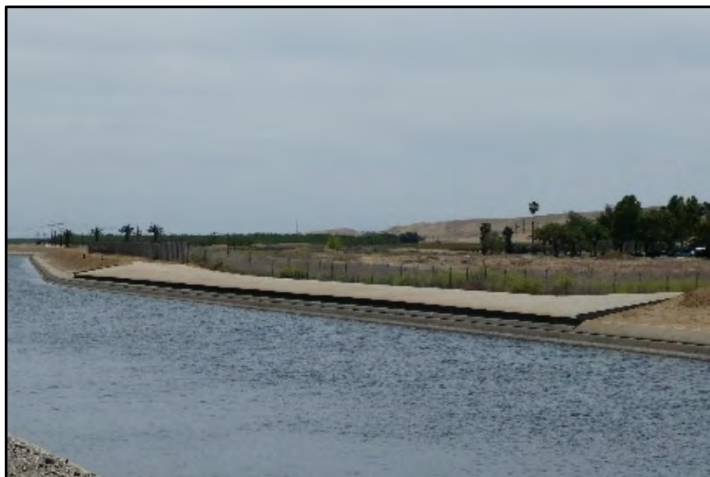
Photograph 226: Concrete overspill apron wasteway at M.P. 39.32/39.42 on the right bank is the only one of its type on the DMC; camera facing downstream from left bank; May 12, 2022 (B00338).

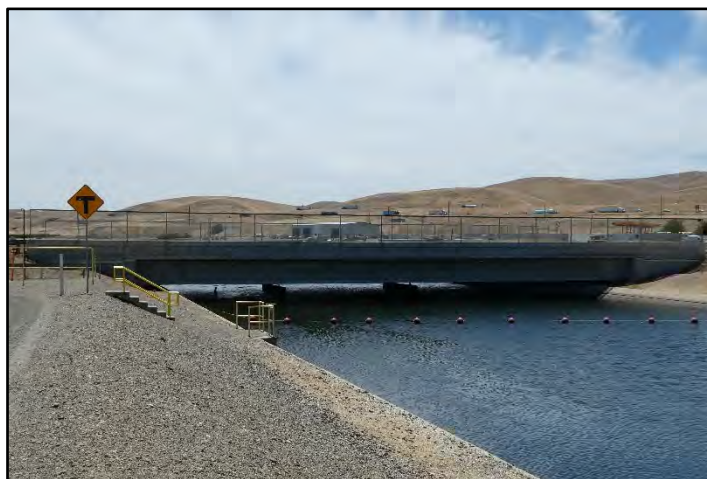
Photograph 231: Non-original replacement county highway bridge at M.P. 39.81 along Sperry Road/Hwy 130, concrete deck measuring 30 feet wide, that stretches between two large abutments with no support piers; camera facing downstream from left bank, May 12, 2022 (B00343).

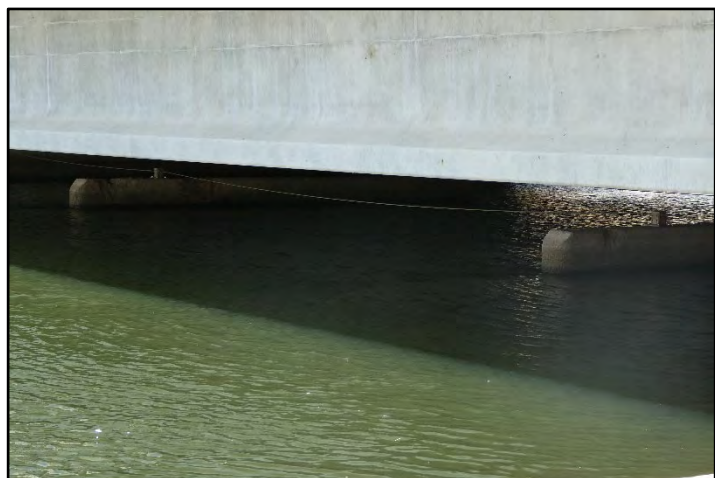
Photograph 232: Non-original replacement county highway bridge at M.P. 39.81 along Sperry Road/Hwy 130, with footings of the original bridge still evident underneath the current bridge; camera facing upstream from left bank, May 12, 2022 (B00350).

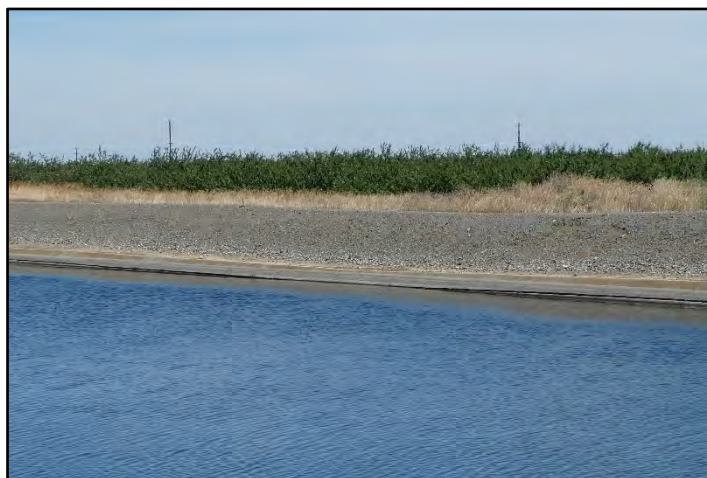
Photograph 233: Subsidence on right bank around M.P. 42.30; camera facing right bank from left bank, May 12, 2022 (B00417).

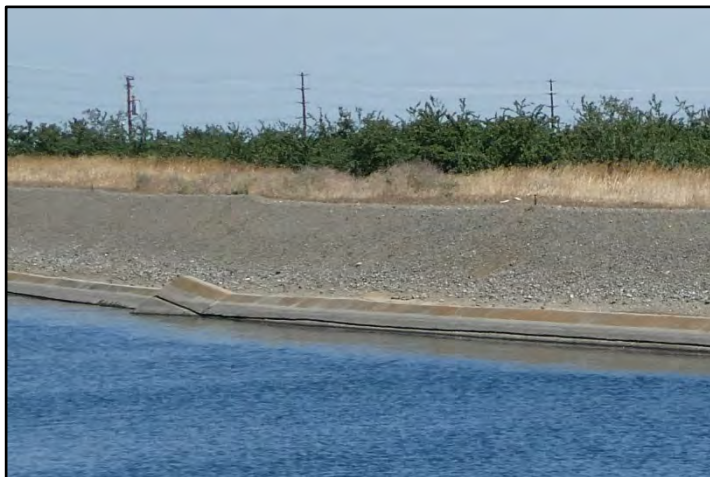
Photograph 234: Repair to the right bank canal lining around M.P. 42.3; camera facing right bank from left bank, May 12, 2022 (B00417).

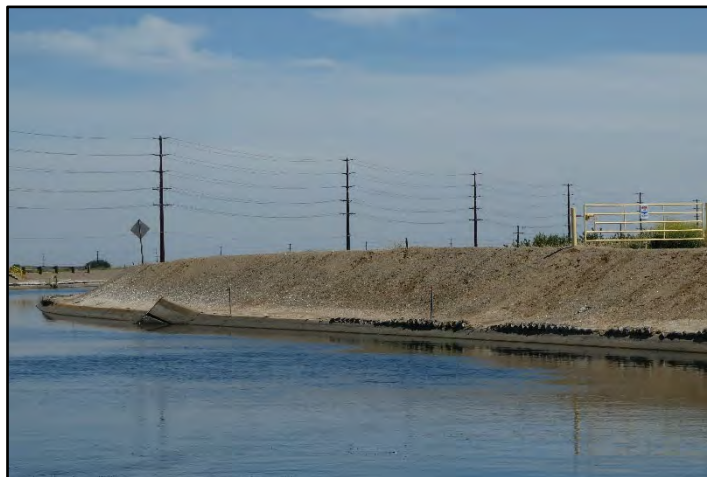
Photograph 235: Repairs to the right bank canal lining around M.P. 42.53; camera facing right bank from left bank, May 12, 2022 (B00426).

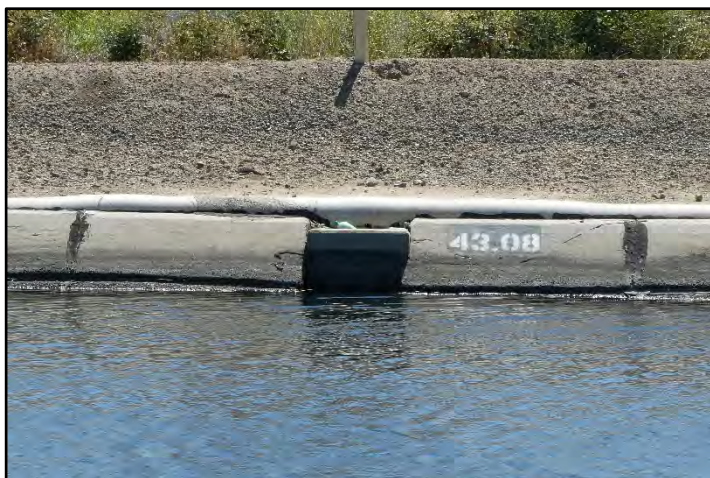
Photograph 236: Patches to right bank canal lining with fresh cracks visible around turnout at M.P. 43.08; camera facing right bank from left bank, May 12, 2022 (B00434).

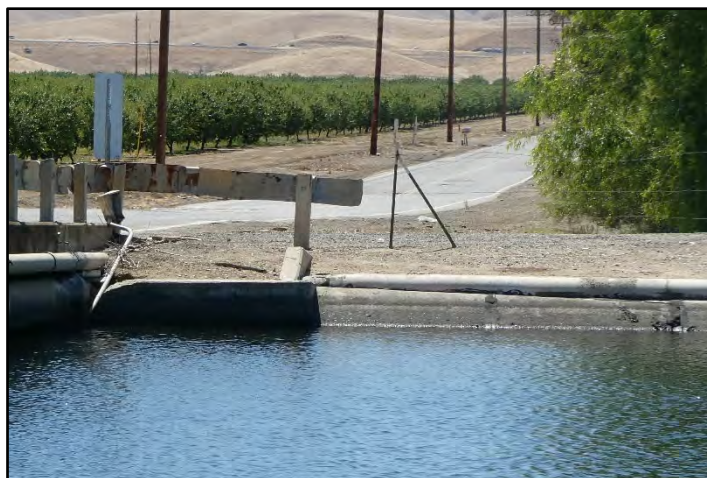
Photograph 237: Patches to right bank canal wall and subsidence just above Marshall Road bridge at M.P. 43.24; camera facing right bank from left bank, May 12, 2022 (B00442).

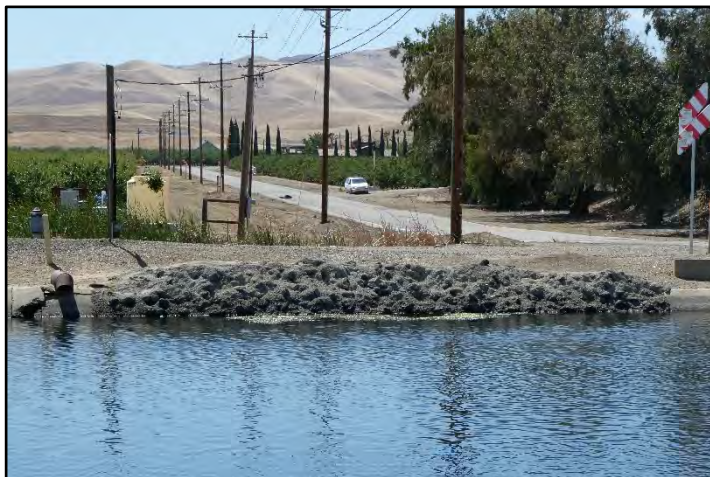
Photograph 238: Large repair to right bank canal wall between Marshall Road bridge and inlet drain at M.P. 43.24; camera facing right bank from left bank, May 12, 2022 (B00447).

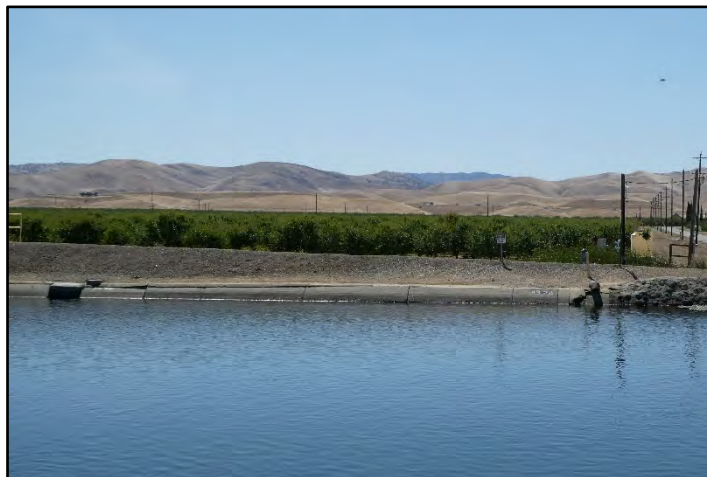
Photograph 239: Cracking in right bank canal lining between a large repair to canal wall just below Marshall Road bridge at M.P. 43.24 and drain inlet with flap gate on right bank at M.P. 43.26; camera facing right bank from left bank, May 12, 2022 (B00448).

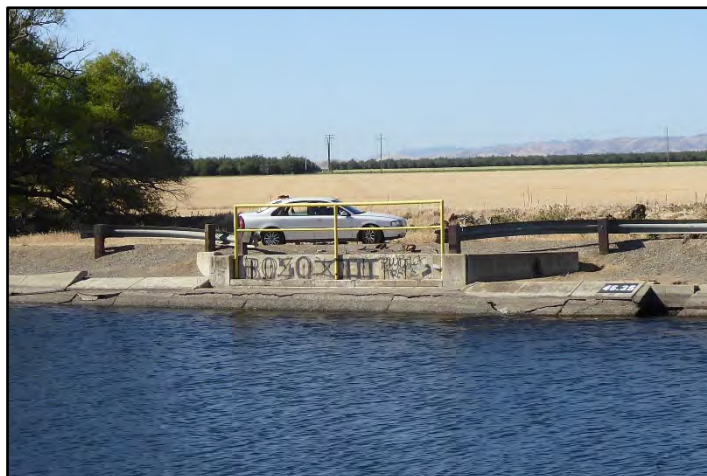
Photograph 244: Right abutment from a no longer extant farm bridge at M.P. 46.36, with cracking visible along the canal lining; camera facing right bank from left bank, May 13, 2022 (A00848).

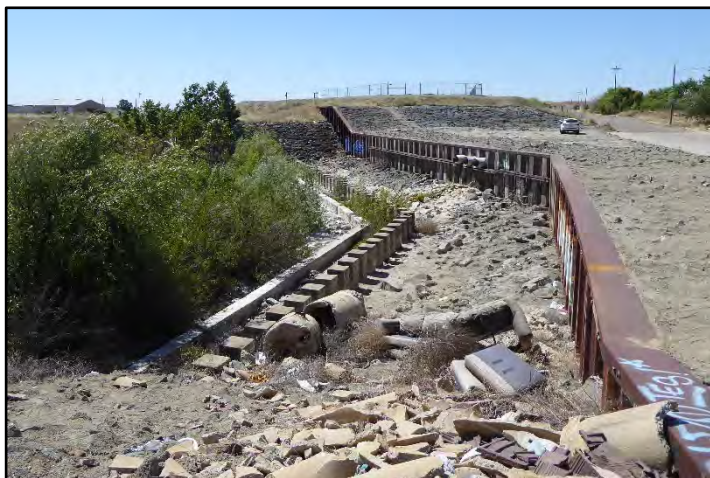
Photograph 254: Retaining wall around siphon and culvert that was repaired in 1995 after sheet piles were damaged in severe storm, fence around siphon outlet visible on elevated embankment in background (top center); camera facing south, May 13, 2022 (A00946).

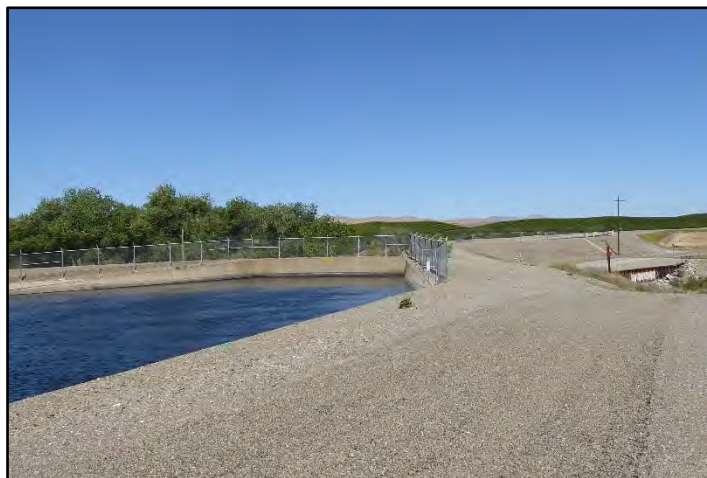
Photograph 255: Outlet headwall of Orestimba Creek siphon, at M.P. 51.27, repaired retaining wall visible in background (far right); camera facing upstream from left bank, May 13, 2022 (A00948).

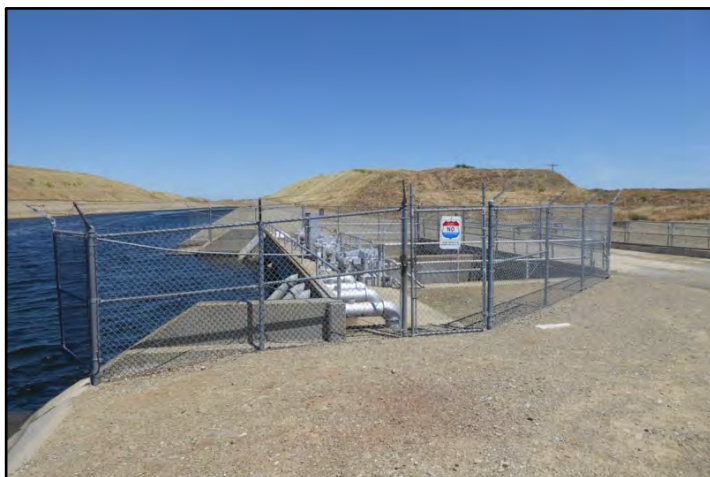
Photograph 256: View of Newman Wasteway inlet structure, looking upstream; camera facing downstream from left bank, May 13, 2022 (A00994).

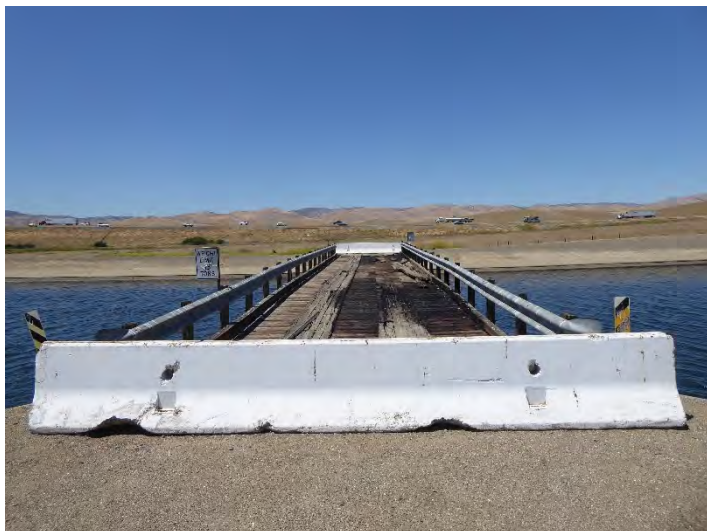
Photograph 270: Detail view of fire damaged deck of Operating Bridge at M.P. 56.02; right bank from left bank, May 13, 2022 (A01020)

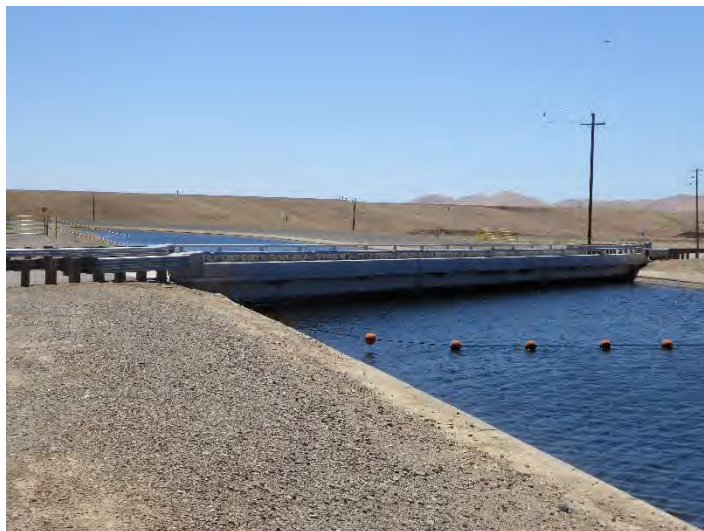
Photograph 271: View of concrete County Highway bridge at M.P. 56.60 along Pete Miller Road with parapet concrete walls, rather than the typical steel guard-rails; downstream from left bank, May 13, 2022 (A01027).

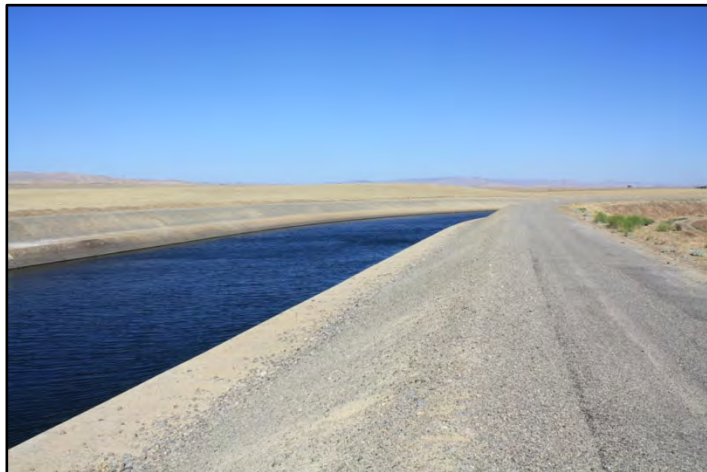
Photograph 303: View of Segment 15 approximately from M.P. 76.64; camera facing upstream from left bank, June 14, 2022 (C0254).

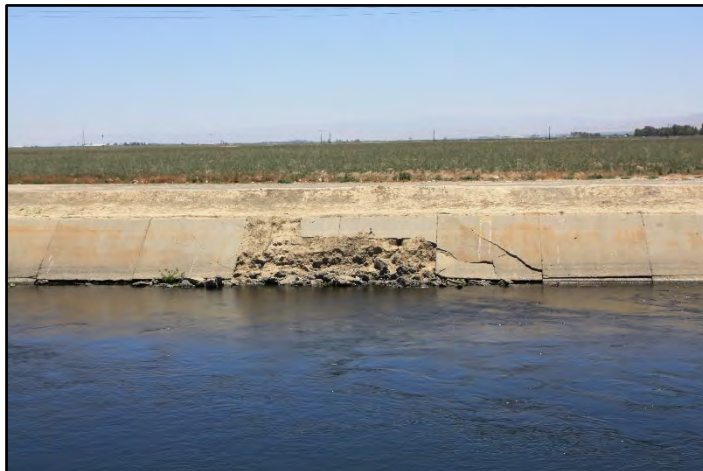
Photograph 339: Deteriorated concrete lining along right bank at approximately M.P. 96.82; camera facing right bank from left bank, June 14, 2022 (C0411).

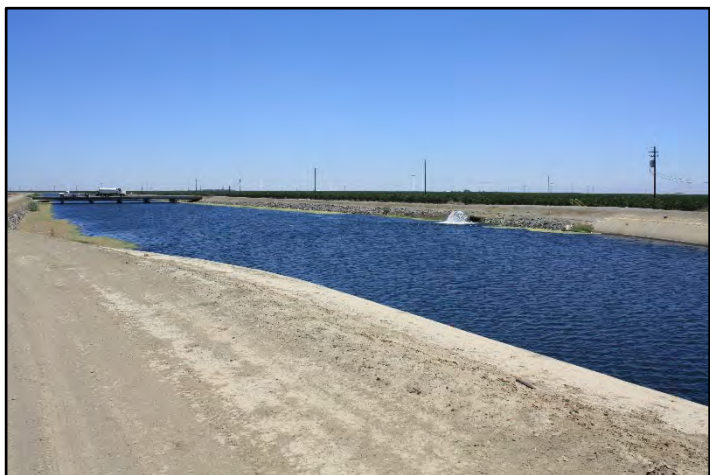
Photograph 340: View of Segment 19 from approximately M.P. 98.62, showing where it transitions from concrete-lined to earth-lined; camera facing downstream from left bank, June 14, 2022 (C0418).

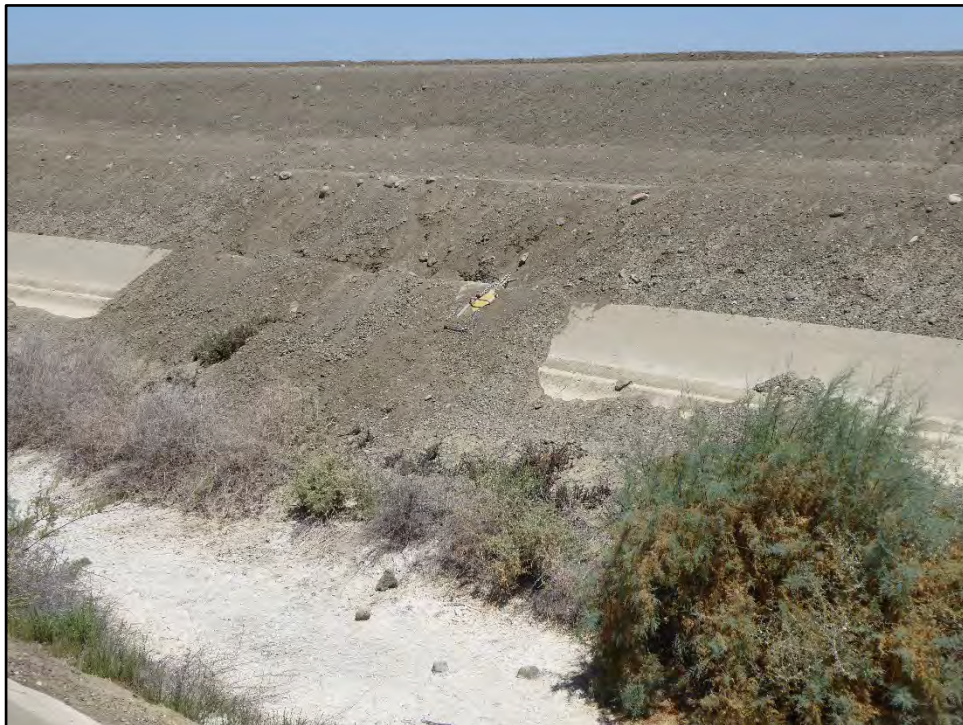
Photograph 11: Downstream view of San Luis Drain stainless steel safety ladder (partially obscured by erosion from the embankment); camera facing northwest, July 20, 2022.

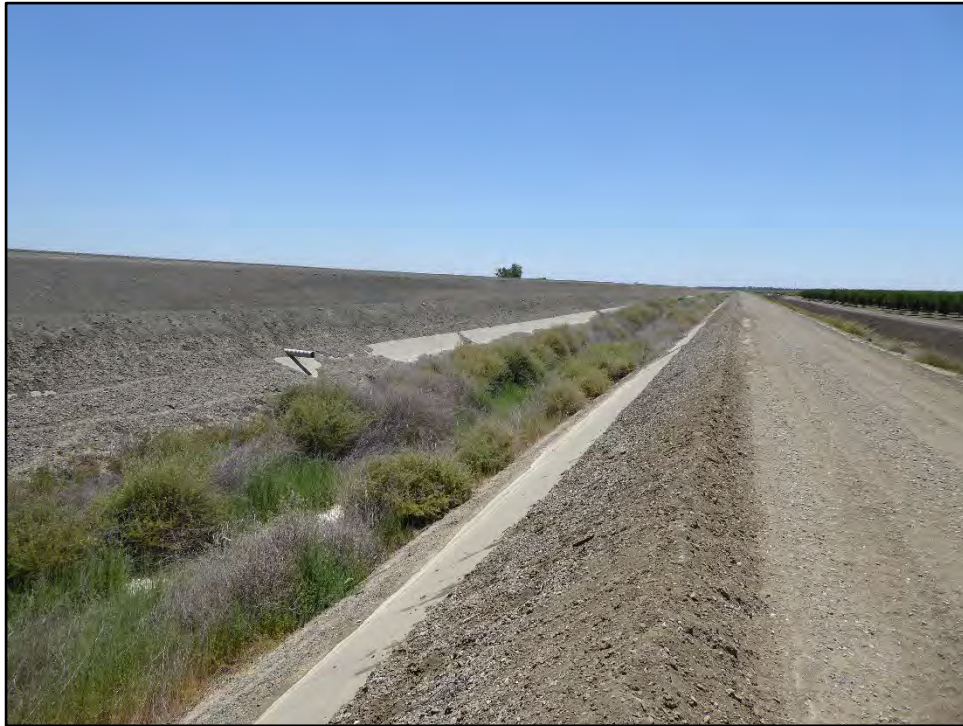
Photograph 12: Upstream view of San Luis Drain, with non-original inlet pipe; camera facing southeast, July 20, 2022.

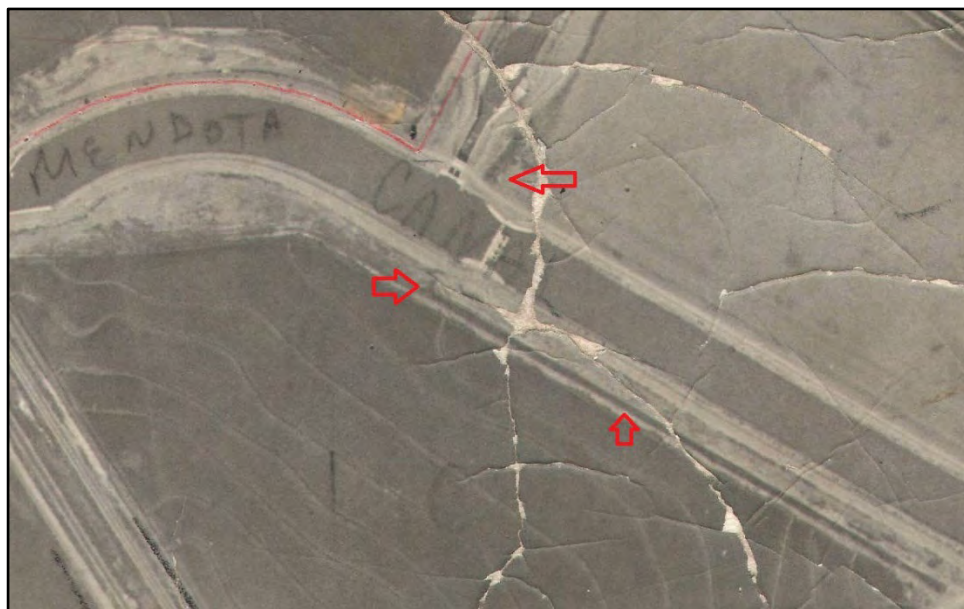
Figure 1: Excerpt of 1957 aerial photograph, with Firebaugh Canal Company drain (identified with arrows) in same alignment as San Luis Drain, adjacent to Delta Mendota Canal.³

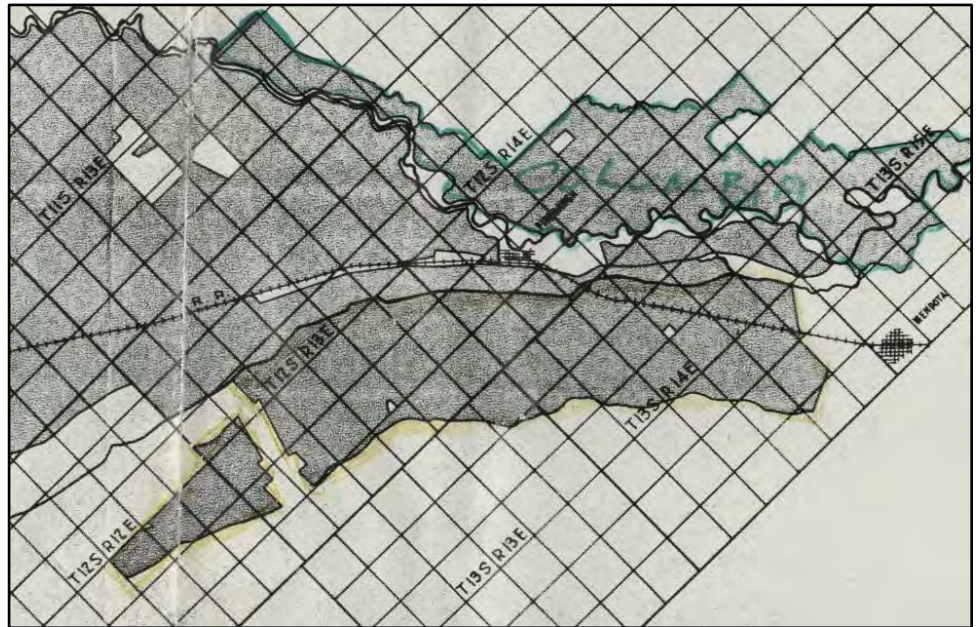
Figure 2: Excerpt of 1939 map showing service areas of San Joaquin River Exchange Contractors; Firebaugh Canal Company (outlined in yellow).⁴
