## Biological Resources

**PROTECTED TREE REPORT  
FOR  
PROPERTY  
AT**

**8426 N. KESTER AVENUE  
LOS ANGELES, CA 91402**

May 12, 2022

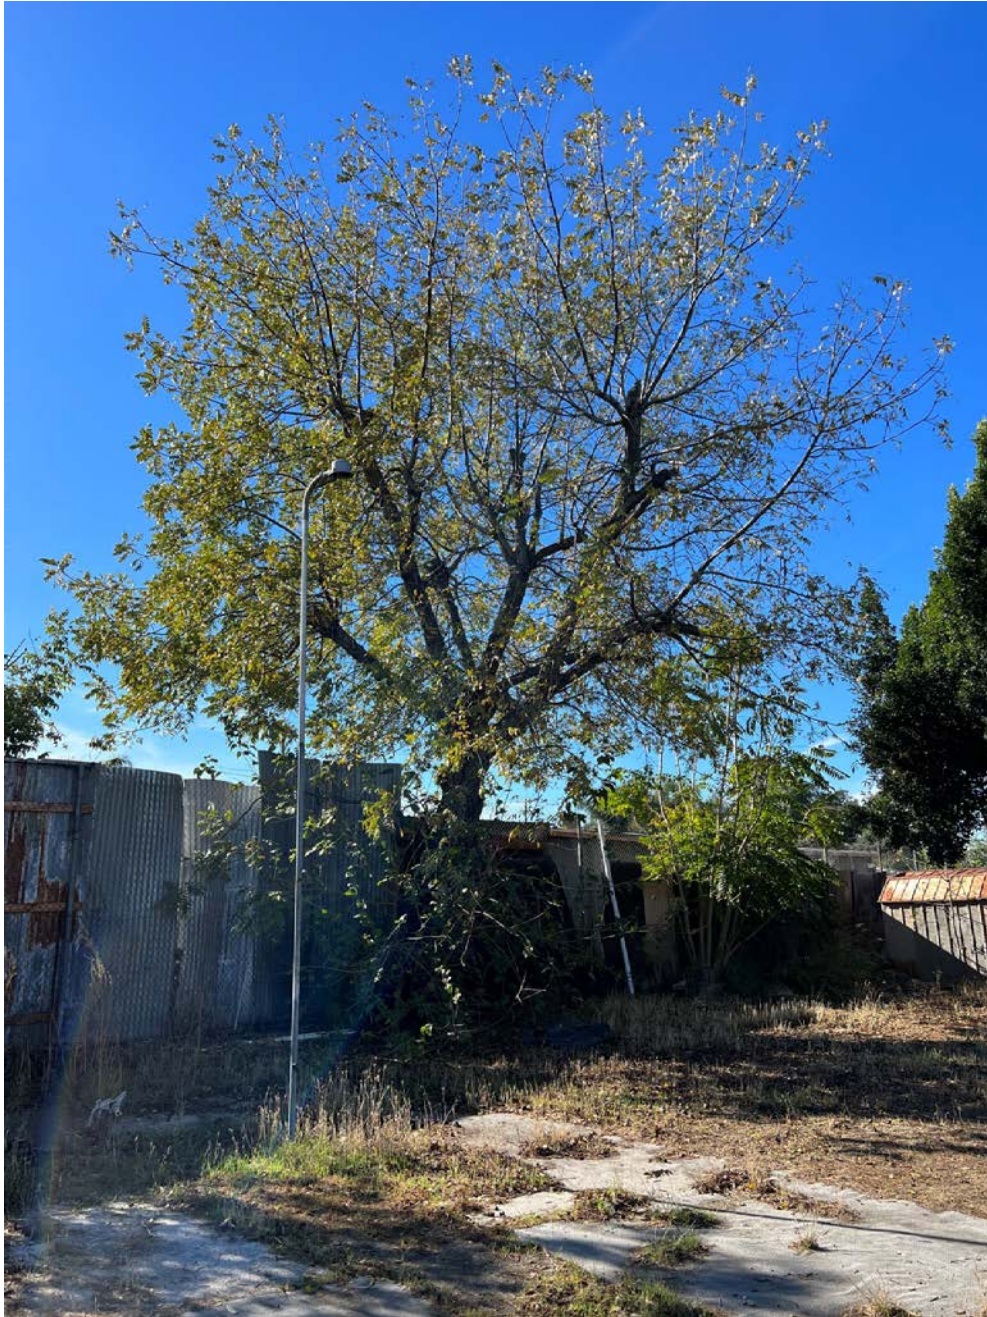
**Tree #958.**

This Southern California black walnut (*Juglans californica var. californica*) tree, originally numbered as T19, is located in the southeast area of the property, quite close to the property line.

The main trunk has a DBH of 25 inches, and it divides to four secondary stems at about nine feet above grade.

Almost all the main **scaffold branches** on this tree have been cut back substantially, but new branches have emerged, and with new **foliage** emerging with the advent of spring, the tree crown looks to be in acceptable form. These are **deciduous** trees, and on my first visit last March, there were no leaves in the **crown** of the tree. There are no **decay cavities** on the trunk or main stems. The main trunk has some **bulging** at various heights, an indication of injury and resulting response growth. The height of the tree reaches about 28 feet, and the longest canopy spread is of 32 feet, in the east-west directions.

Given all of the above, the **vigor** of this tree is average.

On a 0 to 5 scale (0 being dead and 5 being excellent), the **condition rating** for this tree is 3 (Average).

This tree is only four feet from the proposed dwelling, and it will be substantially damaged by excavation for the foundations. The crown of the tree also will have to be cut back significantly, because of conflict with the second story of the dwelling; therefore, this tree has to be removed.

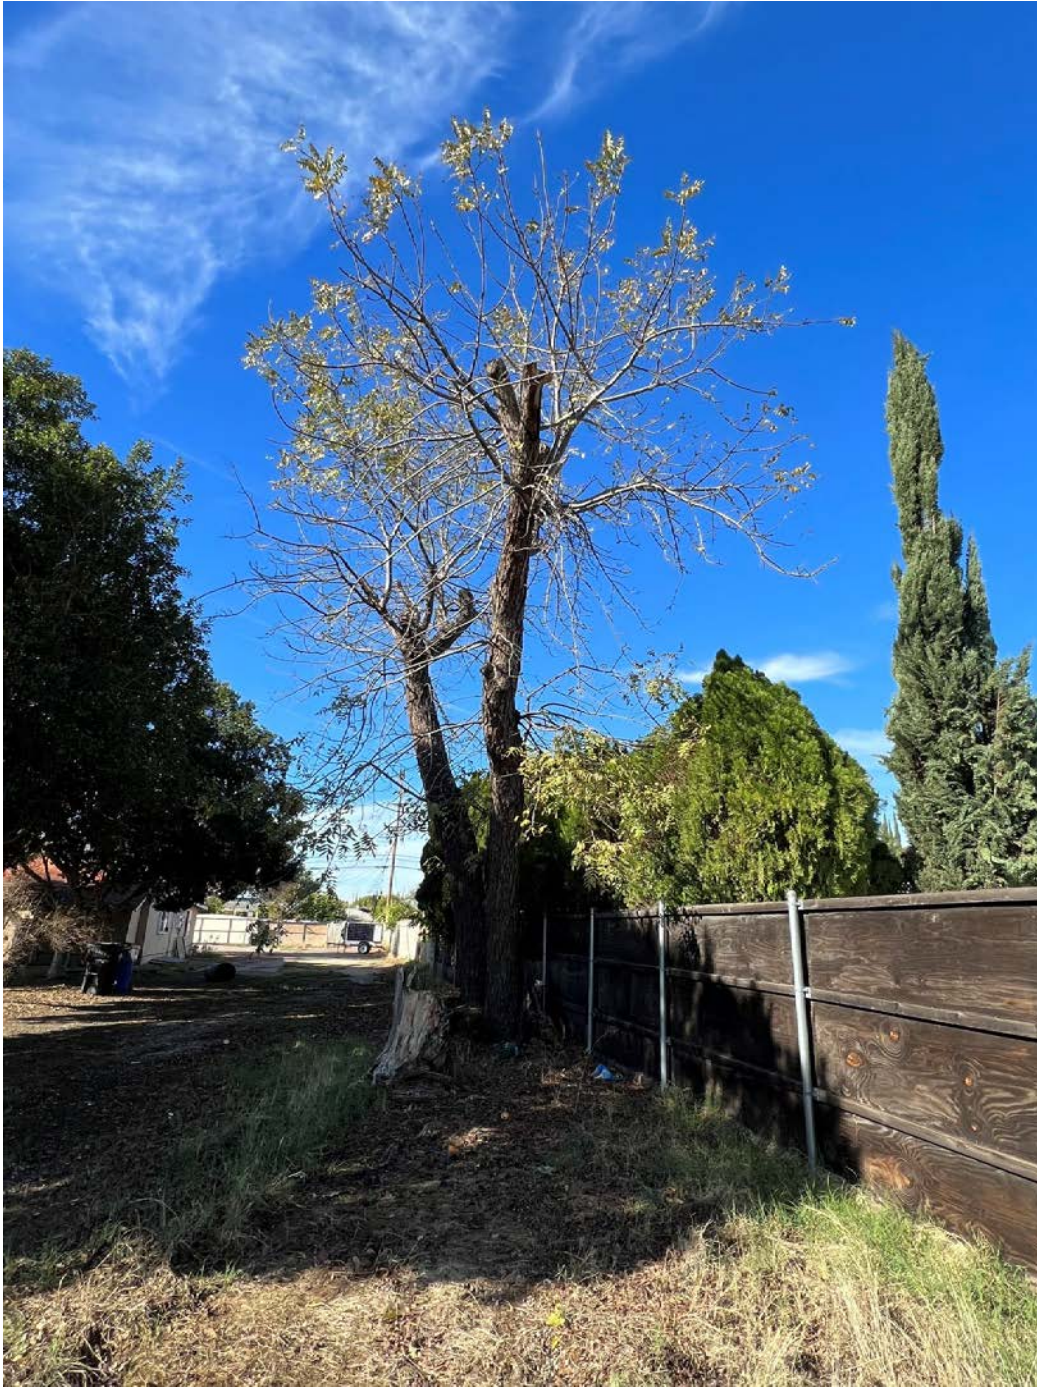
**Tree #959.**

This Southern California black walnut tree, originally numbered as T18, is located at the north side of the property, also quite close to the property line.

This is a multi-stem tree. It originally had four stems, but two of them have been cut back to the trunk base. The remaining two have respective 18 and 20 inches DBH, and the cumulative DBH is 38 inches.

On this tree also, all the main scaffold branches have been cut back substantially, but new branches have emerged, and new foliage is present on the small branches. Branches have also been cut over the north side property. The height of the tree is about 30 feet, and the longest canopy is of 34 feet, in the east-west direction.

This tree also exhibits identical conditions as the previous tree, with deadwood seen in the entire crown.

Given all of the above, the vigor of this tree is average.

On a 0 to 5 scale (0 being dead and 5 being excellent), the condition rating for this tree is 3 (Average).

This tree is quite far from the proposed structure and it can be retained, but it should be protected.

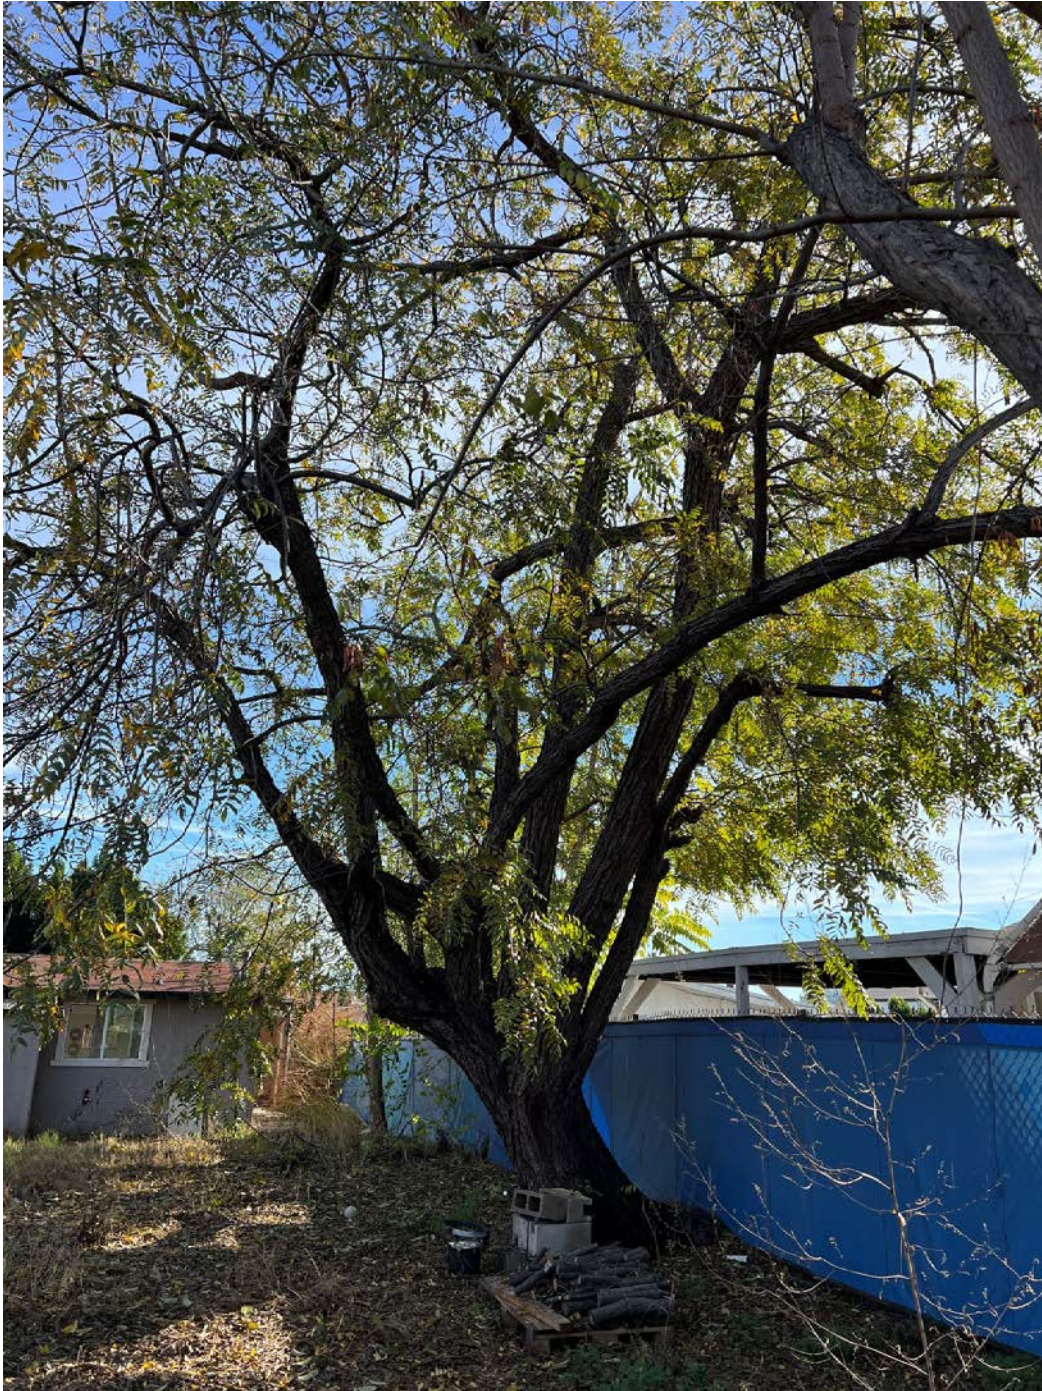
**Tree #960.**

This Southern California black walnut tree, originally numbered as T17, is located close to the south property line, and it is closer to the street compared to the previous two.

This is quite a significant-size tree; its main trunk has a DBH of 40 inches, right at the fork where it divides to main three stems.

This tree has had minor crown reduction compared to the other two trees.

The height of the crown is about 30 feet, and the longest canopy spread is 45 feet, in the east-west directions.

But this tree also has deadwood and dieback, and some minor decay cavities are visible.

Given all of the above, the vigor of this tree is average.

On a 0 to 5 scale (0 being dead and 5 being excellent), the condition rating for this tree is 3 (Average).

This tree is very close to the proposed dwelling of Lot 6, and it will be impacted significantly; therefore, it should be removed.

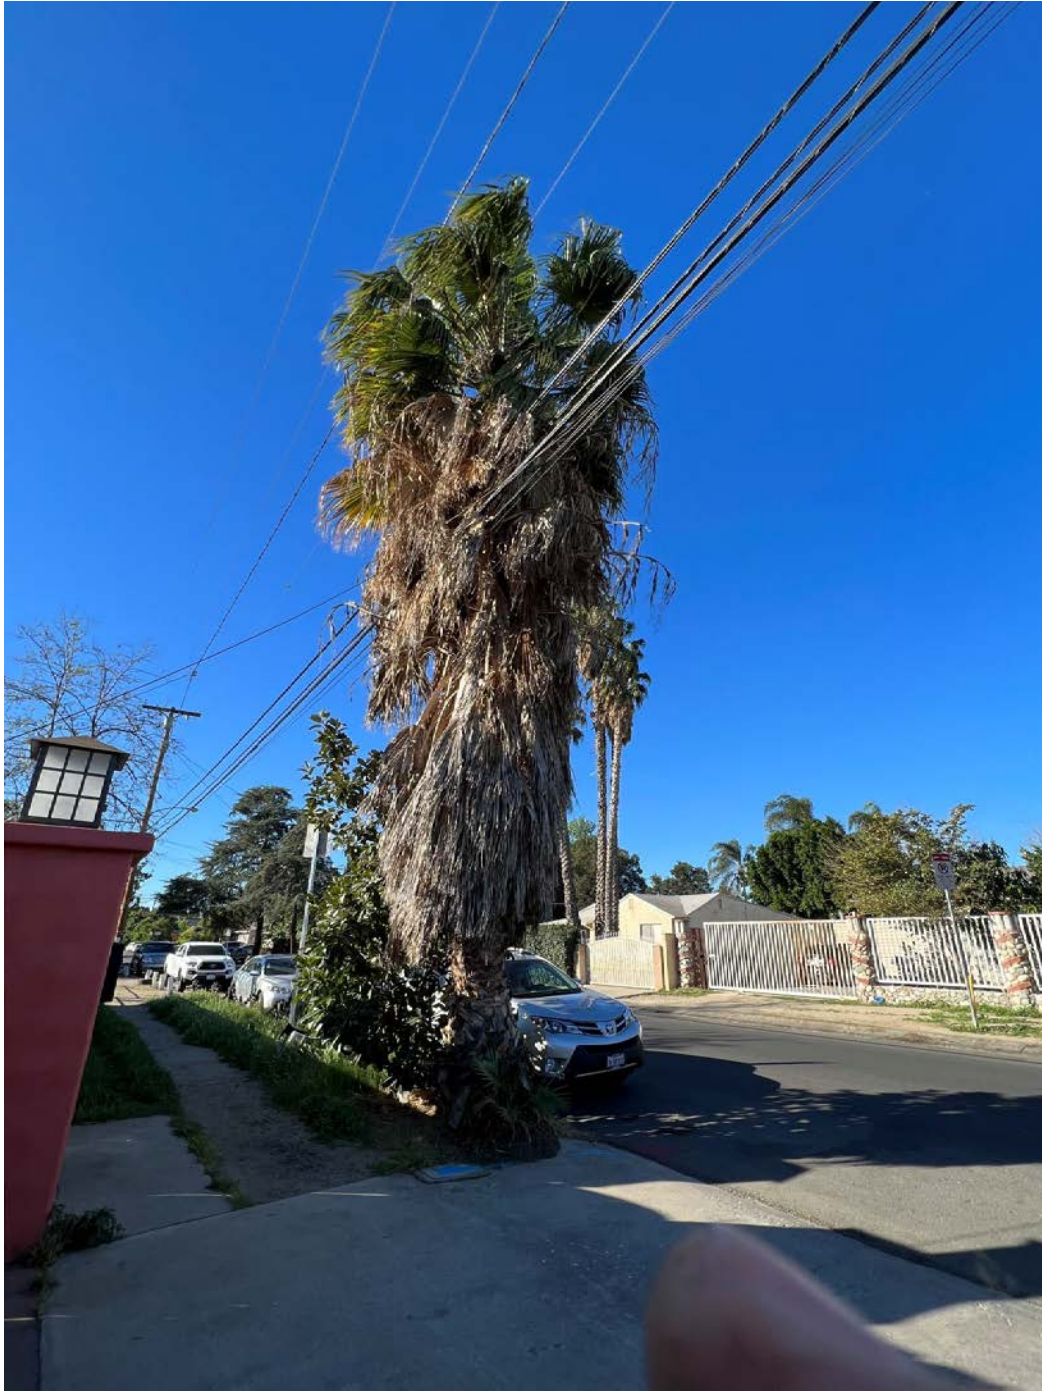
**Trees #961 and #962.**

This is a Mexican Fan palm (*Washingtonia robusta*) tree, originally identified as T2, located on the right of way planter, along Kester Ave.

It has a total clear trunk height of 20 feet, and it is overall in good condition.

Unfortunately, there are power lines overhead, and it will eventually have to be removed.

On a 0 to 5 scale (0 being dead and 5 being excellent), the condition rating for this tree is 4 (Good).

This tree is located within the footprint of the proposed new driveway; therefore, it should be removed.

These two trees are very young Southern Magnolia (*Magnolia grandiflora*) trees, located on both sides of the existing driveway, on the right of way planter. They were originally identified as T1 and T3.

They have a crown height of 11 and 7 feet respectively, and cumulative DBH of 4 and 5 inches.

They both are in average condition.

Both trees are far from the construction footprint, and can be retained. But they should be protected.
